**St Mary's Church,  
Church Road  
Hayling Island  
Application for reduction of Yew**

This document supports a Planning Application submitted by Andrew Skeet ONDipArb for reduction of ancient yew "11" in TPO 1615 at St Mary's churchyard.

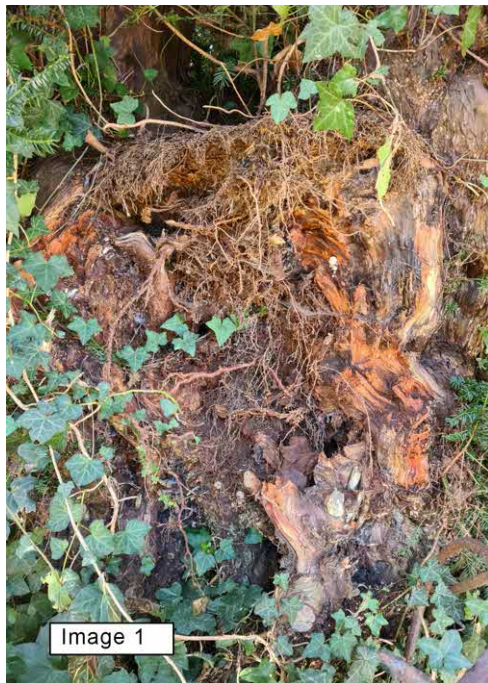
**Image 1** shows failure point

Late summer 2024 a large diameter (500mm approx) primary stem broke at the base and fell into the churchyard. This stem was part of the more ancient east side of the tree. Reason for failure was extensive basal decay. This was partially due to combined passive deterioration over centuries and active decay by *Laetiporus sulphureus*. This stem had not been braced or propped.

My recommendation is that reduction work to lower the tree's centre of gravity, reduce its wind resistance (sail area) and start moving to a smaller lower and denser crown, should be carried out. Light reduction work on the east side was carried out when the props were fitted in 2016 with the intention further reduction would follow. This work will inevitably diminish the tree's appearance somewhat but is the best way of ensuring the welfare and maximum longevity of the most important and interesting ancient lower structure. As viewed principally from the east, it can be seen that the tree has already made good progress on forming a smaller lower crown which the proposed reduction work will be using as a guide

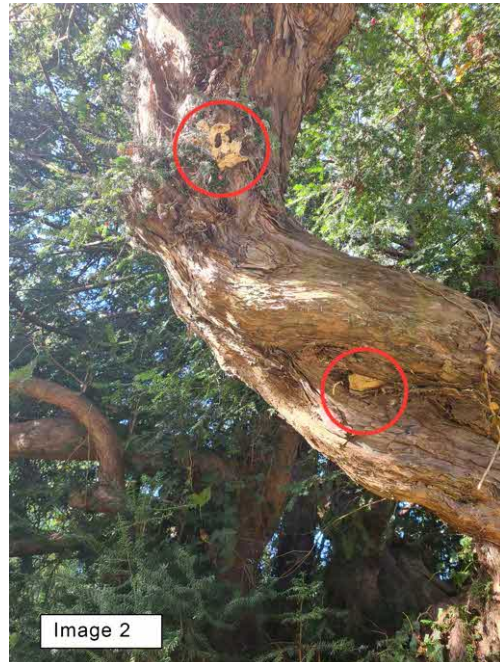
**Image 2** shows examples of Laetiporus bracket remains on a primary stem close to the fracture. This stem is a likely candidate for failure.

It is often the case that a multi stem tree which loses a primary stem is more prone to further damage. This is due to fracturing of the base and an increase in how wind forces can act on the remaining structure.

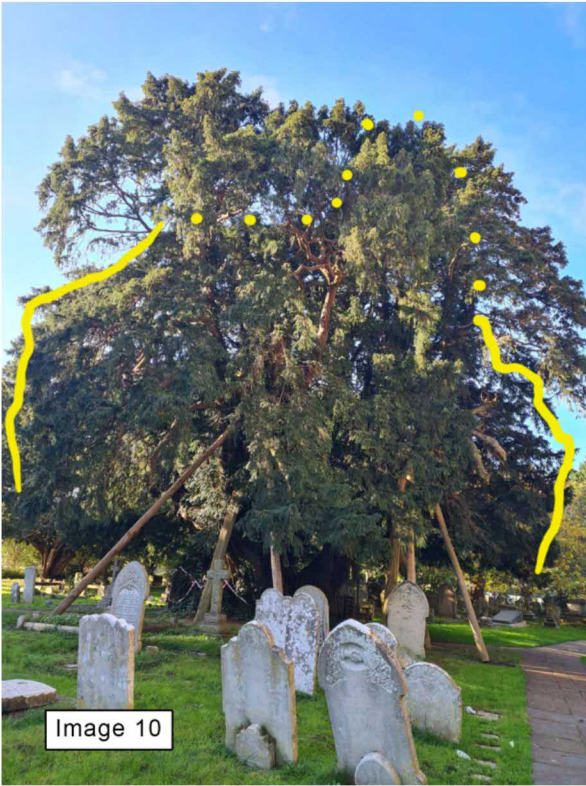
**Image 10** – illustrating secondary crown being naturally formed by the tree
