## Site inspection report for

### Langstone Lodge

#### 1 Langstone Road

24/2837/GEN

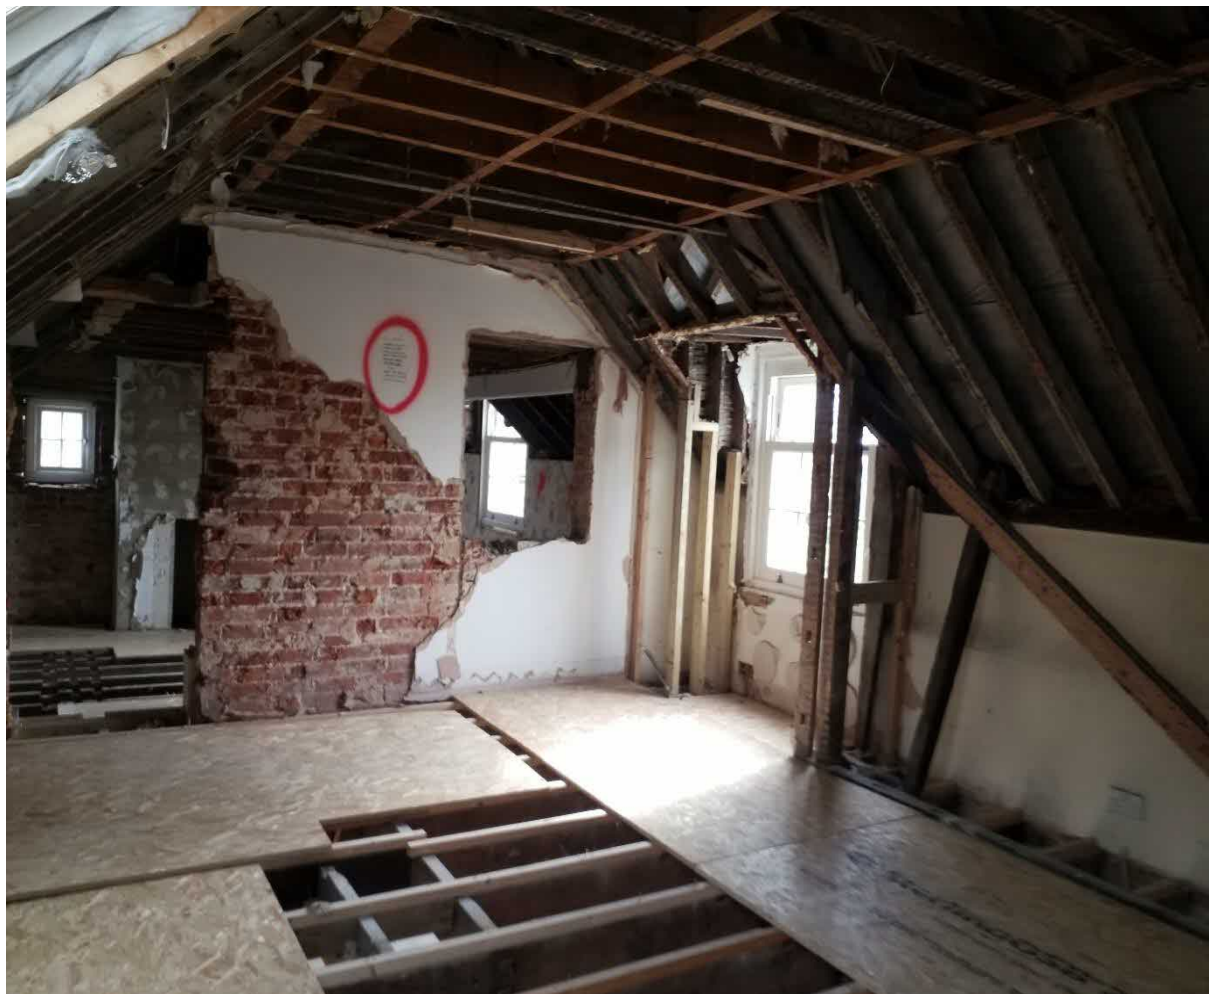
Photo 23 (Alterations to roof structure)

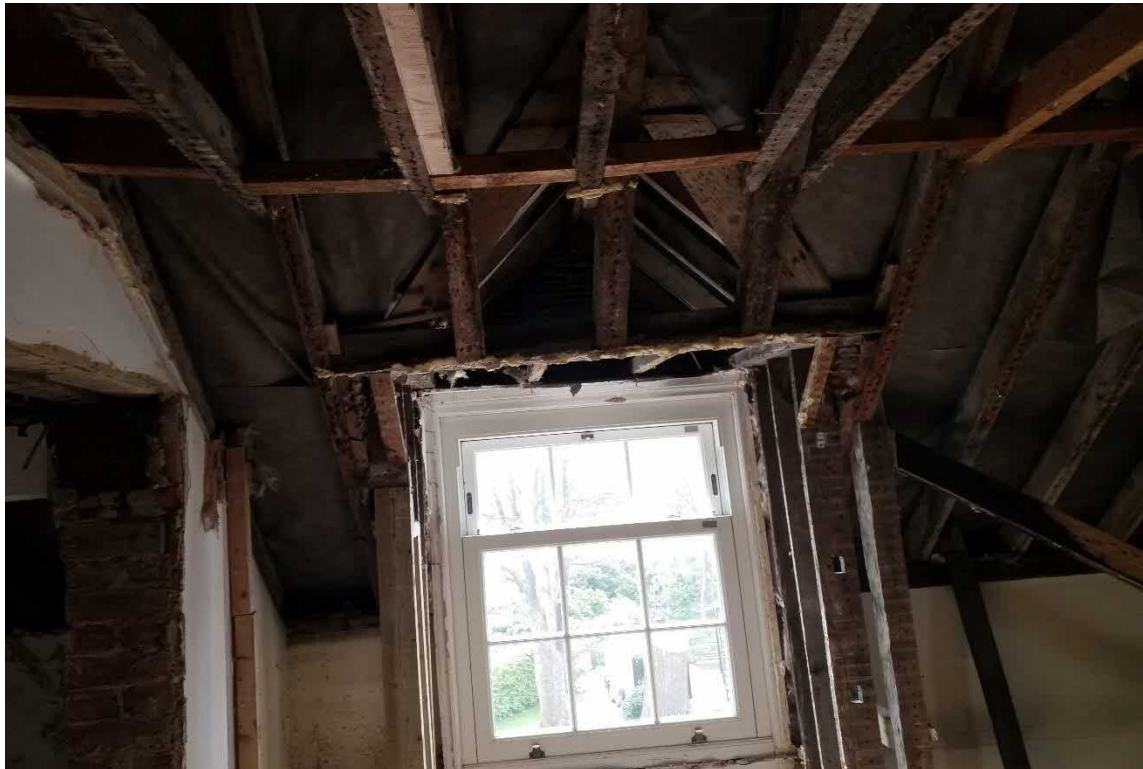
Photo 24 (Existing dormer)

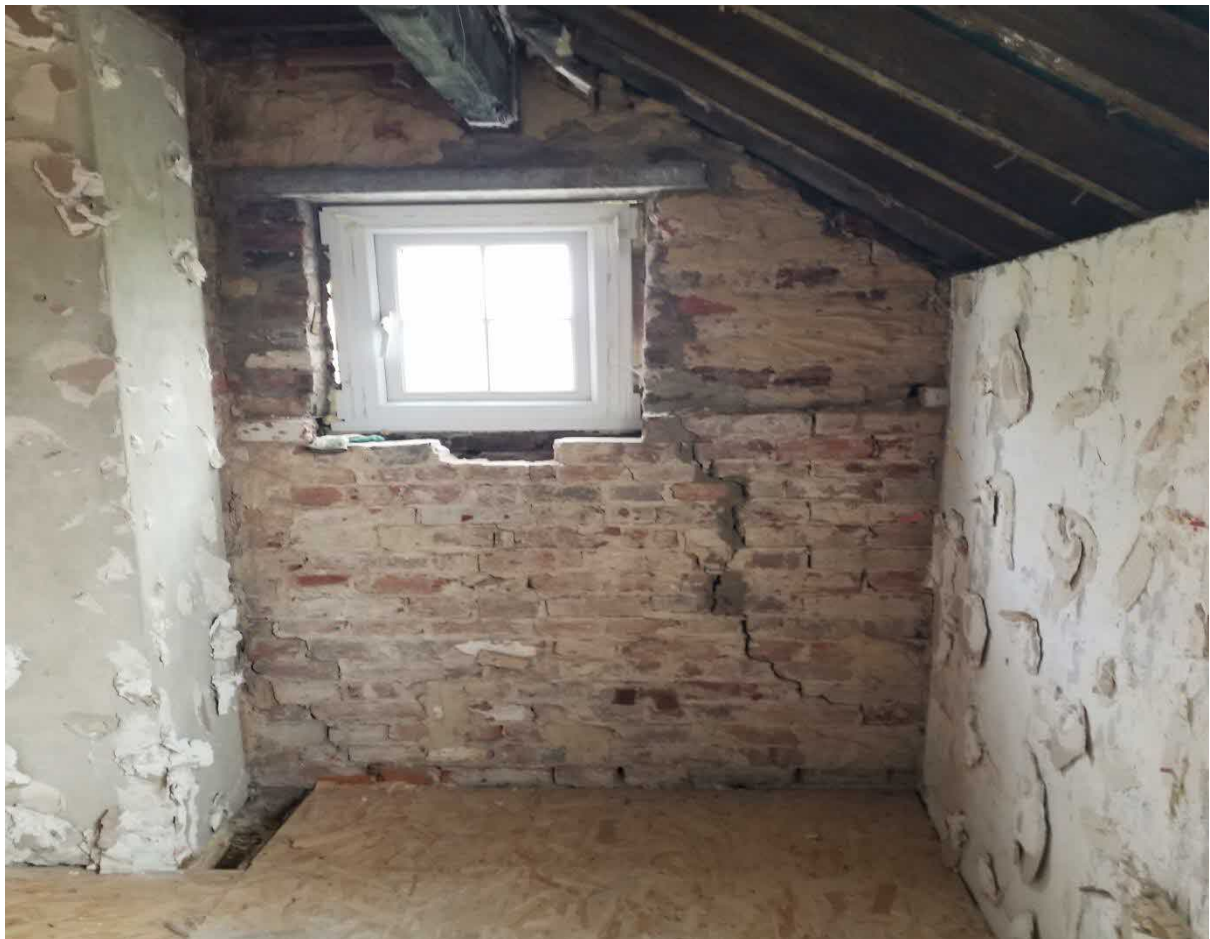
End gable does show signs of movement (bowing outwards) this is likely due to installation of concrete lintels in loft area in a lime mortar structure cracking visible in this location.

Photo 21 (Cracking to side gable internal – Concrete lintel)

Possible Solution Remove lintel and replace using correct mortar and restitch brickwork together.

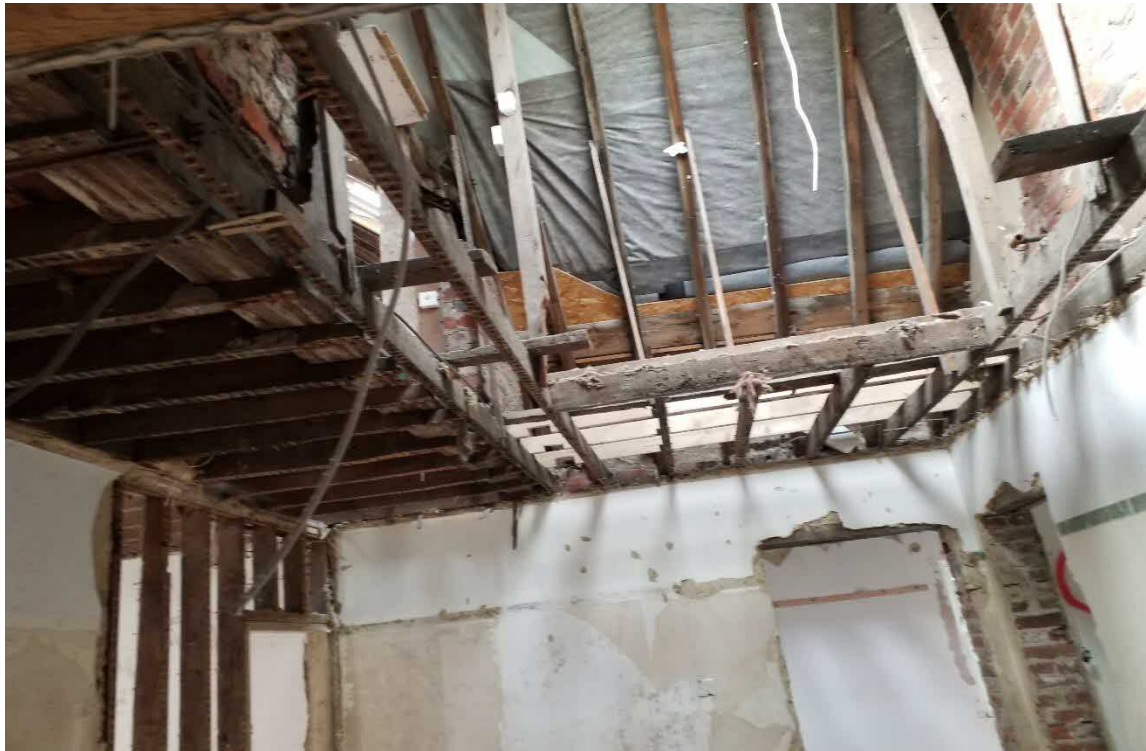
Photo 22 (Poor support to both roof and floor opening)

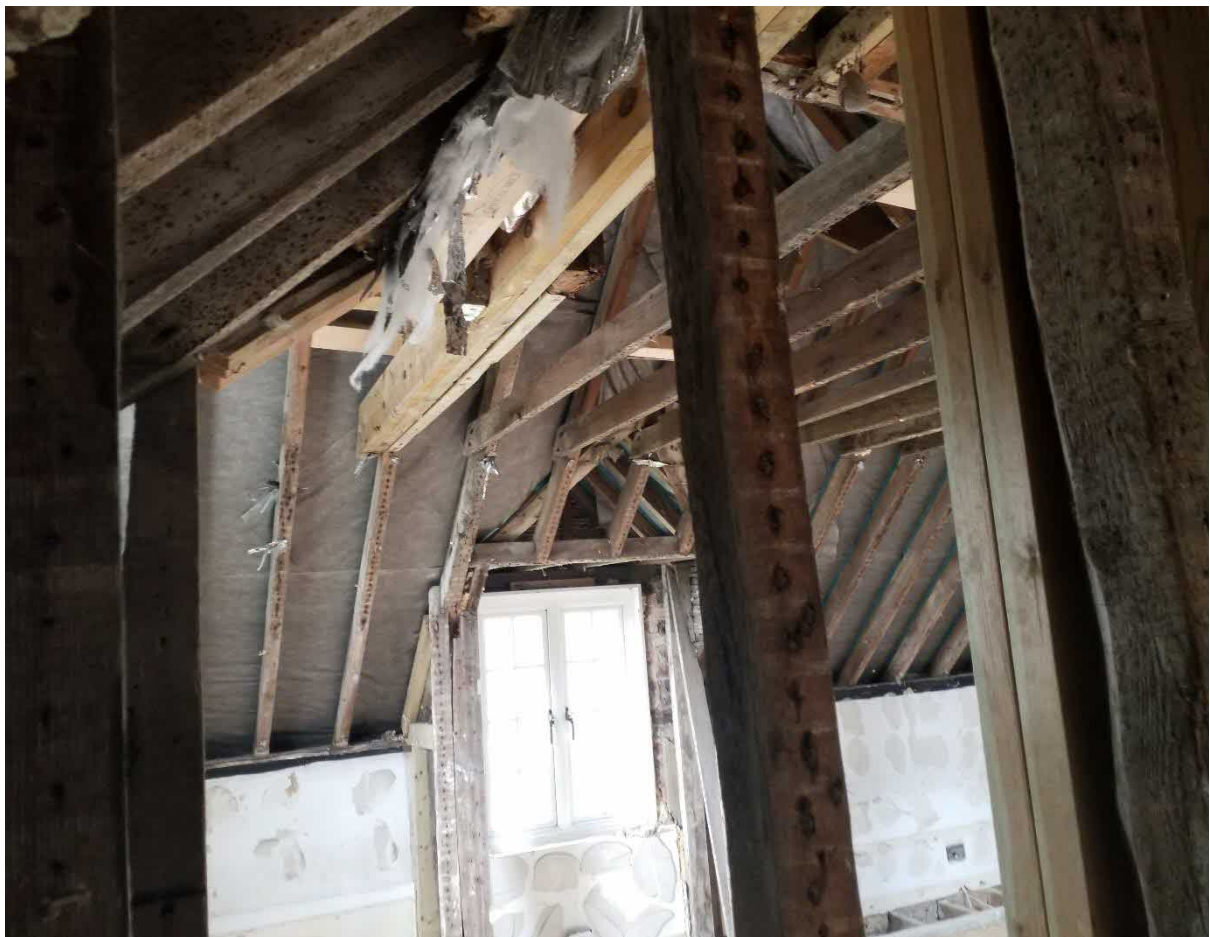
Photo 20 (Alterations undertaken)

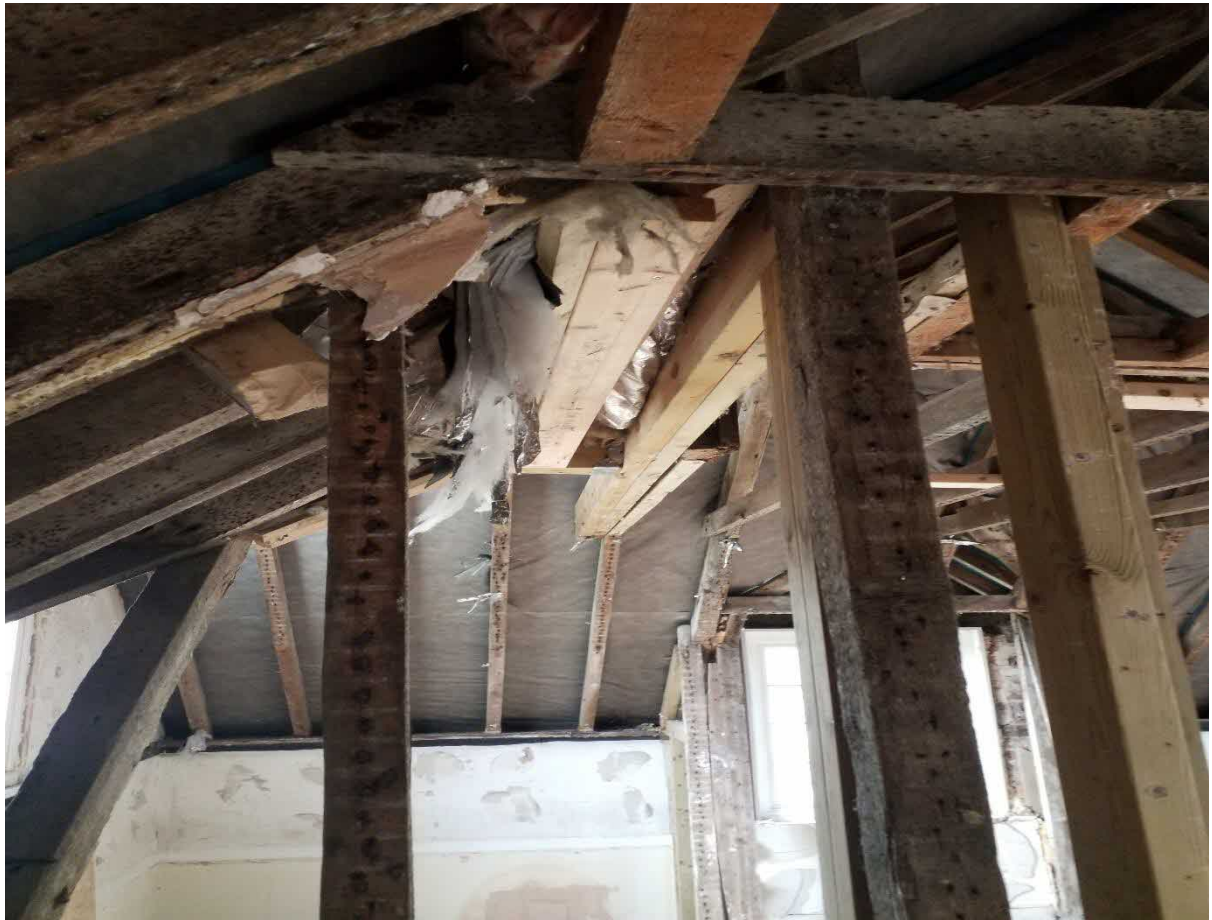
Photo 8 (Roof alterations)

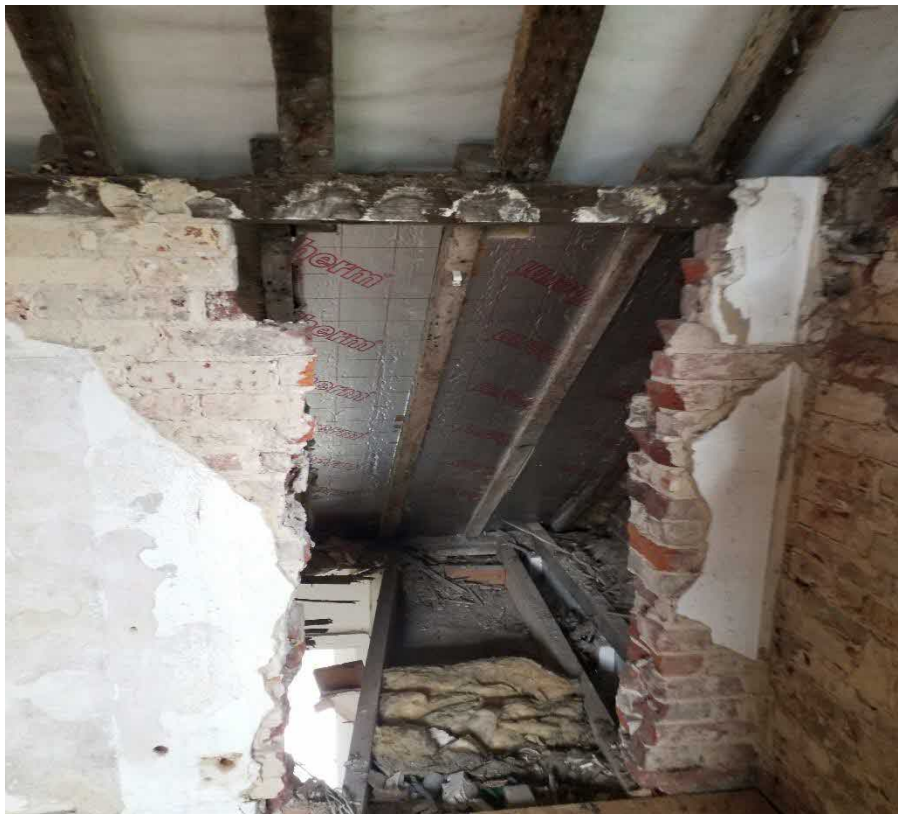
Photo 18 (Supporting wall removed)

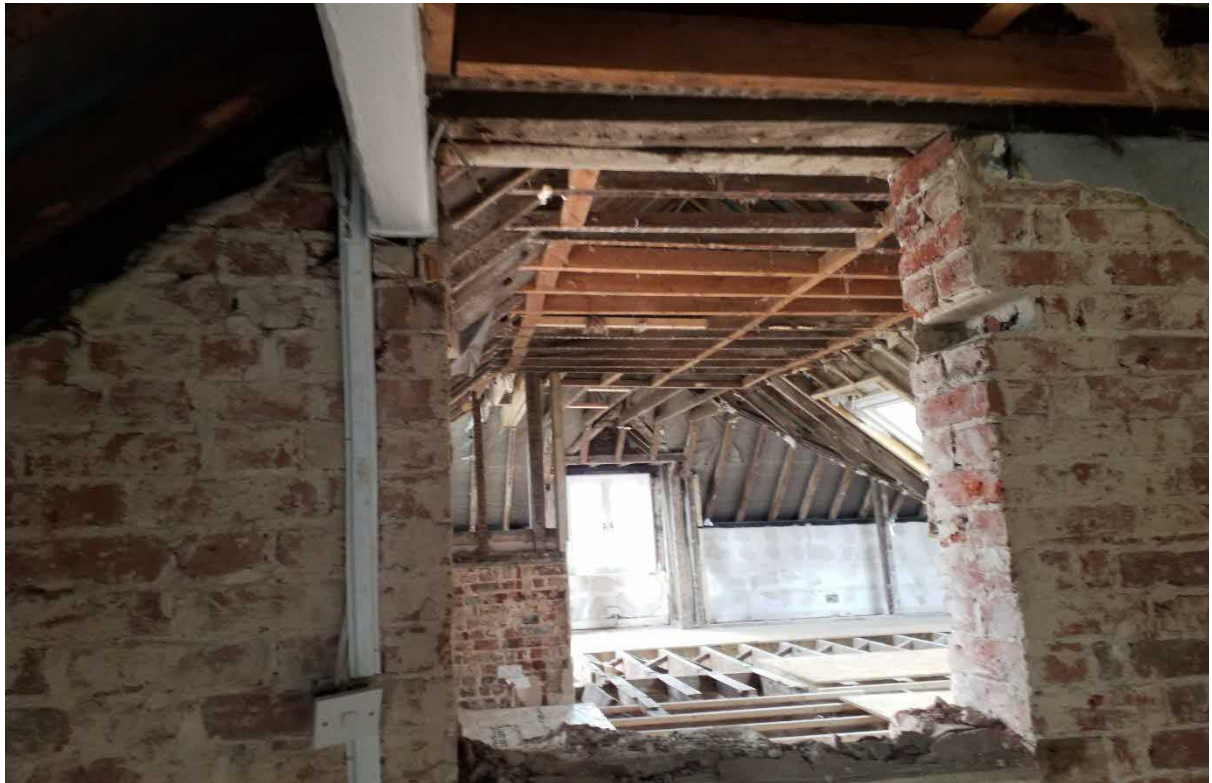
Photo 17 (Openings created)

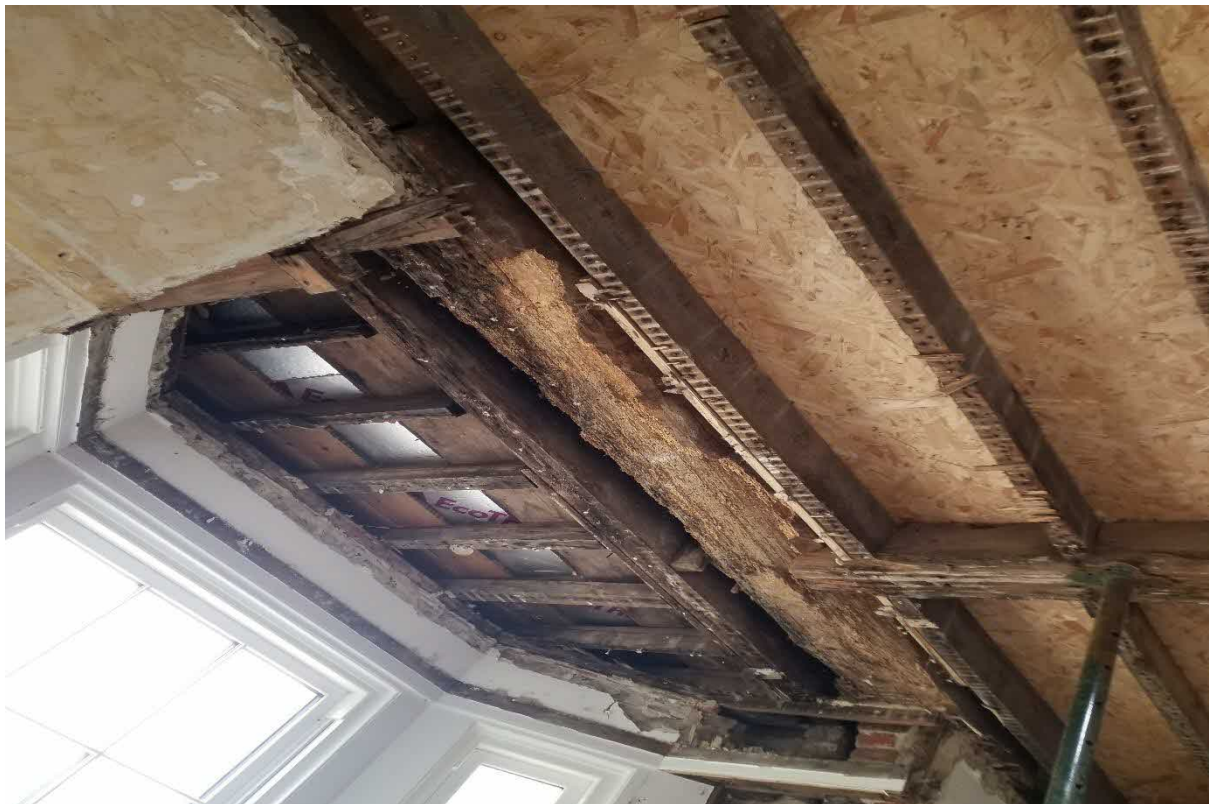
Photo 17 (Timber beam)

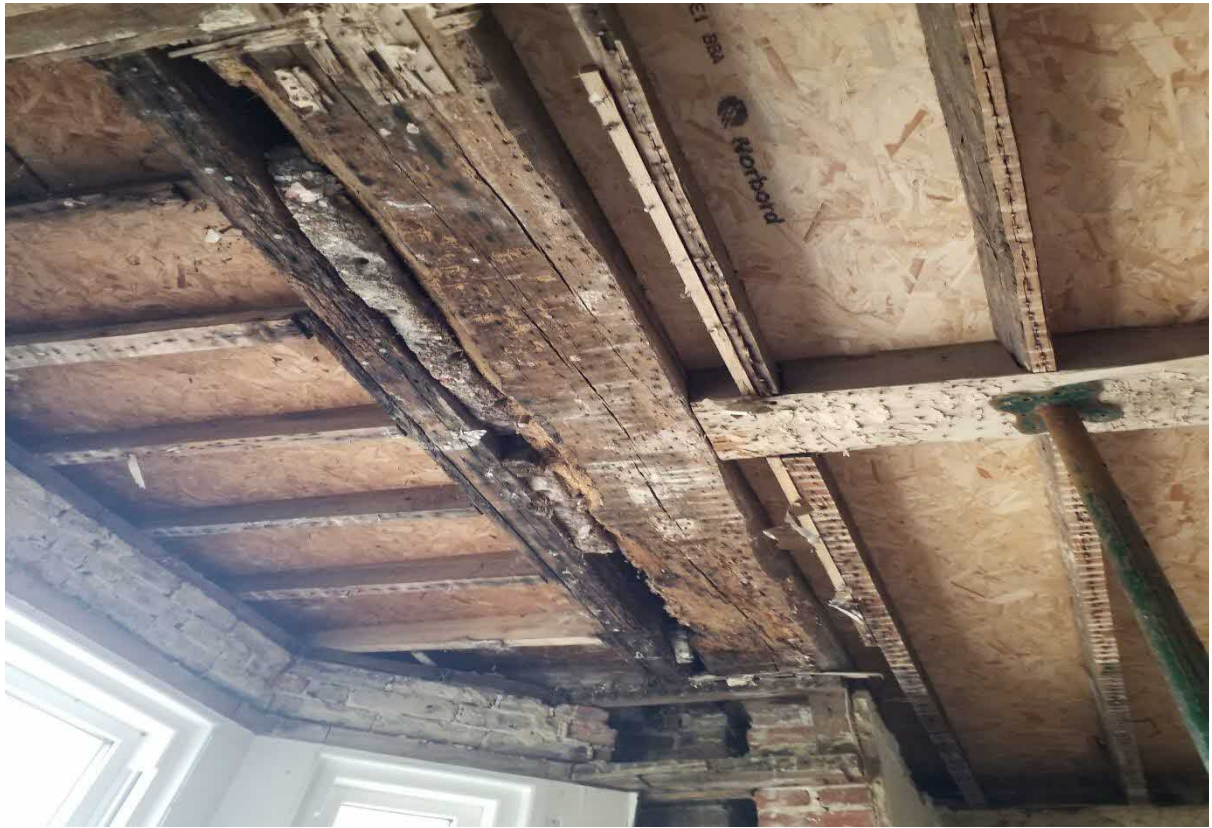
Internal supporting timber beams and floor members should be inspected on a floor-by-floor level as some areas are showing poor connection / condition due to age, previous alterations and where roof has issues.

Photo 9 (Timber beam lack of connections)

Possible Solution These areas should be checked and replaced as necessary.

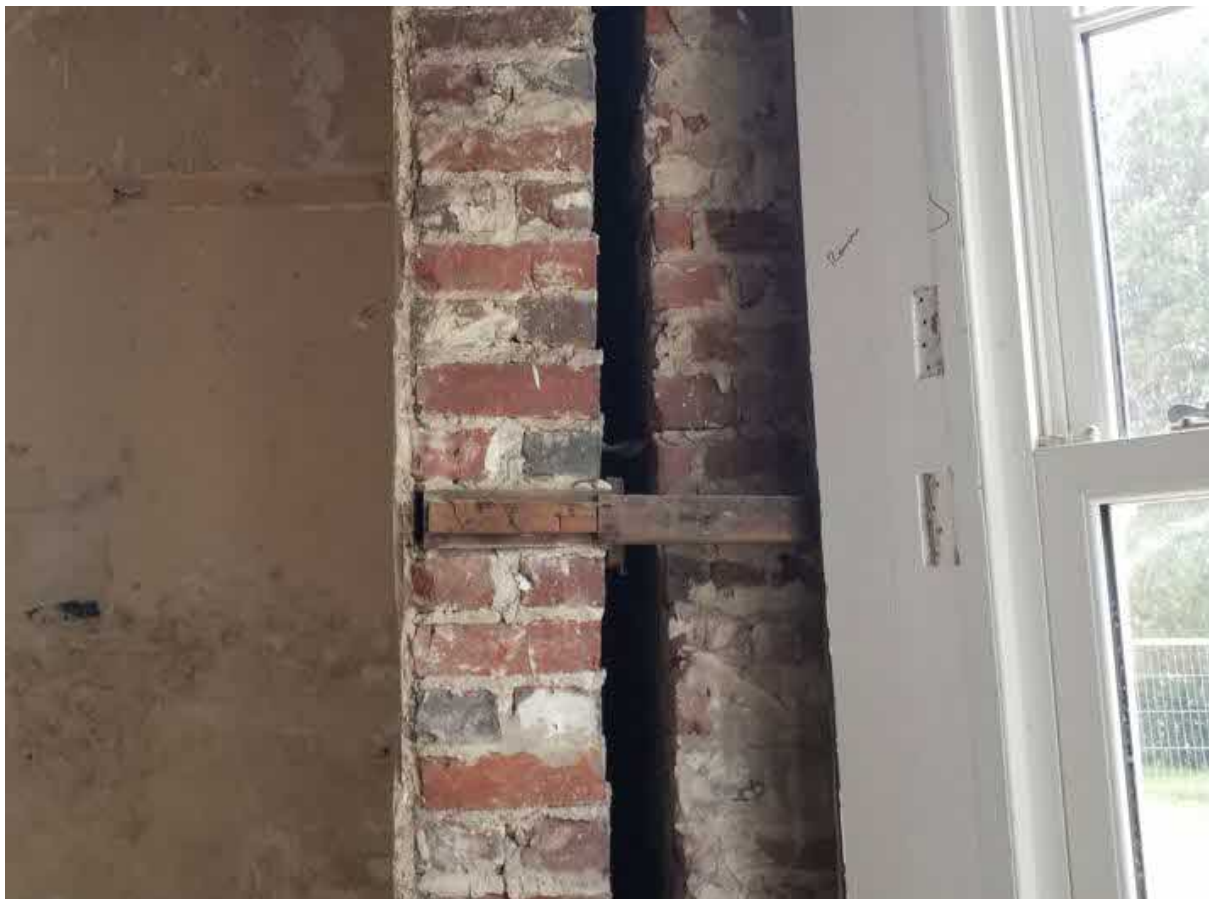
Photo 15 (External Wall structure)

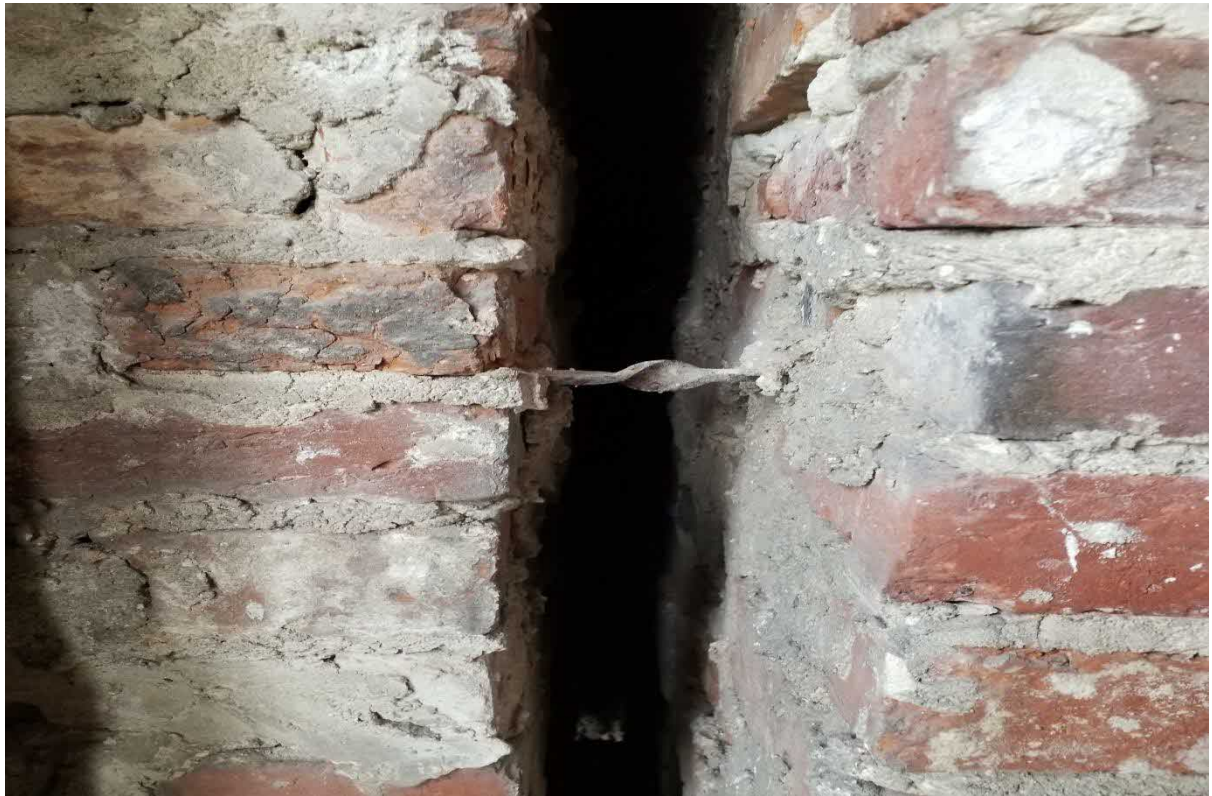
Wall tie failure is not an unknown event no clear failures could be directly linked to this at ground or first floor regarding bowing or cracking in wall structure visible in these areas.

Photo 6 (Wall tie design found)

Possible Solution Installation of new wall ties is a possible solution should the need arise.

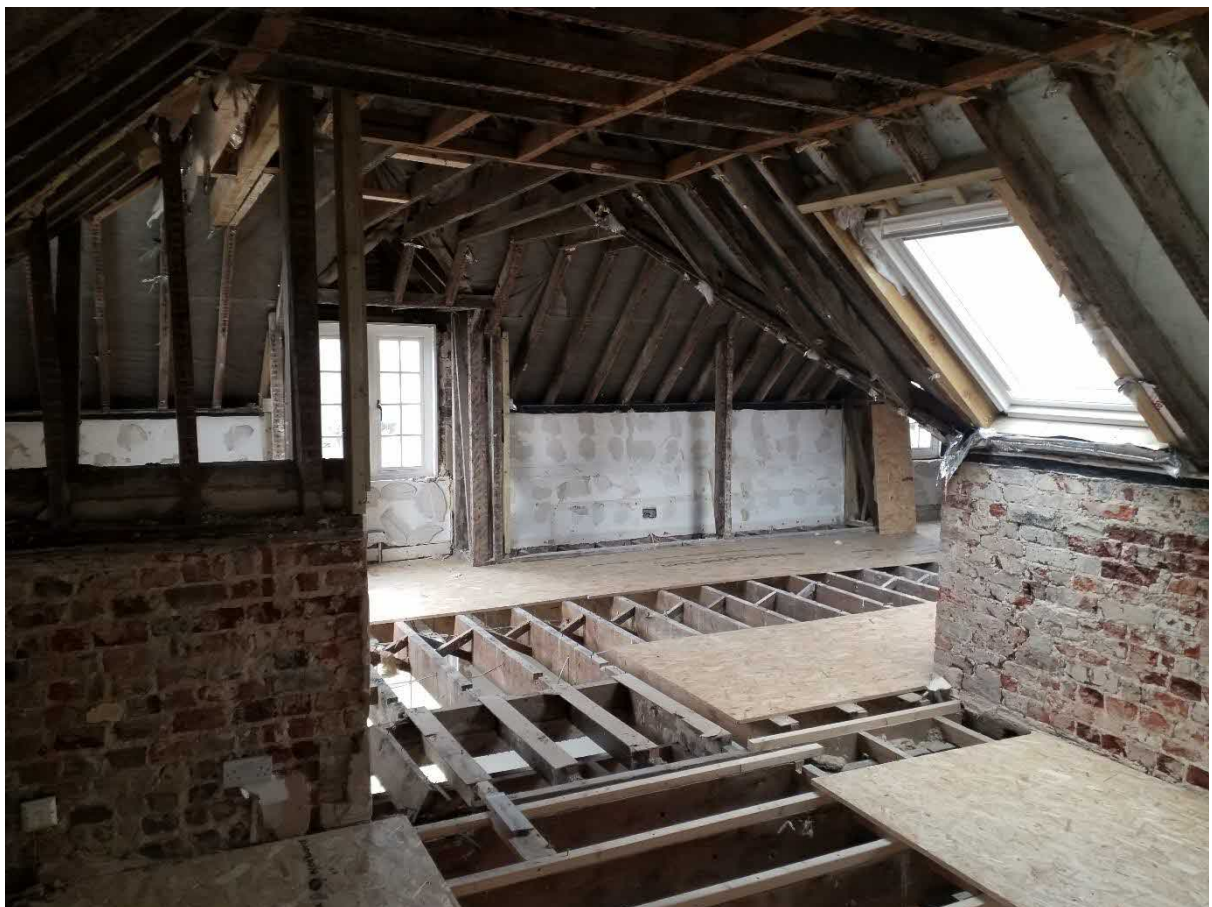
Photo 10 (roof structure)

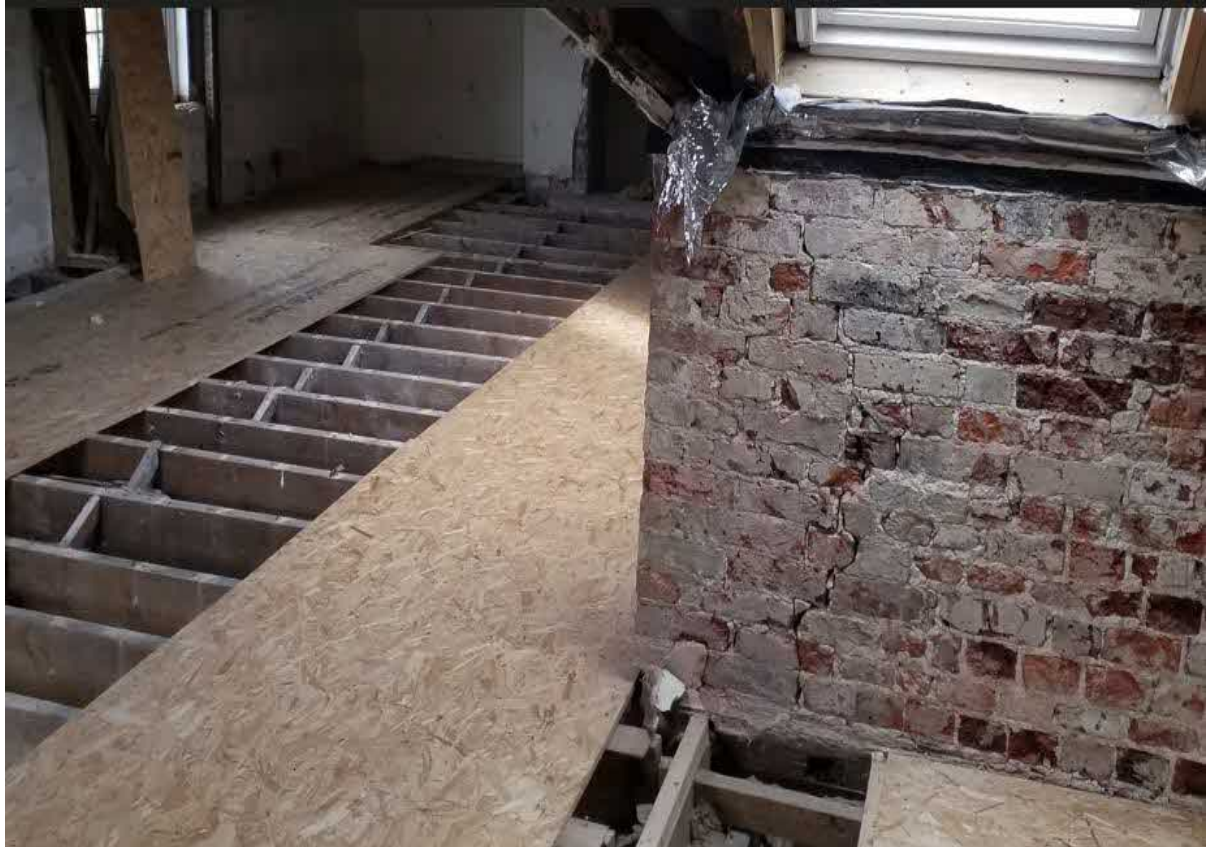
Photo 7 (Roof supporting wall cracking)

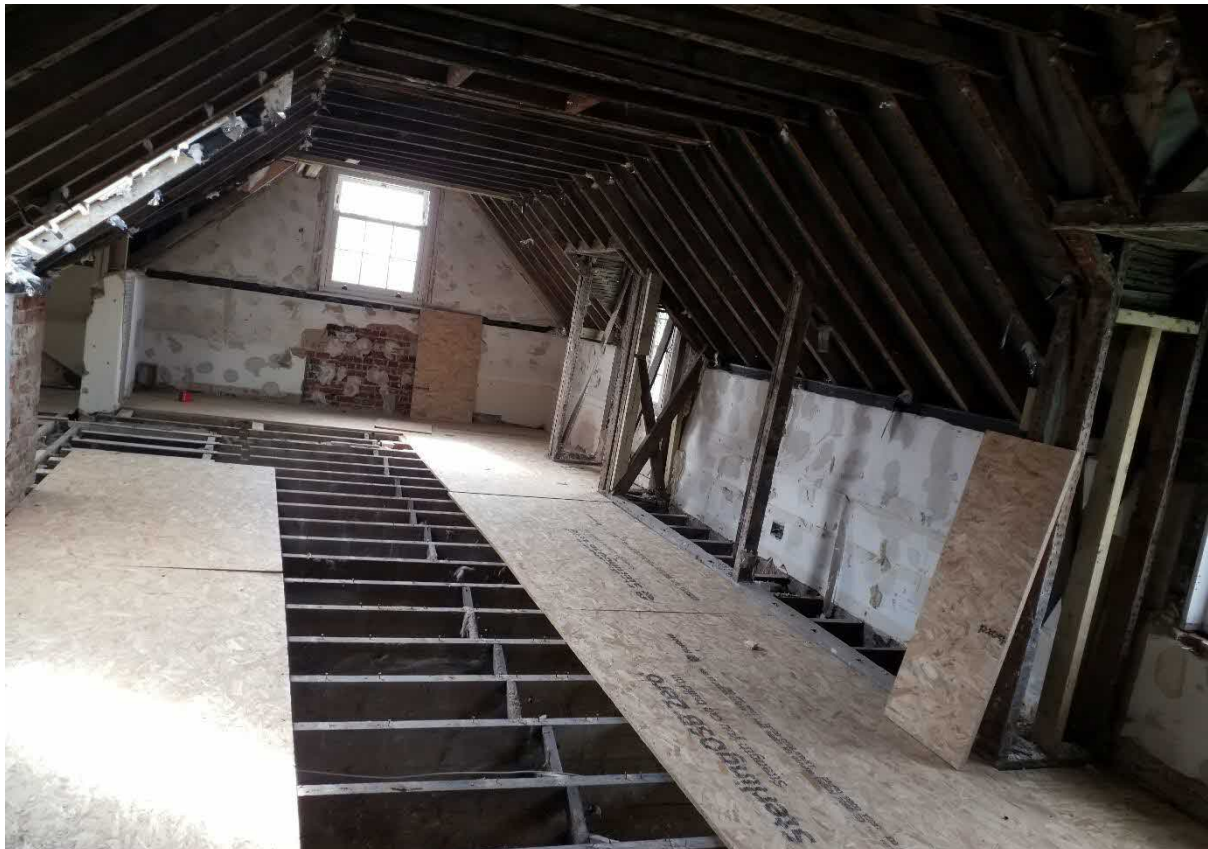
Photo 14 (Roof showing alterations)

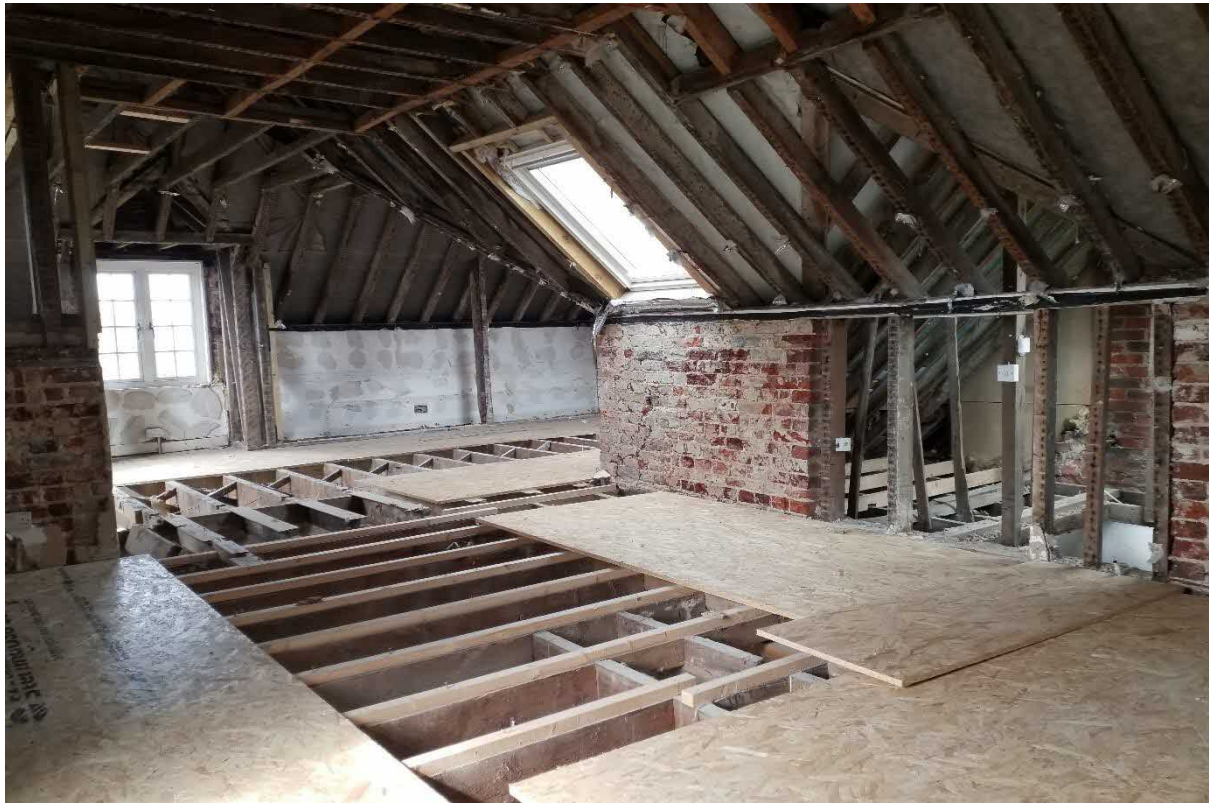
Photo 3 (Roof structure)

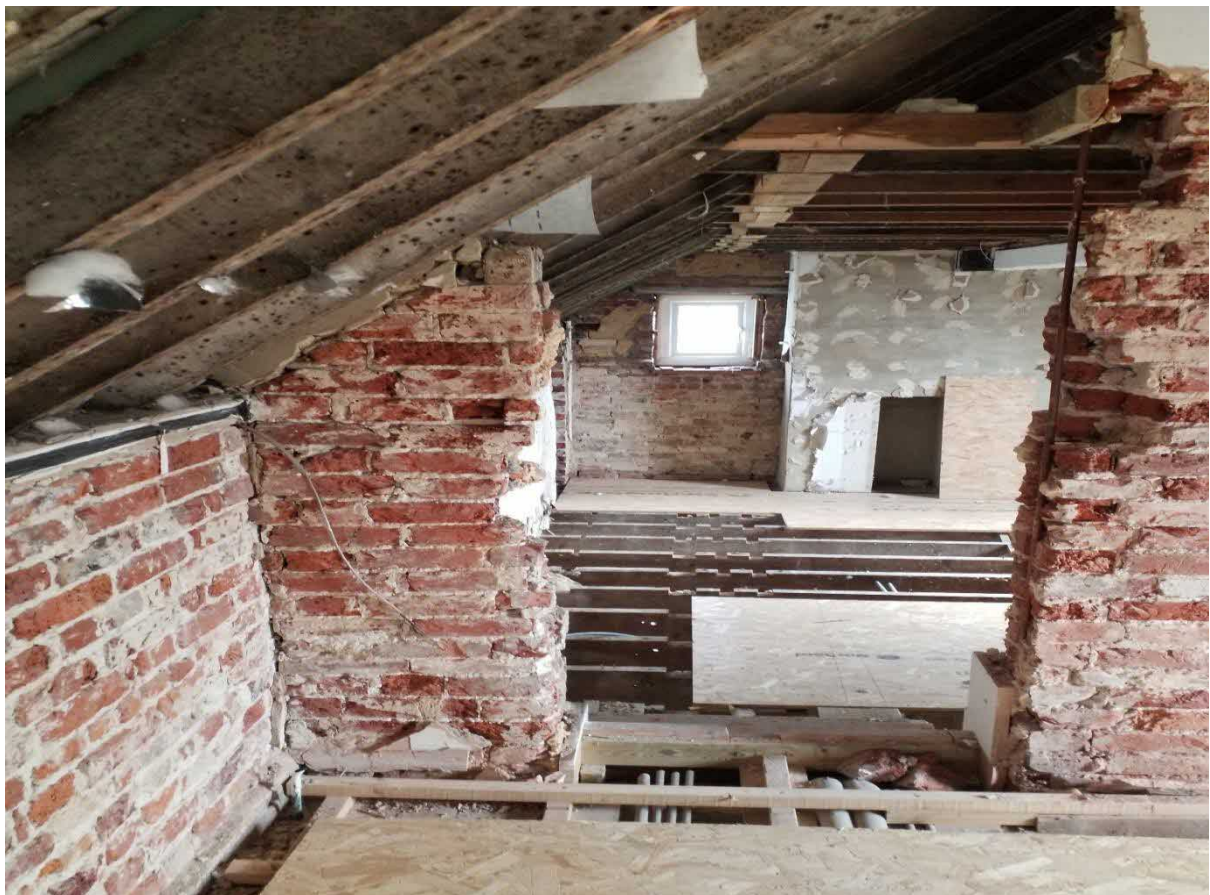
Photo 4 (Roof structure changes)
