### Short report for 45 Hulbert Road Waterlooville, PO7 7NX

Prepared for Ken Hamilton

Date: 19<sup>th</sup> February 2021

Ref: TH 2727

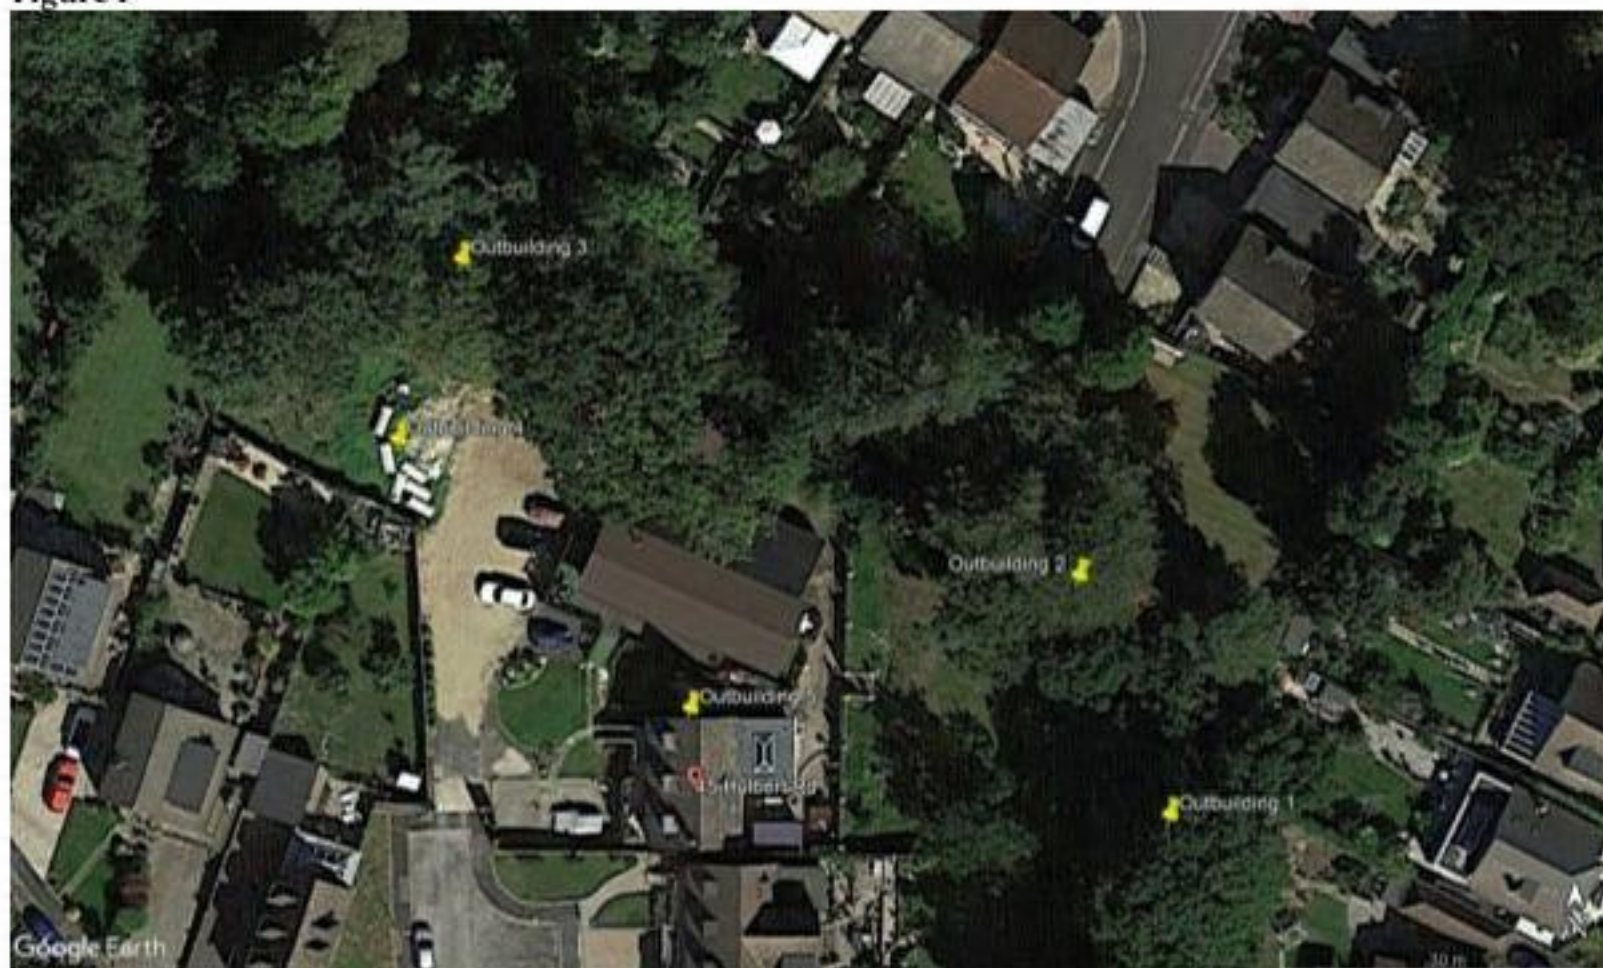
1.2 I have been instructed to visit 45 Hulbert Road and assess whether any trees could have been affected by the construction of several new outbuildings (see Figure 1 below for locations).

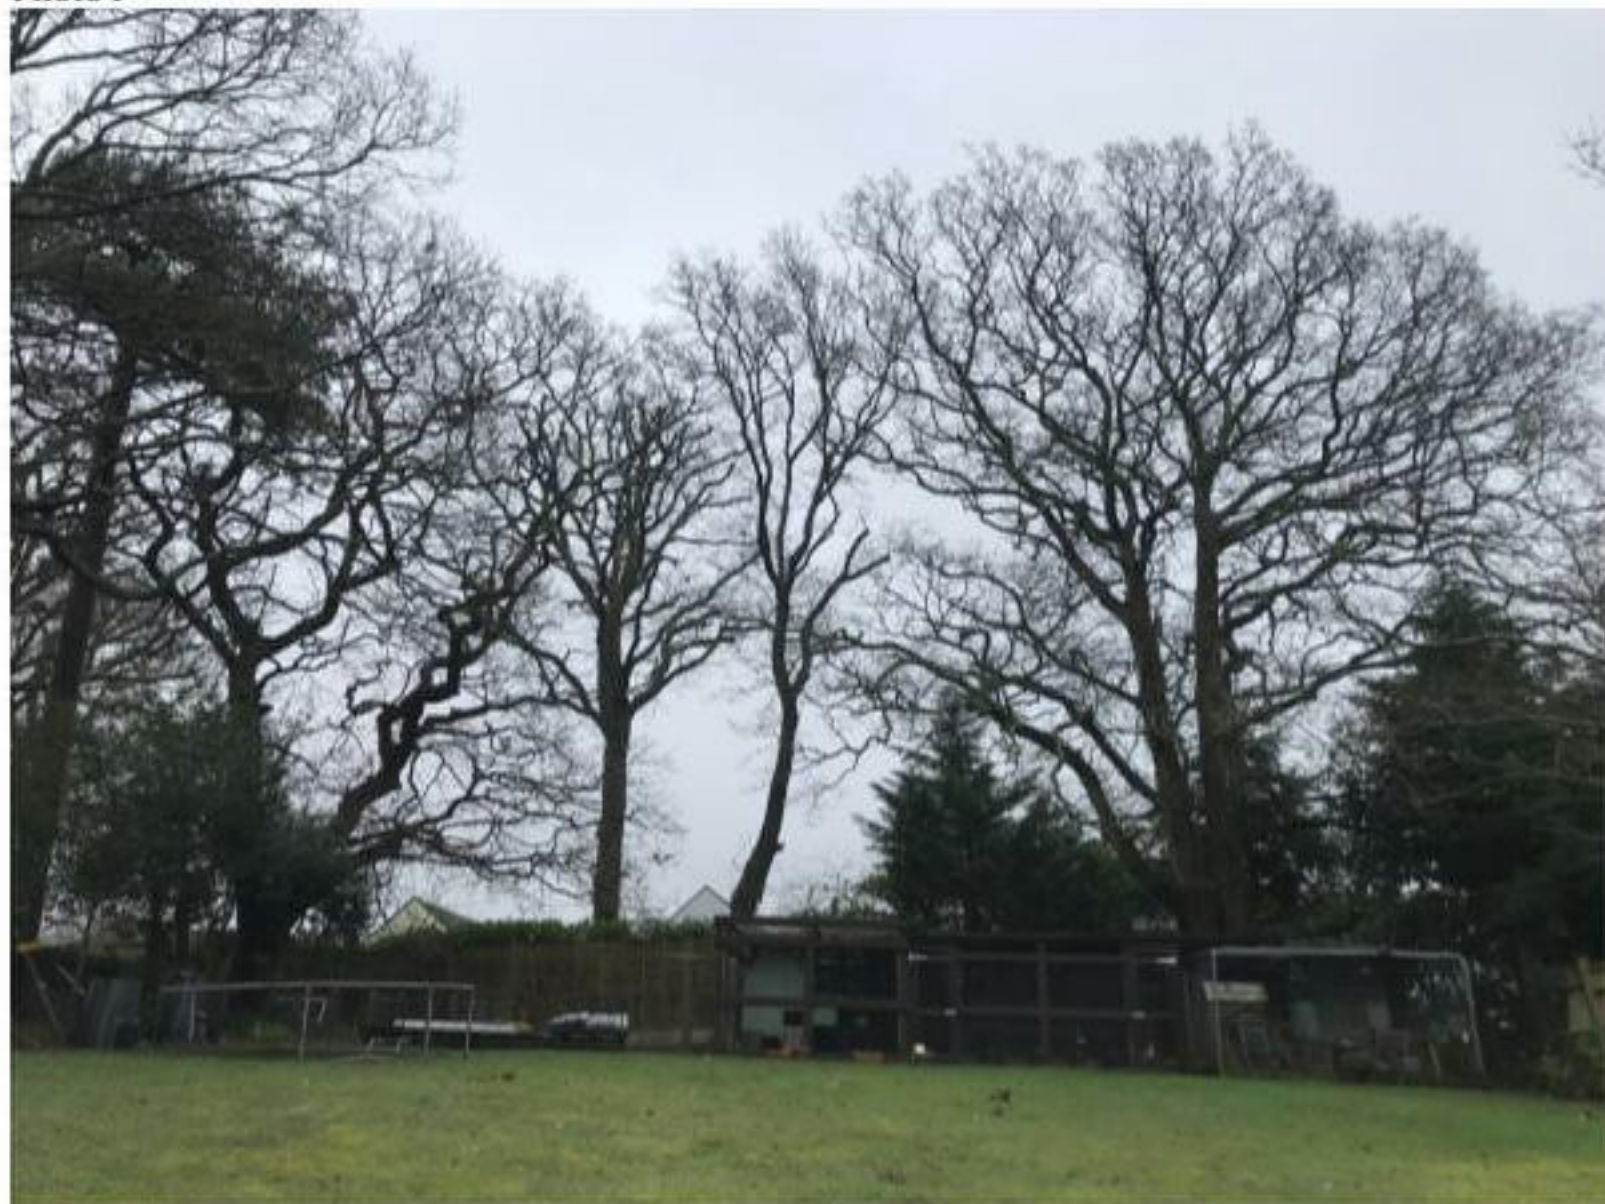
**Photo 1**

2.1 At the top of the rear garden (eastern end), a chicken coup has been constructed close to a mature, third-party Oak. The coup has been constructed using light building materials and is supported by wooden posts sunk into the ground. Apart from the digging of the post holes, there does not appear to have been any excavations or changes in levels around the tree. The paving slabs that run along the rear of the coup are simply resting on the ground.

2.2 The building will have a slight 'umbrella' effect on the rooting area of the tree (due to intercepted rainwater that would otherwise have reached the ground); however, the rainwater guttering pipe runs off the back of the coup (between it and the Oak) and so, due to the sloping land, some rainwater will percolate beneath it – to within the area now covered.

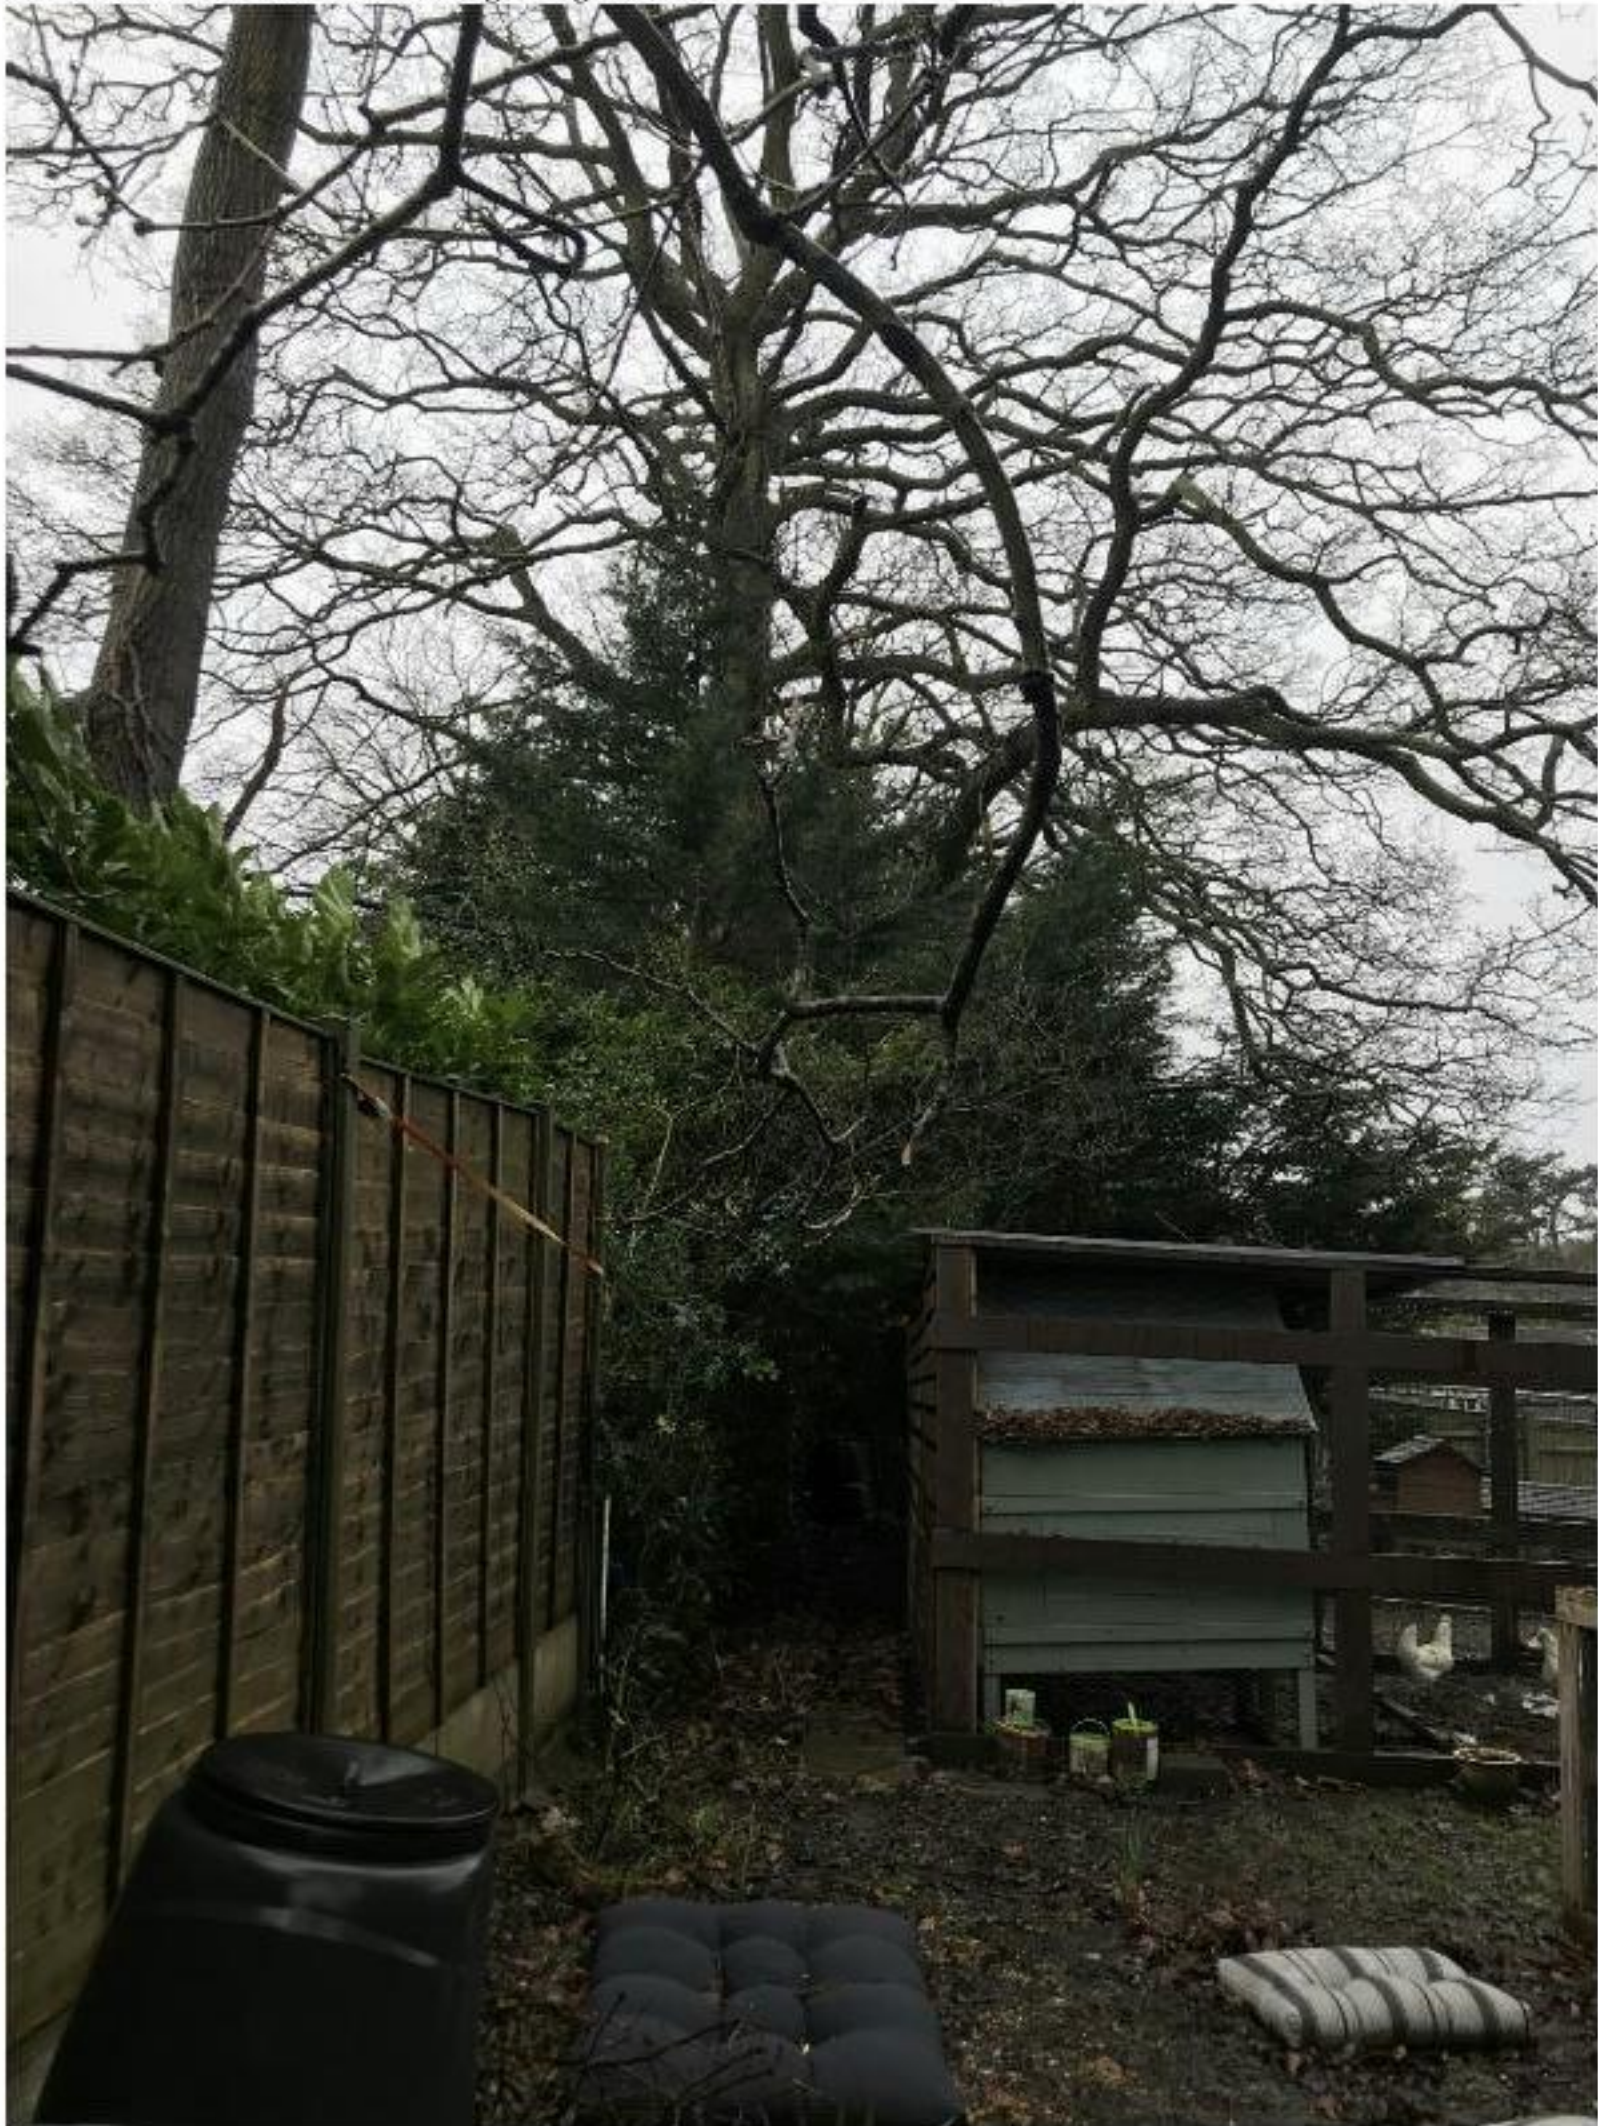
**Photo 2.** There have been no changes in ground levels.

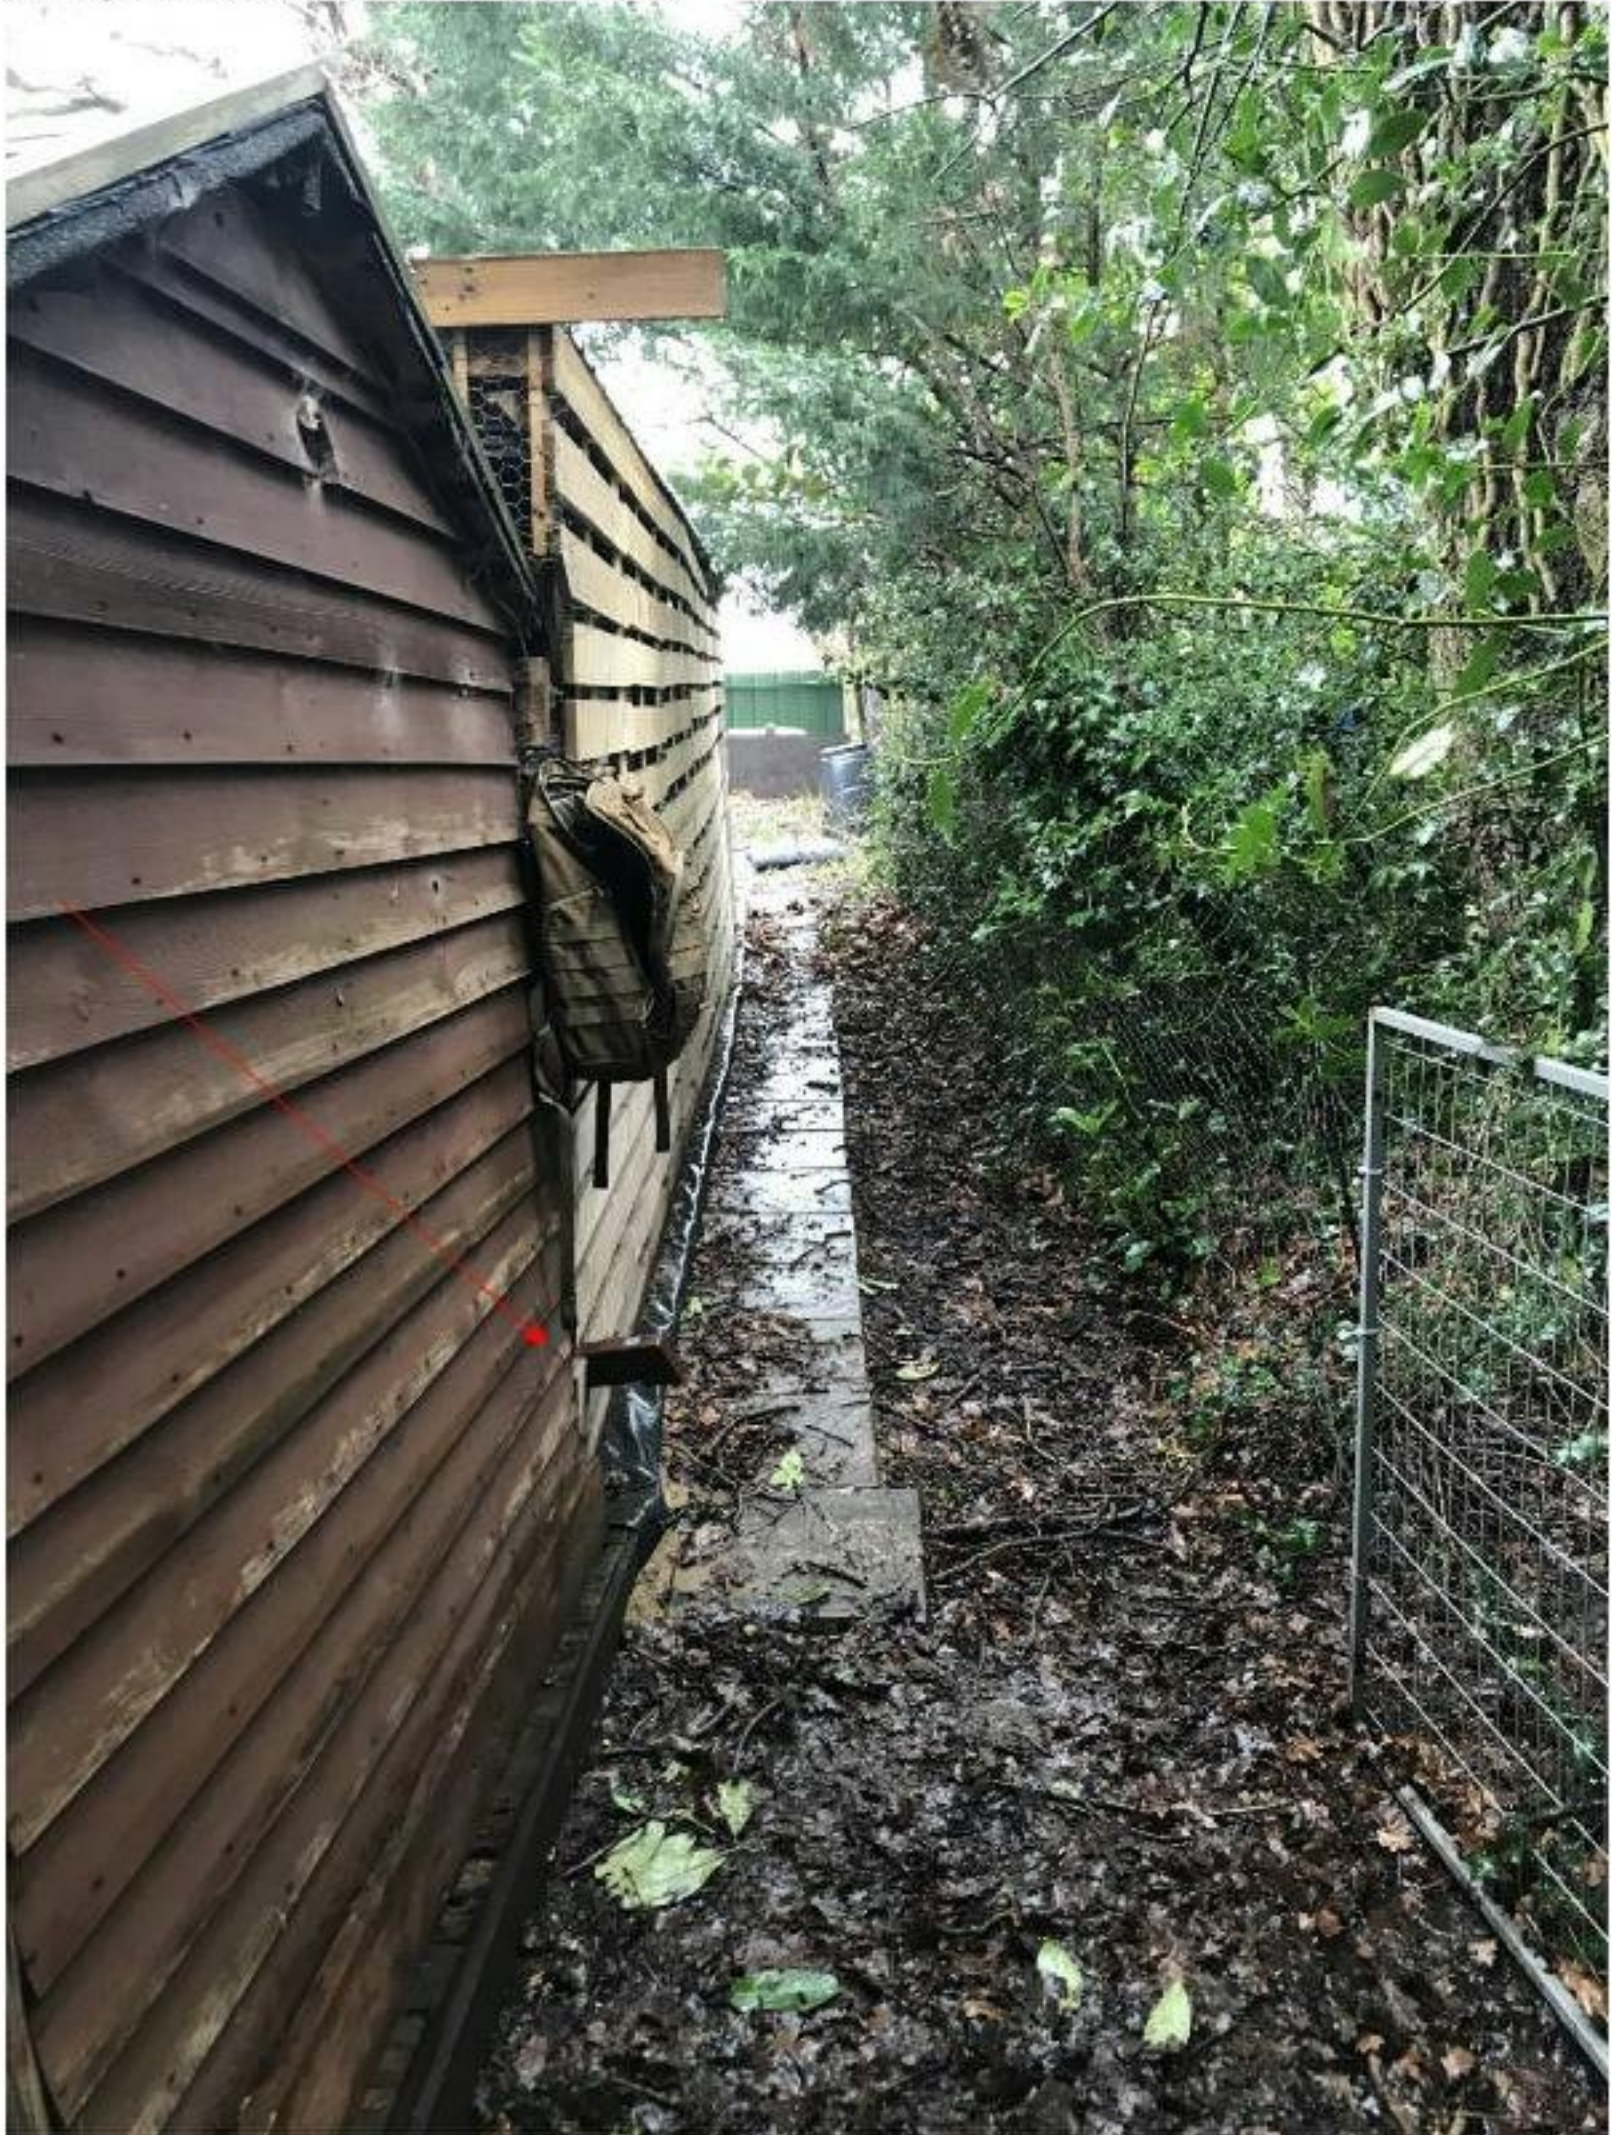
**Photo 3.** Rainwater outlet marked with an arrow

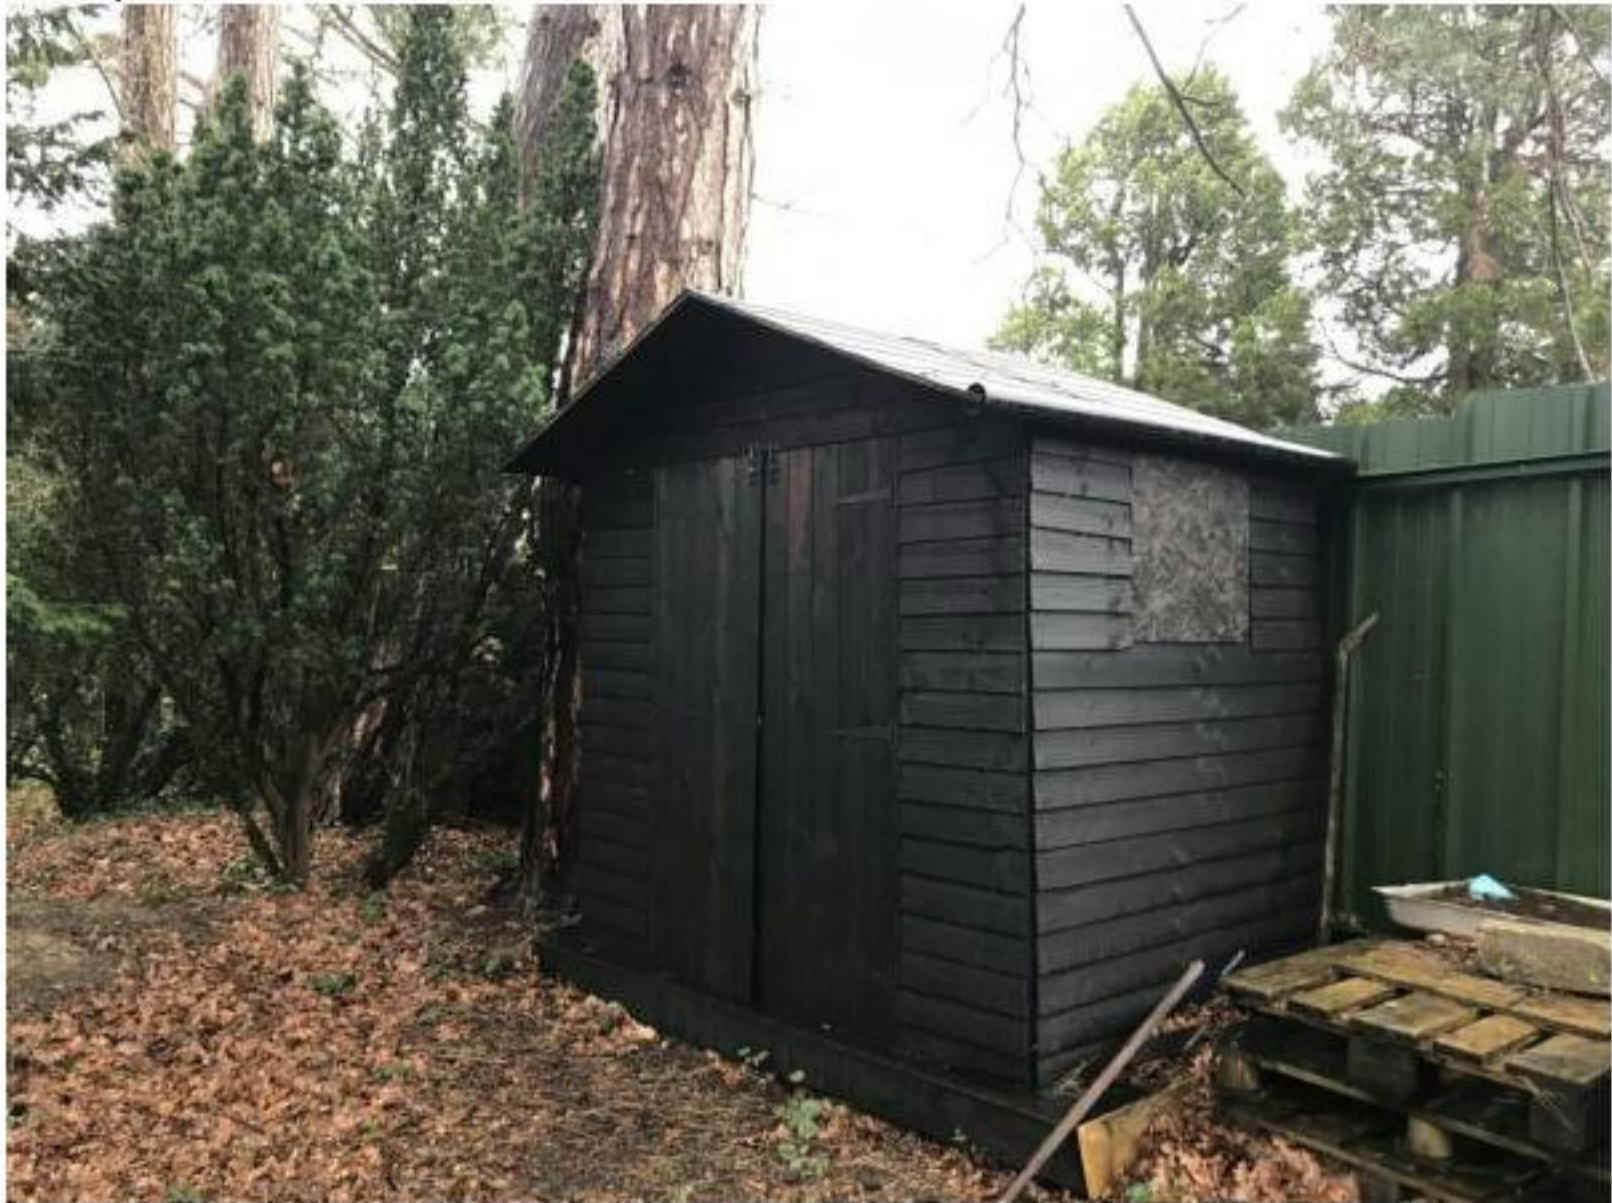
**Photo 4**

3.1 Along the northern boundary of the rear garden, a small shed has been constructed close to a mature Corsican Pine. The shed sits on a wooden crate and so there has not been any excavations or changes in levels around the tree. The shed is far too small to have any effect on rainwater reaching the roots.

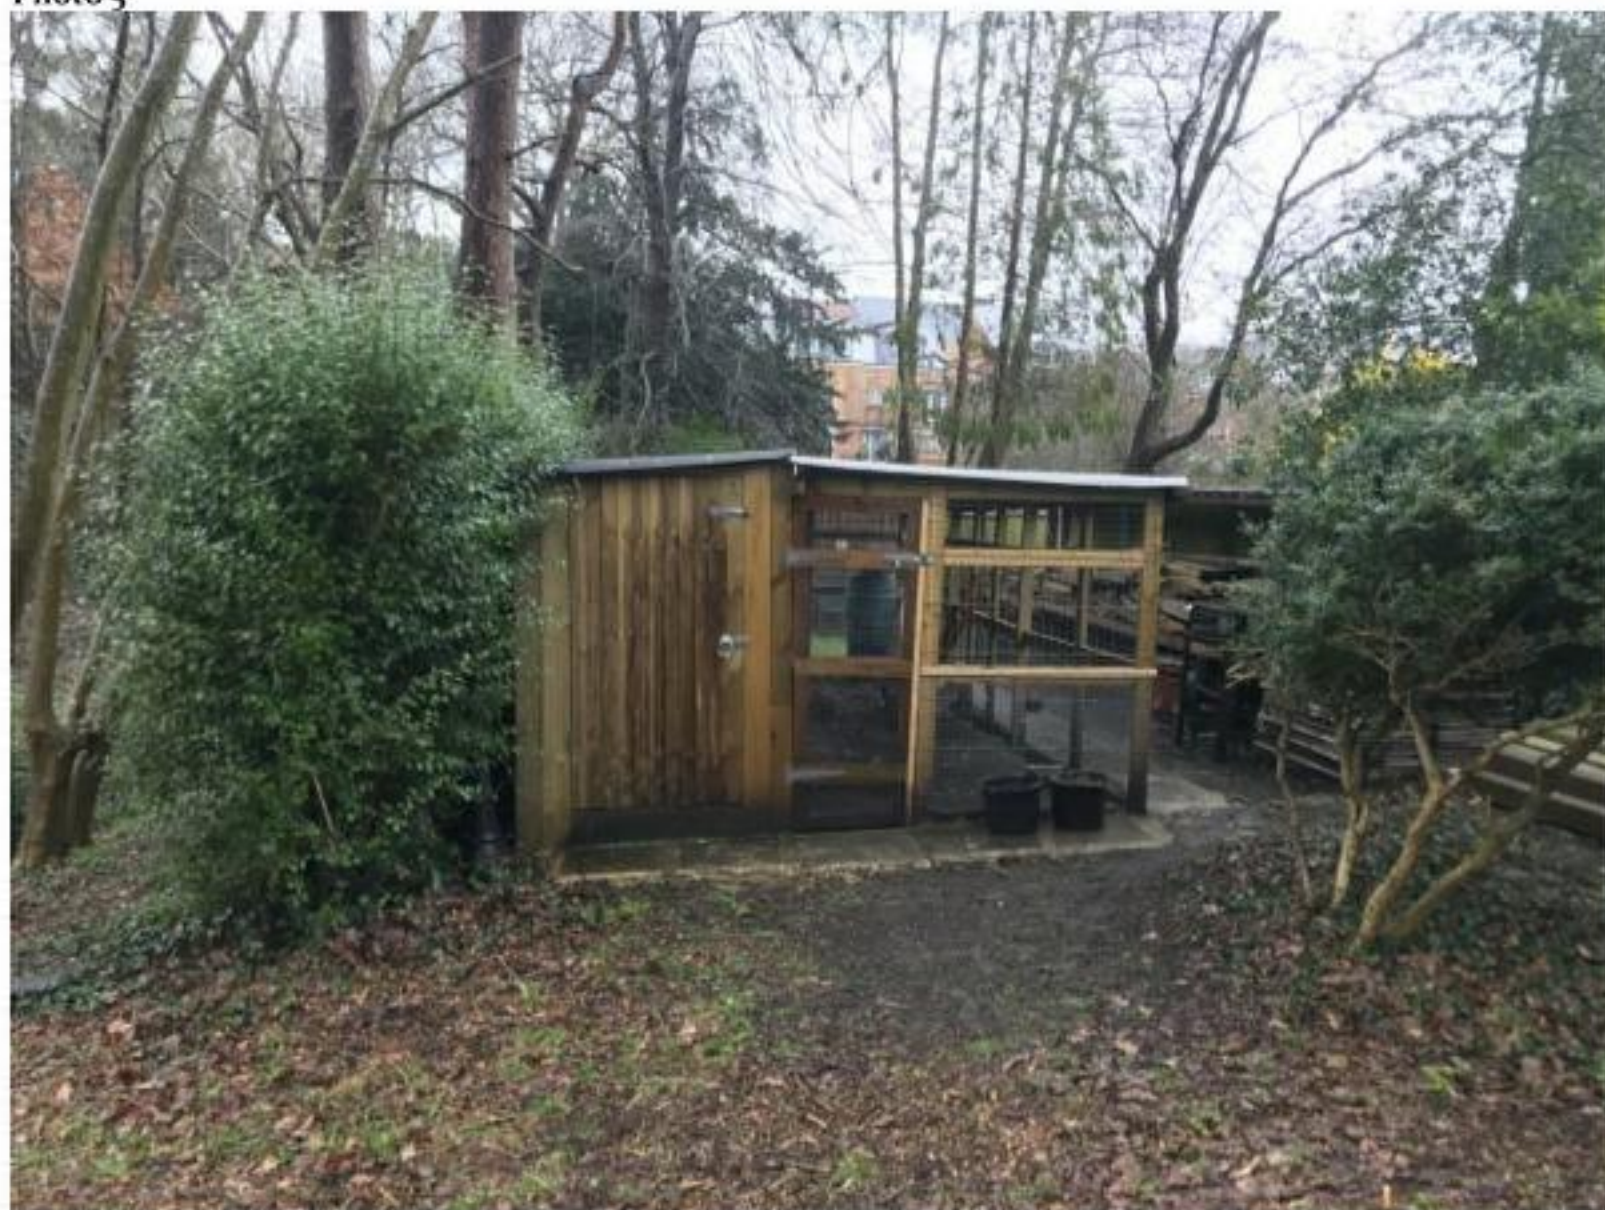
Photo 5

4.1 Close to the north-eastern section of the garden, a 2<sup>nd</sup> chicken coup has been constructed close to line of maturing Pines and Ashes. Again, it has been constructed using light building materials and is supported by wooden posts sunk into the ground. Again, apart from the digging of the post holes, there does not appear to have been any excavations or changes in levels around the tree. The trees are growing next to a small stream, and so there are no concerns about the lack of rainwater reaching the roots. The paving slabs that run along the front and side of the coup rest on the ground.

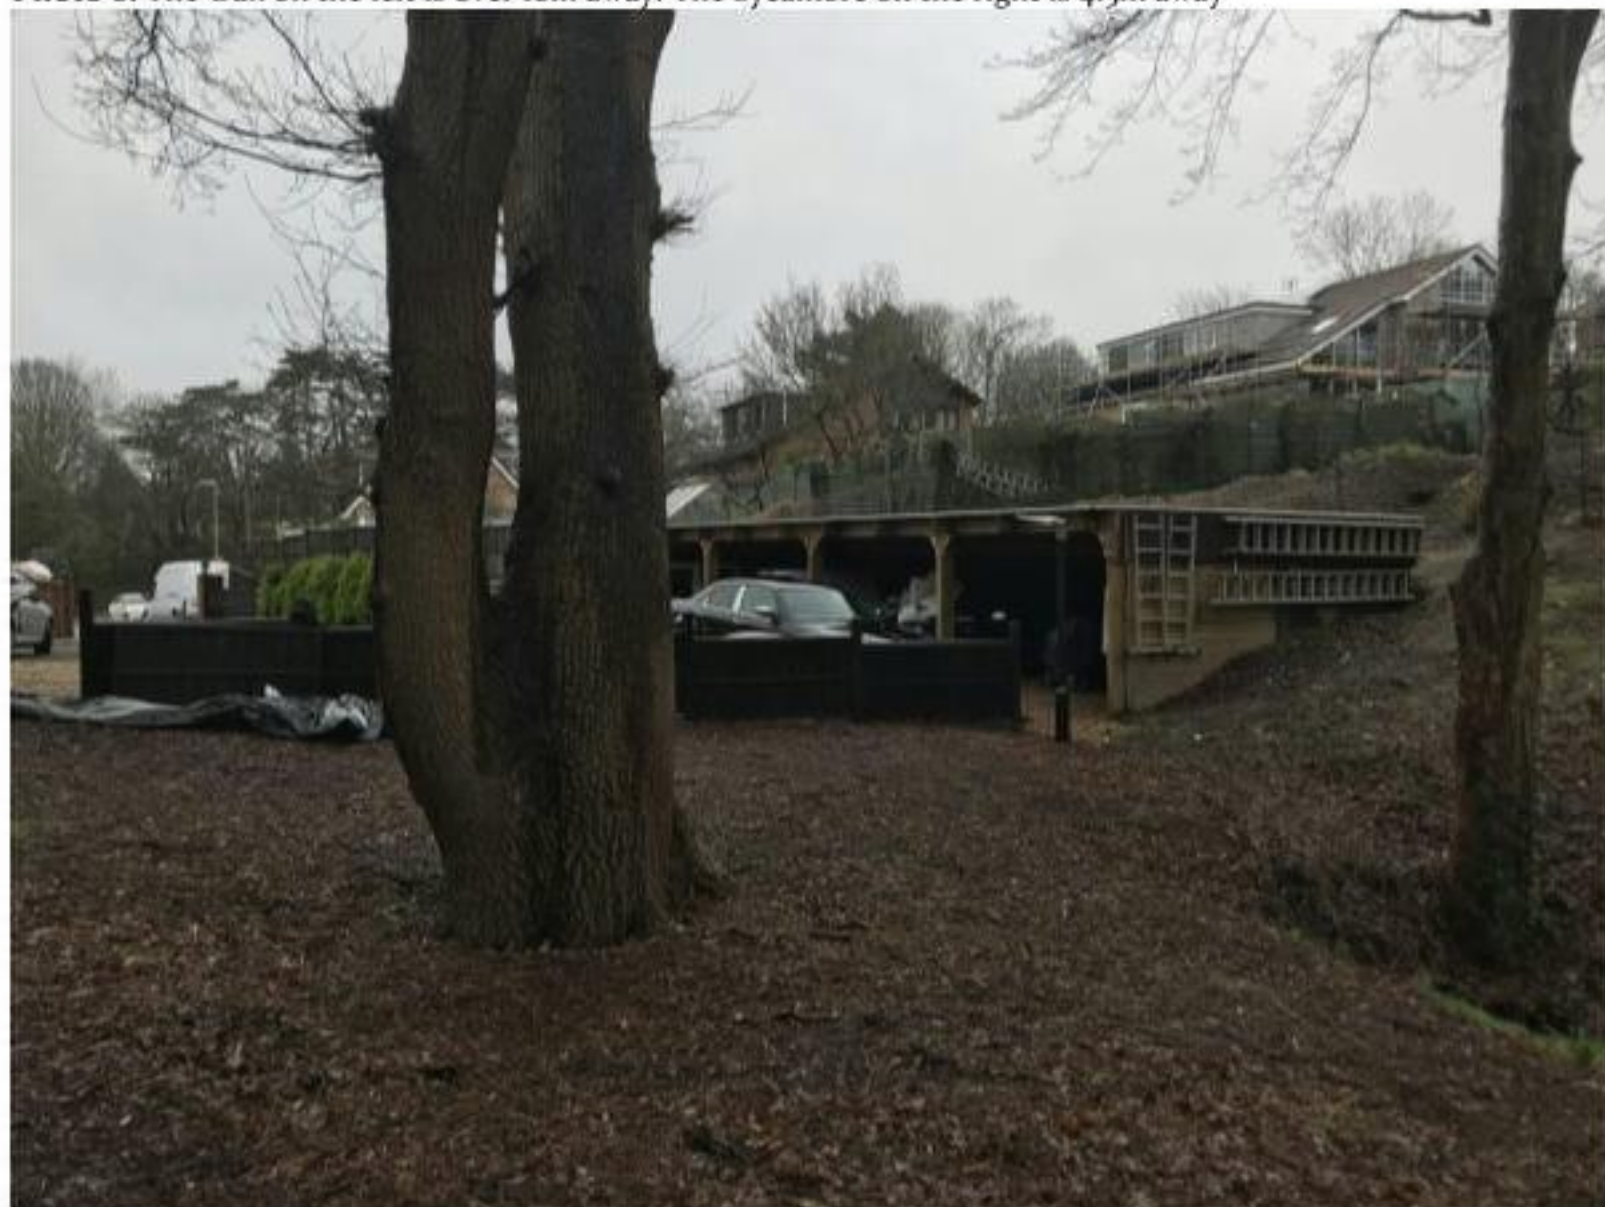
5.1 A new car port has been constructed by excavating into a raised area of soil. There may have been some very minor root damage at the periphery of the nearby Sycamore's rooting area, but it is 4.5m away and so any damage will have been negligible. The nearby Oak is over 10m away and so it is unlikely to have been affected at all. In any case, it is possible to off-set any minor root incursions, for both trees, within soft areas contiguous with their rooting areas.

**Photo 6.** The Oak on the left is over 10m away. The Sycamore on the right is 4.5m away
