## **TREE HEALTH & SAFETY** **AUDIT**

**20 Queens Road, Waterlooille**

**Mr & Mrs C Flint**

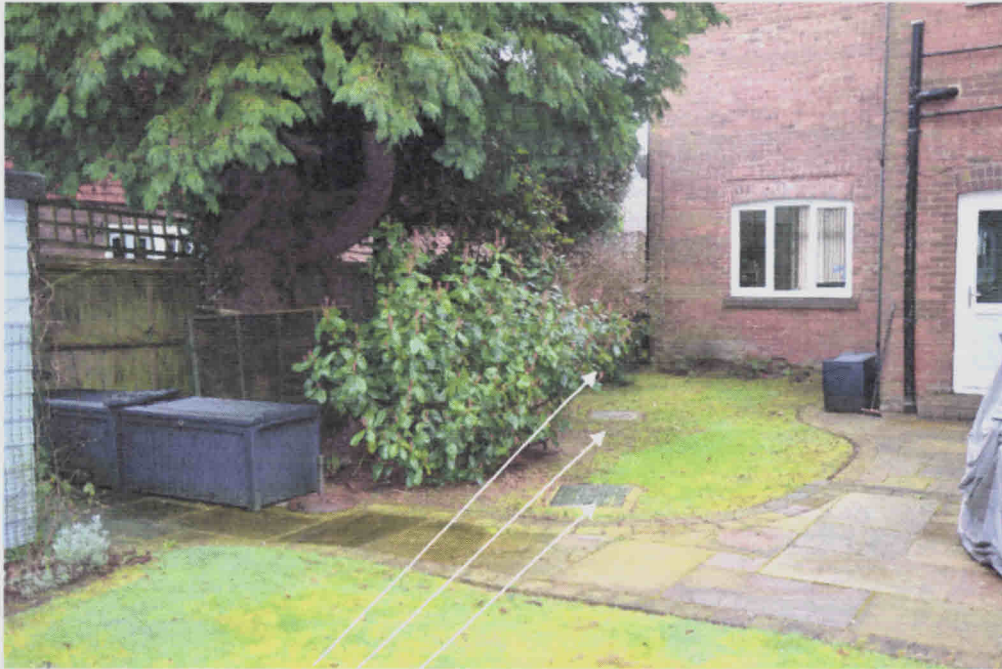
Manhole covers

Illustrating the relationship between tree; drain run & property

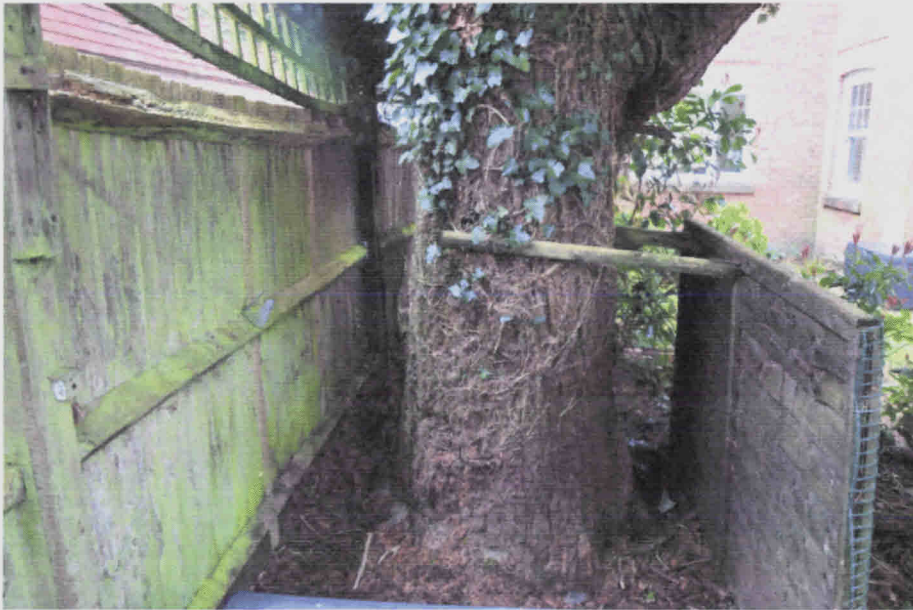
Illustrating the close proximity to the boundary fence and the neighbouring property.

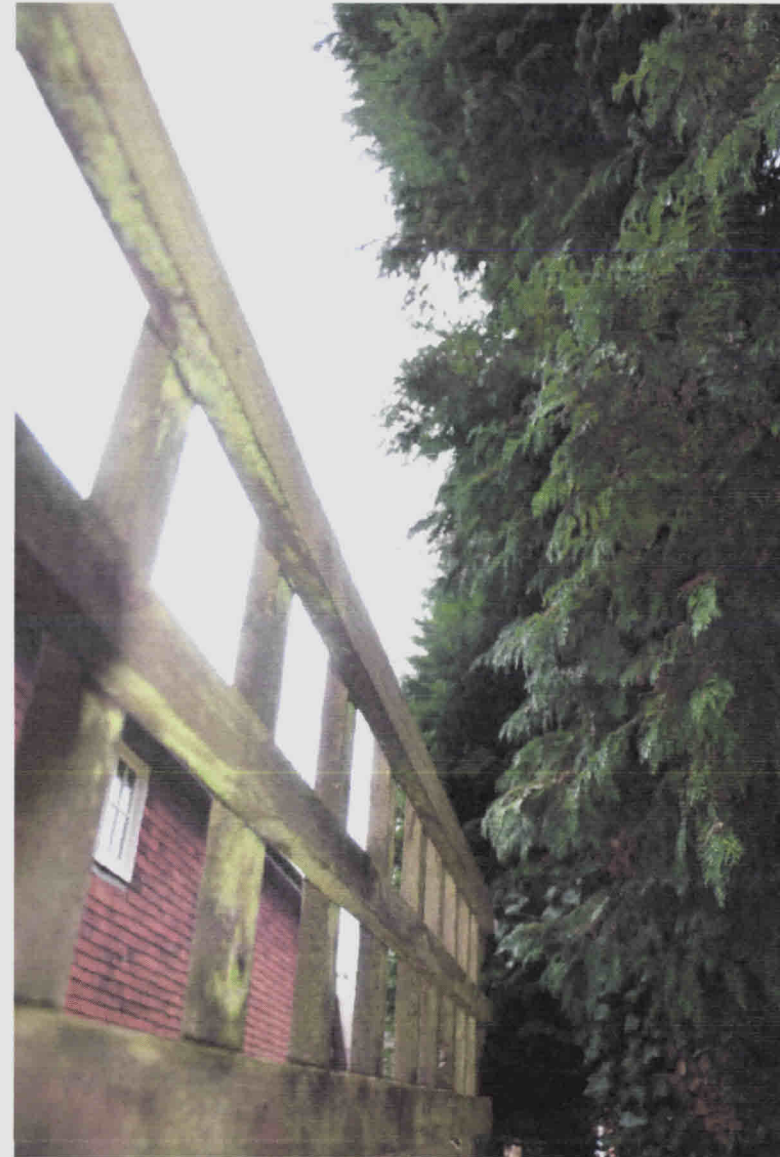
Illustrating the heavy lopping back on the east side in line with the neighbours boundary.

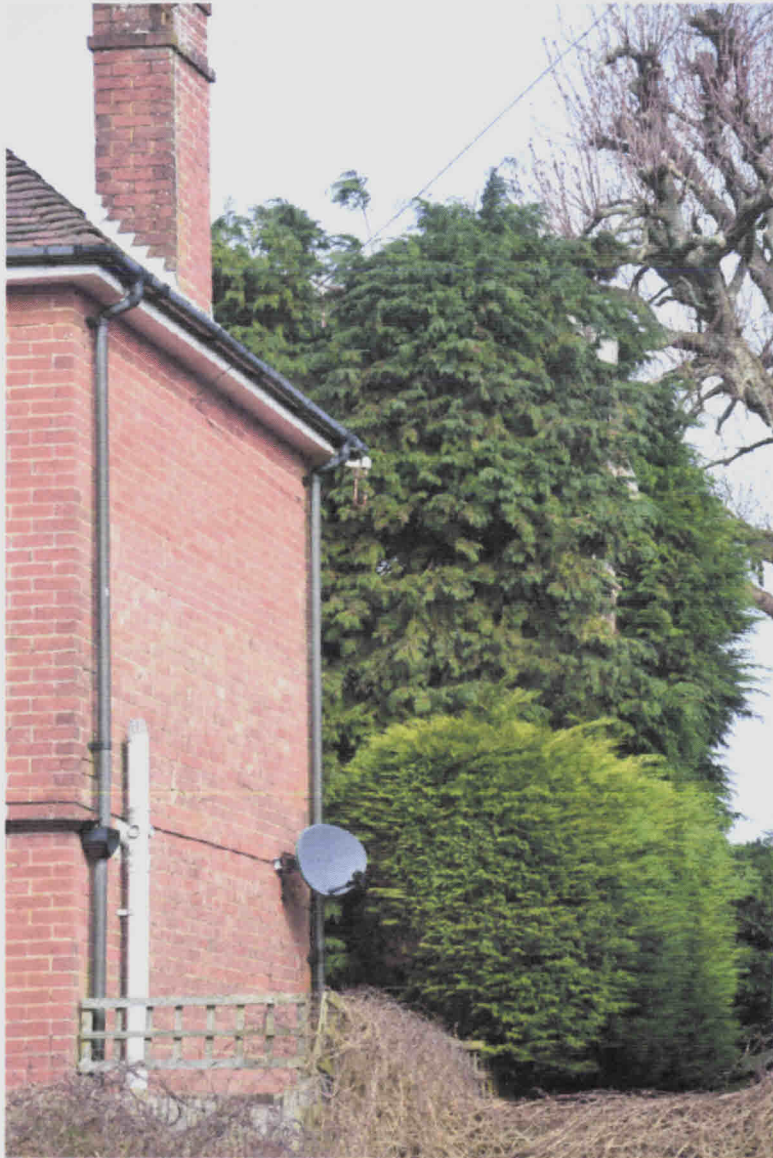
The tree viewed from Queens Road (to the south)

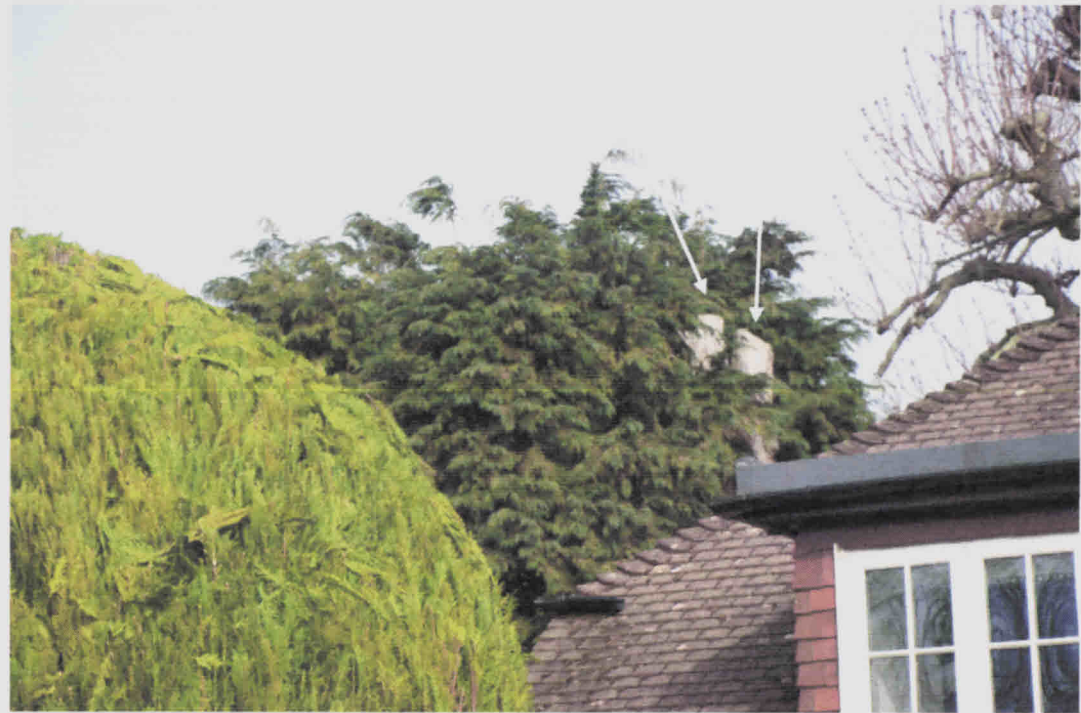
The picture below illustrates quite clearly the large numerous wounds of 30cm or more diameter that were left from a previous heavy lopping operation

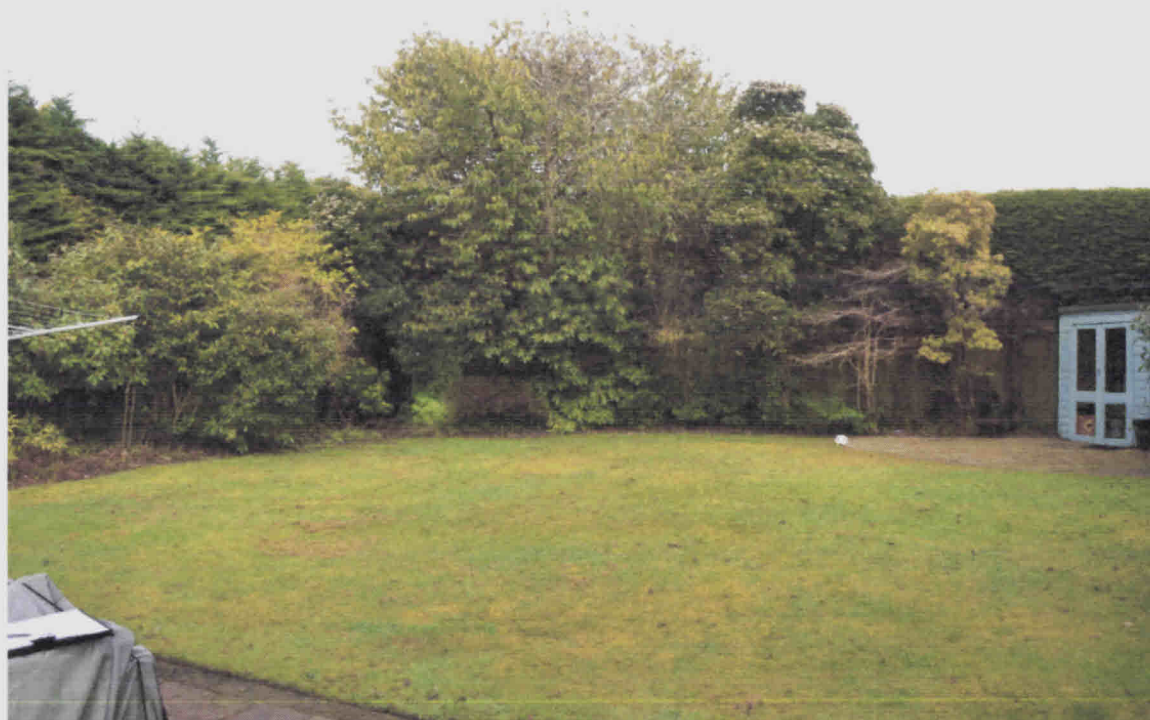
Looking to the north of the tree to show the large area of rear garden that would readily accommodate a replacement tree

- 4.1 The root incursion and blockage of the drainage system will only be resolved by either the complete removal of the tree or replacement of the drainage system with root resistant materials.

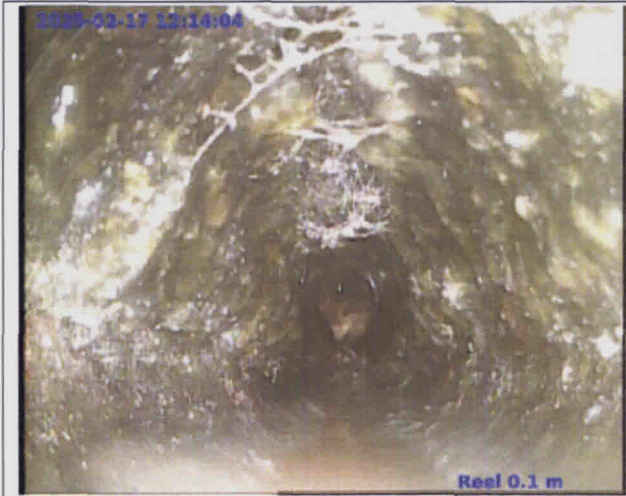
Observation (1): scale

Type: DEE = Attached Deposits Encrustation

attatched deposits and root will need a full descale

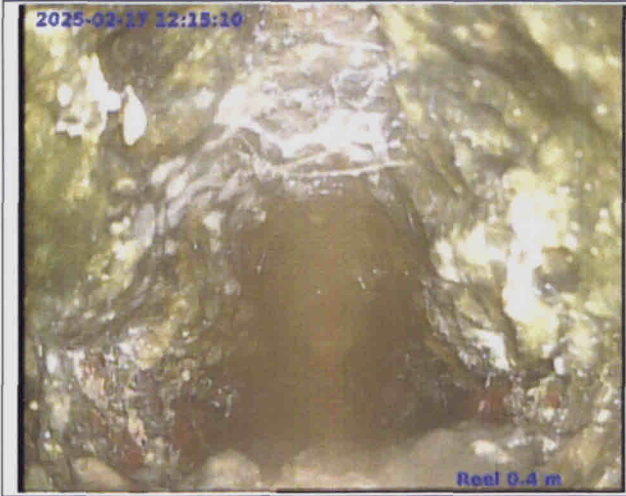
Observation (2):

Type: SA = Survey Abandoned

unable to pass scale and deploaced joint

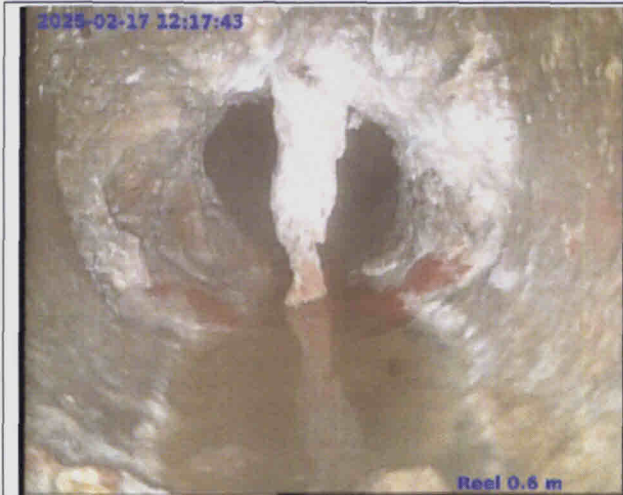
Observation (1): deposits

Type: DEE = Attached Deposits Encrustation

hard deposits will need a full descale

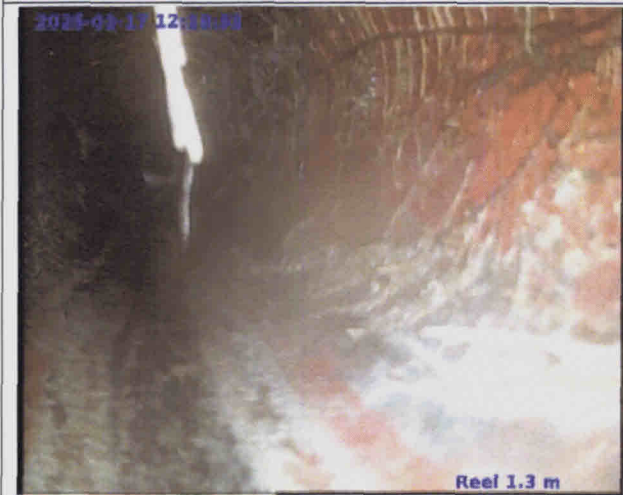
Observation (2): roots

Type: R = Roots

roots have infested the system will need a clean and poss

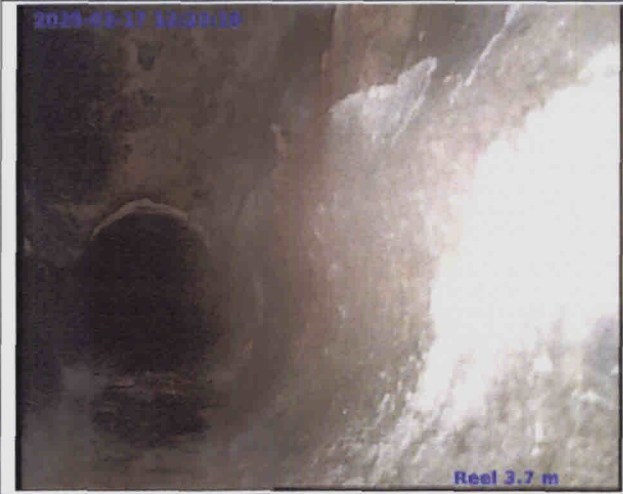
Observation (3):

Type: MH = Manhole

3.7 mtrs of liner to solve root ingress

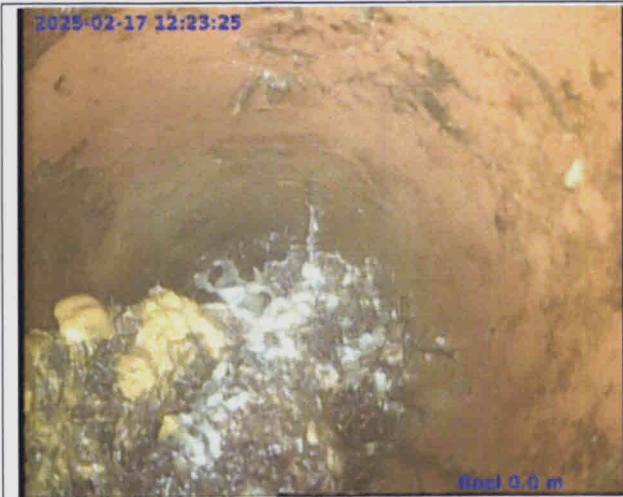
Observation (1):  
Type: R = Roots  
Reel Position: 0.0 m  
100% root mass leading to svp will need root cut and 3m!

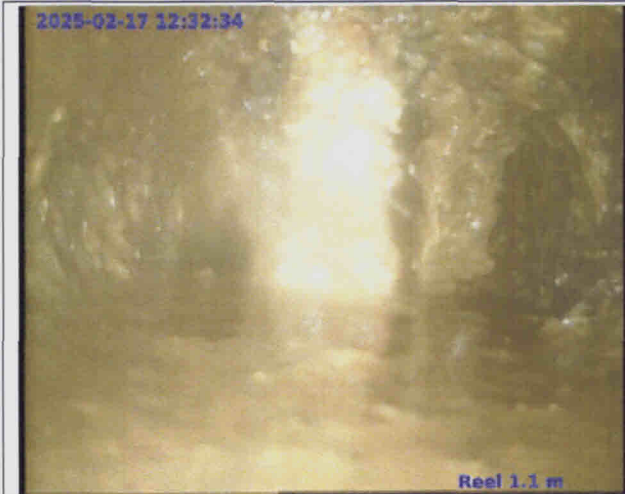
Observation (1): deposits

Type: DEE = Attached Deposits Encrustation

this line is needing a full descale

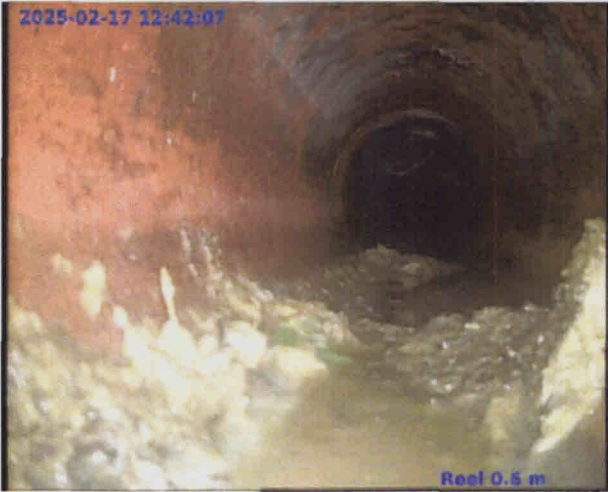
| | <p>Observation (1): deposits</p> <p>Type: DEE = Attached Deposits Encrustation</p> <p>Reel Position: 0.6 m</p> <p>build up of silt and fat</p> |

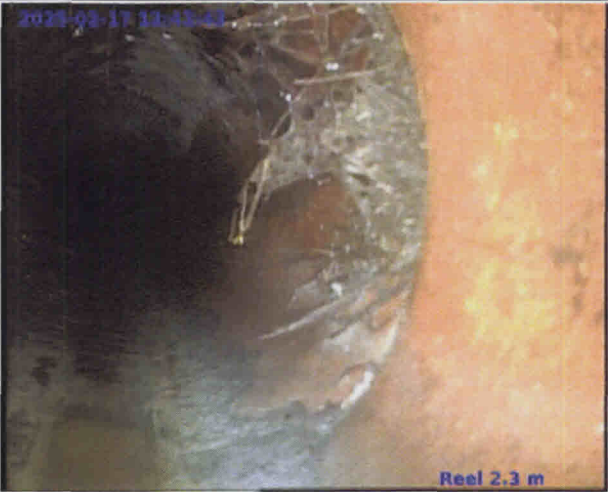
| | <p>Observation (2): roots</p> <p>Type: R = Roots</p> <p>Reel Position: 2.3 m</p> <p>full descale and root cut</p> |

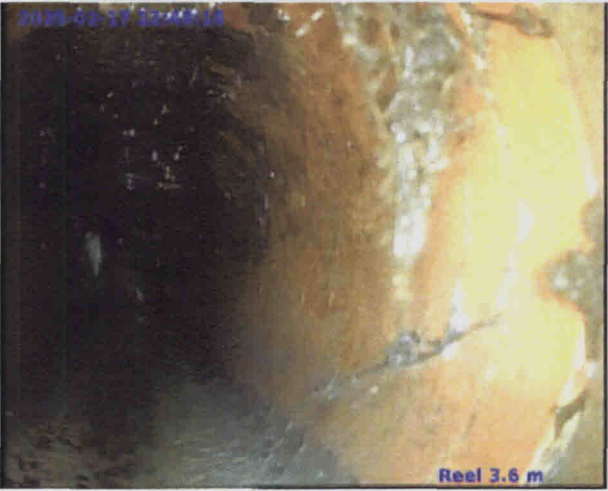
| | <p>Observation (3): displacement</p> <p>Type: JD(M) = Joint Displaced medium</p> <p>Reel Position: 3.6 m</p> <p>and root ingress</p> |
