**YACHT HAVEN SITE, HAYLING ISLAND**

**Remediation Verification Report**

January 2022

| <b>Requirement</b> | <b>Data</b> |
|---|---|
| Report Reference | 300b/YachtHaven/Alpine/RVR |

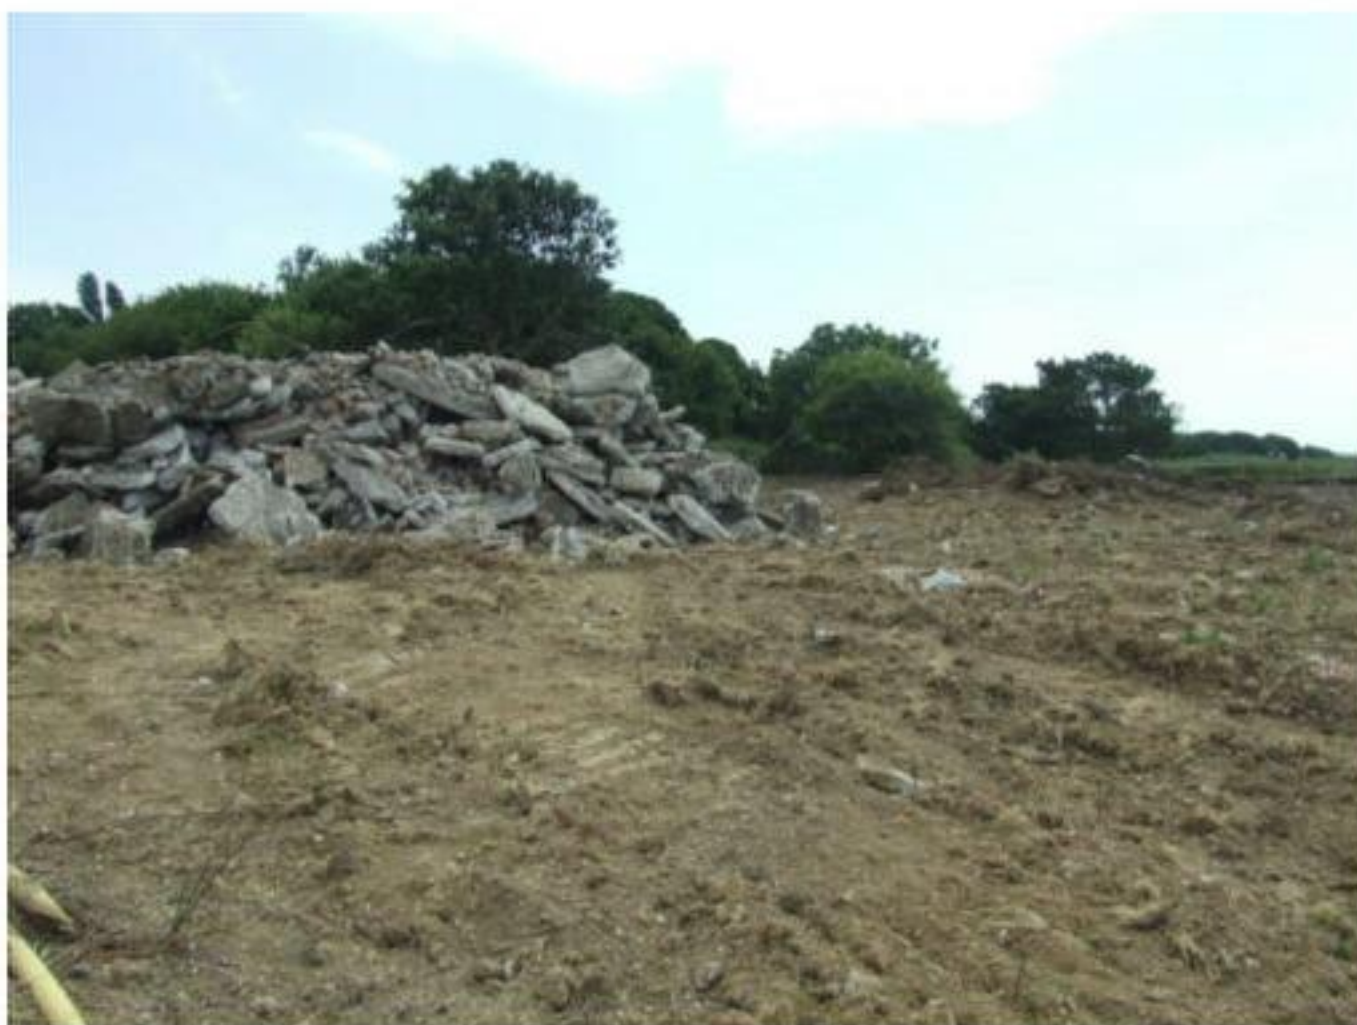
- 5.1.1 The site was visited on 3 July 2018 to confirm that the fly-tipped waste and bonfire residuals had been removed, the existing buildings had been demolished, waste concrete and brick from building demolition stockpiled and that site clearance had been largely completed. See photographs in Appendix A.

Photo 1: Demolition & site clearance as photographed in July 2018. Waste stockpiled ready for removal.

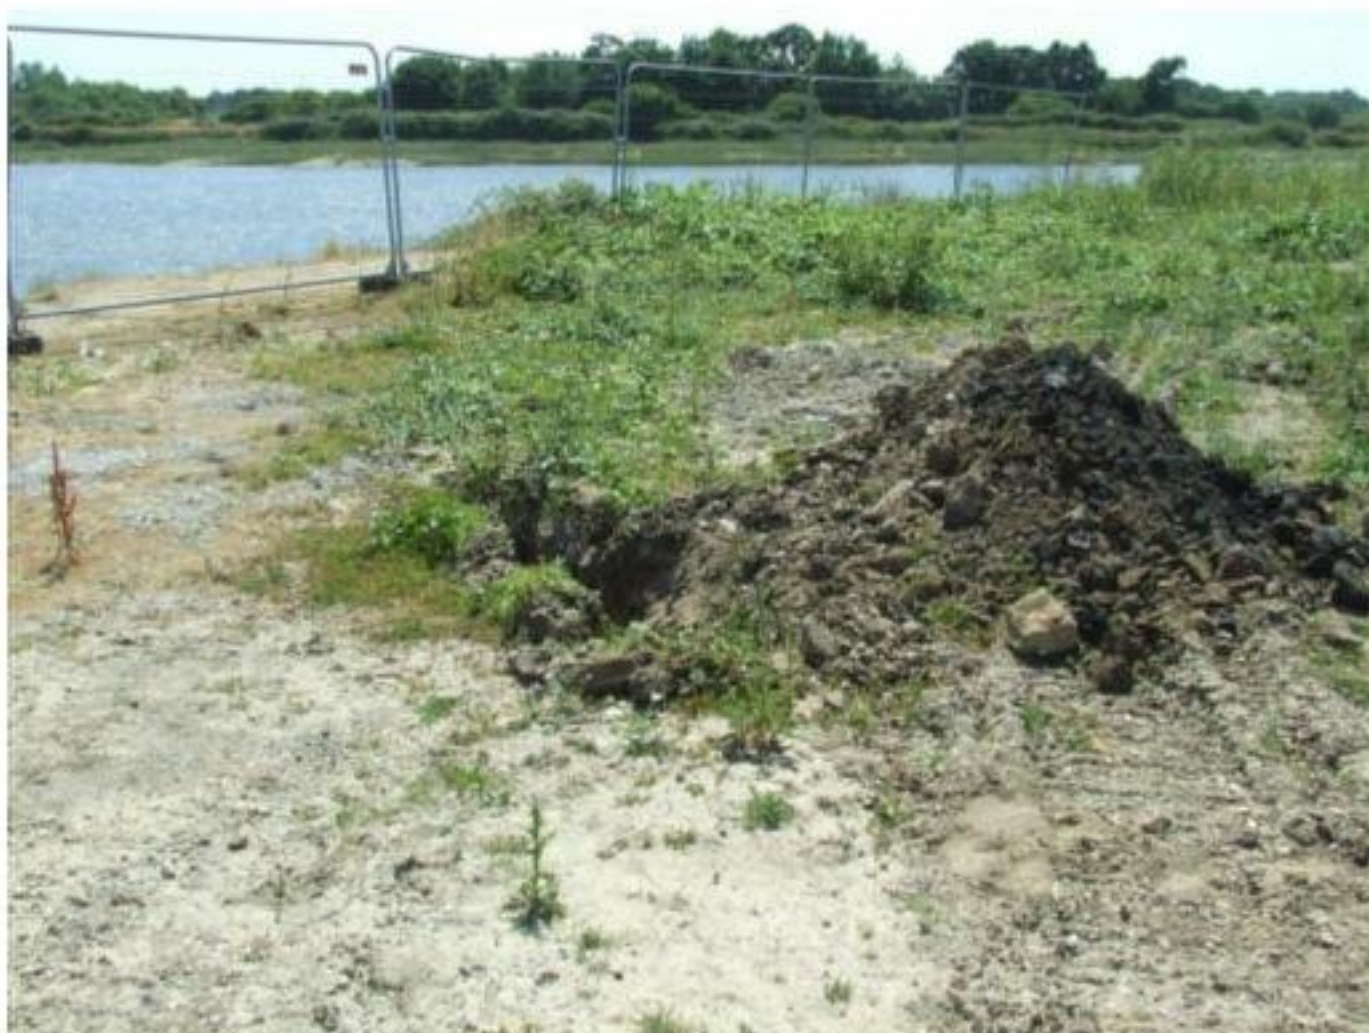
- 5.1.2 Soil samples were taken during the site visit at critical locations and analysed for the contaminants previously identified and compared with the results of the previous site investigations (Contamination Risk Assessment – Additional Investigations report August 2018). The results of the analysis confirmed the extent and nature of the contamination previously identified. The results of the investigation confirmed that the proposed remediation strategy remained appropriate. Further confirmation was given in Contamination Risk Assessment – Additional Investigations (August 2018).

Photo 2: Typical trial pit excavated as part of the July 2018 site investigation.

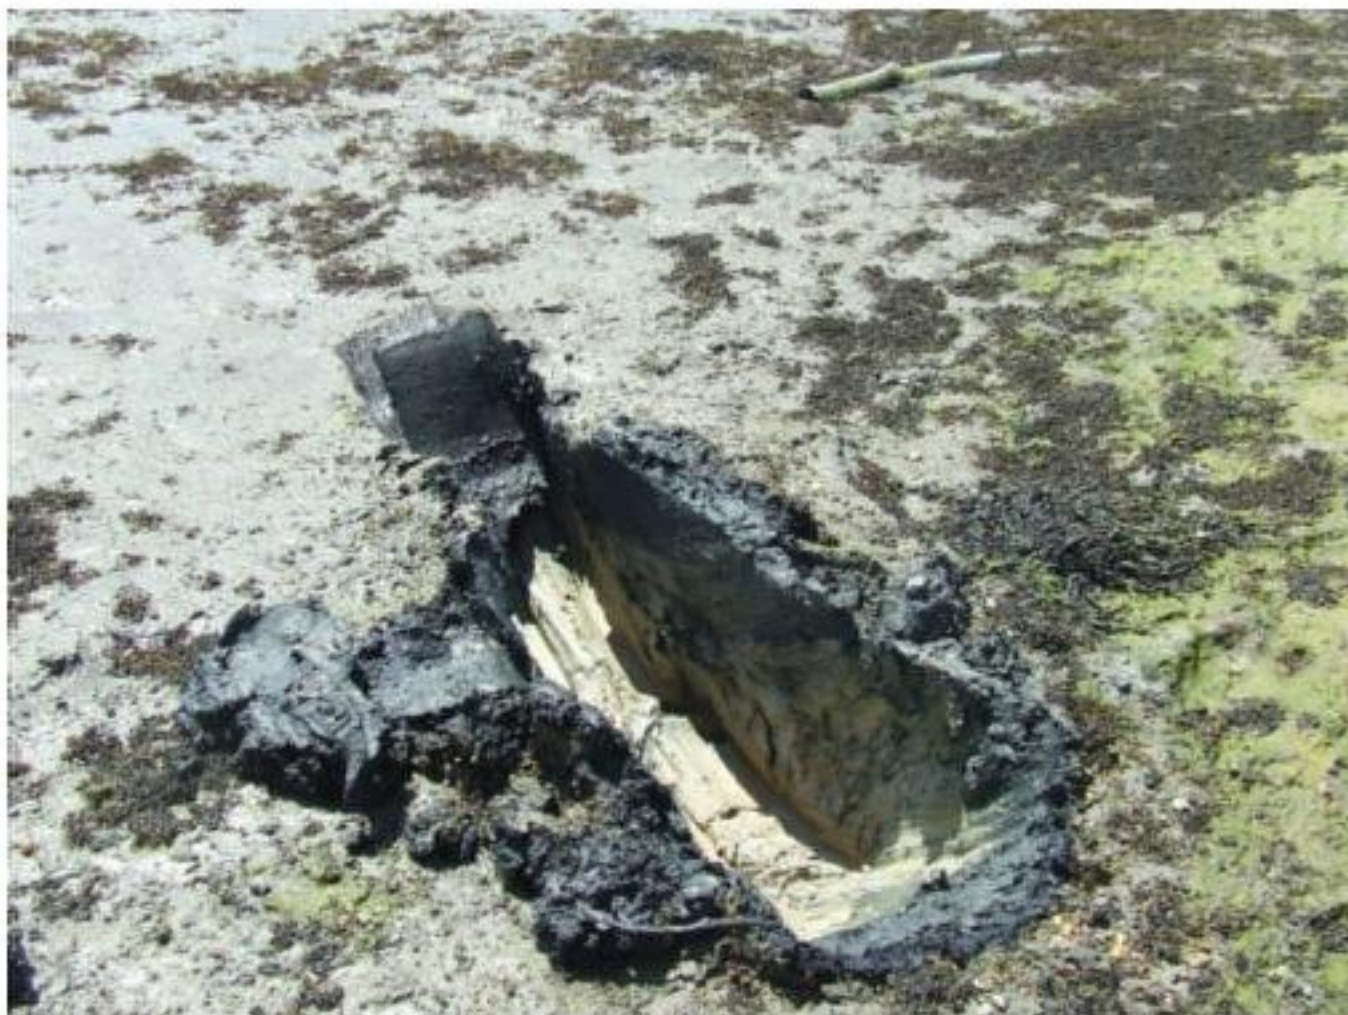
- 5.1.3 The investigation work included analysis of samples taken from the inter-tidal mud seaward of the site, to establish whether there was any evidence of contamination from the site leaching into the foreshore. The only contamination identified comprised traces of hydrocarbons in the sample taken closest to the boatyard, and a trace of tributyltin from the sample taken between the boatyard and the boat moorings in the channel. No evidence of contamination leaching from the site was identified.

Photo 3: Inter-tidal mud sampling undertaken in July 2018.

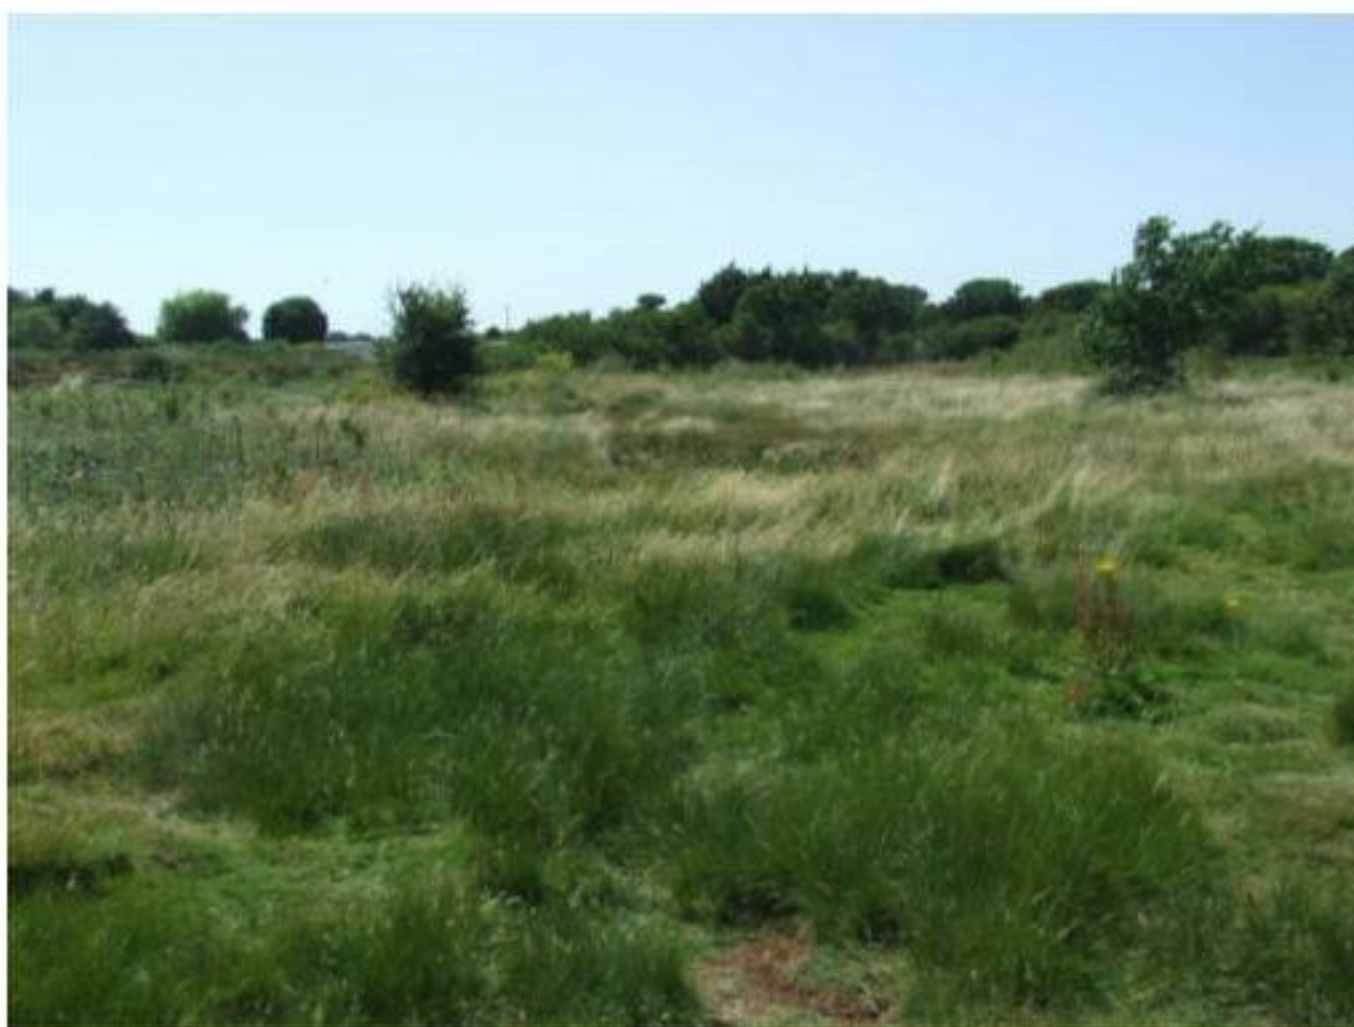
Photo 4: Wildlife area (coastal meadow) in July 2018.

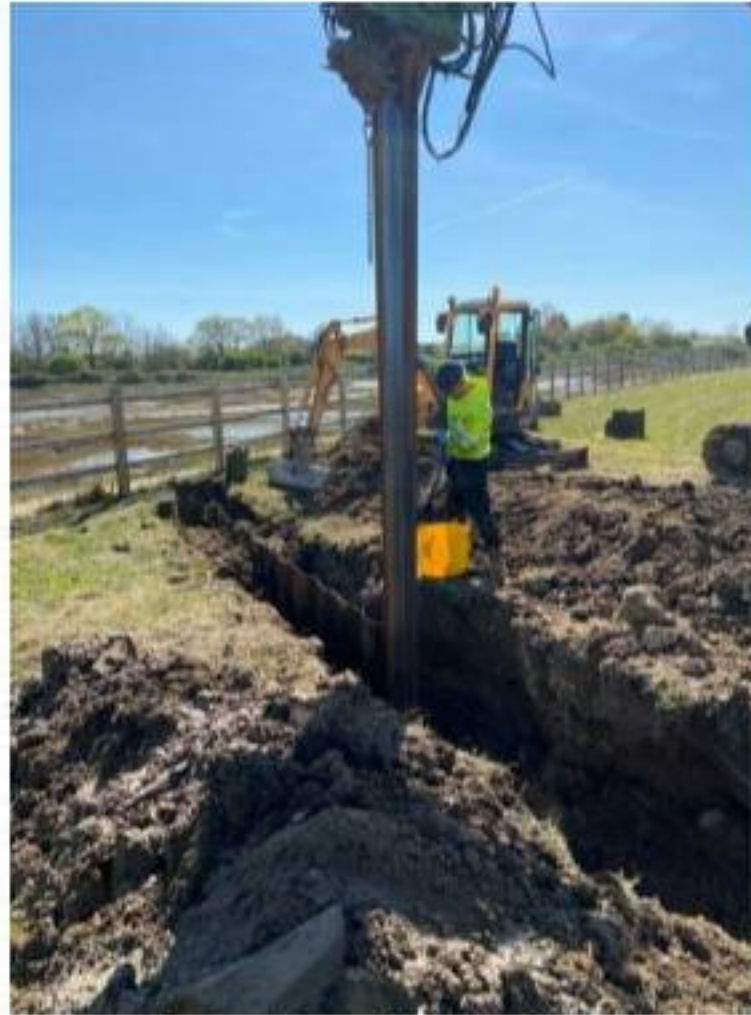
5.3.1 The contamination migration barrier comprises a light steel sheet-piled wall along the frontage, covering the area where soil contamination was originally identified. The function of the barrier was to prevent possible migration of contaminative materials from the site to the foreshore and inter-tidal zone.

Photo 5: Setting & driving sheet piles for the contamination migration barrier (Photograph provided by Yachthaven).

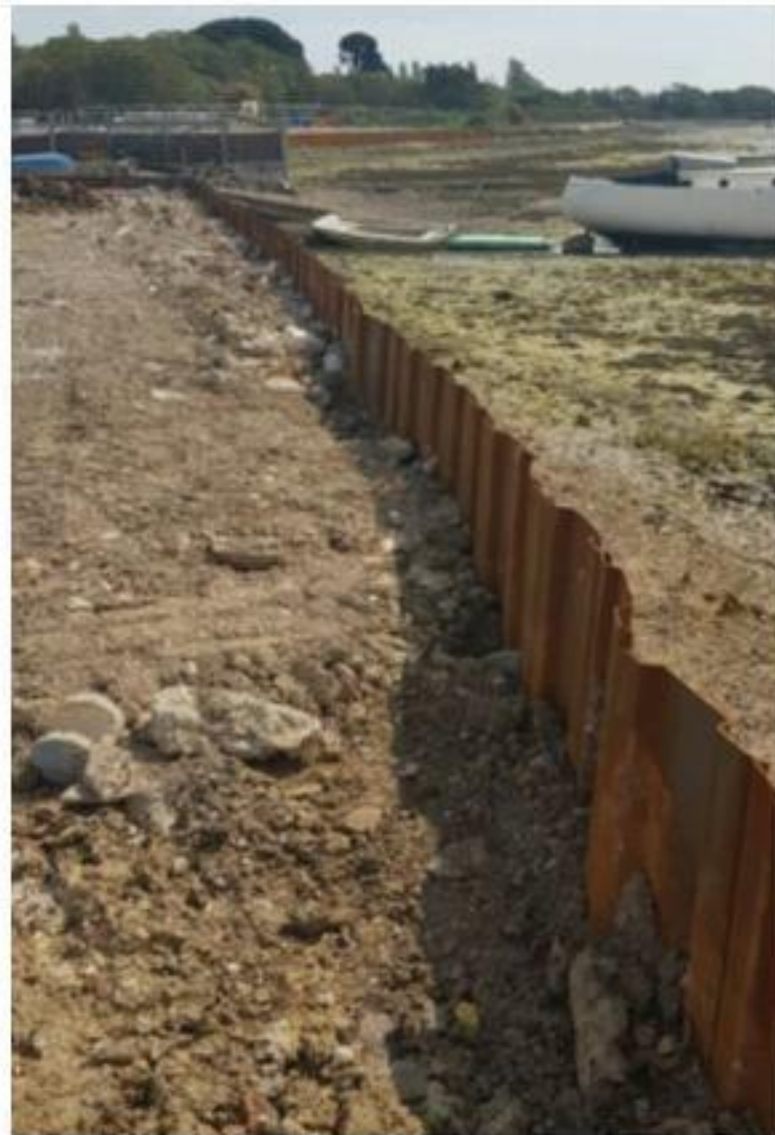
Photo 6: View of the completed sheet pile contamination migration barrier prior to capping & placing revetments (Photograph provided by Yachthaven).

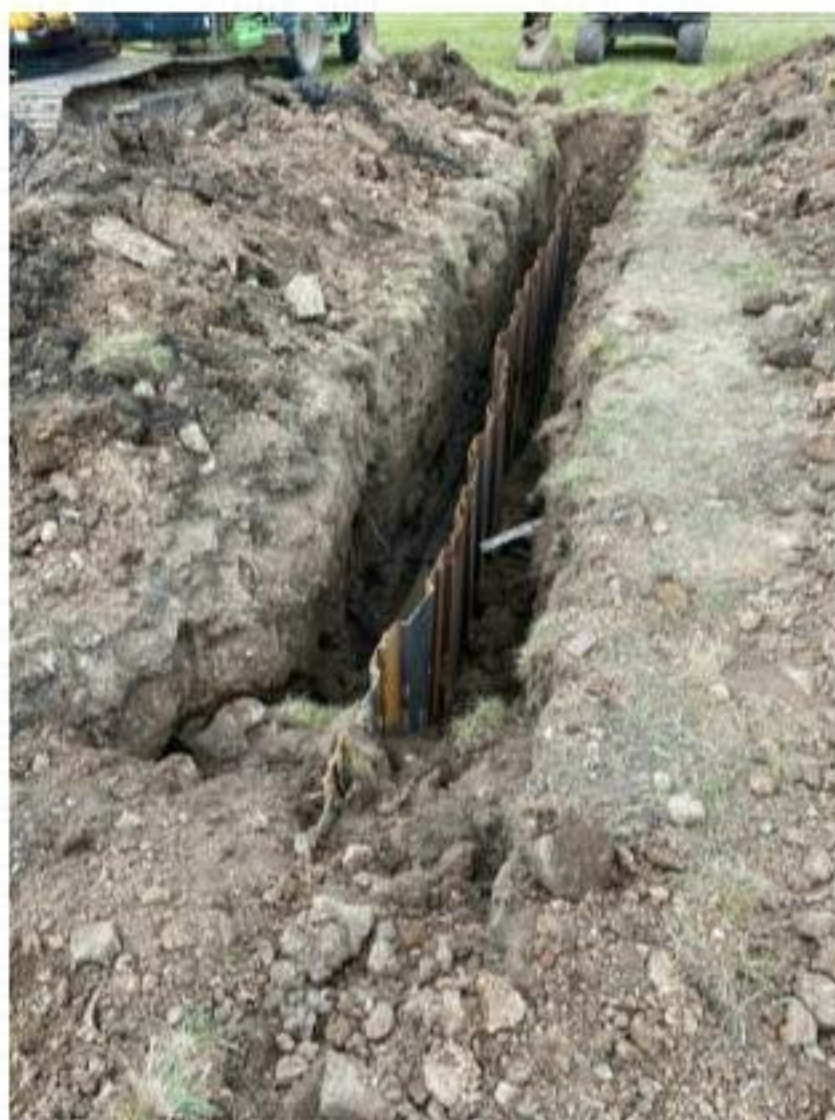
Photo 7: Landward return at end of contamination migration barrier (Photograph provided by Yachthaven).

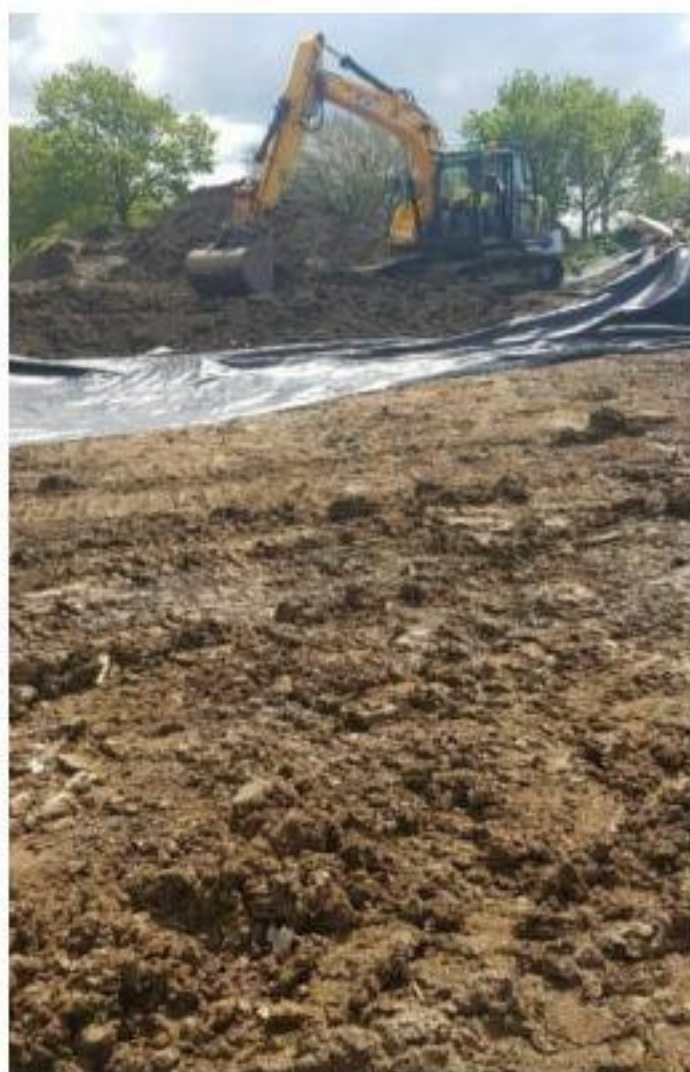
- 5.2.1 The photographs in Appendix B show the remediation work in progress in the soft landscaped areas in the central and eastern part of the site. The works comprised, removal of the made ground, the placing of the geotextile membrane and bringing the ground up to level using clean topsoil from an uncontaminated source.
- 5.2.2 The waste transfer notes for the waste materials and soils removed from the site are provided in Appendix C and summarised in Table 5.1 below:

Photo 8: Excavation, geotextile placement and topsoil placement (Photograph provided by Yachthaven).

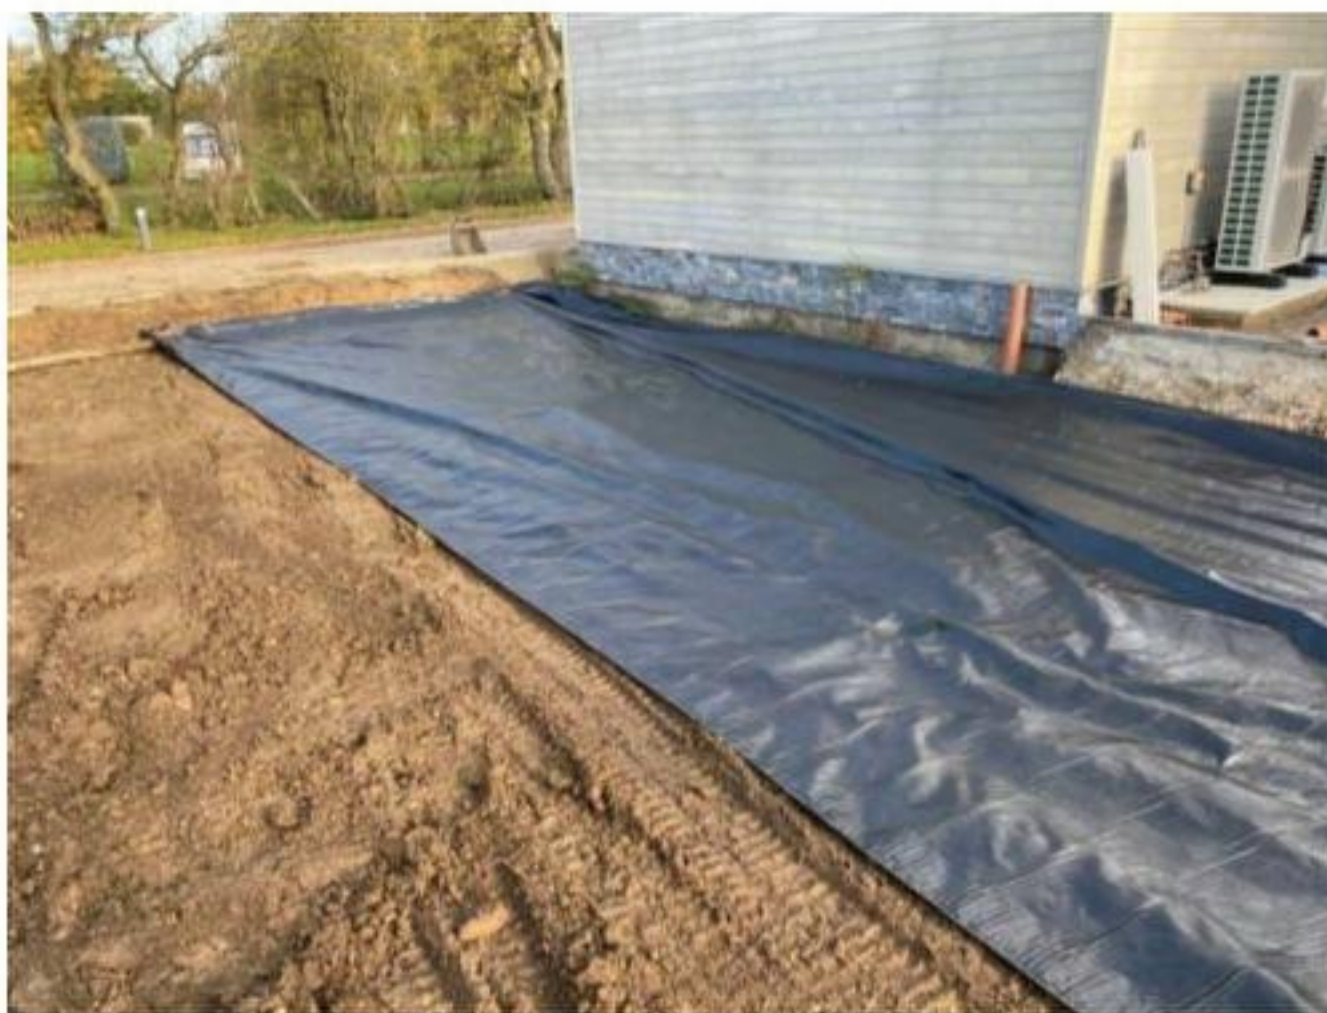
Photo 9: Excavation and geotextile prepared for topsoil placement  
(Photograph provided by Yachthaven)

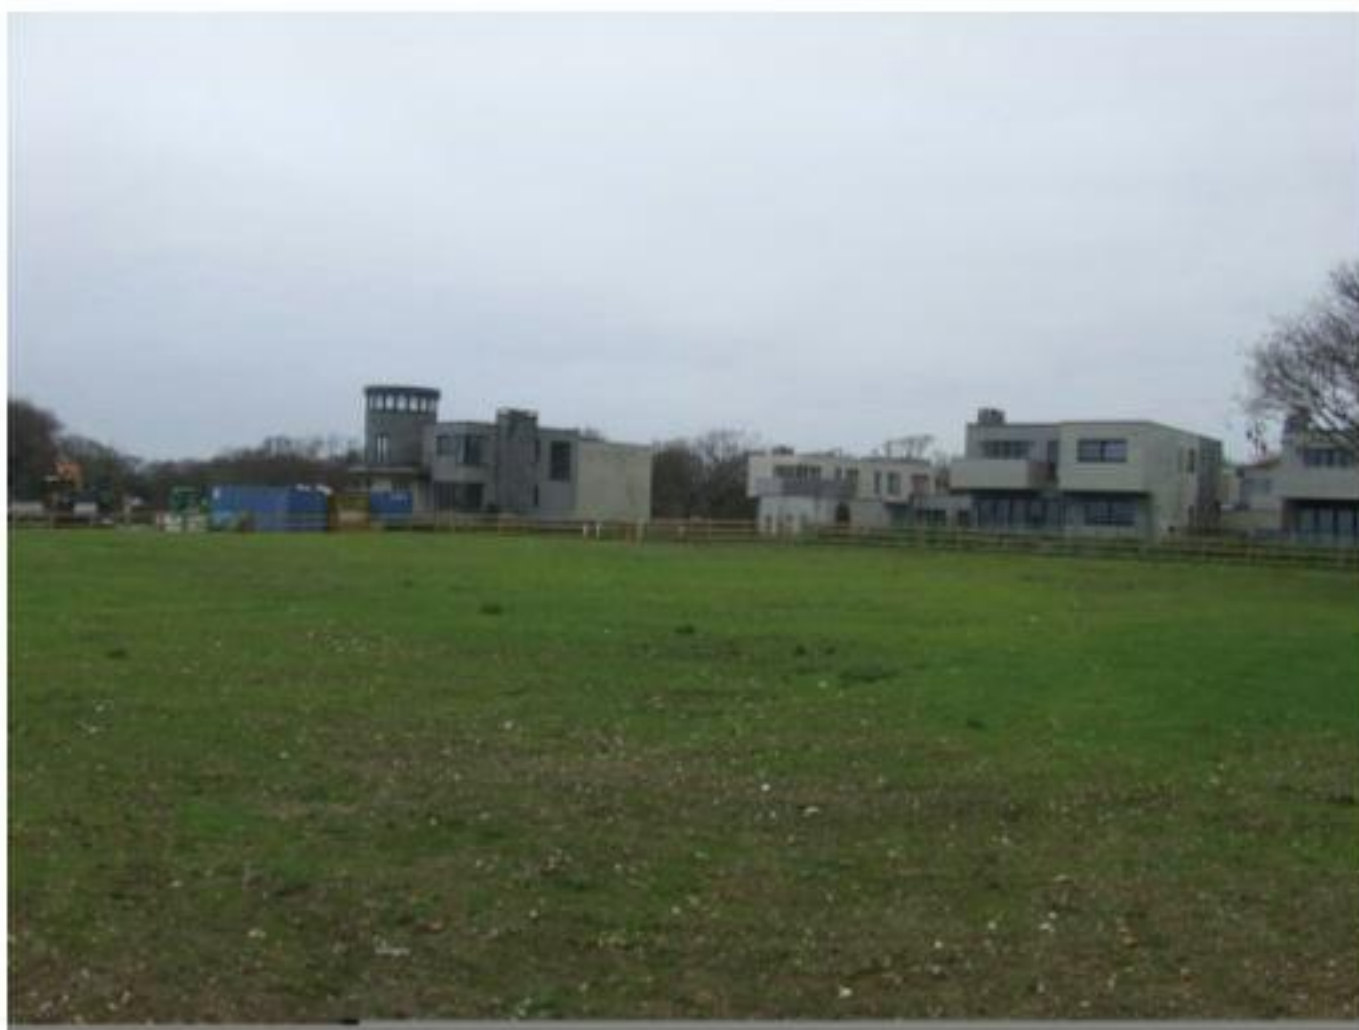
- 5.4.3 The coastal grassland area had been cleared of all waste and the area treated as recommended in the Remediation Strategy. Clean topsoil had been placed to a suitable depth and top sown with a suitable grass seed mix. The grass had germinated and showed good coverage. See photographs in Appendix B.

Photo 10: Coastal grassland recently seeded (Photographed January 2022)

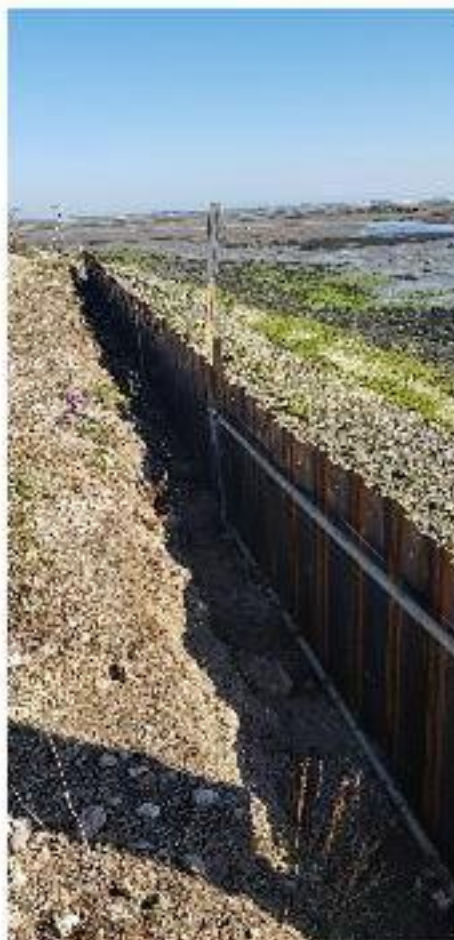
- 5.3.2 The site was visited on Monday 10 January 2022 to, inter alia, confirm that the contamination migration barrier had been completed as specified.

Photo 11: The contamination migration barrier - East.

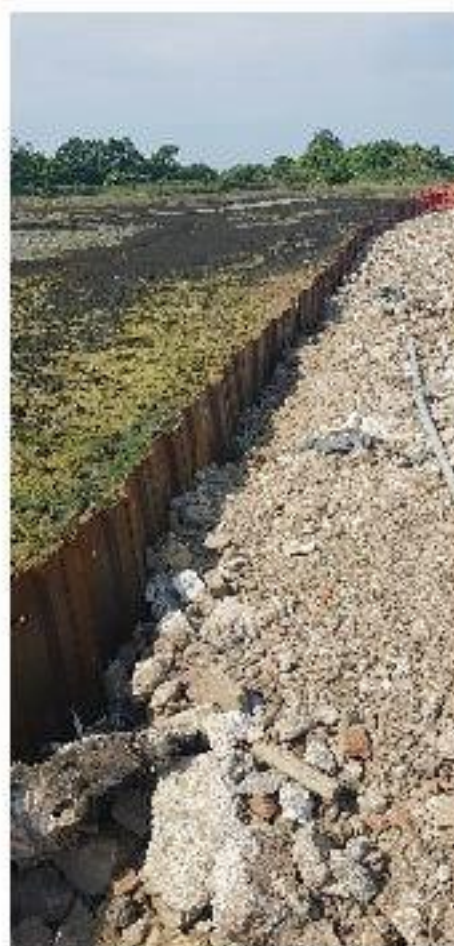
Photo 12: The contamination migration barrier - West.

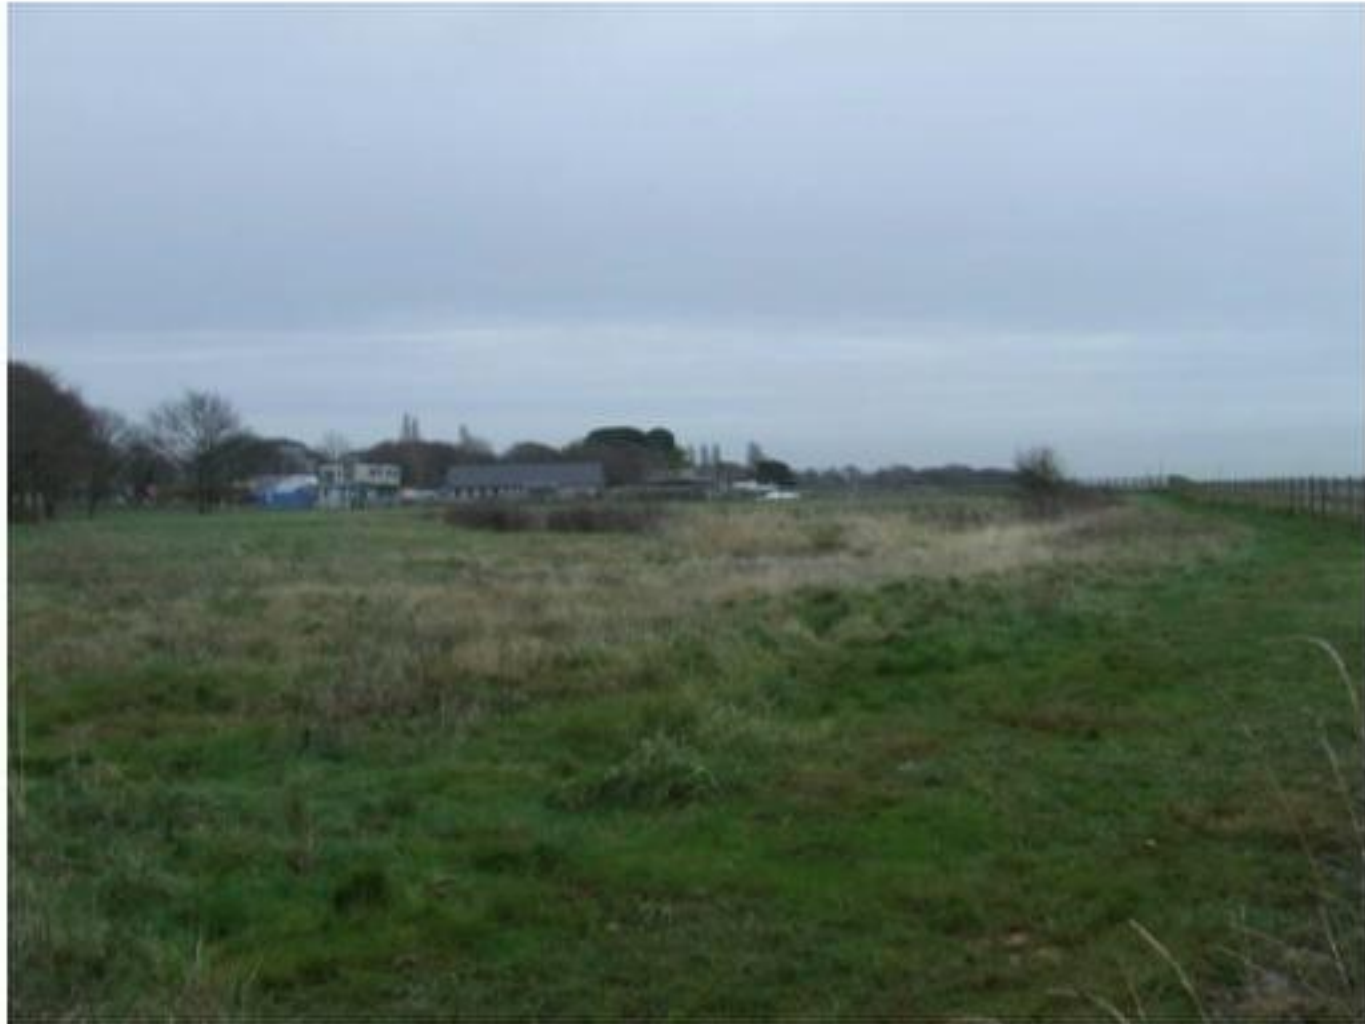
- 5.4.2 The coastal meadow habitat had been securely fenced and all waste had been removed, to leave the area in a generally pristine condition. Varying areas of shorter and longer vegetation had been preserved and allowed to develop undisturbed. A lower area in the centre provides an area of marshy habitat and a small area of bank around the edge. Ecological enhancements included a variety of bird nesting boxes, mainly fixed to the trees on the northern boundary of the area (within an established tree line). It is understood that reptiles were captured in the development area and relocated to the wildlife area at the start of the works. The habitat enhancement has been supervised by Ecosupport Limited acting as Ecological Clerk of Works. See photographs in Appendix B.

Photo 13: Wildlife area – coastal meadow (Photographed January 2022).
