**TECHNICAL REPORT ON A SUBSIDENCE CLAIM**

[REDACTED]  
**97 Sutton Road  
Waterlooville  
PO8 8PT**

**SUBSIDENCE CLAIM**

DATE 14 September 2022

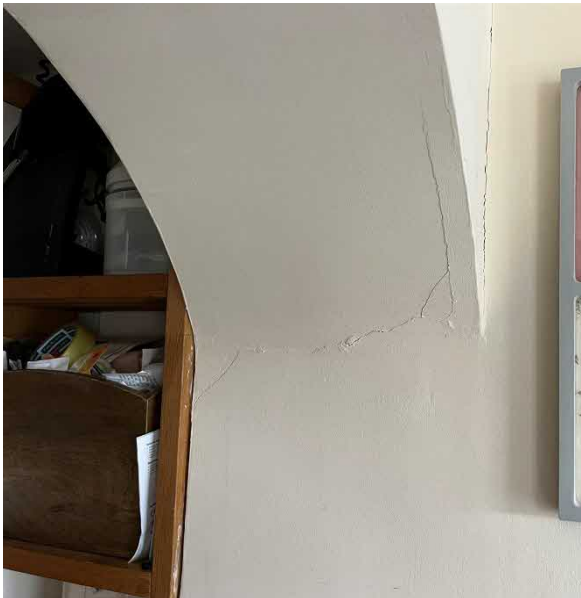
Left junction

Slight vertical crack at left extension junction translating to horizontal crack at base of arch

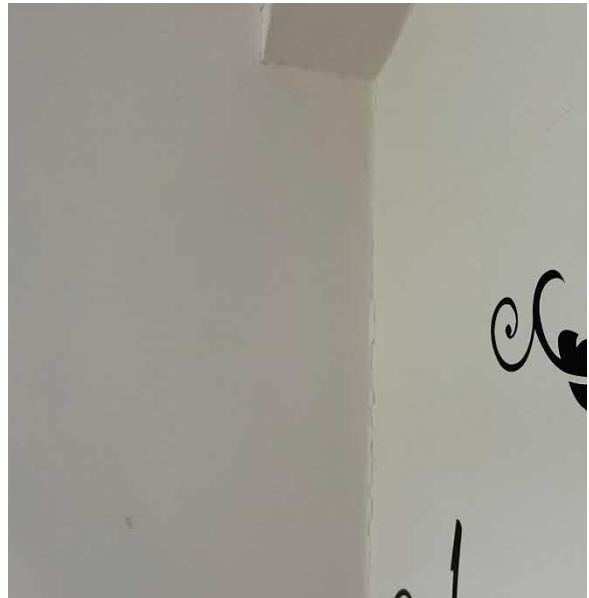
Right junction

Slight vertical crack at right junction

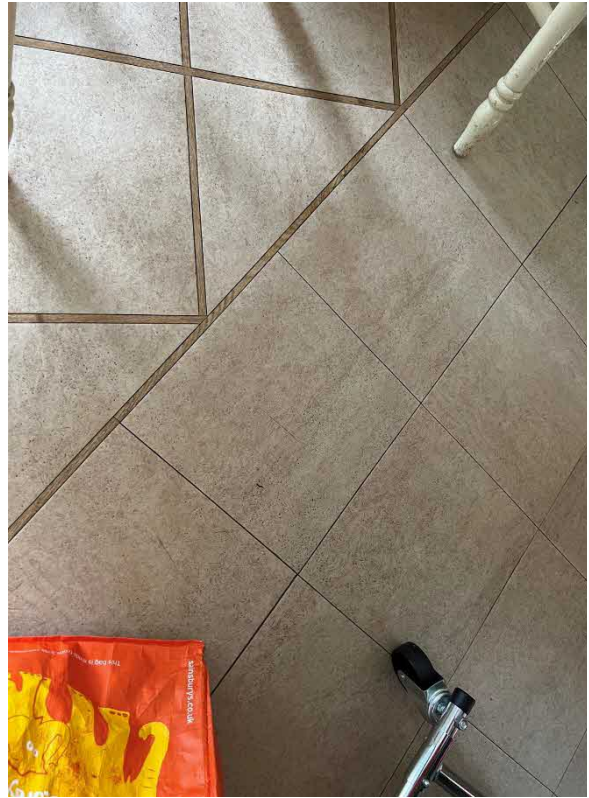
Floor junction

Drop of flooring to the extension causing a slight lip in the flooring at the junction
