Ref: 1CO108540/200323/L1

Date: 23<sup>rd</sup> March 2020

**Geo-Environmental Letter Report –  
97A Lovedean Lane, Waterlooville, PO8 9RN**

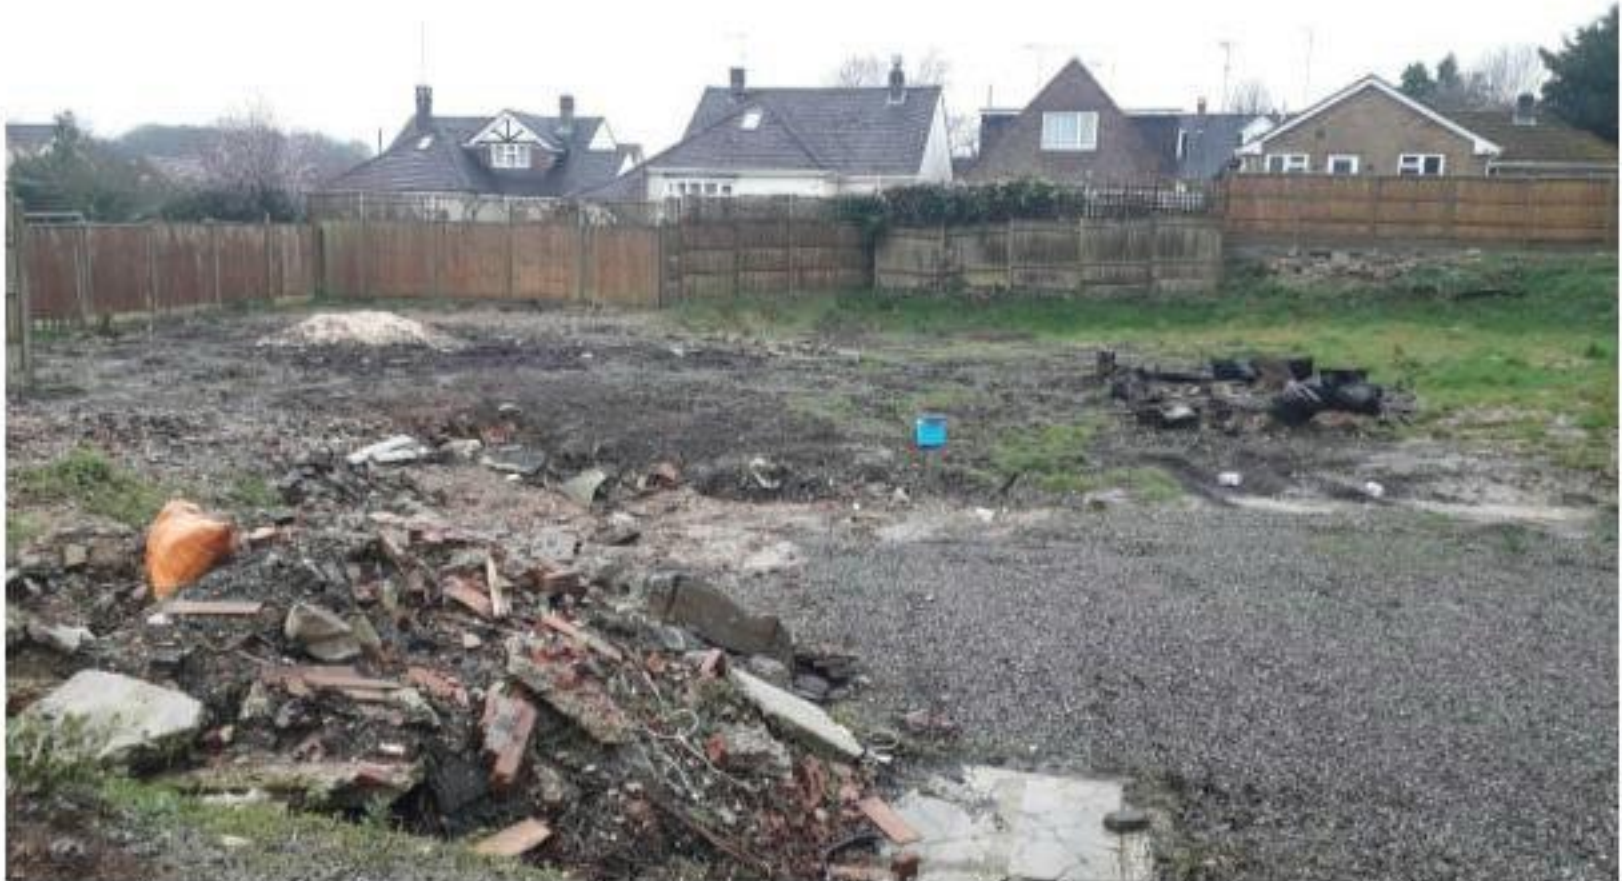
Plate 1: Overview of the site facing south and in the direction of the former chalk pit.

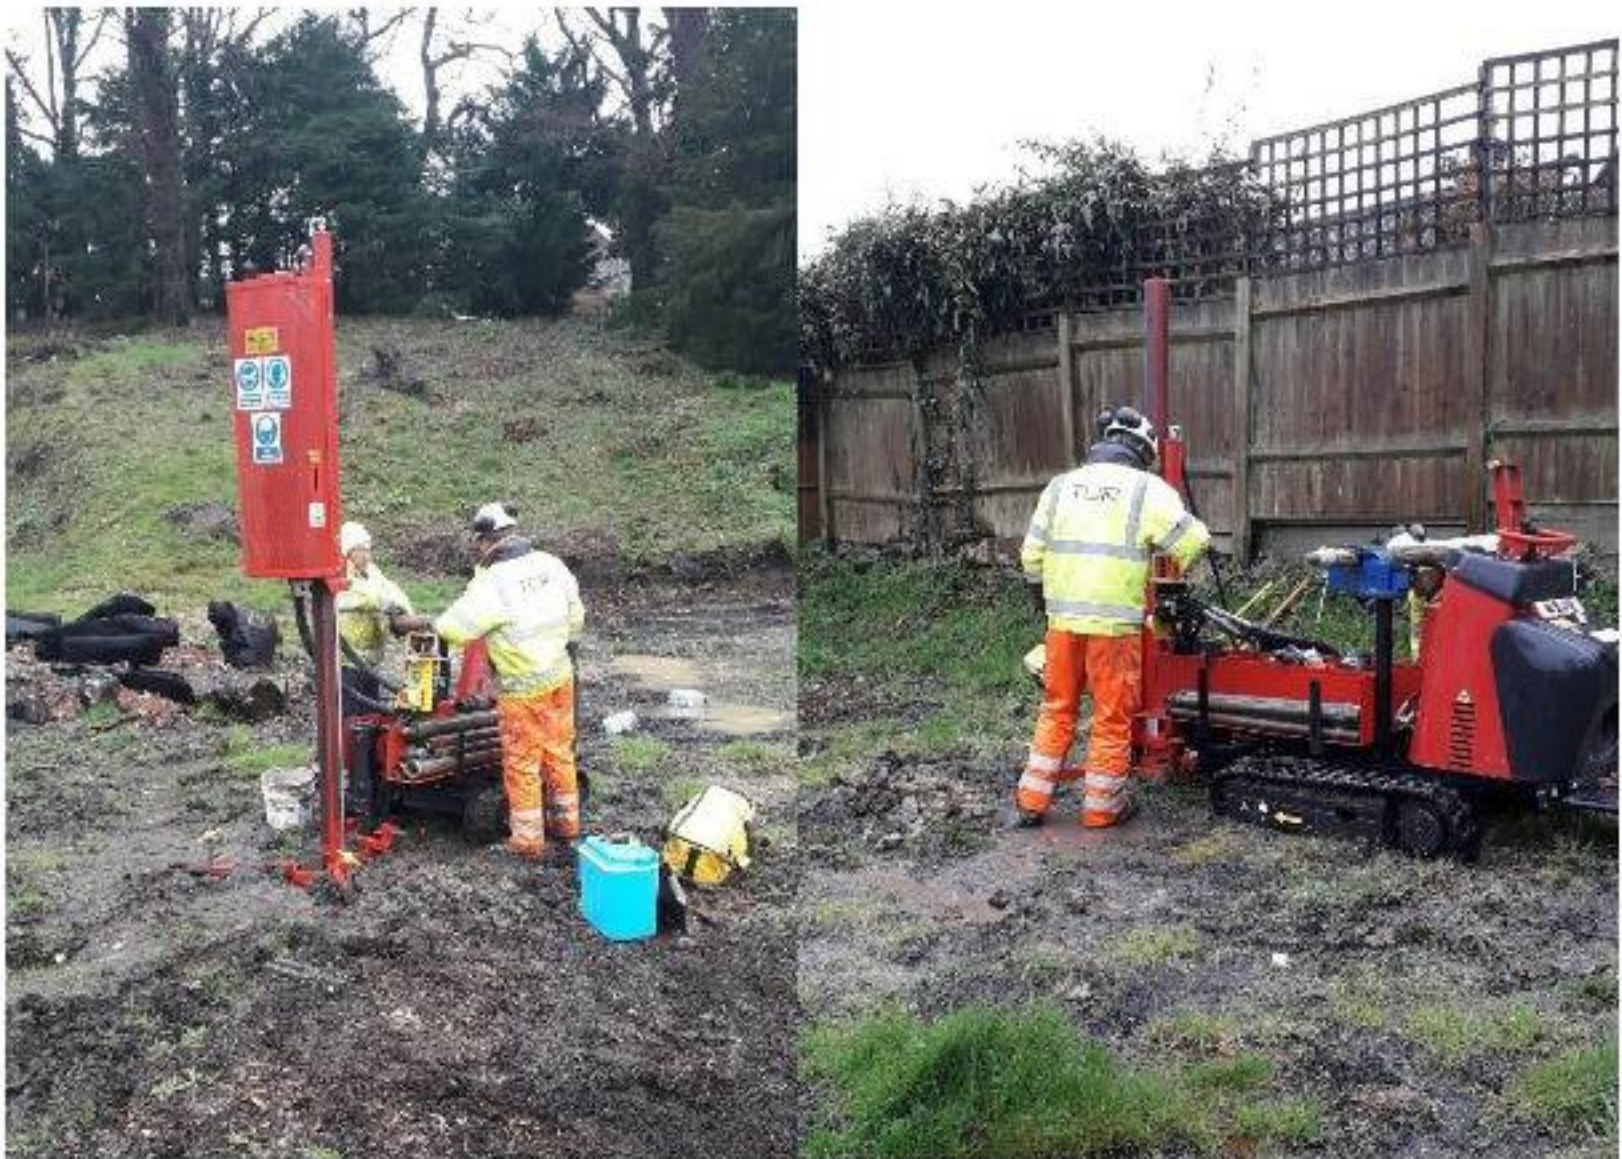
Plate 2: Drilling WS201 (left) and WS202 (right).

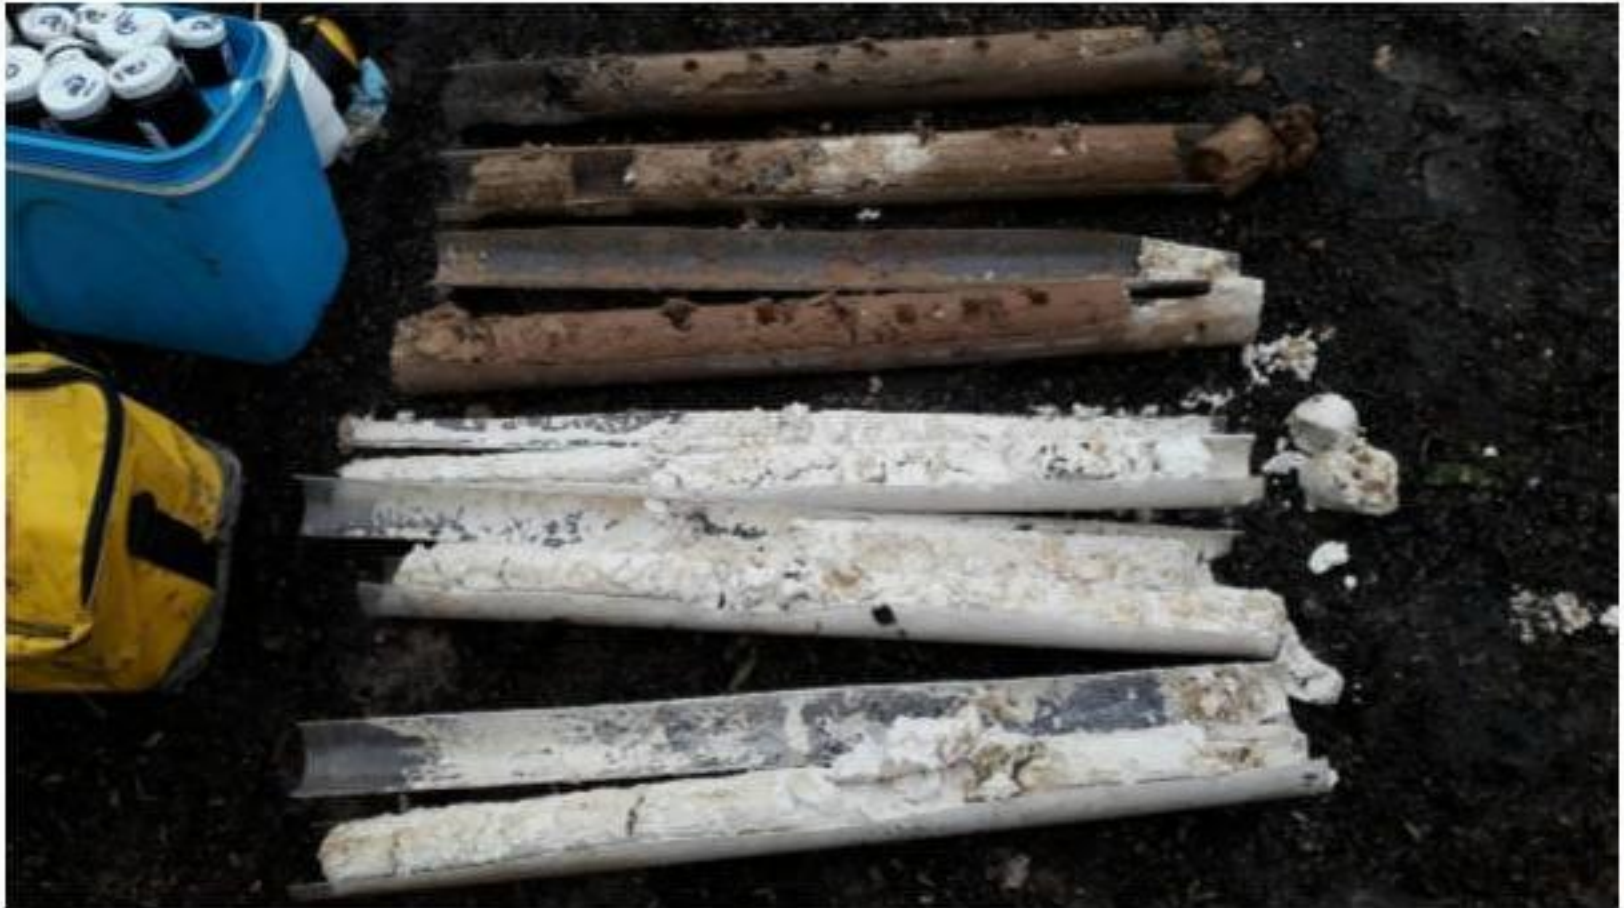
In WS201 between 3.85 and 6.20mbgl the chalk was recovered as off-white silty gravel.

Plate 3: Window Sample recovery from WS201 showing 1.20 to 7.00mbgl.

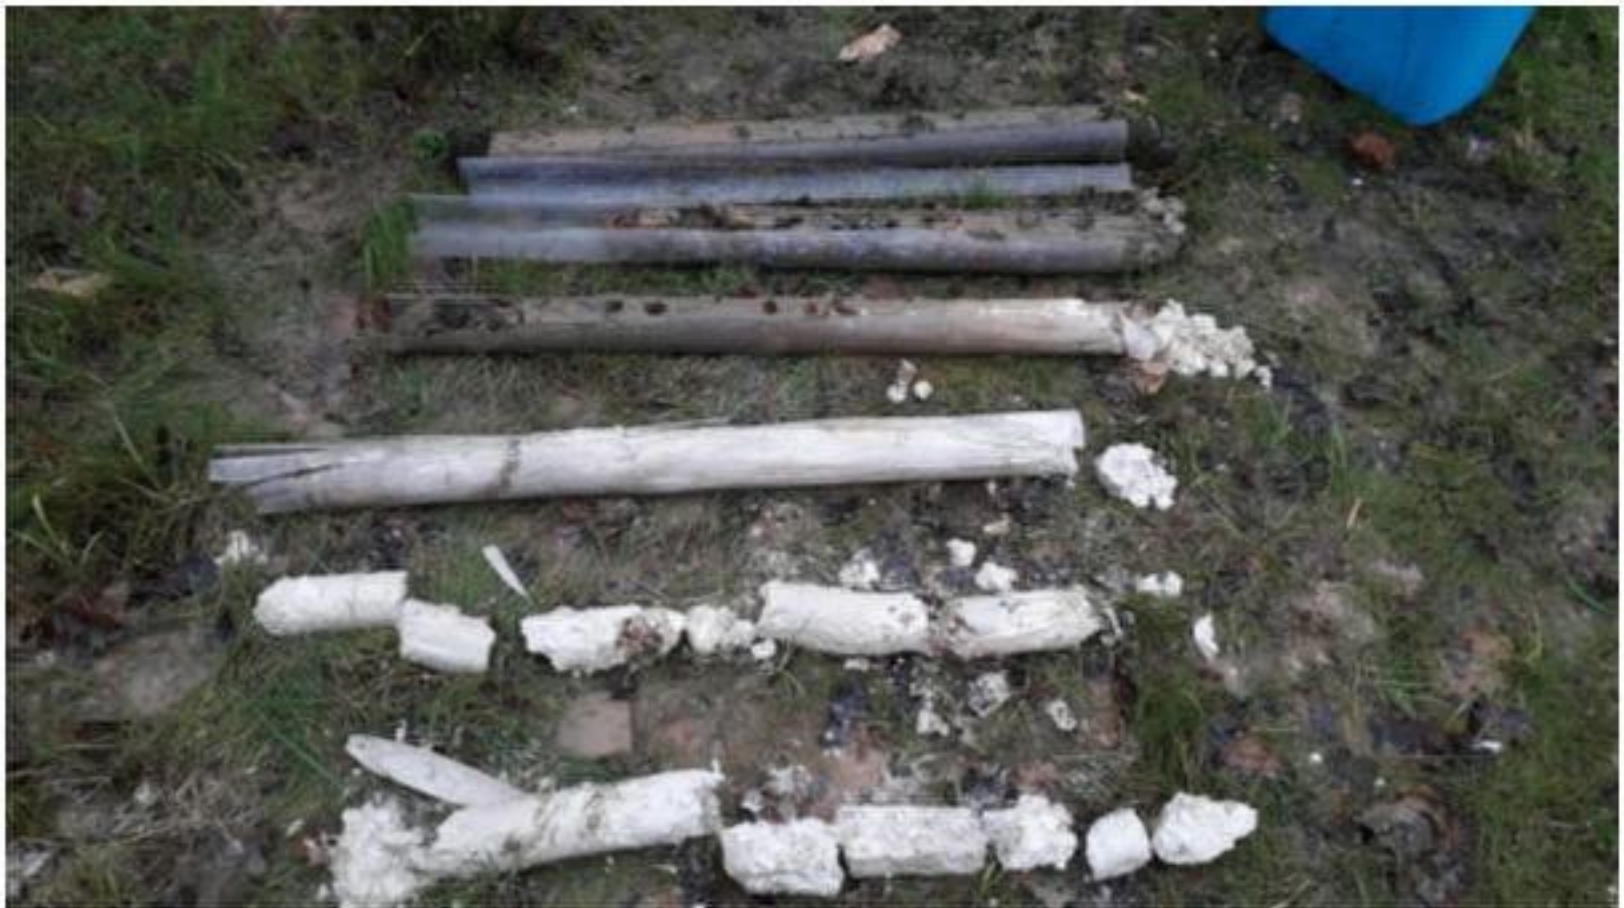
Plate 4: Window Sample recovery from WS202 showing 1.20 to 7.00mbgl.
