2c Padnell Avenue  
WATERLOOVILLE  
Hampshire  
PO8 8DY

INSURANCE CLAIM

CONCERNING SUBSIDENCE DAMAGE

ENGINEERING APPRAISAL REPORT

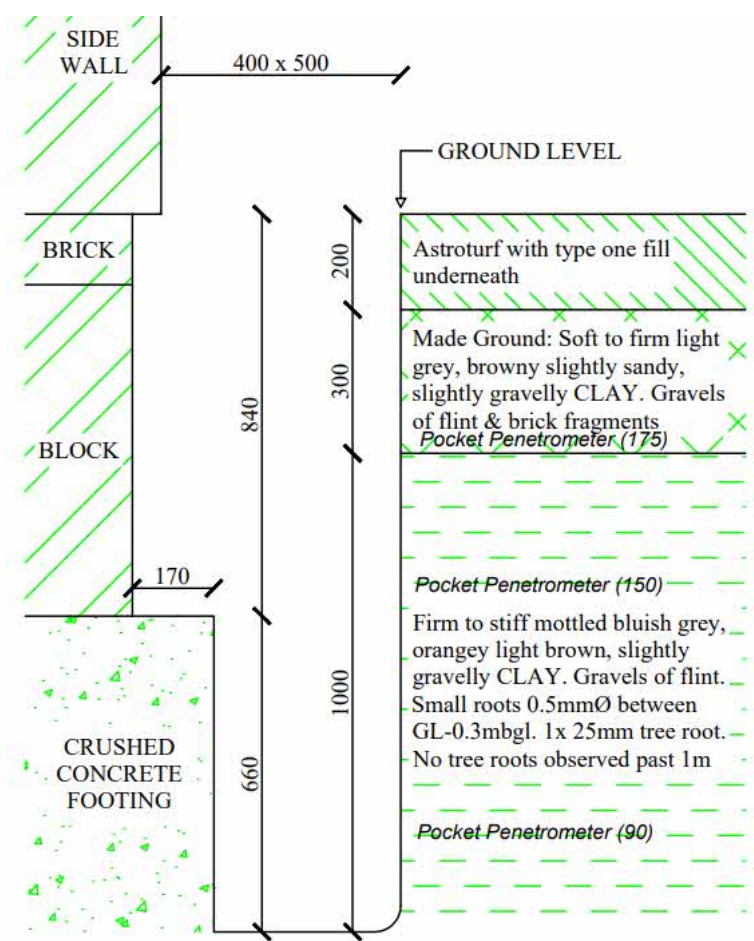
This was located at the rear right-hand corner of the property.

The underside of the foundation is at 1.5m below ground level with the foundation comprising a crushed concrete strip. The soil beneath the property foundations has been identified as firm to stiff mottled bluish grey orangey light brown slightly gravelly clay with roots identified as oak as described in the section above.
