11<sup>th</sup> January 2022

Our ref: GE20565/FG01/220111

**RE: Phase 2 Manor Farm, Lower Road, Bedhampton – Soakage Testing and Installation of Groundwater Monitoring Wells**

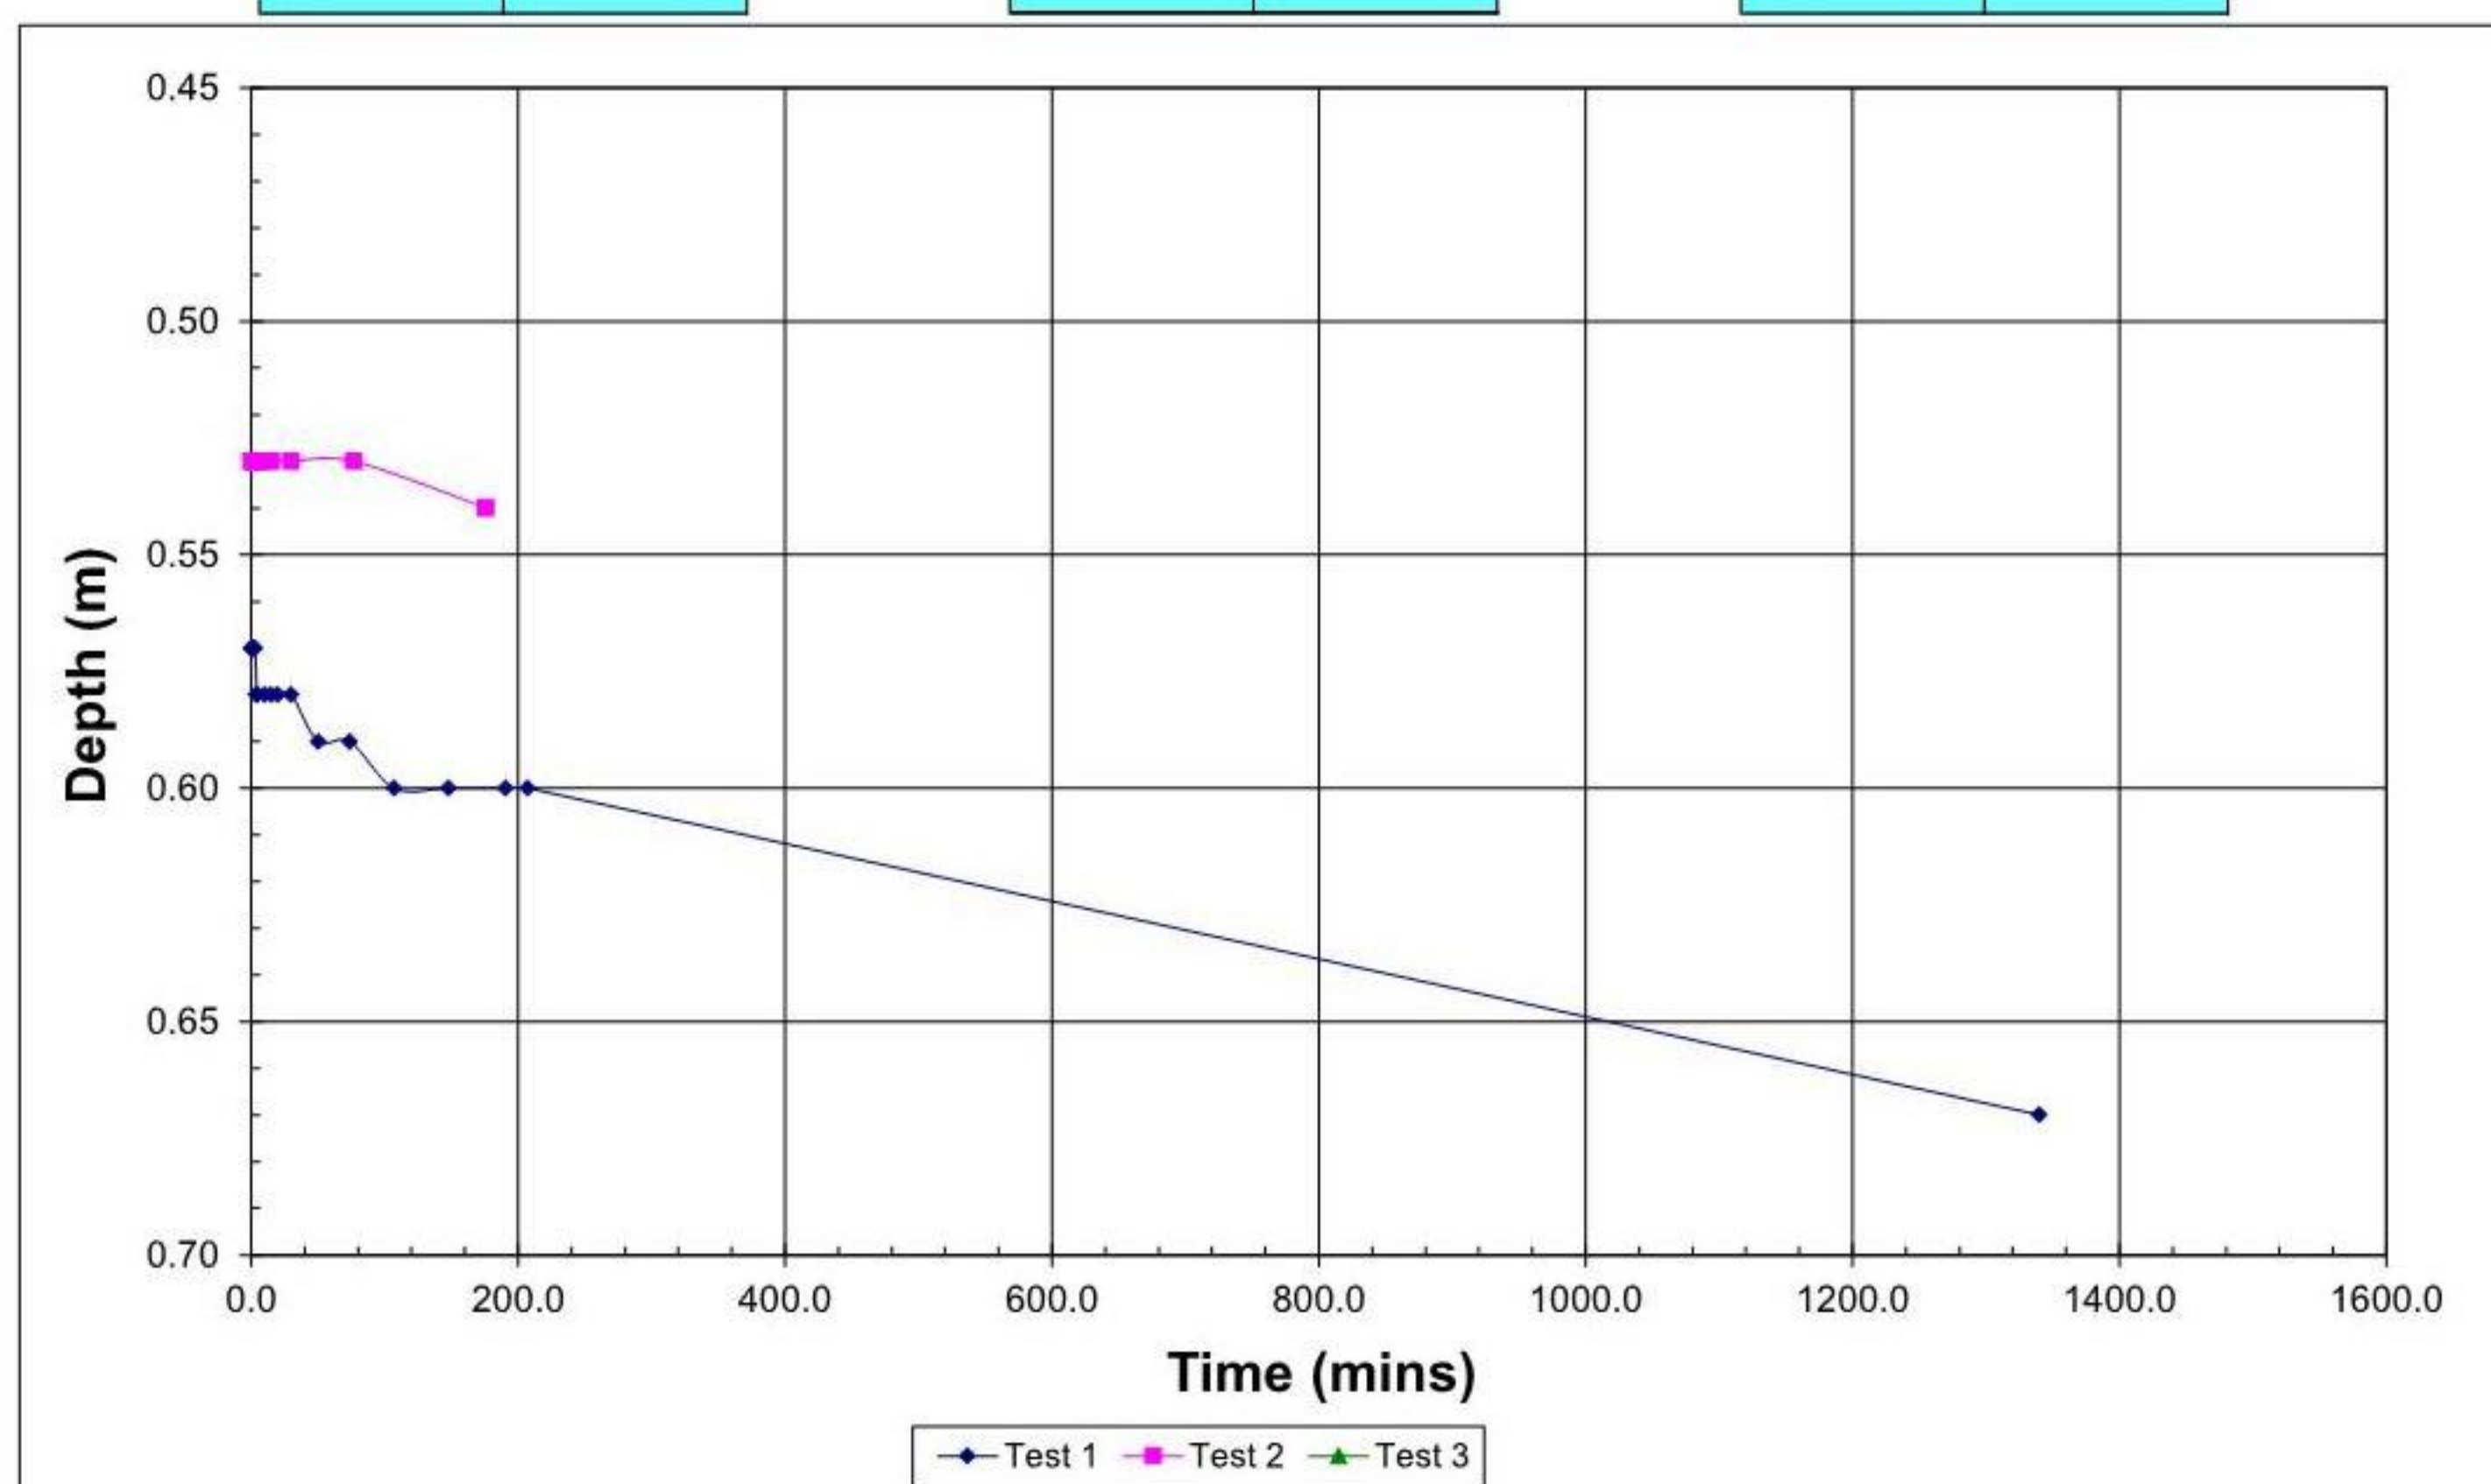
| Pit reference | SA01 |

The testing was undertaken over two consecutive days. It was not possible to calculate an infiltration rate for SA02, as water levels within this trial pit increased during the testing period, therefore the test was deemed to have failed. There was an insufficient fall in head to calculate an infiltration rate for the tests undertaken within SA01, which were located within the cohesive River Terrace Deposits, and it is not considered suitable or reliable to estimate a permeability based on the actual measured range as this would be likely to derive an overly optimistic permeability. The soakage testing results are presented within Appendix B.

| Soil infiltration rate (m/s) | Insufficient fall in water to complete test | |
| Soil infiltration rate (mm/hr) | Insufficient fall in water to complete test | |

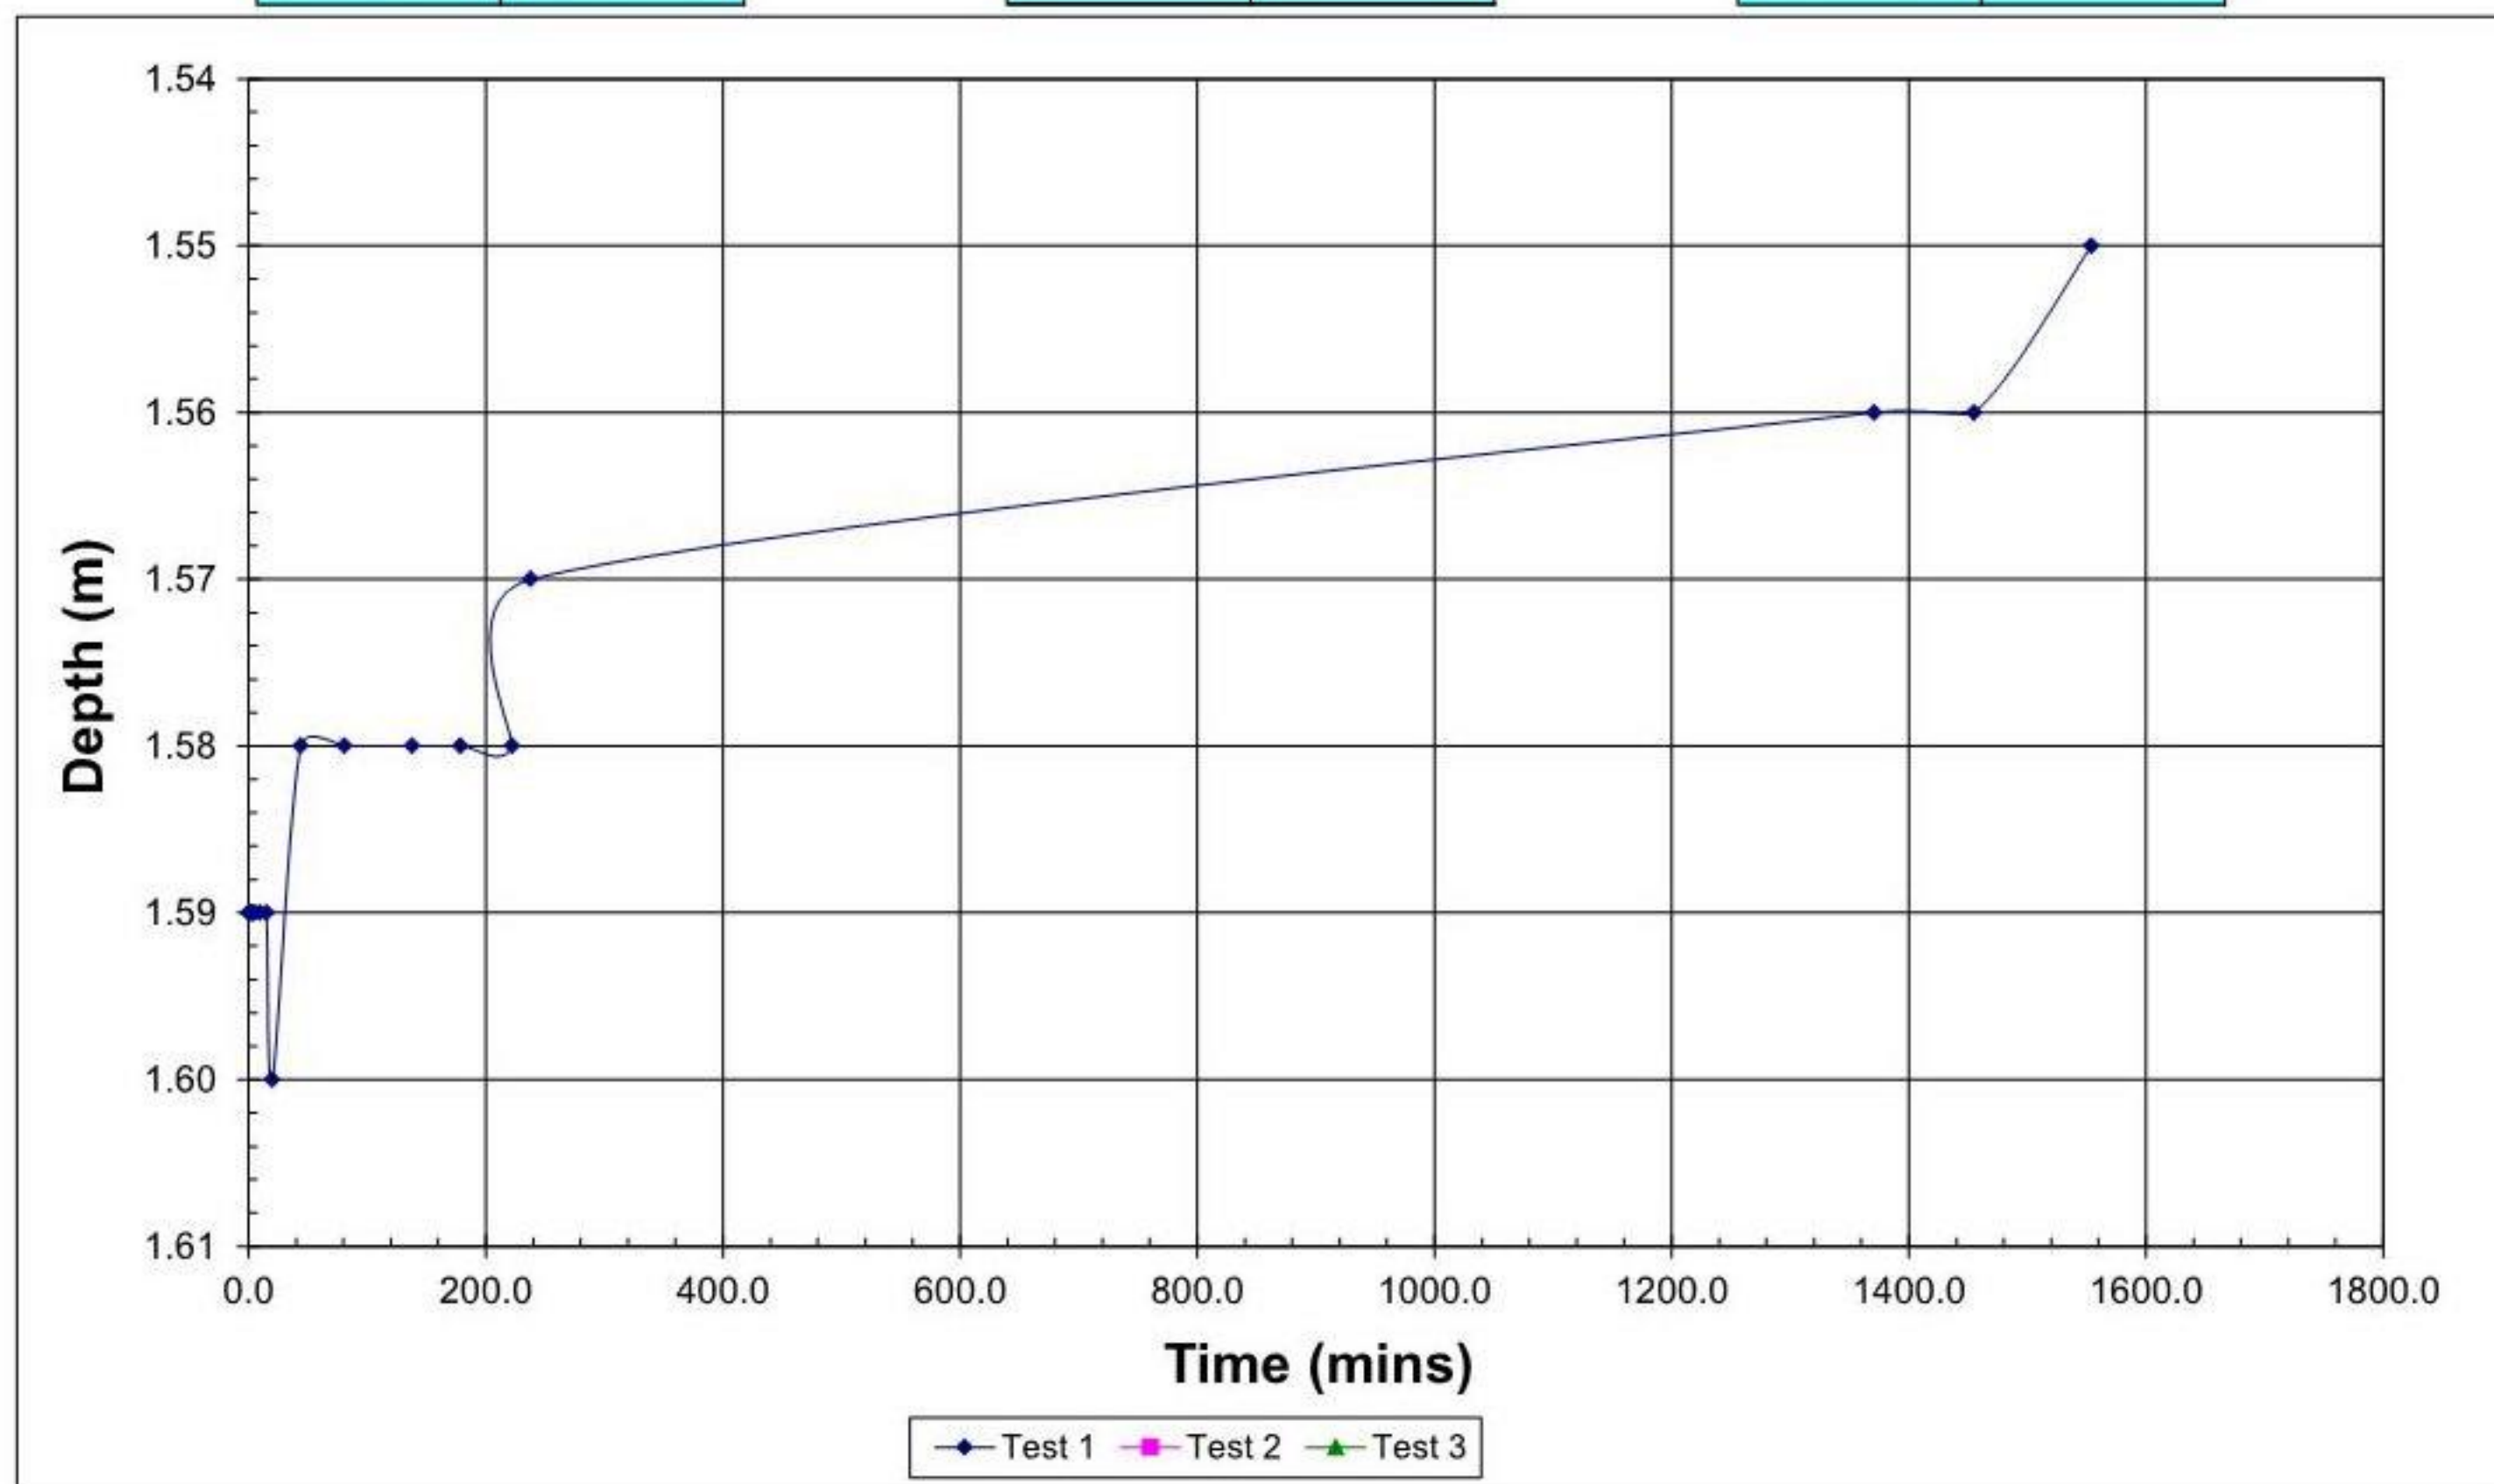
| <b>Soil infiltration rate (m/s)</b> | Insufficient fall in water to complete test | |
| <b>Soil infiltration rate (mm/hr)</b> | Insufficient fall in water to complete test | |

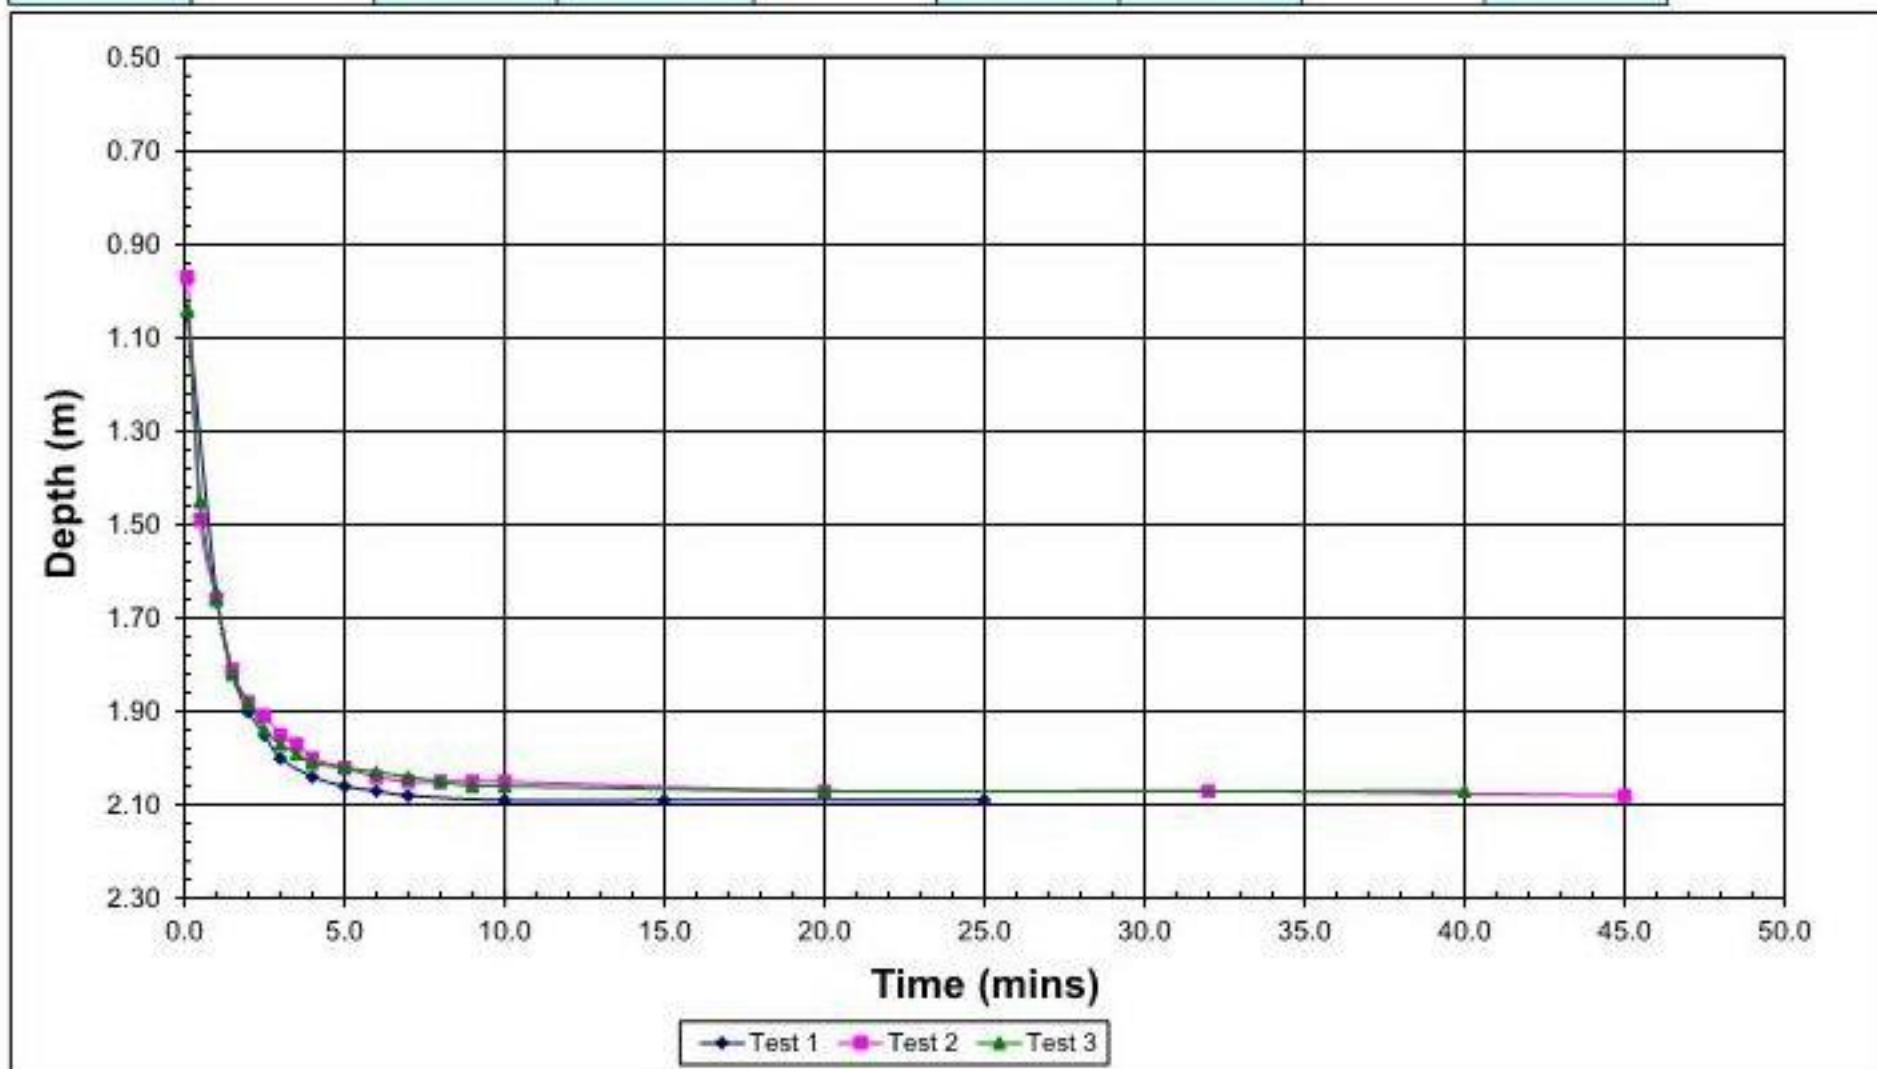
Groundwater was present within the borehole during testing and was recorded at a depth of 2.09m bgl prior to commencing testing. The estimated preliminary infiltrations rates for each test undertaken within BH01 are summarised within Table 3 below with the results presented in a graphical format in Appendix C.

| Trial Pit | Stratum tested | Estimated infiltration rates (m/s) | | |
|---|---|---|---|---|
| BH01 | Chalk | $2.29 \times 10^{-7}$ | $1.41 \times 10^{-7}$ | $1.43 \times 10^{-7}$ |

Given the presence of highly weathered Chalk strata at relatively shallow depth, it is recommended that any infiltration devices are located at least 20m from any structures.
