# Arboricultural Appraisal Report

## Subsidence Damage Investigation at:

97 Sutton Road  
Waterlooville  
PO8 8PT

28/10/2022

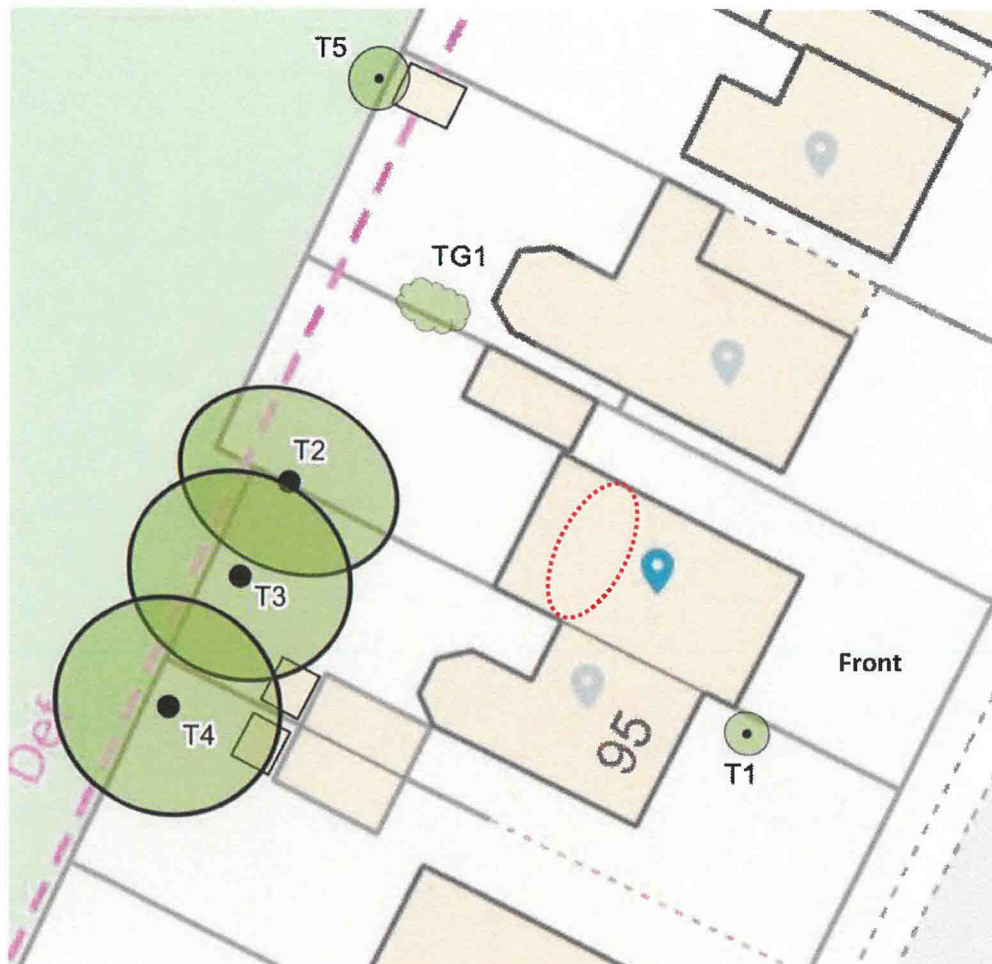
Our survey has identified vegetation within influencing distance of the building with a current potential to influence soil volumes below foundation level. The vegetation considered to be most significant in relation to the current damage is T2, with a potential contribution from T3.

Approximate areas of damage

If an arboricultural solution is to be implemented to mitigate the influence of the trees/shrubs considered to be responsible for the damage, we recommend that T2 be removed and T3 reduced. We did consider removing both current claim oaks although the amplitude of damage (BRE Digest 251 slight) indicates that it may be possible to restore stability with T3 retained but subject to crown reduction and regular repeat pruning.

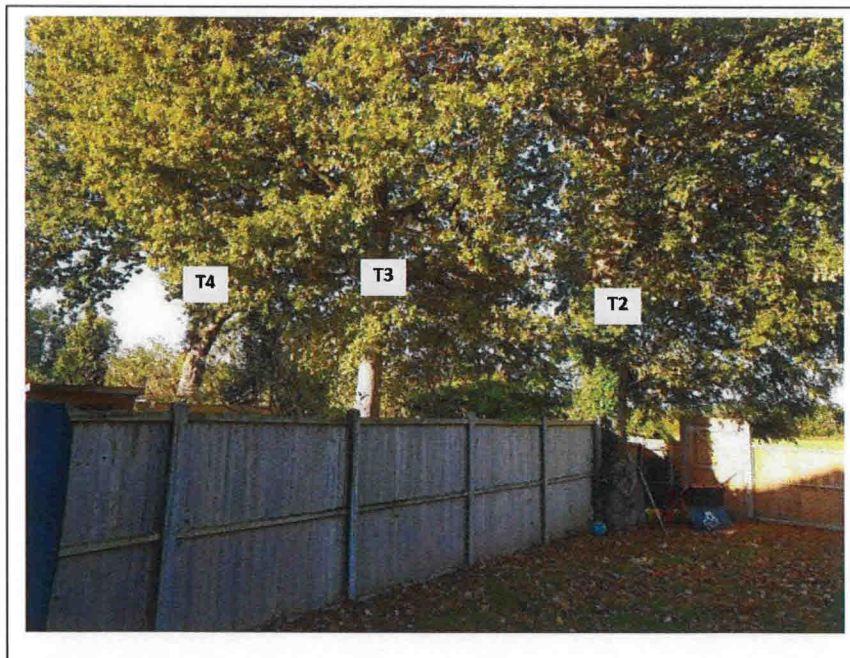
| Tree No. | Species | Ht. (m) | Dia. (mm) | Crown Spread (m) | Dist. to building (m) | Age Classification | Ownership |
|---|---|---|---|---|---|---|---|
| T2 | English Oak | 16 * | 730 | 12 * | 11 | Older than Property | Joint Policy Holder & 95 Sutton Road PO8 8PT |
| T3 | English Oak | 16 * | 740 * | 14 * | 12 | Older than Property | Third Party 95 Sutton Road PO8 8PT |

View of T4, T3 and T2

| Tree No. | Species | Ht. (m) | Dia. (mm) | Crown Spread (m) | Dist. to building (m) | Age Classification | Ownership |
|---|---|---|---|---|---|---|---|
| Recommendation | | Remove to ground level removing any regrowth annually. | | | | | |
| Recommendation | | Reduce height to 9m and crown spread to 8m leaving balanced crown. Prune on a biennial cycle to maintain at broadly reduced dimensions. | | | | | |
