## Tree Inspection Report

Site: 162 Stakes Hill Road  
Waterlooville  
Hampshire  
PO7 7BS

Date: 11<sup>th</sup> June 2019

Ref: NJCL 444

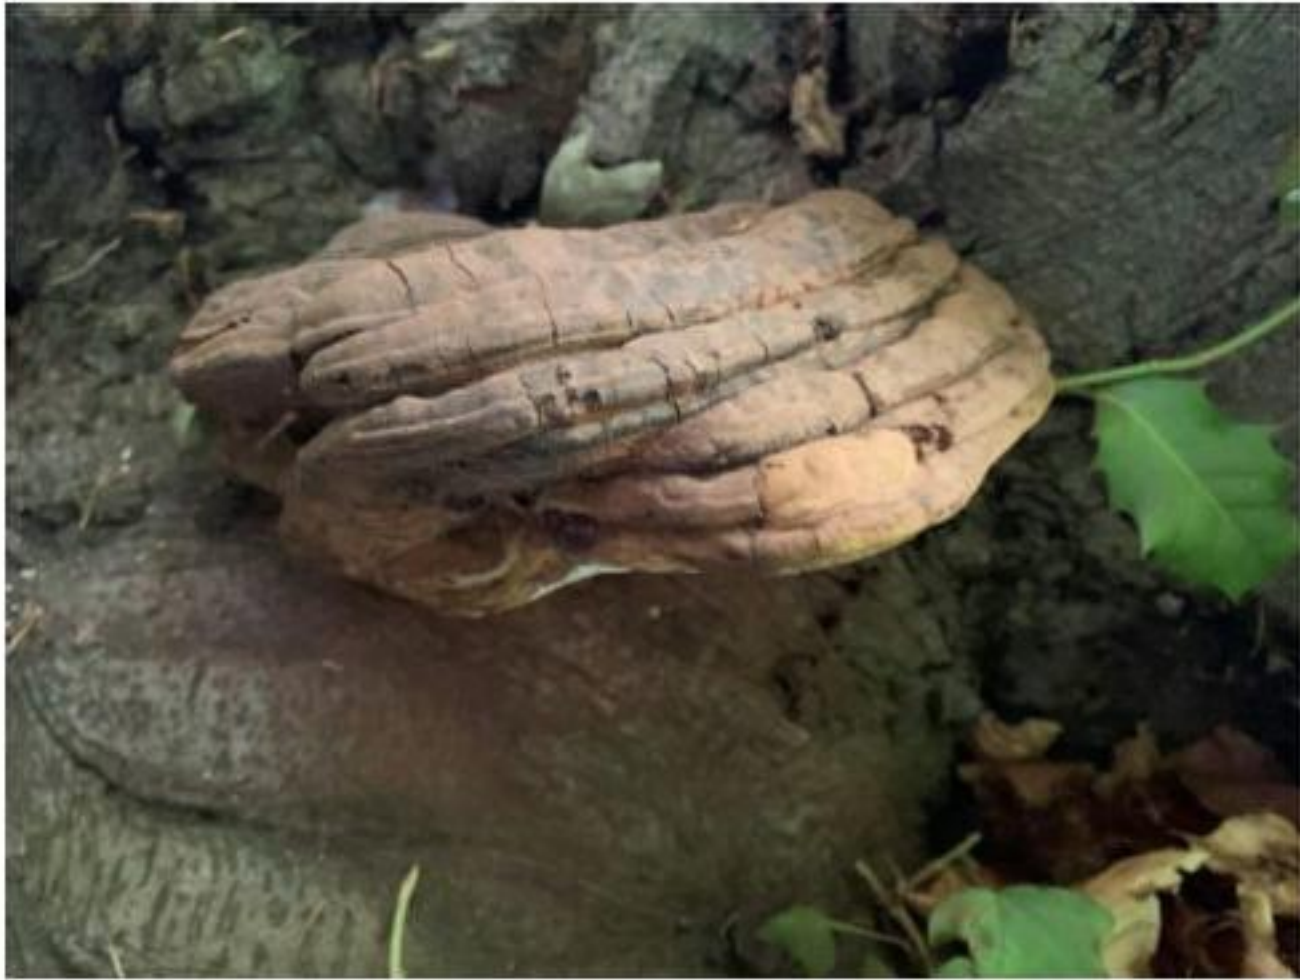
Figure 1 – Fruit body of *Ganoderma adspersum* at the base of the tree

The fungus identified at the base of the tree, *Ganoderma adspersum*, is commonly associated with beech, and causes decay within the lower stem and root system which can lead to the mechanical failure of host trees. However, the partially decayed wood retains considerable tensile strength. As a result, it may take a great many years before the decayed zone becomes dangerously large in relation to the extent of sound wood, as trees can produce compensatory growth of extra wood due to increased flexure caused by the decay.

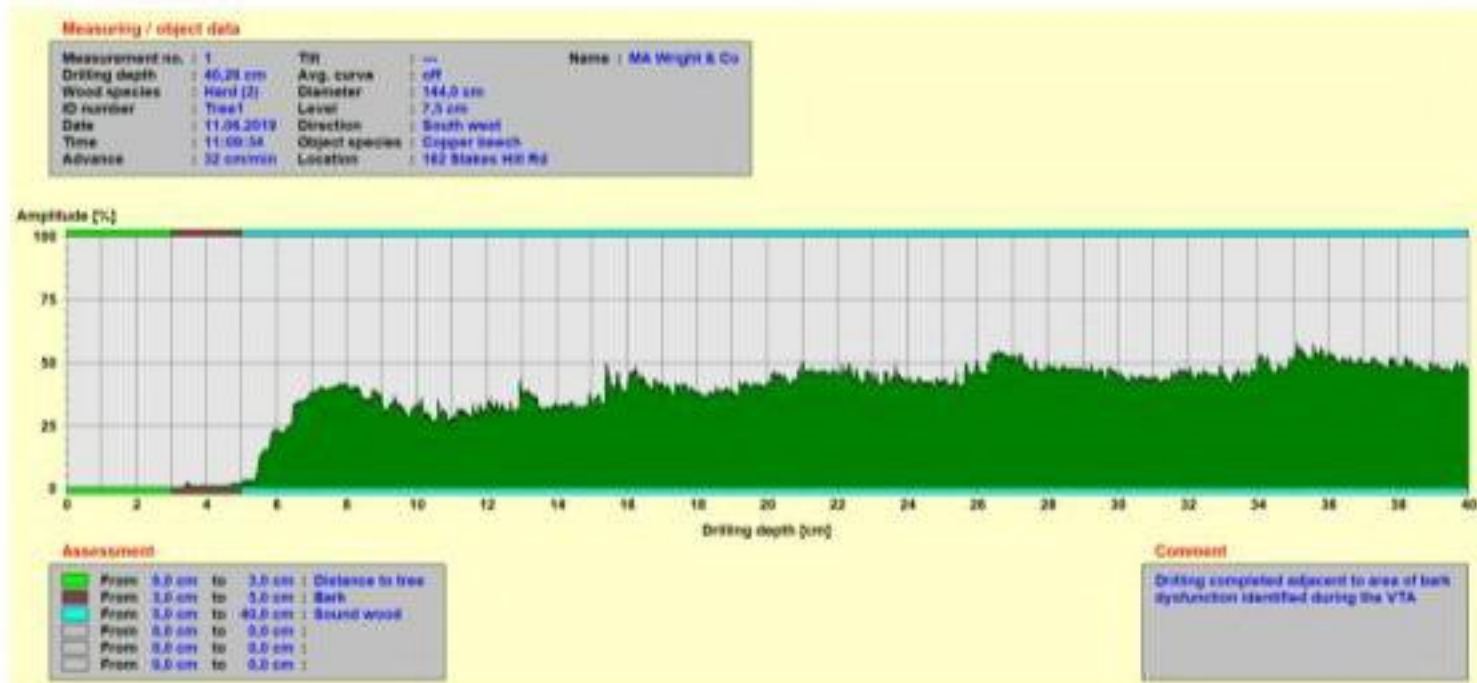
Two drillings were completed at the base of the tree. The first was located between measuring points 17 & 18 where an area of dysfunctional bark was identified during the visual tree assessment. The drilling at this location, at a height of approximately 75mm above ground level and to a depth of 400mm, didn't record any reduction in drilling resistance and supported the results of the tomogram (Figure 3).

Figure 3 – drilling 1 result

Figure 4 – drilling 2 result

The tomogram displays reduced sonic velocity on the southern side of the main stem at the test level, indicating likely decay. This is supported by the results of the test drillings completed on the northern and southern side of the tree. I do not consider that extent of the likely decay is currently structurally significant.

Management is however required to remove the risks associated with the dead wood within the crown and the peripheral die back displayed. I therefore recommend that the following remedial pruning is completed within the next 3-6 months and the tree is re-assessed in the next 3 years.

- Removal of component dead wood
- Removal of Ivy from the tree
- Peripheral crown reduction and reshaping of approximately 1.5 – 2.0m
