VERIFICATION REPORT

PLOTS 117-118 & 136-138

WOODCROFT FARM, WOODCROFT LANE,

VISTRY SOUTHERN

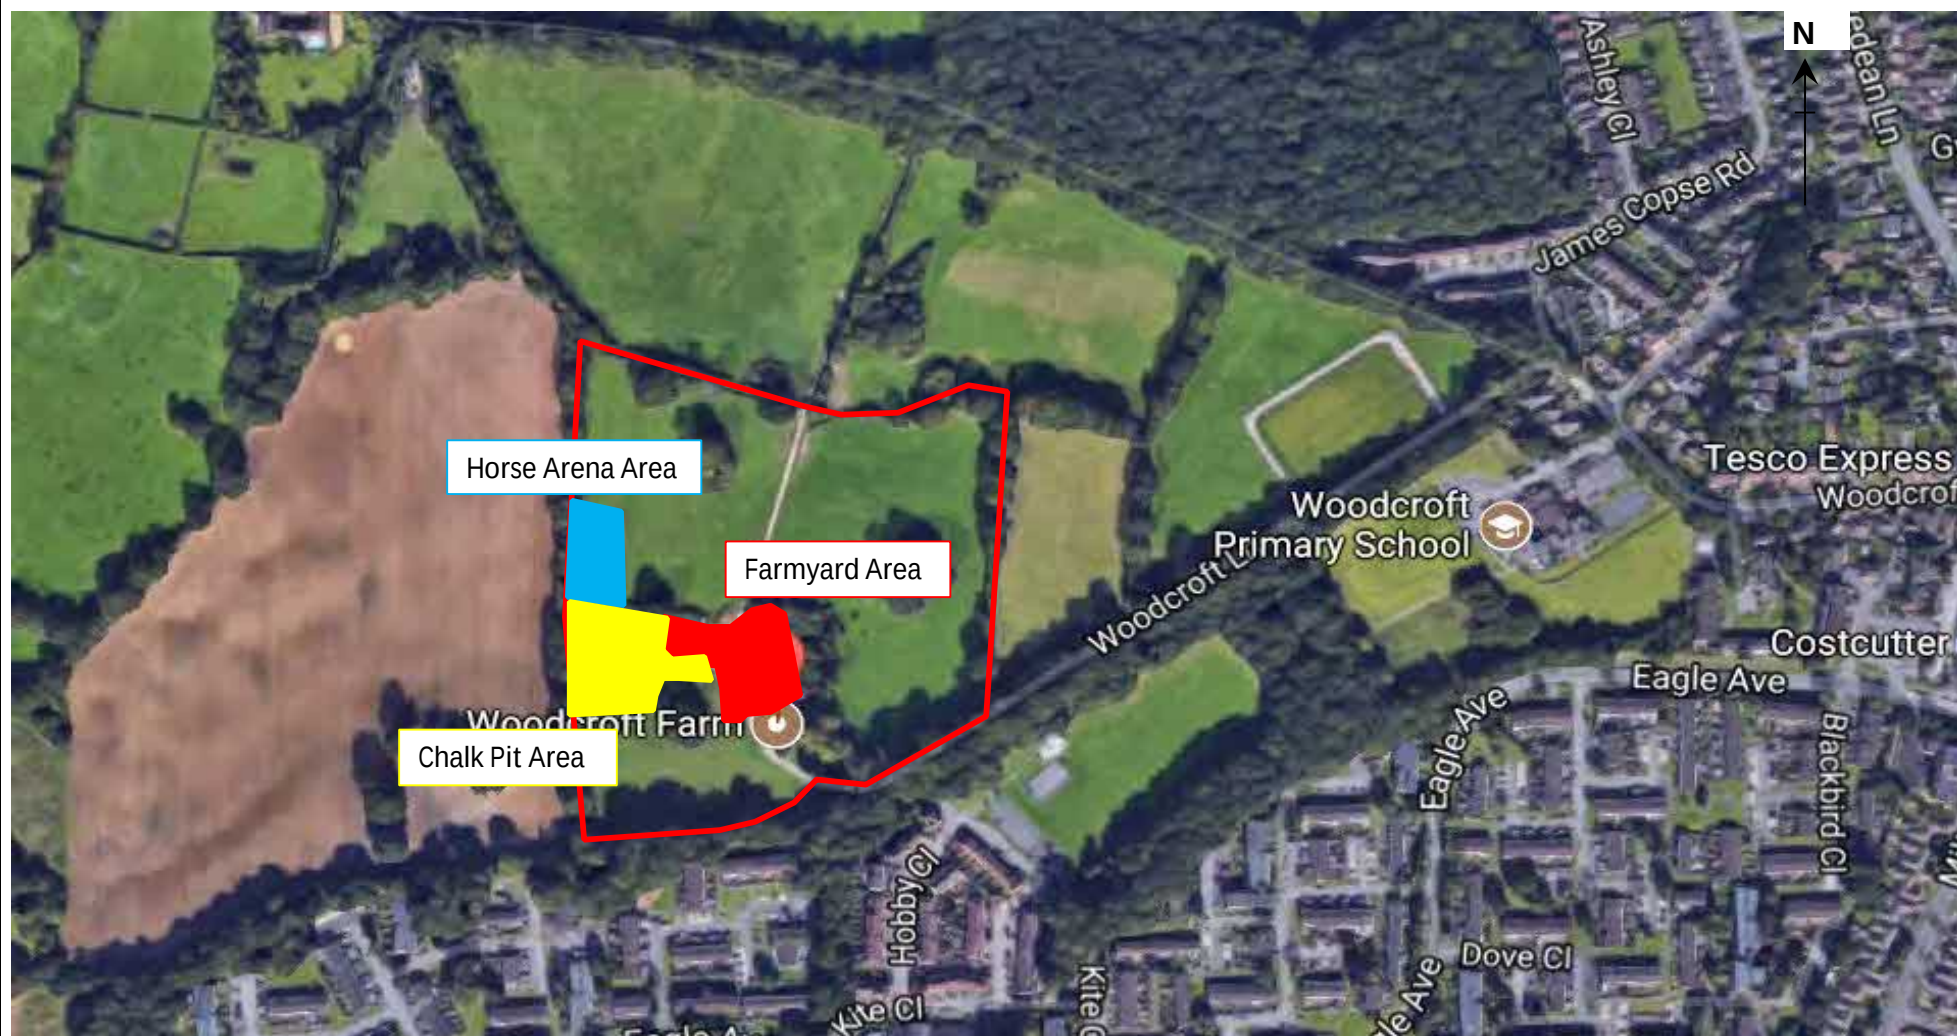
Plots 136-138 lie within the area of the site known as the former chalk pit area (Figure 2), therefore the Remedial Strategy GE16943/RSVP-CP-V6.0/DEC20 for the former chalk pit area is the strategy relevant for the proposed remedial works for these specific plots. Plots 117-118 lies within the area of the site known as the former farmyard area (Figure 2), therefore the Remedial Strategy GE16943/RSVP-FY-V6.0/DEC20 for the former farmyard area is the strategy relevant for the proposed remedial works for these specific plots.

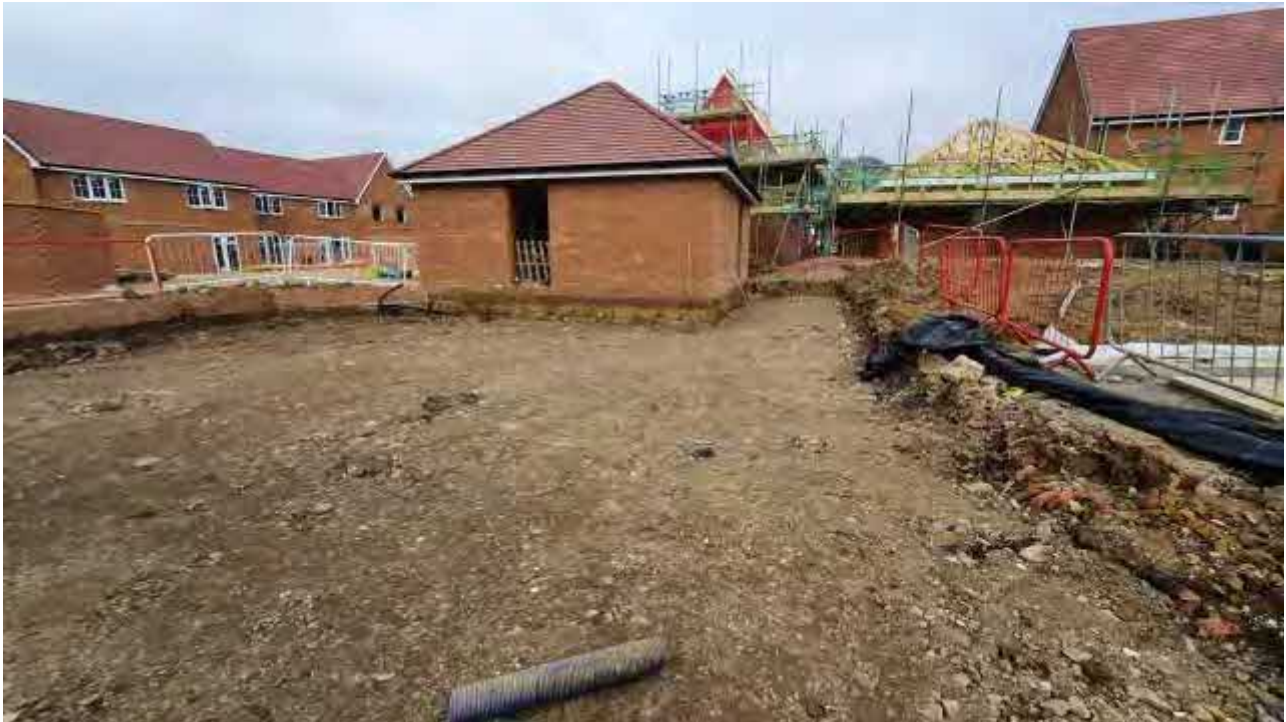
Plate 1 – View of crushed concrete installed across Plots 117-118

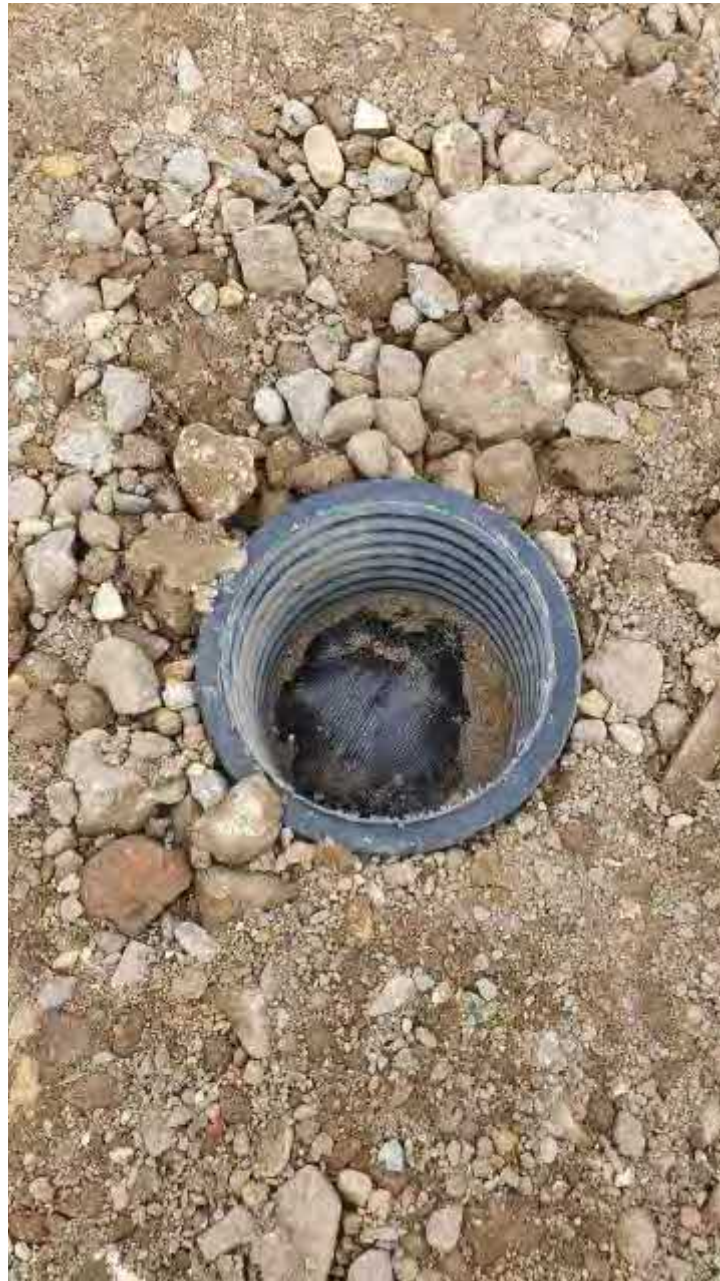
Plate 2 – View of geotextile membrane installed beneath the crushed concrete in Plot 117

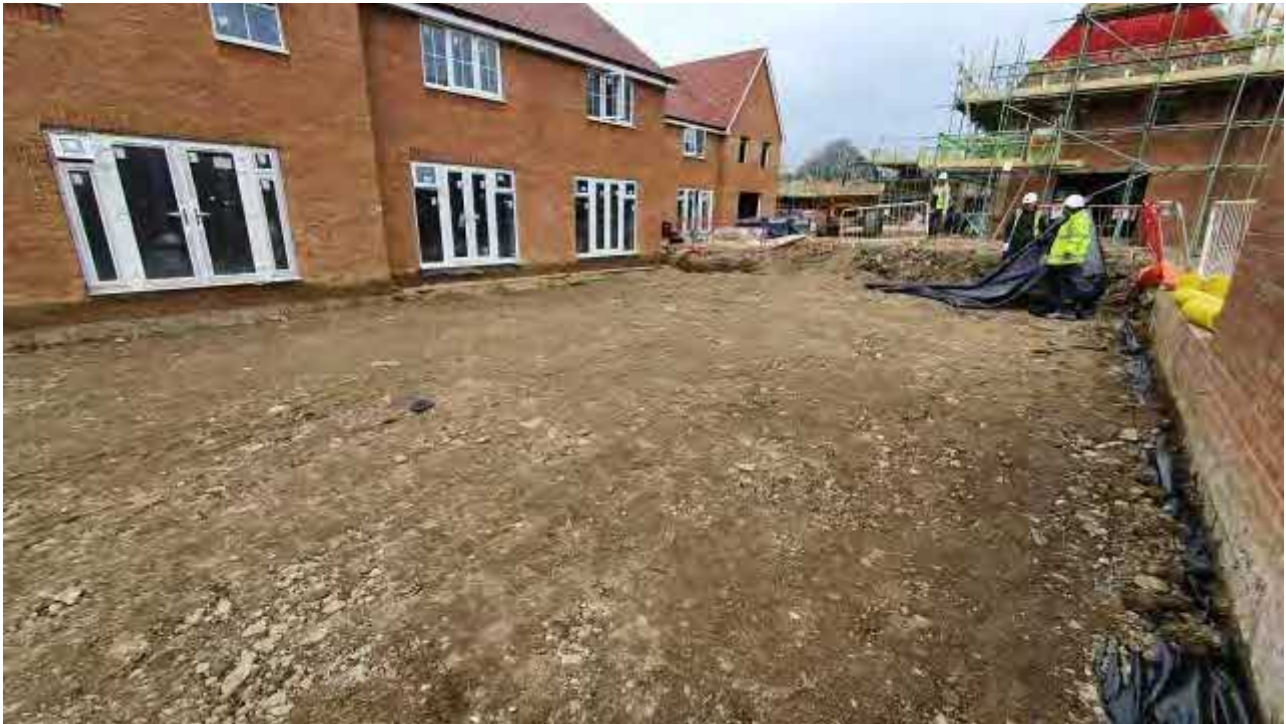
Plate 3 – Crushed concrete installed across Plots 136-138

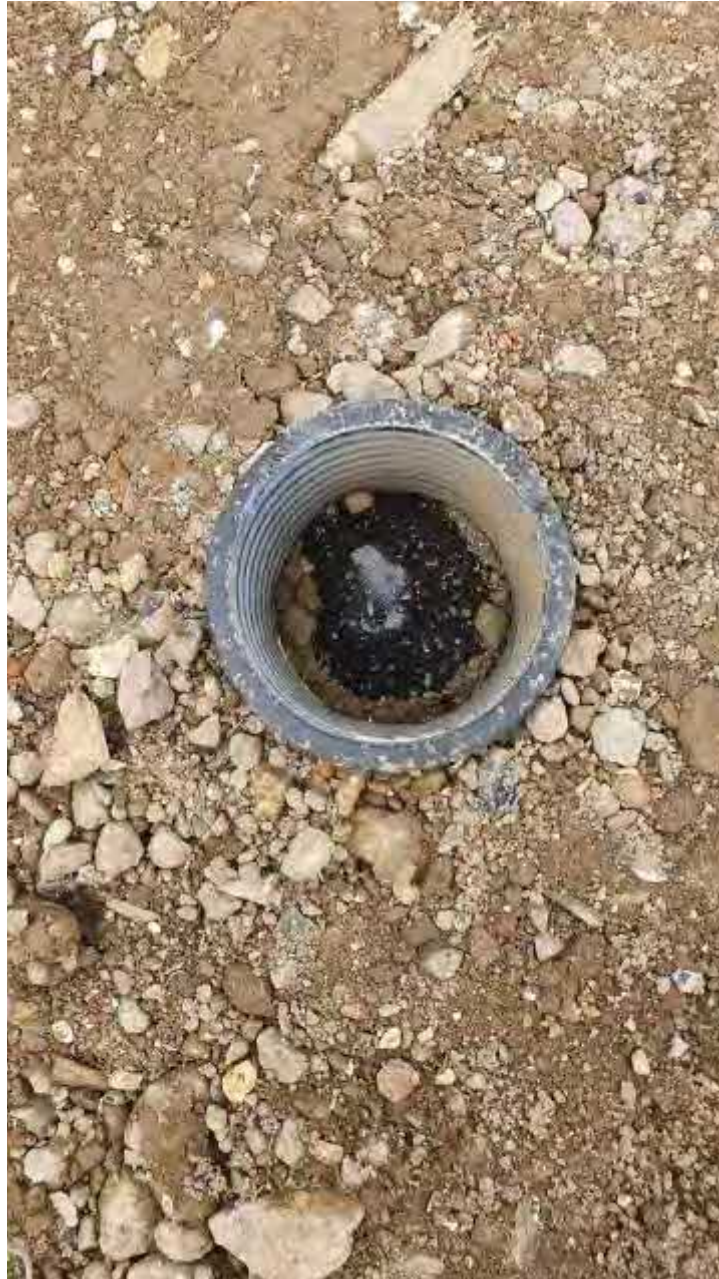
Plate 4 – Geotextile membrane installed beneath crushed concrete in Plot 136

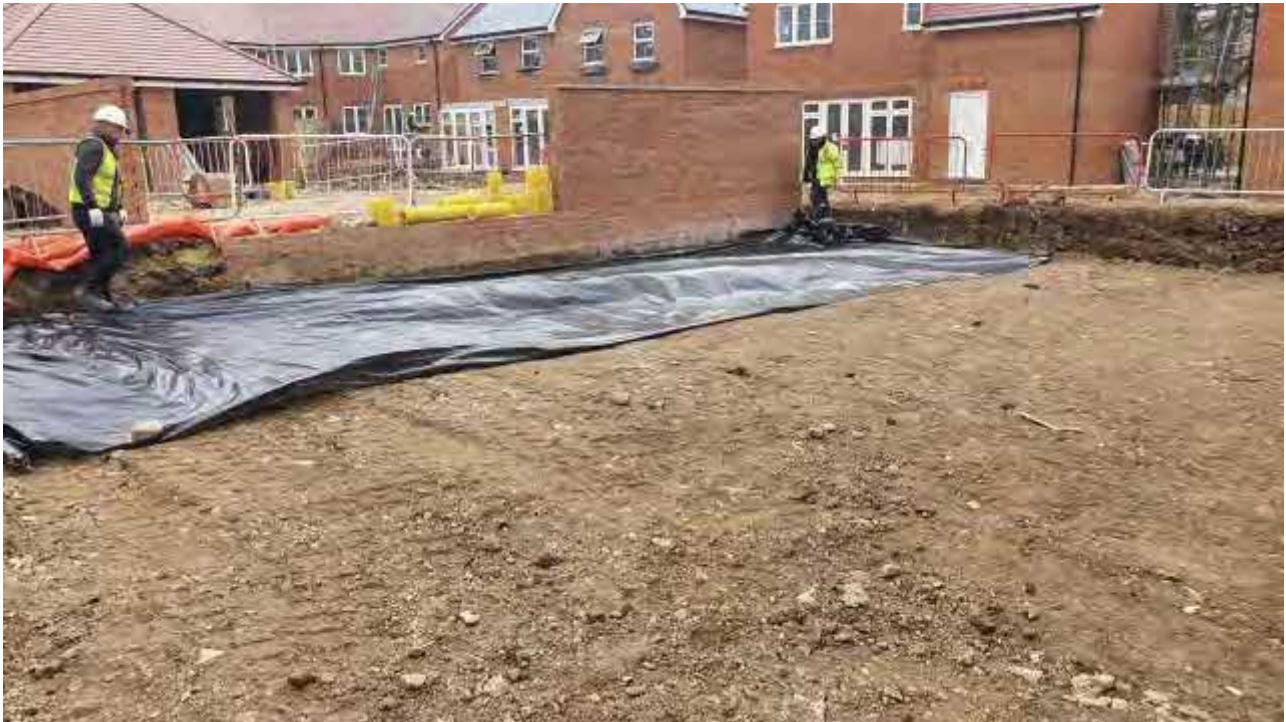
Plate 5 – View geotextile membrane being installed above crushed concrete in Plots 136-138
