**Tree Assessment and Protection in relation to Construction at:  
44 Topaz Grove, Havant, Hampshire**

**Arboricultural Assessment and Protection Method Statement**

**Site:** 44 Topaz Grove, Havant

**Date:** 16<sup>th</sup> February 2012

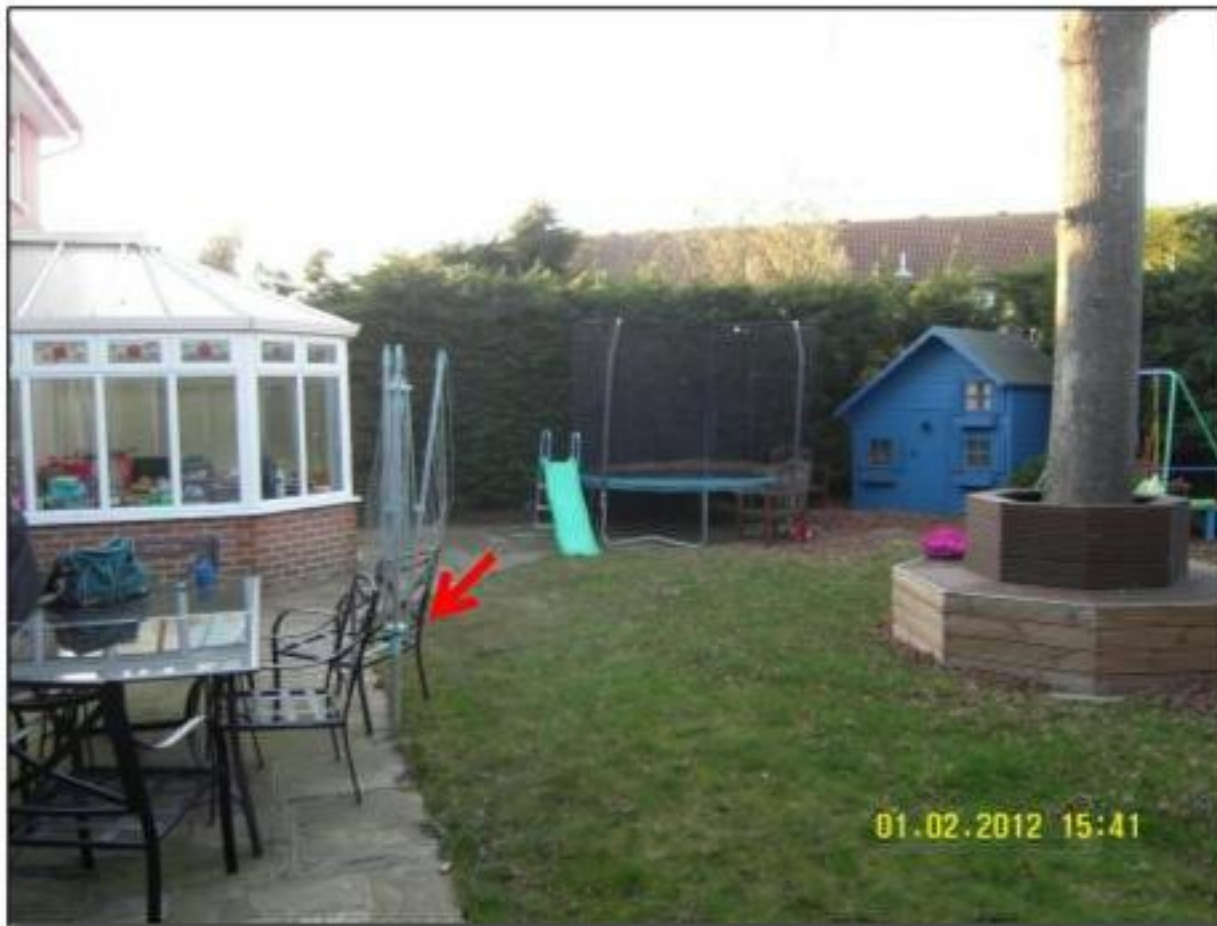
The rear conservatory with the Turkey Oak central to the garden.  
Arrow shows the location of soil investigations

- 2.3 The Oak tree is mature and comprises two stems arising from a union at around 1m from ground level. The union between the two stems has formed with some bark included, which weakens that union somewhat. I note that the tree has been reduced in size at least once and that new growth has developed quite vigorously. The tree's canopy is dense as a result and no doubt further pruning, at least, will be required.

- 2.4 The existing conservatory has extended into the BS root protection area (RPA), which is an area derived, by a calculation in Table 2 of the BS, from the tree's diameter. Some roots are likely to have been encountered at the time of construction and I could detect no significant adverse impact upon the tree in terms of its condition as a result.

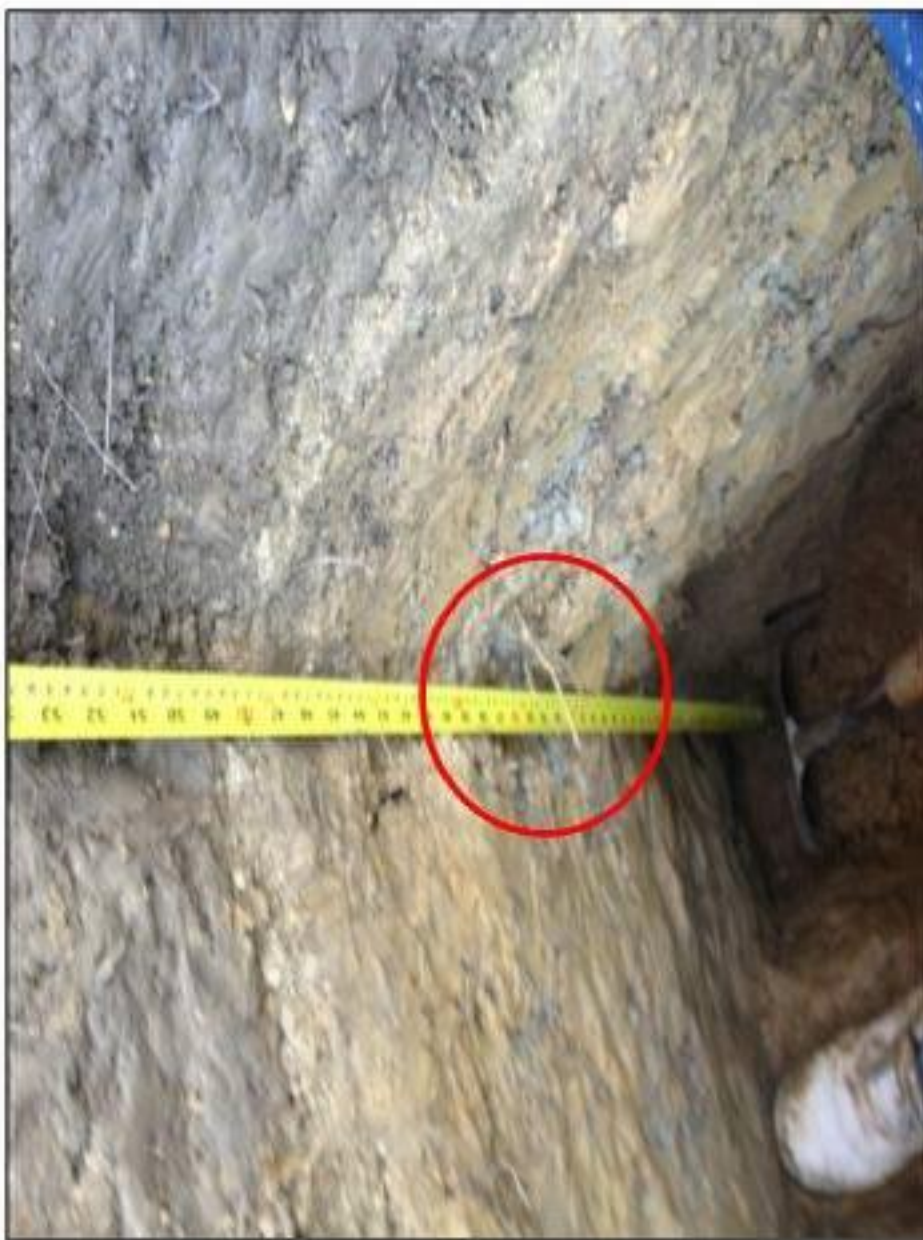
of the view that this tree will tolerate excavations, to form these footings and which may require the removal/shortening of a small number of roots. Soil investigations have shown that a very limited number of roots grow in the vicinity of the proposal. The image below reflects the soil profile at the proposed line of the new footing.

Fine roots (circled) exist in the upper soil horizon (to approx. 1m depth) but none that would be directly associated with tree anchorage.

2.7 The local soil is likely to be of a shrinkable nature, apparently having high clay content. It will be prudent to consult a structural engineer in respect of foundation design, where this proposed construction is located within the influencing distance of a mature tree. In this case, the NHBC guidance 'Building near trees' suggests that Turkey Oak falls within the high water demand category and will have a

potential to attain 24m at its mature height. These details, coupled with the soil analysis in terms of shrinkability, will determine foundation design, and which should account for the continued growth of or the removal of the tree.
