**Re: Root Induced Clay Shrinkage Subsidence – Formal notification of request for vegetation management as a remedy**

# Arboricultural Appraisal Report

## Subsidence Damage Investigation at:

97 Sutton Road  
Waterlooville  
PO8 8PT

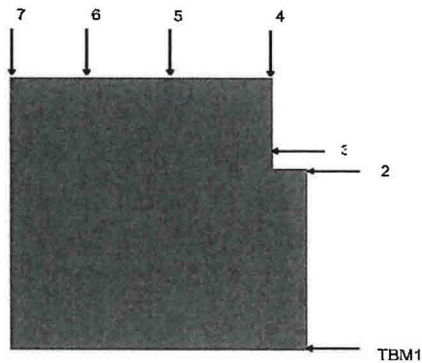
- 28/11/22 Readings taken, 07/10/22 Point 3 refixed Extra point added to rear.
- A common brickcourse could not be followed, subsequently relative data only.
- A further visit is due in late Jan/Feb

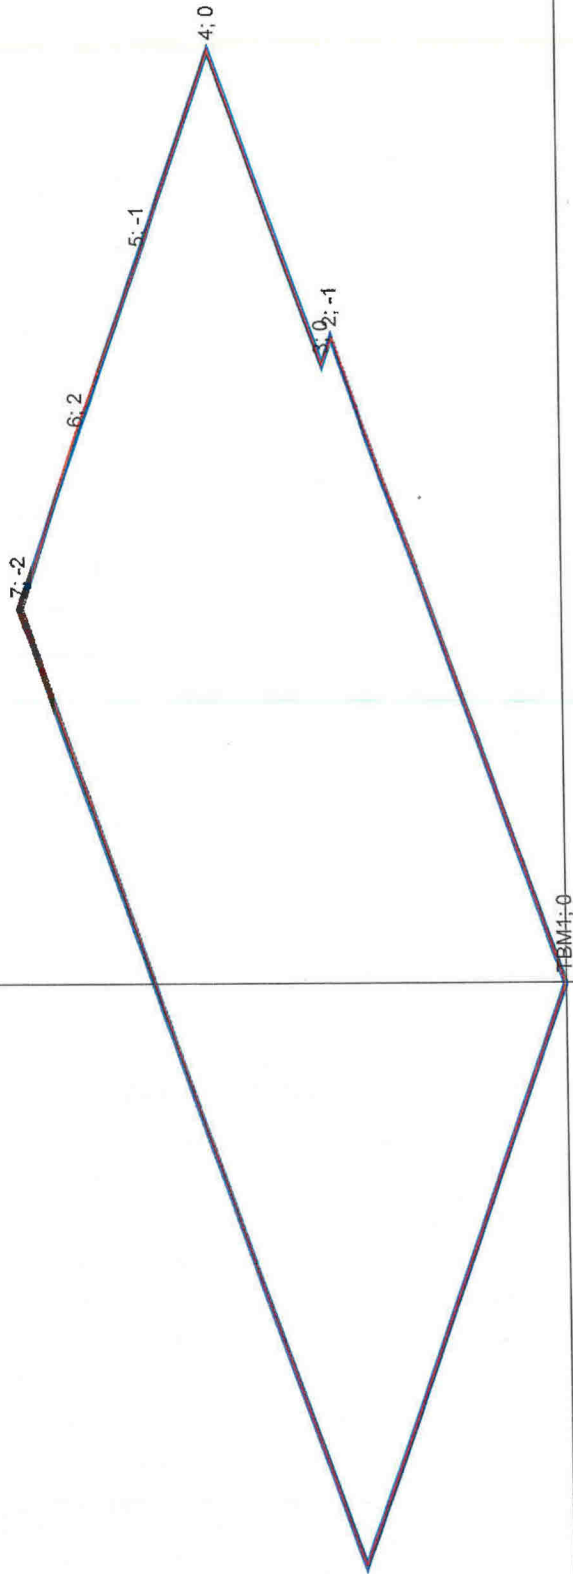
LEVEL MONITORING - RELATIVE MOVEMENT SKETCH

Point labels give level difference of last reading from original datum in mm.
