Our ref: GE17736/GR02/181102

**RE: Manor Farm, Lower Road, Bedhampton**

Further to your instruction, we write to present the results of the supplementary ground investigation and in-situ testing undertaken to assess the potential for use of borehole soakaways as part of a drainage solution for storm water discharge from the proposed development.

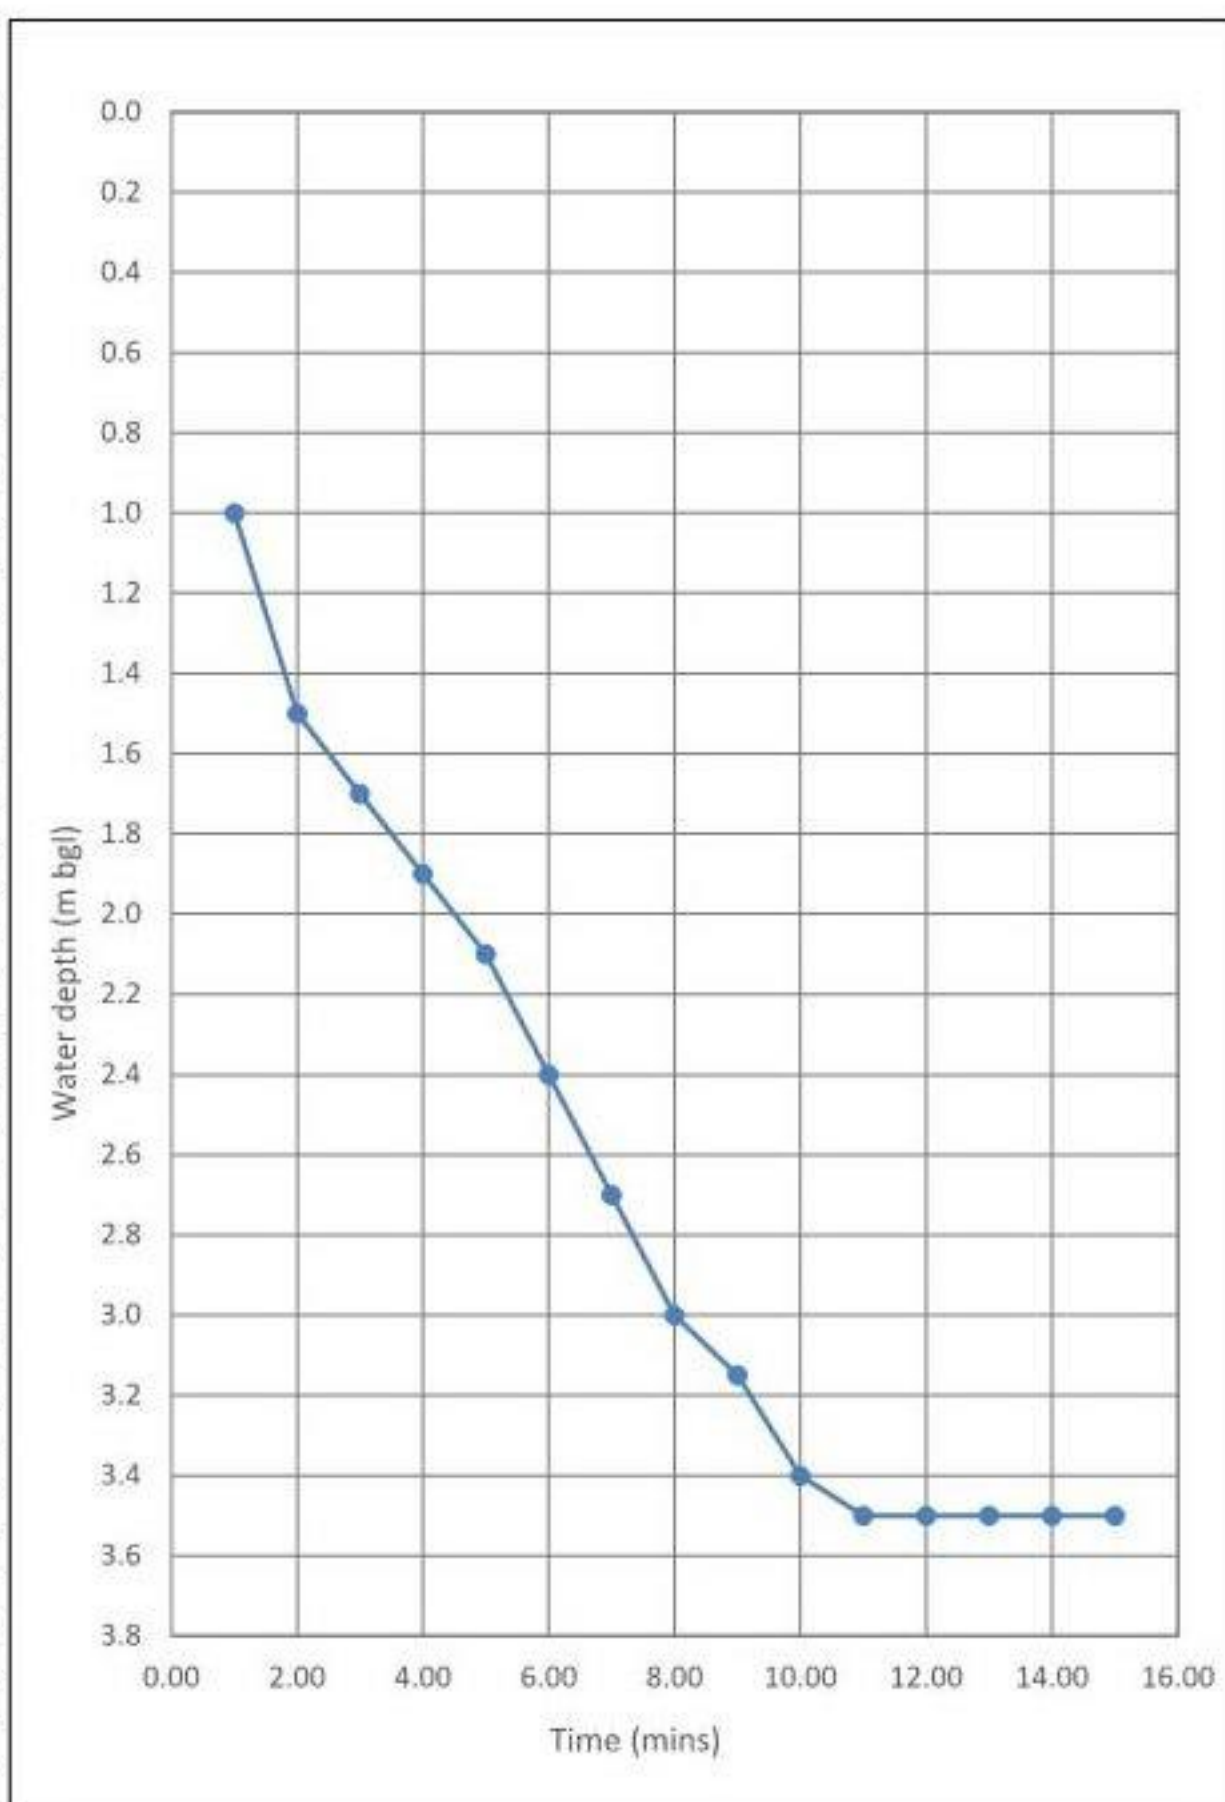
| Borehole | Test location depth | Infiltration rate (m/s) |
|---|---|---|
| BH101 | 14-15m bgl | $1.63 \times 10^{-4}$ |

The falling head tests at depth within both boreholes were undertaken below the depth at which water ingress occurred, i.e. the tests were surcharging groundwater. Whilst a potentially suitable infiltration rate has been derived for the falling head tests at depth, direct discharge of storm water into groundwater is not normally acceptable. As such, consultation with the EA and Portsmouth Water should be sought at the earliest opportunity.

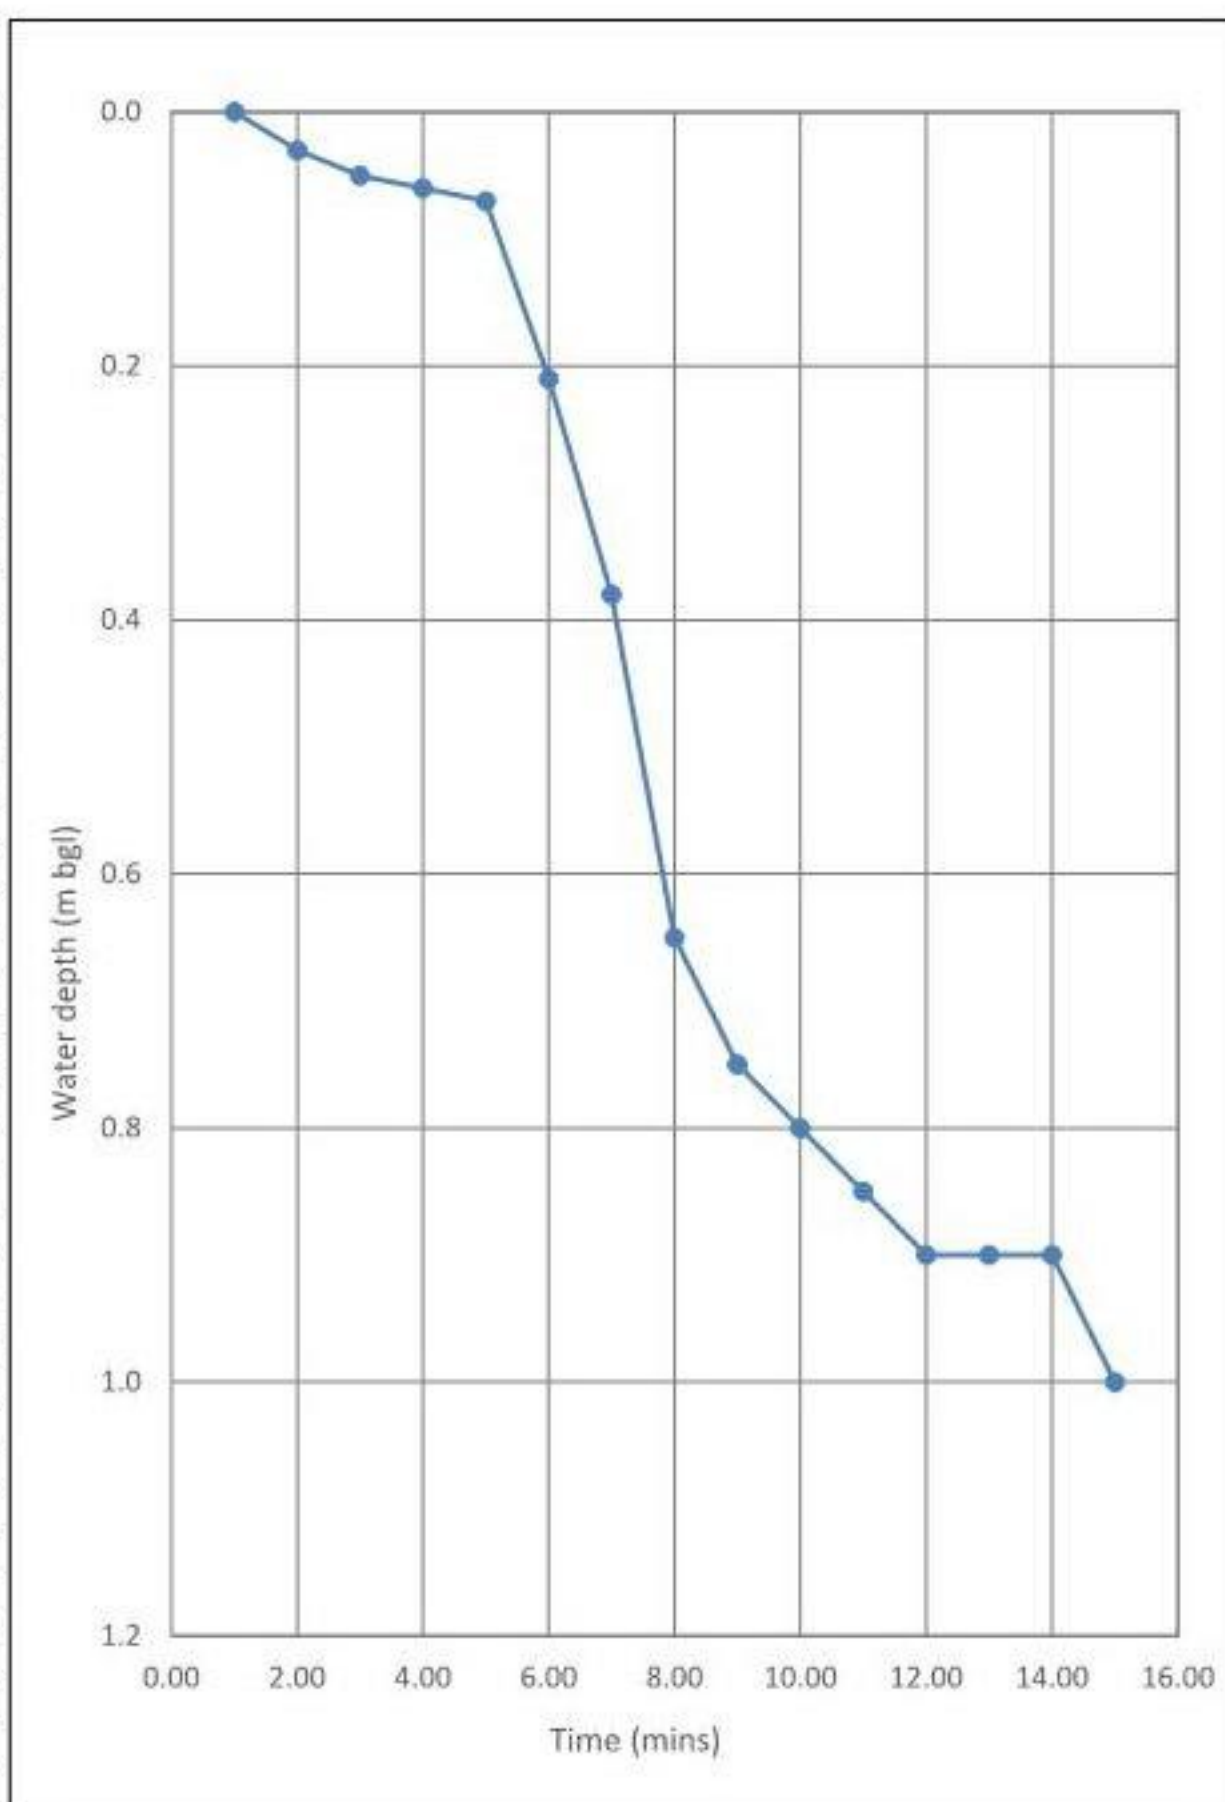
| Borehole | Test location depth | Infiltration rate (m/s) |
|---|---|---|
| BH102 | 3-5m bgl | $1.00 \times 10^{-5}$ |

Whilst an infiltration rate of  $1.0 \times 10^{-5}$  m/s was derived from the shallower falling head test undertaken in BH102, it should be noted that trial pit soakage testing in similar ground conditions, a similar test depth range and in the same area of the site was unsuccessful and thus the rate of infiltration would appear not to be uniform and consistent.

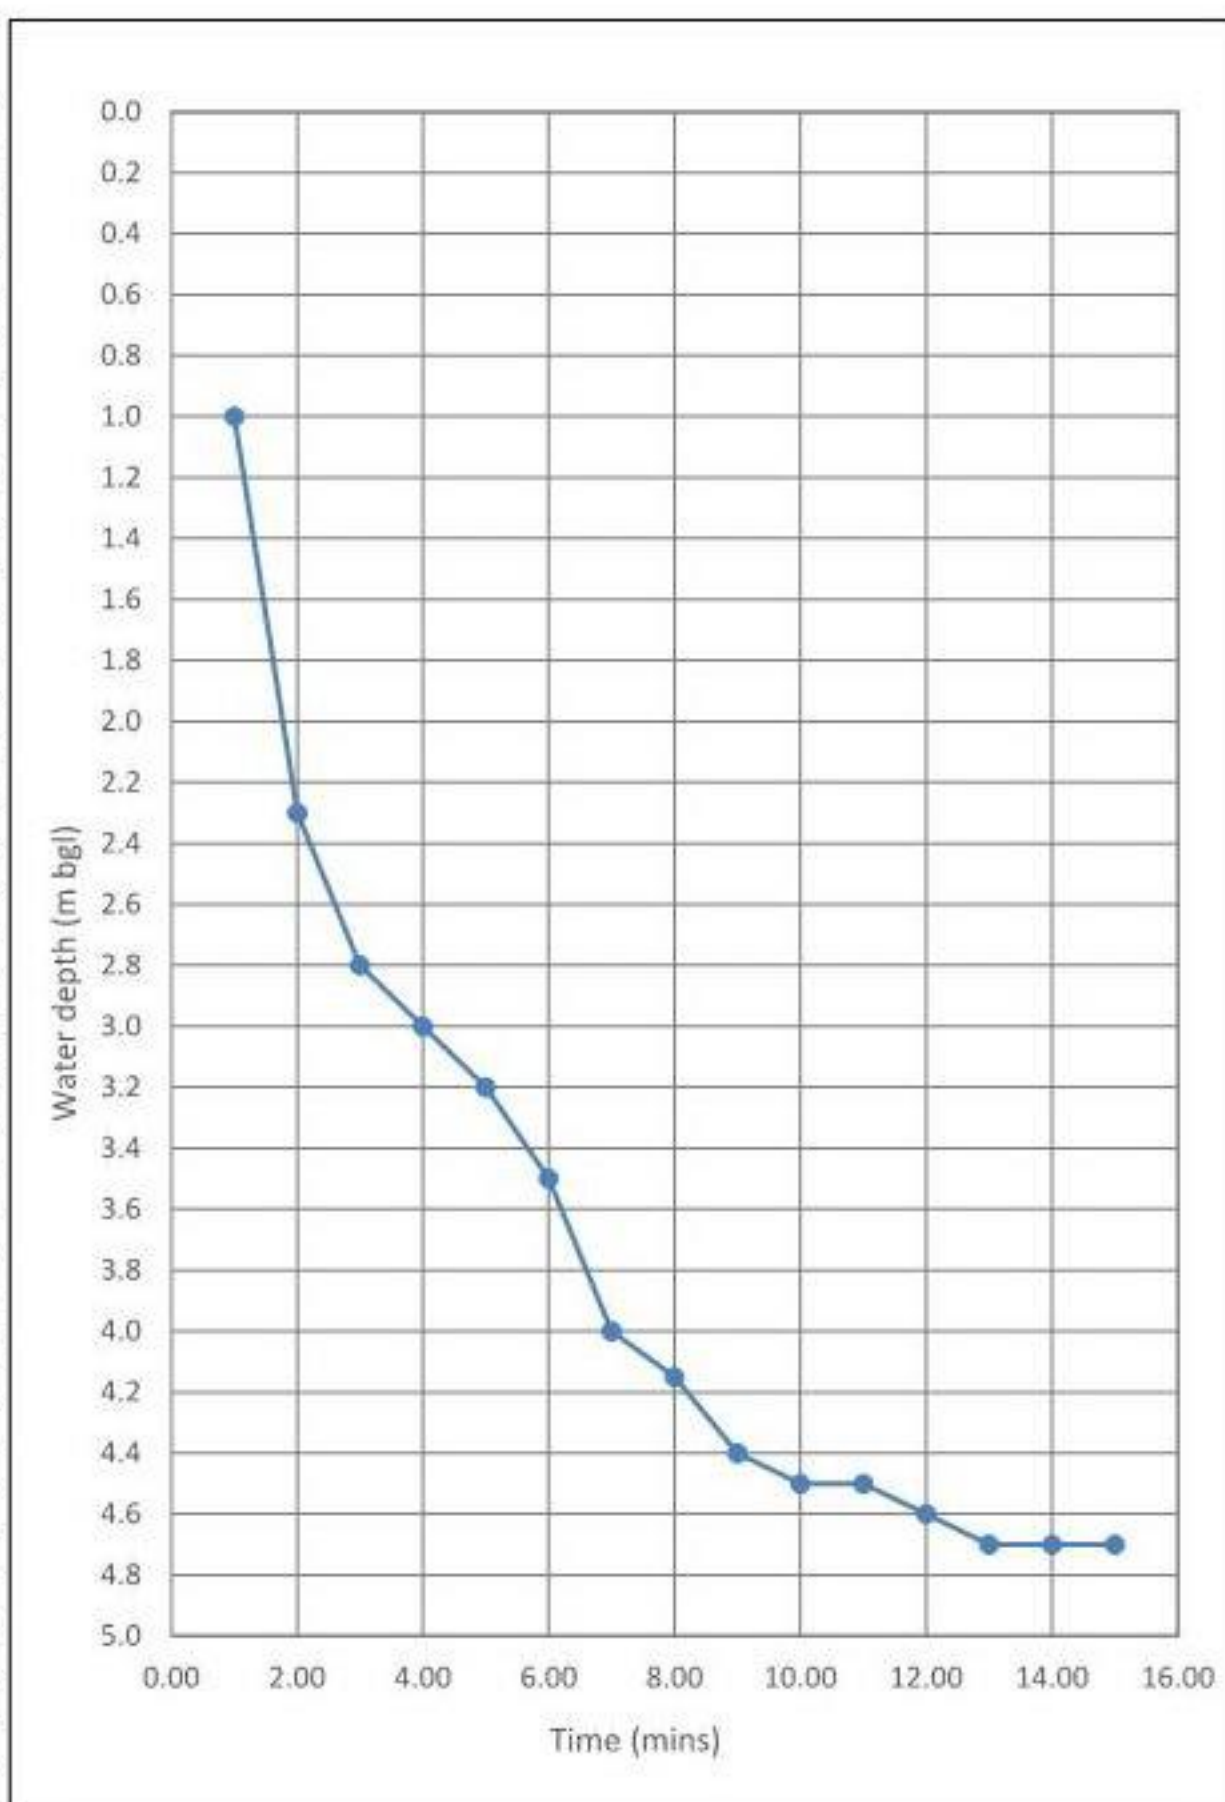
| Borehole | Test location depth | Infiltration rate (m/s) |
|---|---|---|
| BH102 | 14-15m bgl | $1.37 \times 10^{-4}$ |
