## ADDENDUM TECHNICAL REPORT

Crawford Reference: SU1700265

Leisurelands  
Gutner Lane  
Hayling Island  
Hampshire  
PO11 0RN

### SUBSIDENCE CLAIM

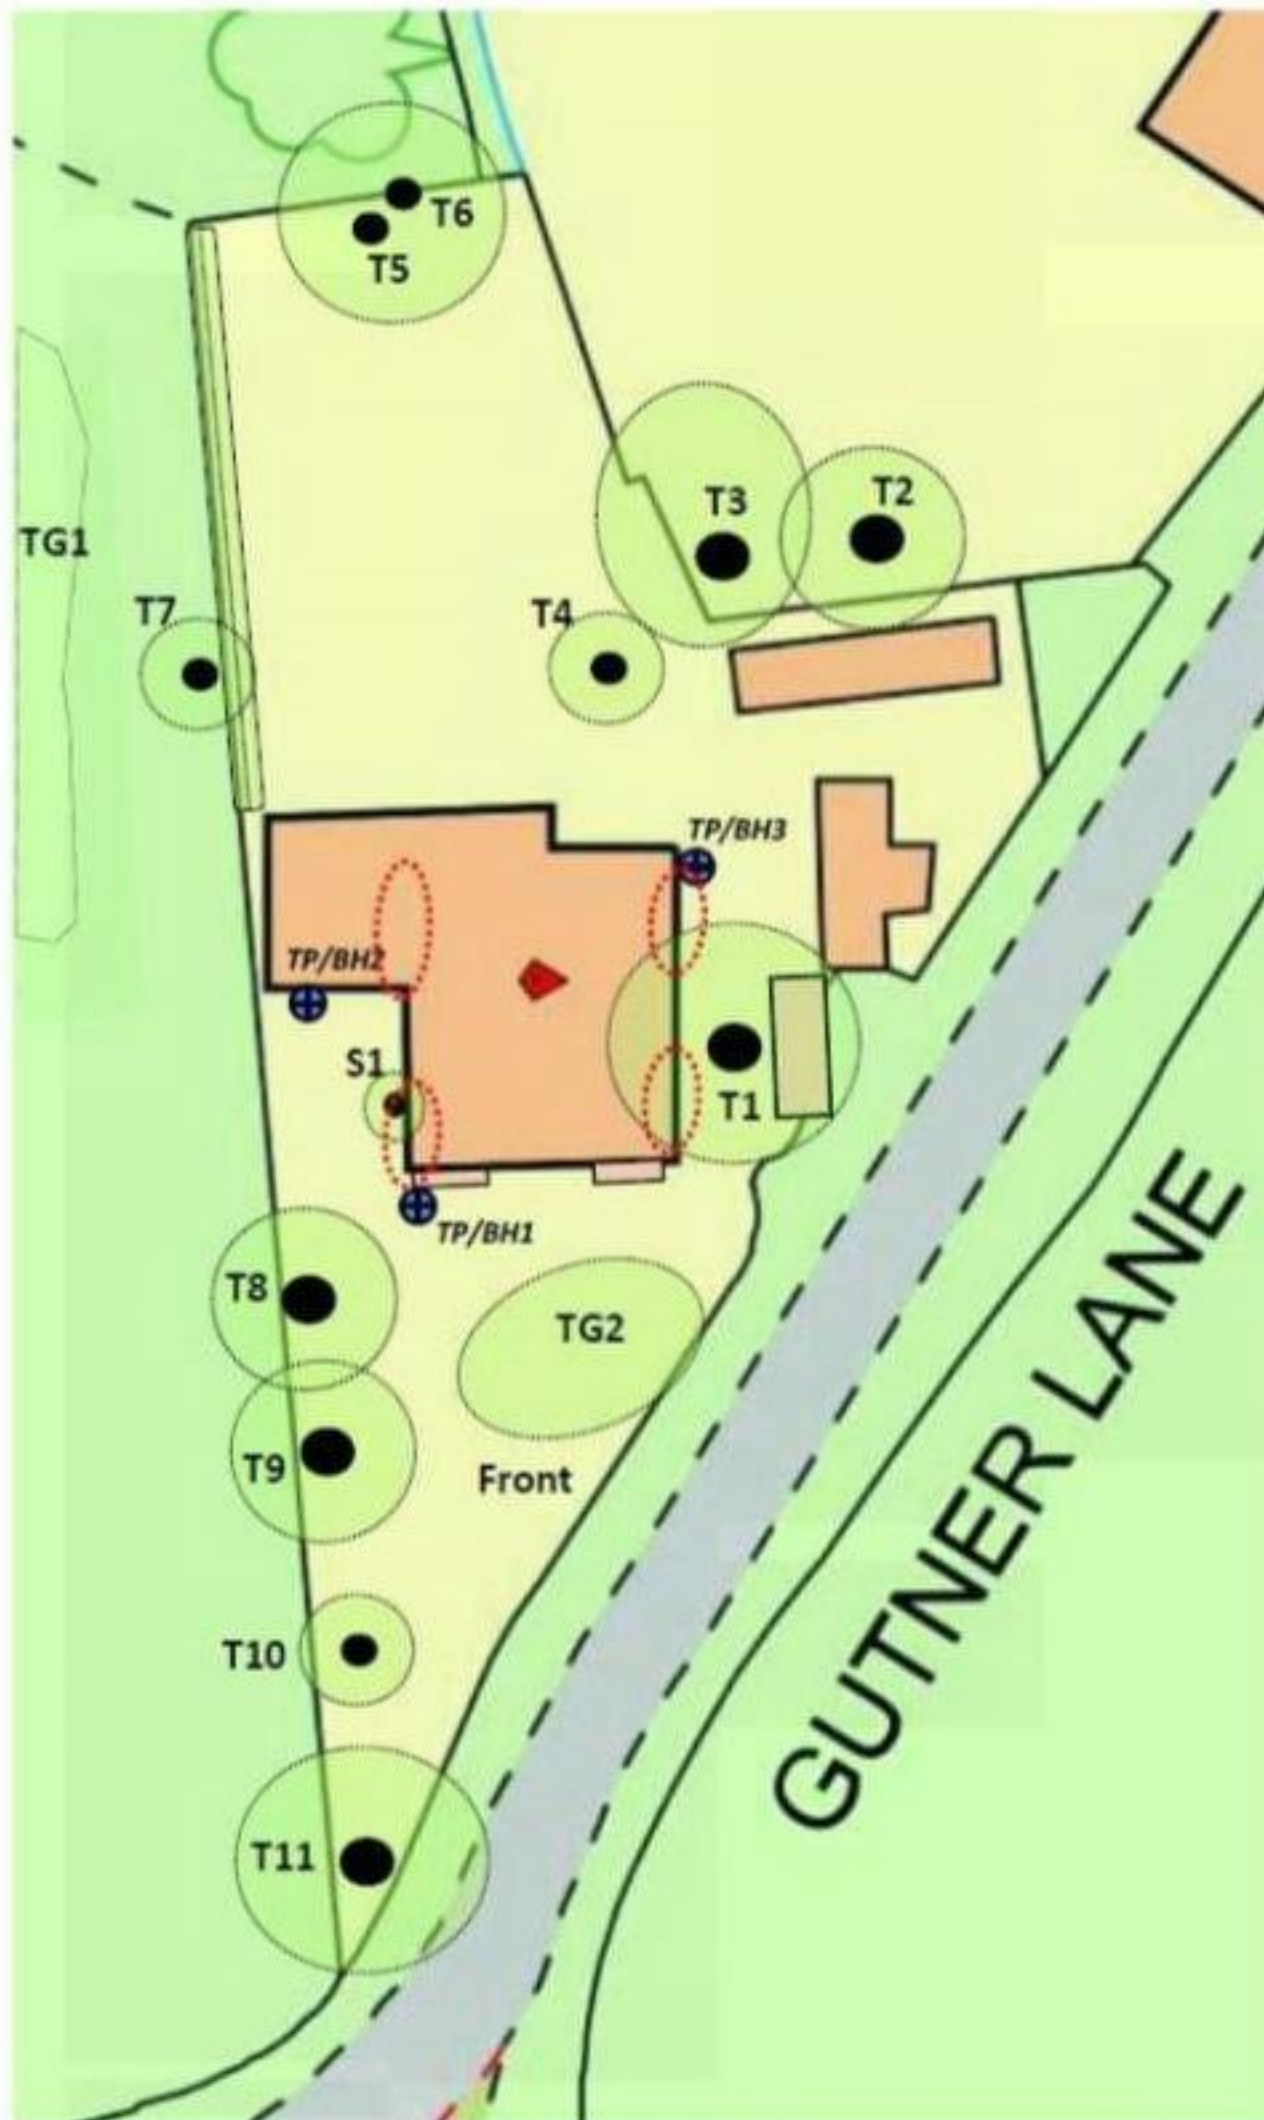
Plan not to scale – indicative only

Approximate areas of damage

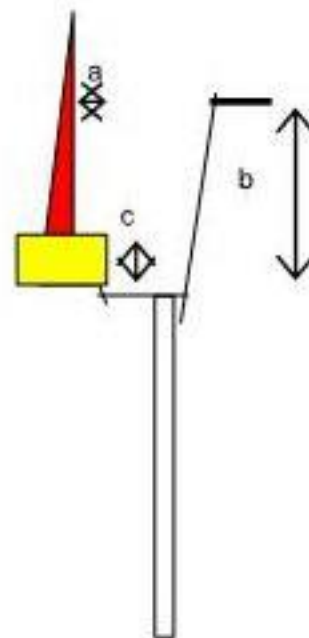
Foundation Details

| No. | Borehole Depth | Footing (a) | Underside (b) | Thickness (c) |
| TH1 | 3.00 m. | 470 mm. | 550 mm. | 550 mm. |
| TH2 | 3.00 m. | 160 mm. | 800 mm. | 270 mm. |
| TH3 | 3.00 m. | 170 mm. | 400 mm. | 250 mm. |

In TH/BH1 the concrete strip type footing was cast on a 450mm thick layer of made ground overlying a firm to stiff clay. Roots were encountered below underside of foundation to approx. 2.50m depth. Standing water was encountered at 2.50m.

In TH/BH2 the concrete strip type foundation was cast on a stiff becoming firm, moist clay soil to termination. There was no evidence of roots or standing water in the excavation.

TH/BH3 showed the concrete footing cast on firm to stiff, moist silty clay with roots of live appearance beneath the foundations. There was no evidence of standing/water ingress in the excavation.
