### Arboricultural Report

**30 Cardinal Drive, Waterlooville**  
**PO7 8LZ**

Date: 15<sup>th</sup> October 2019

Ref: TH 2159

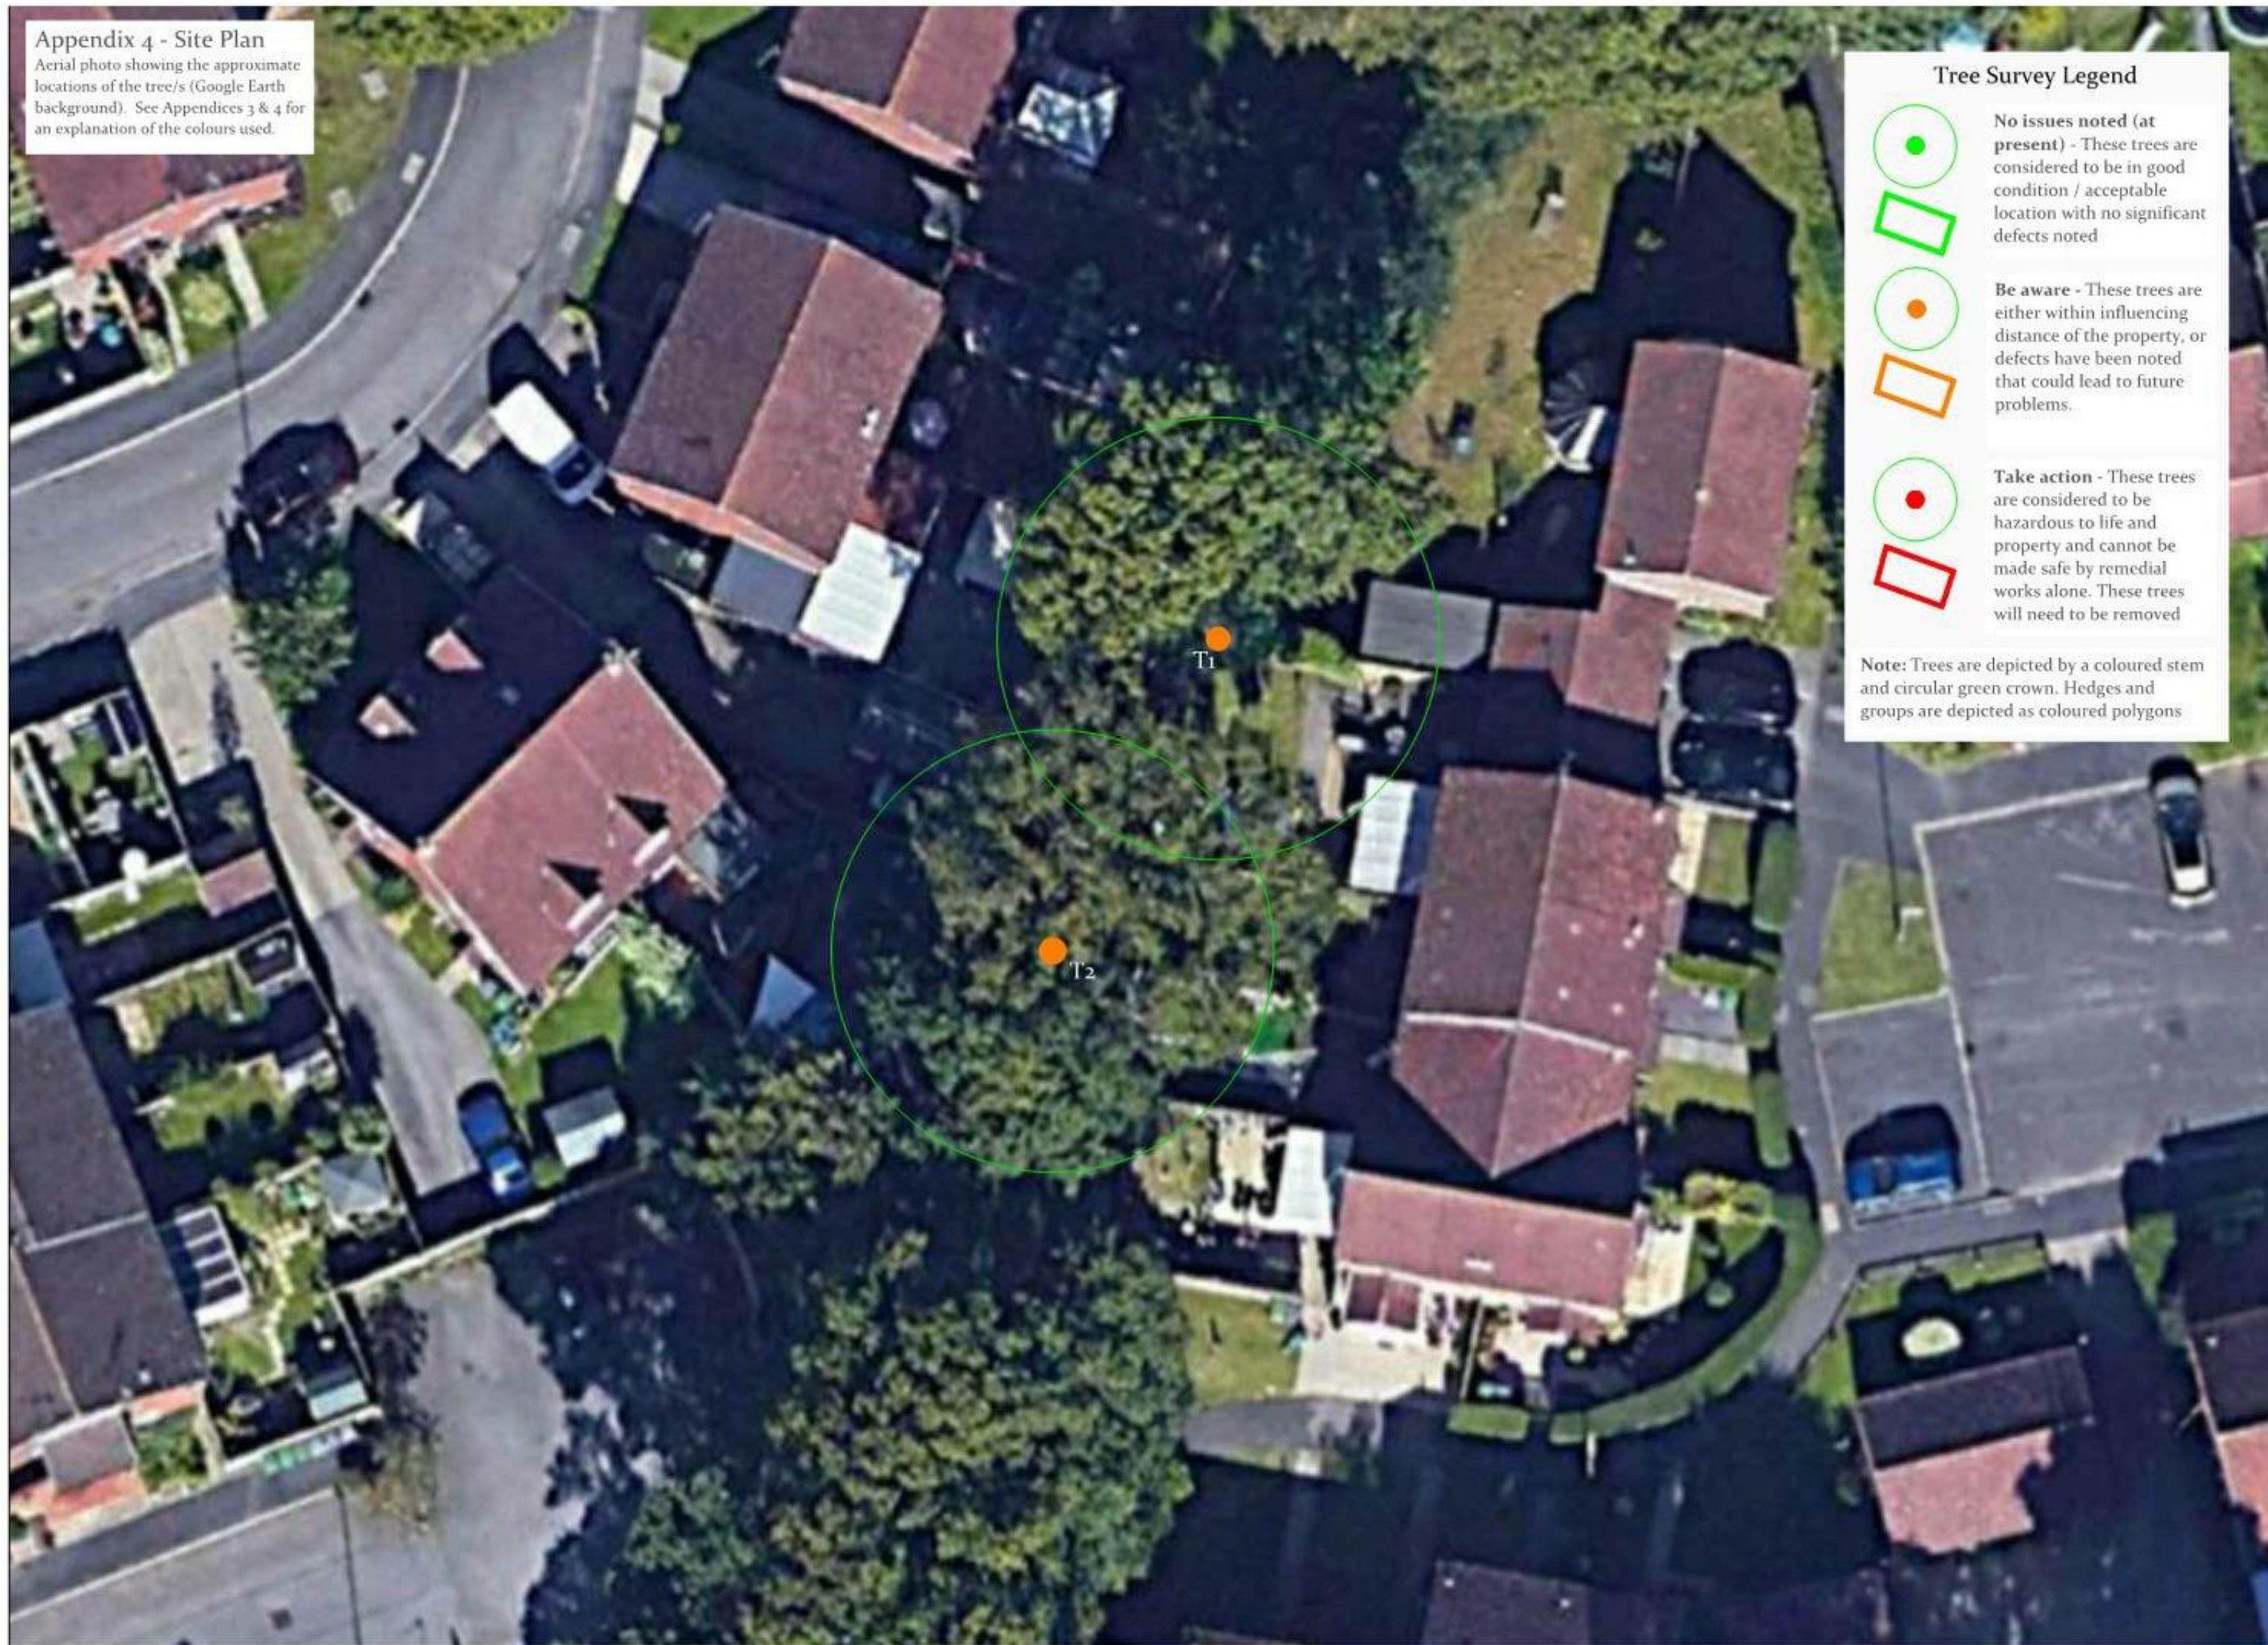
#### Appendix 4 - Site Plan

13.1 It is more likely than not that the two Oaks (T1 and T2) are contributing to subsidence damage.

Aerial photo showing the approximate locations of the tree/s (Google Earth background). See Appendices 3 & 4 for an explanation of the colours used.

13.2 To allow the soils to recover, and to provide long-term stability, the Oaks should be removed. Alternatively, the damaged structure should be under-pinned to ensure the foundations extend to beneath the influencing depth of the Oaks.
