**CCTV REPORT FOR: 1a DURLEY AVENUE  
WATERLOOVILLE  
PO8 8XA**

**Site Visit:** 15-Feb-23  
**Report Date:** 27-Apr-23

Address: 1a DURLEY AVENUE, WATERLOOVILLE, PO8 8XA

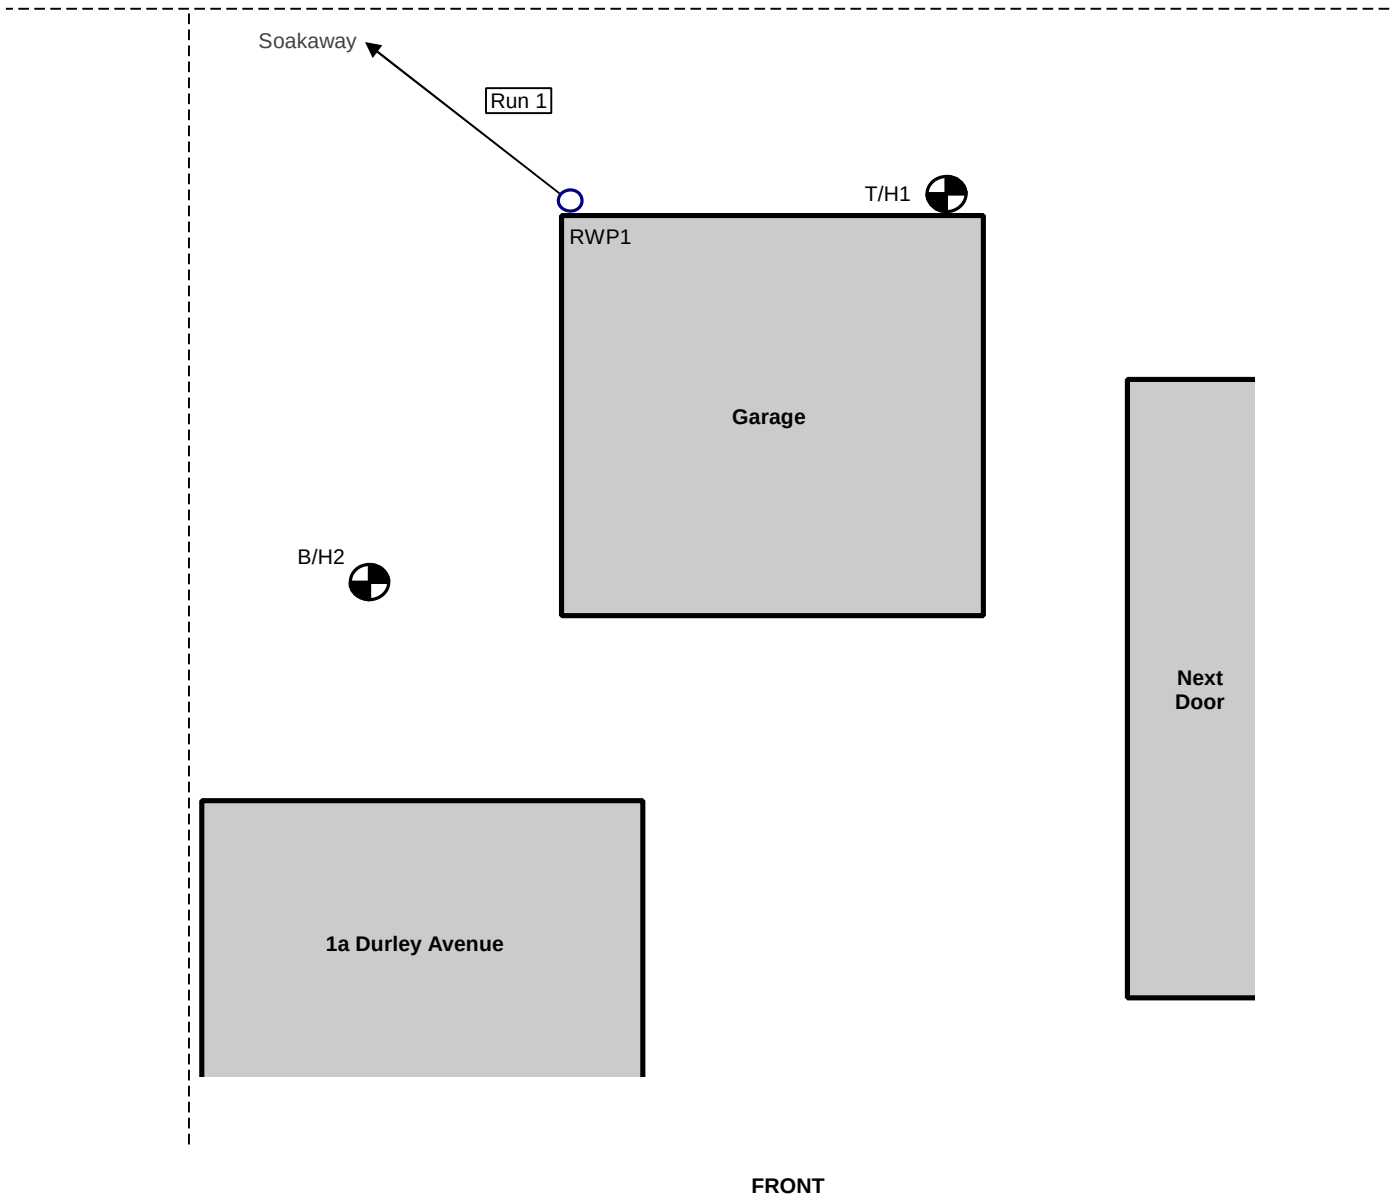
**Note: Runs shown in red have been adopted by the local water authority.**

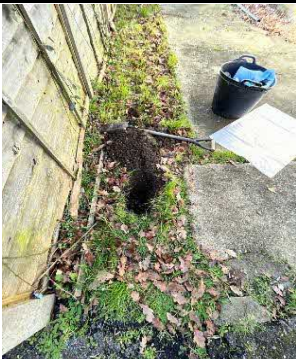
| Depth (m) | Soil Descriptions<br>(NB: Field crew description only) | Test Type | Depth (m) | |
|---|---|---|---|---|
| | Photograph | <u>V(n) 100</u> | 4.000 | |

| <p style="text-align: center;"><u>Borehole Only</u></p> | <p>Roots Depth &amp; Diameter:</p> <p>From 0.8m</p> <p>Down to 1.8m</p> <p>up to 2mm diameter</p> <hr/> <p>Water Depth Hit &amp; Rise:</p> <p>Hit at 3.5m</p> <hr/> <p>Reason for Termination:</p> <p>Hole at instructed depth</p> |

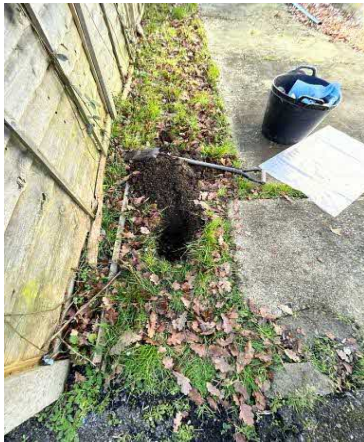
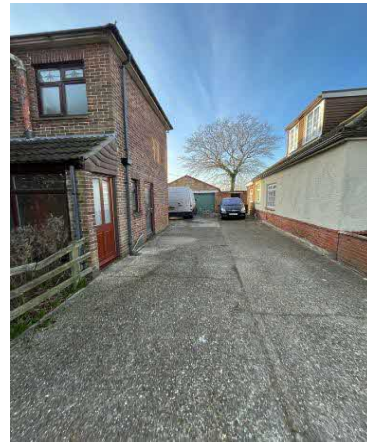
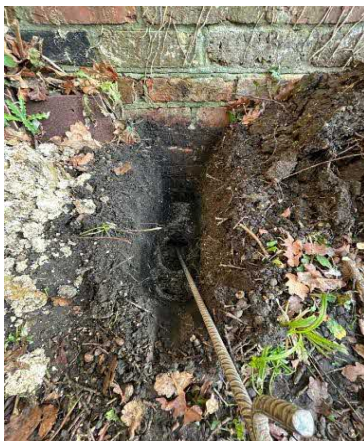
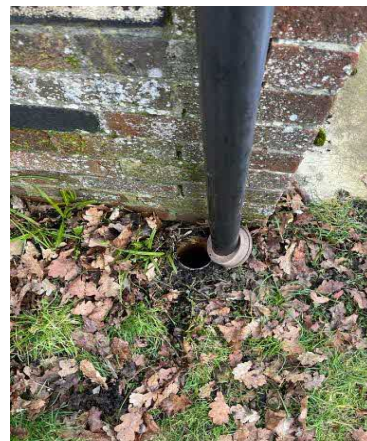
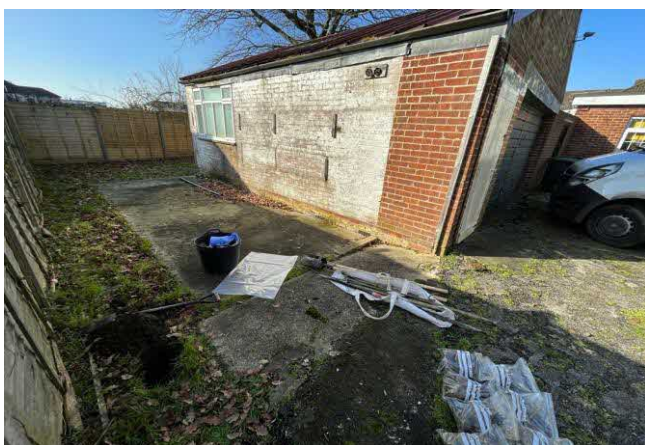
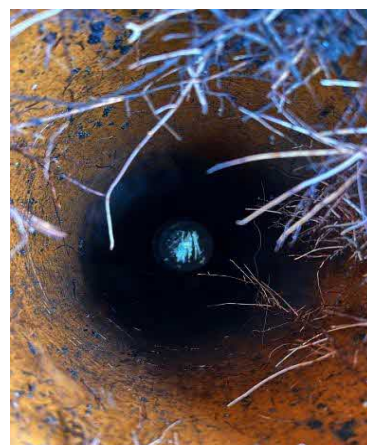
Run 1 - Storm - Private:  
Some debris in the pipe and slight root ingress.  
Water flowing well from RWP

No recommendations are required.
