# Arboricultural Report

- Pre-development Arboricultural Tree Survey
- Arboricultural Impact Assessment
- Arboricultural Method Statement

39  
Havant Road  
Emsworth  
Hampshire  
PO10 7JD

Prepared for:  
Mr Simon O'Hea

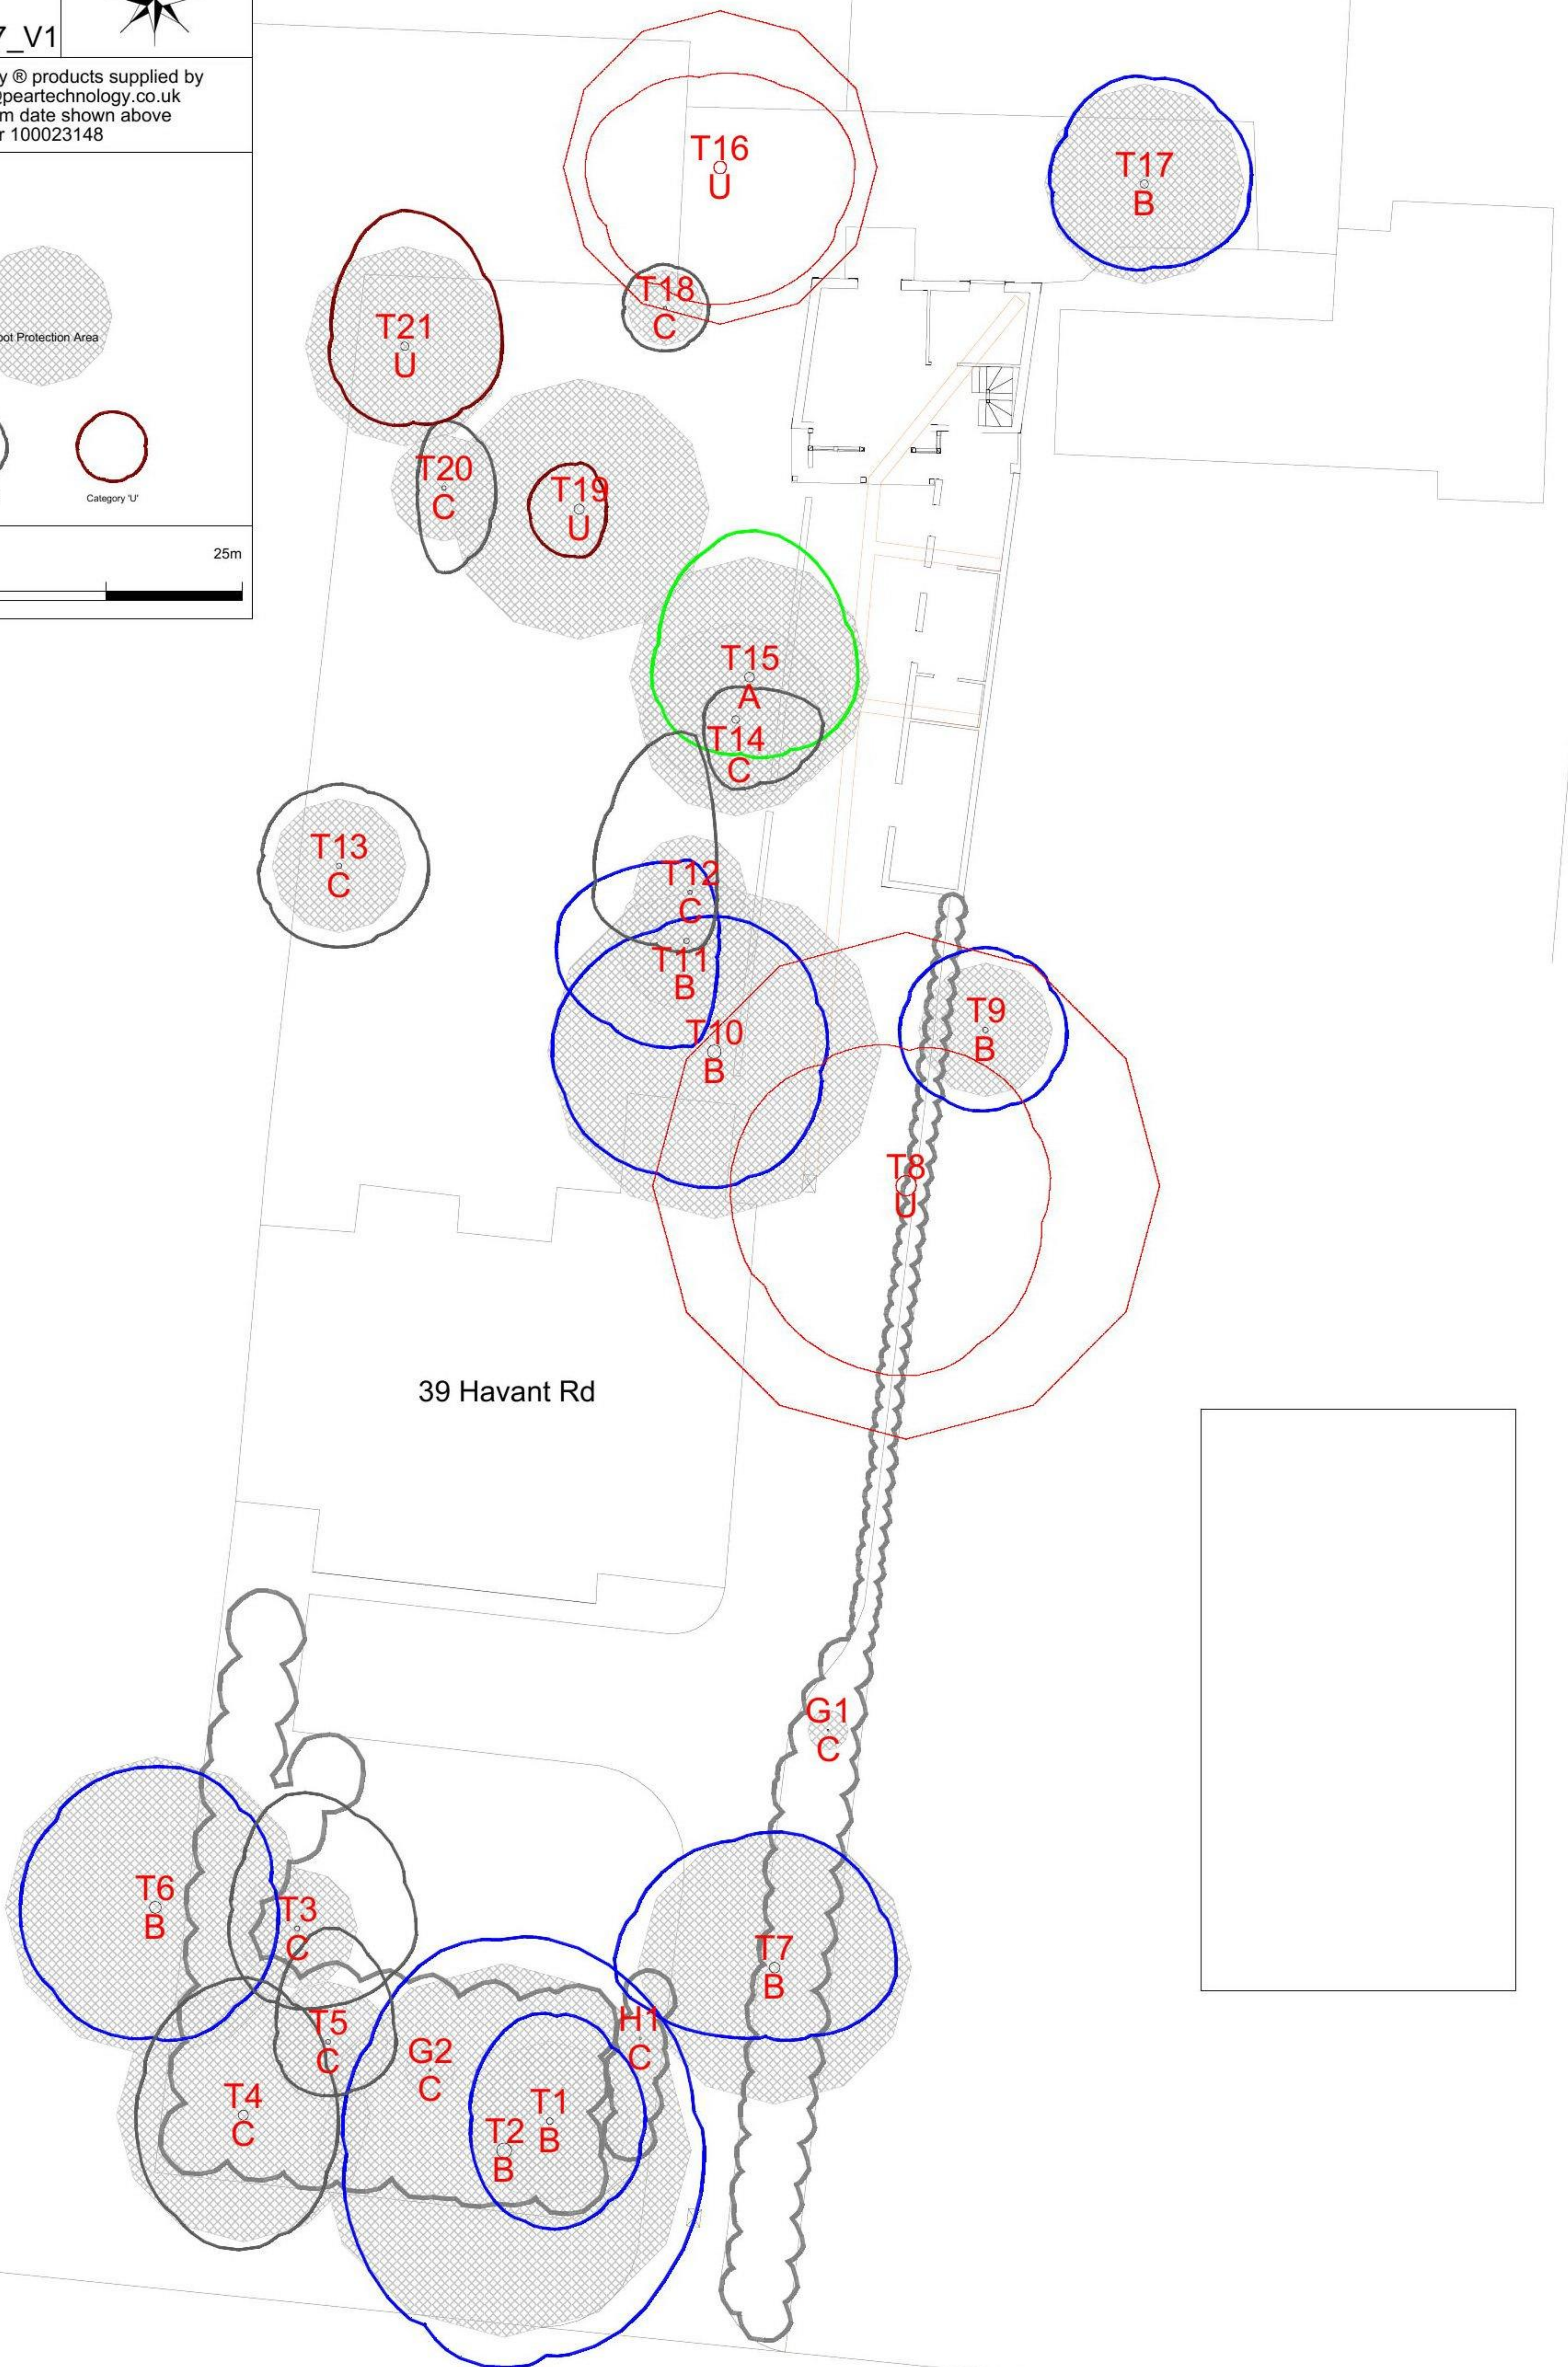
## 39 Havant Road Tree retention/Removal Plan

4.3.1. Two category **U** trees have been identified for removal. **T8** and **T16** have irremediable defects which predispose them or component parts of their structure to failure. The loss of these trees may be mitigated through supplementary planting elsewhere at the site if appropriate.

4.4.1. Some minor pruning works are required to the eastern canopy of **T15**. This work has been recommended in order to safeguard the canopy of the tree from potential mechanical injury.

4.4.2. The reshaping and pruning of the canopy of **T18** has been recommended to ensure that it is maintained at its current size. This has been specified in light of the installation of the arched window on the western elevation of the Coach House.

4.4.3. The location of trees to be removed/retained and trees or hedges requiring pruning can be viewed on the **Tree Retention/Removal Plan** found in **Appendix B**.
