CCTV REPORT FOR: 28 DAMASK GARDENS  
WATERLOOVILLE  
PO7 8QZ

Insured: Mrs. Hayley Psaila  
Reference: LIV-SN-23-006703 Ins Ref: 800-16-008022

2nd Site Visit: 21-Aug-23  
2nd Report Date: 31-Aug-23

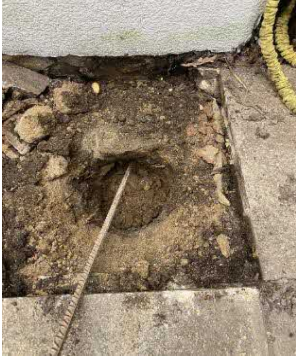
| Location: Rear Left Corner of Conservatory | T/H No. 1 |

| Depth (m) | Soil Descriptions<br>(NB: Field crew description only) | Test Type | Depth (m) | |
|---|---|---|---|---|
| 0.40 | Soft/firm brown CLAY with rare medium gravel (inc. brick) & roots | V(n) 34 | 0.400 | |
| 1.00 | Soft/firm brown CLAY with rare medium gravel & roots | V(n) 52 | 0.500 | |
| 1.50 | Soft/firm light grey/brown CLAY with rare medium gravel & rootlets | V(n) 70 | 1.000 | |
| 2.00 | Firm/stiff grey/brown CLAY with rare medium gravel & rootlets | V(n) 88 | 1.500 | |
| 3.00 | Firm/stiff grey/brown CLAY with rare medium gravel | V(n) 126 | 2.000 | |

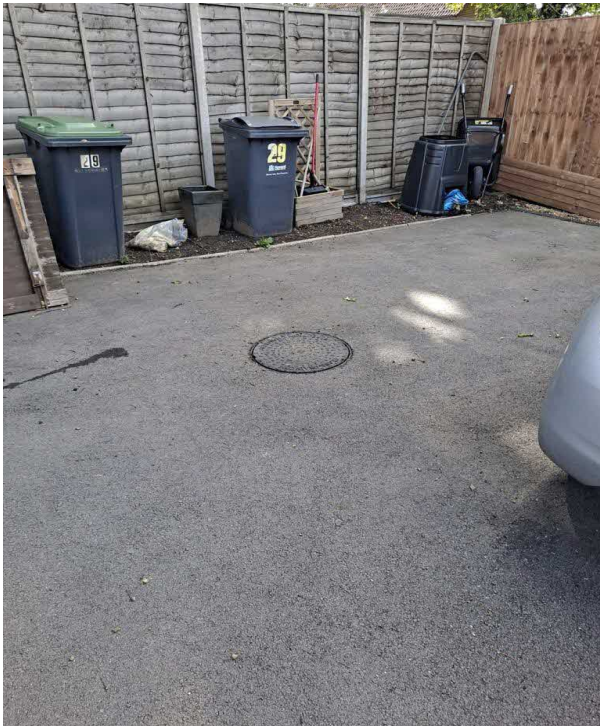
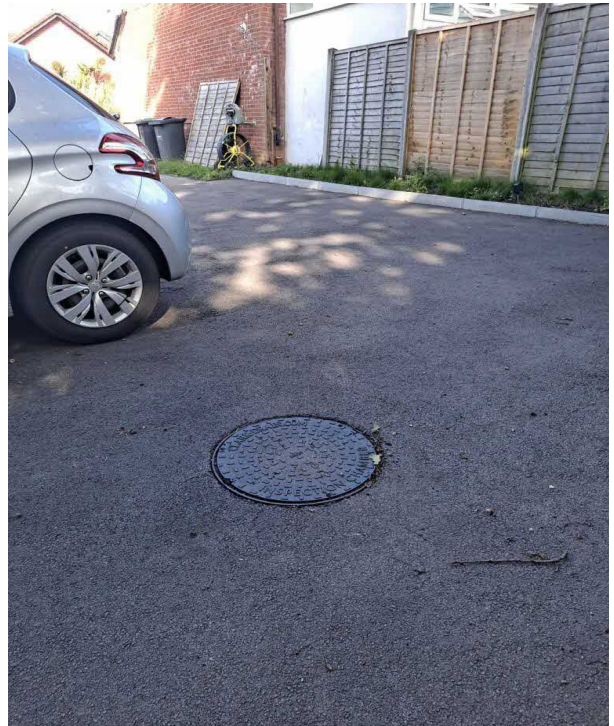
MH2 in tarmac parking area

Pipework runs from RWP1 downstream off the property boundary and connects to an unknown run and 7.3m before running into a chamber (MH2) set into the tarmac parking area.

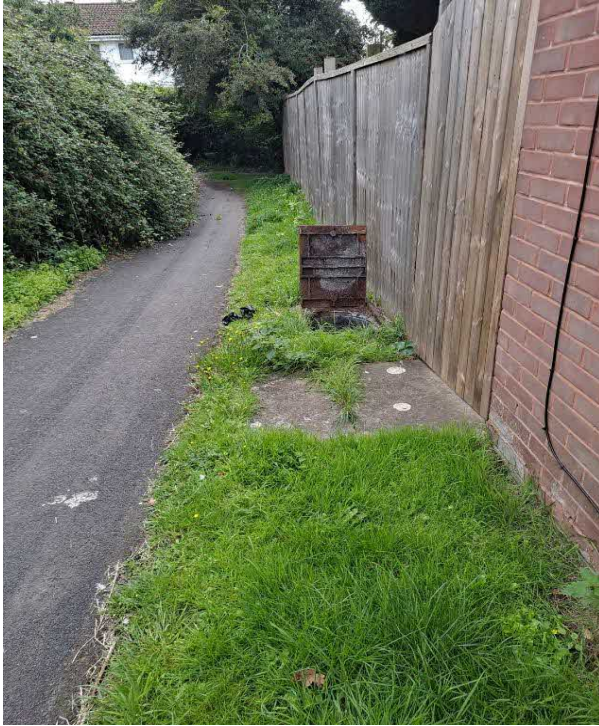
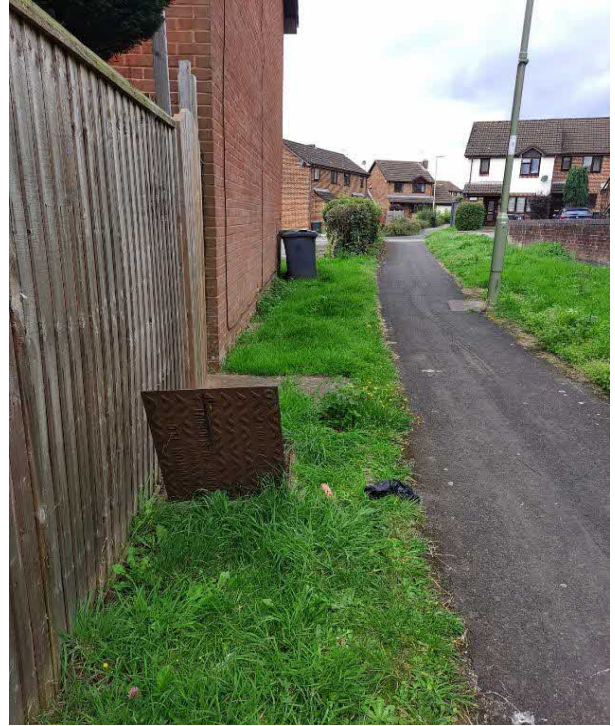
MH3 in grass verge

Tracing the pipework downstream we located a chamber (MH3) set in the grass verge to the left of the neighbouring property. When we lifted the cover to this we found that this was also holding water backing up from pipework further downstream. We attempted to jet from the chamber but were still not able to clear the debris and water.

There are high levels of debris and standing water in the shared pipework serving MH3. As this pipework is believed to be the responsibility of the local water authority we recommend that they are contacted so that they may clear the blockages from the pipework.

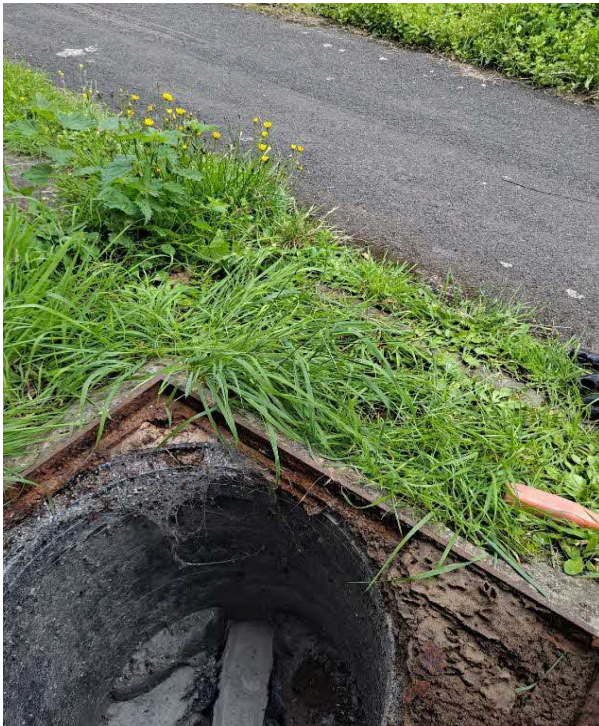
Unfortunately the high levels of water and debris in the shared pipework prevented a CCTV survey.

MH3 blocked downstream

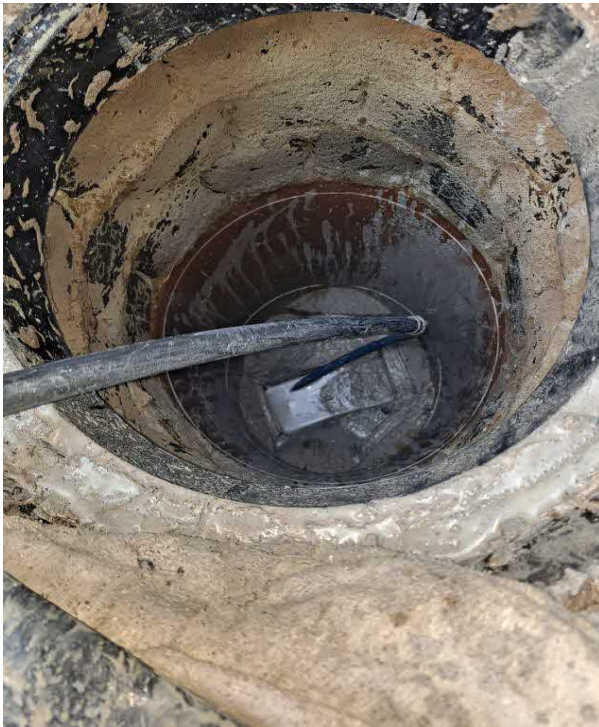
We carried out high pressure water jetting from MH1 to attempt to clear the build up of grease/fat prior to carrying out a CCTV survey. We jetted the pipework upstream and downstream but we were not able to clear the debris from the pipework.

MH1 jetting in progress

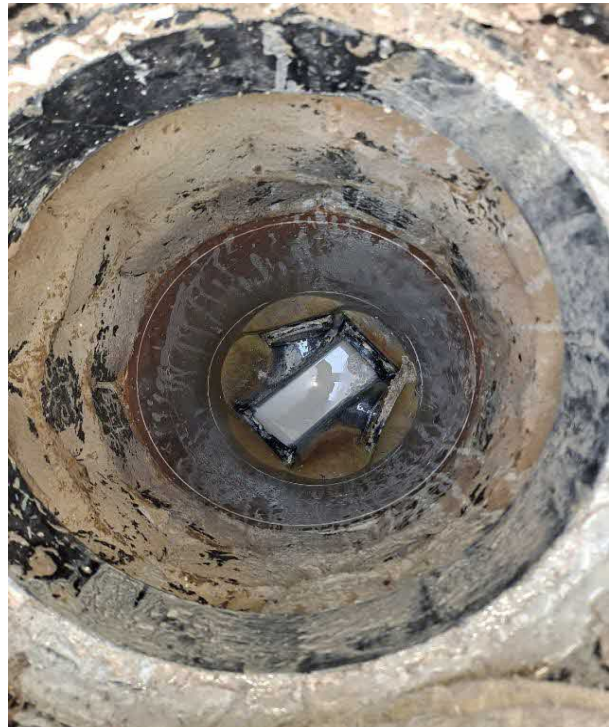
MH1 unable to clear
