**BS5837 ARBORICULTURAL REPORT,  
ARBORICULTURAL IMPACT ASSESSMENT  
& METHOD STATEMENT**

| <b>OUR REFERENCE</b> | <b>AC.2018.226</b> |
| <b>SITE</b> | <b>7 Avondale Road, Waterlooville, Hampshire, PO7 7ST</b> |

**Rear extension to existing residential detached dwelling  
and realignment of low level garden wall and raised patio  
area**

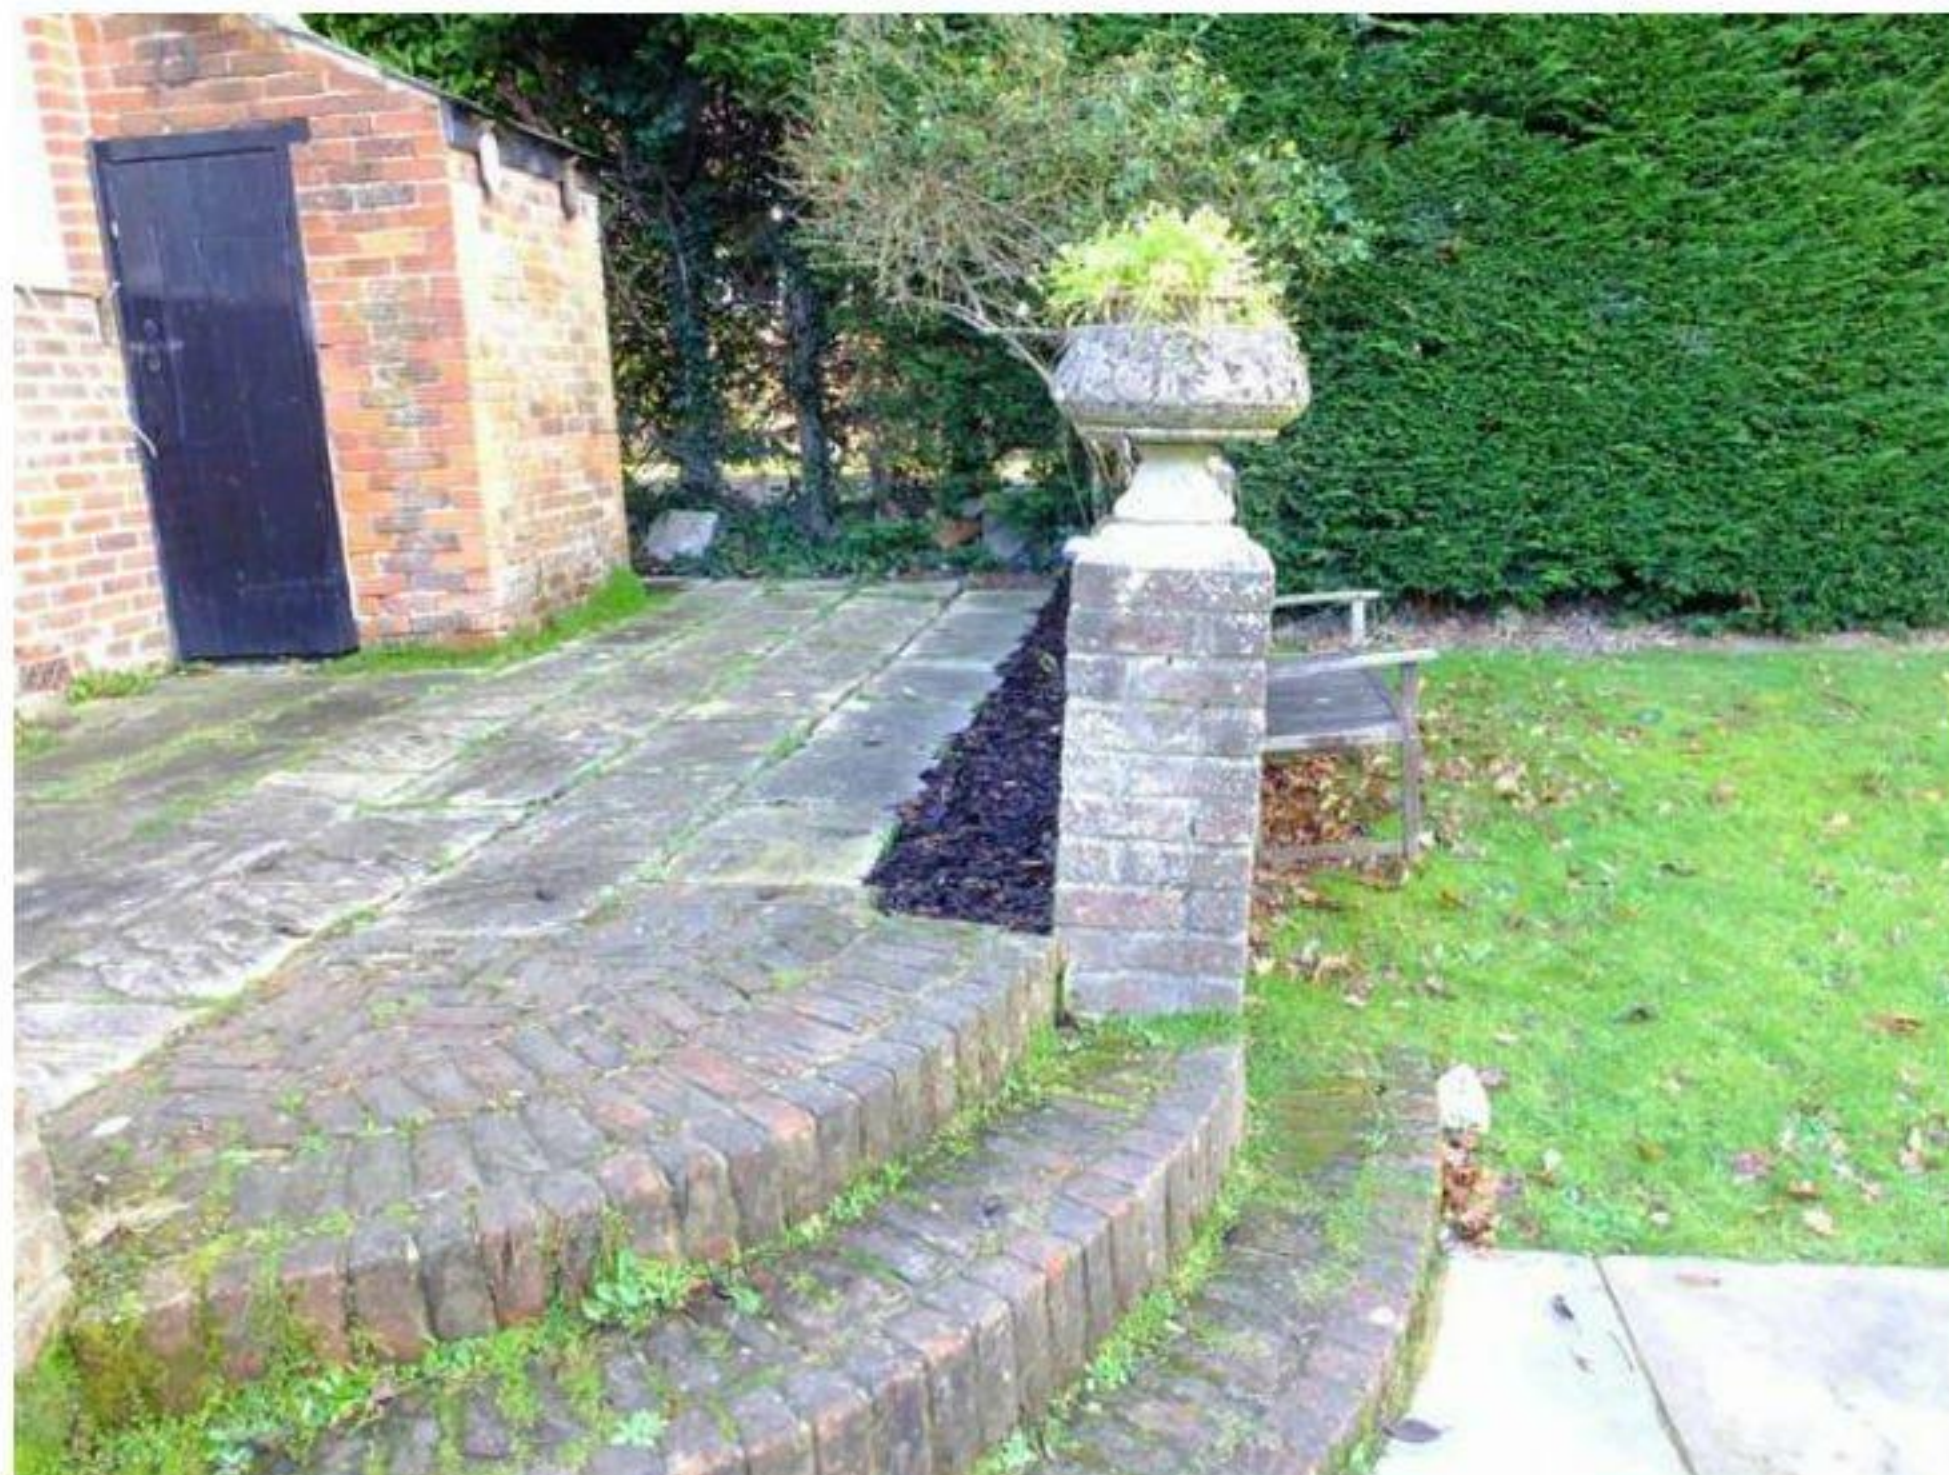
**Image 4** Existing wall on west side that is going to be match on east side

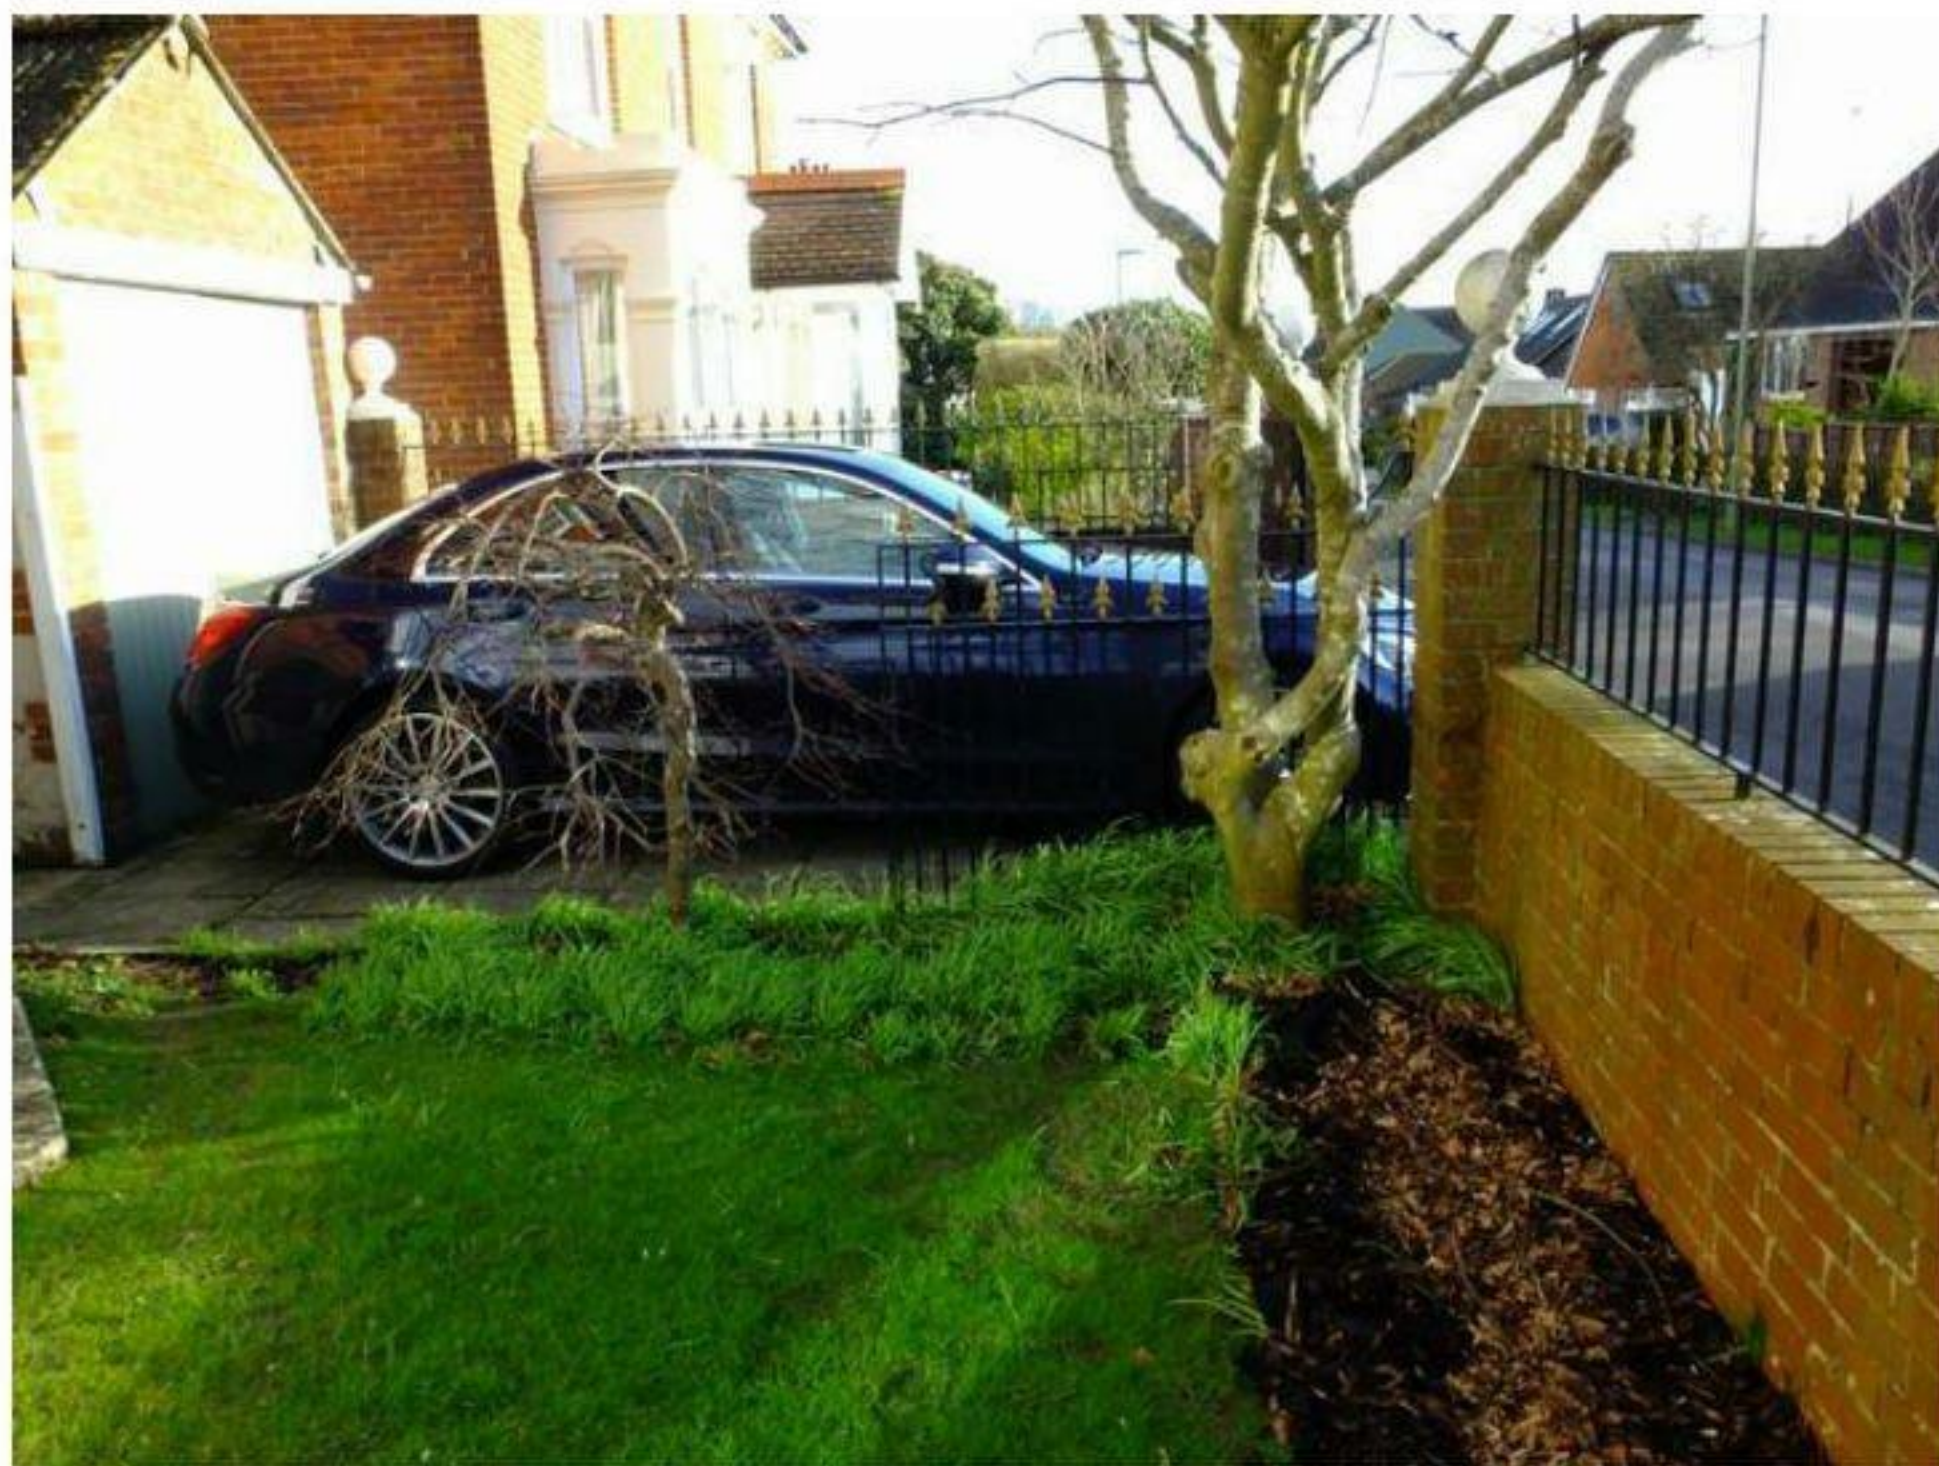
**Image 6** T9 on right and T10 on left (to be relocated)

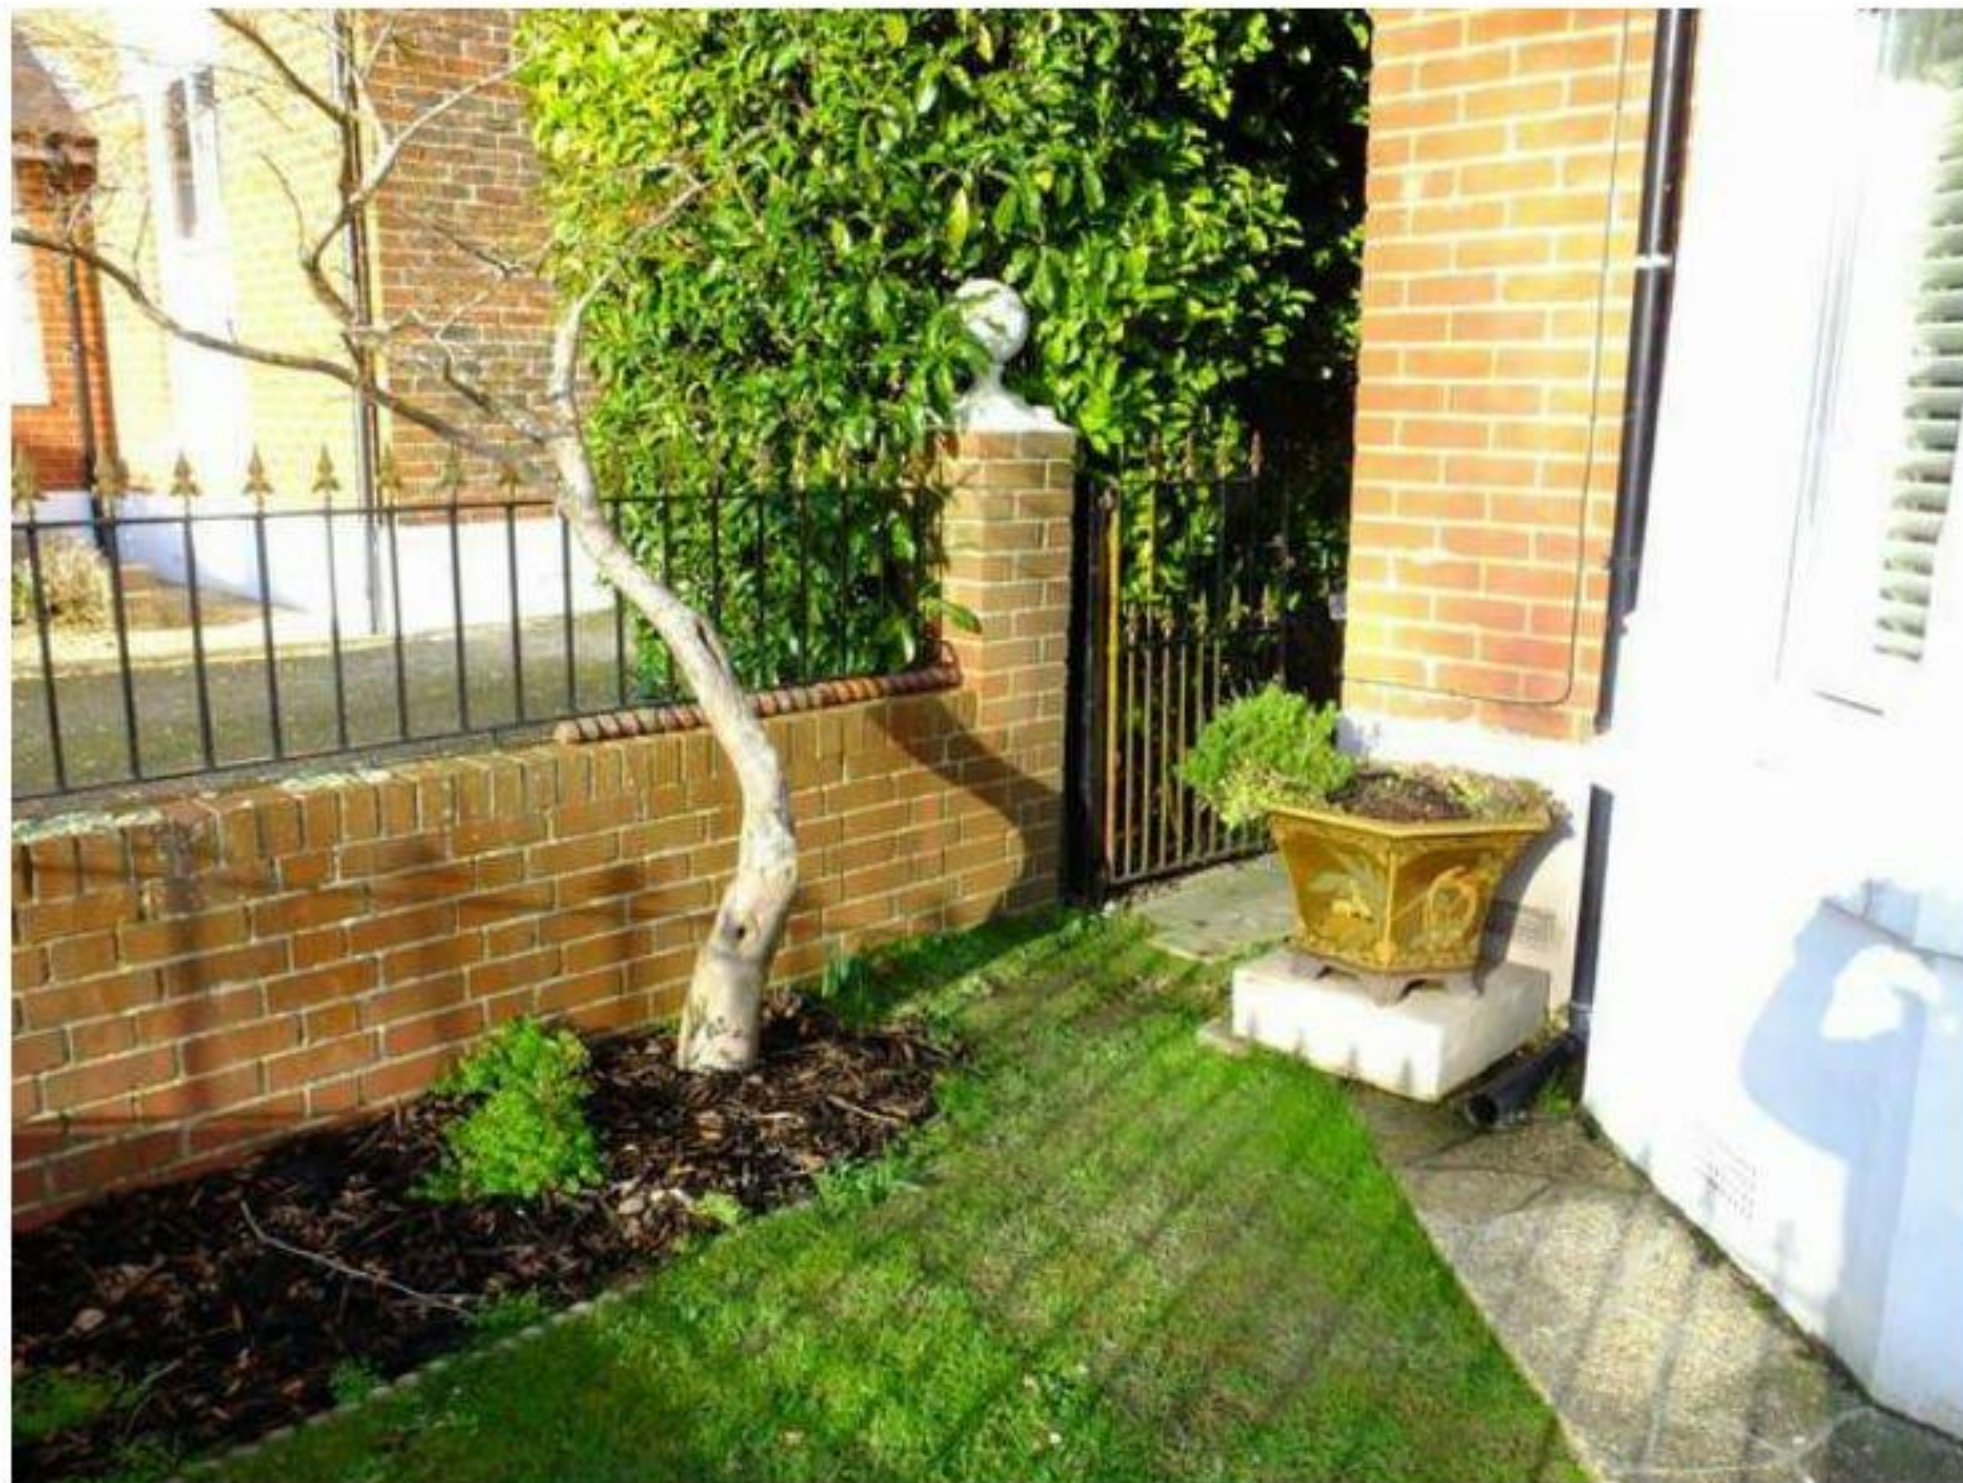
**Image 7** T11 with existing stem damage that is to be removed for site access

| Tree Id No | Tree Species | Stem Diam (mm) | Stem No | Tre e Hgt (m) | Ult Hgt (m) | Crown Height N, E, S, W (m) | | | | FSB Hgt (m) | FSB Dir | Life Stage | Life Exp | BS 5837 Cat Pre | Canopy Spread N, E, S, W (m) | | | | Phys & Struct Condition | Comments | Recommen ded Work | RPA Annex D (m) | Re- Inspe ction |
|---|---|---|---|---|---|---|---|---|---|---|---|---|---|---|---|---|---|---|---|---|---|---|---|
| T 11 | Japanese Maple, <i>Acer palmatum</i> | 60 | 1 | 2 | 3 | 1 | 1 | 1 | 1 | - | - | SM | 40+ | C1 | 0.5 | 0.5 | 2 | 0.5 | P Good, S Fair | Small low level tree with stem damage from two previous limb removals. | Remove to facilitate site access | 0.9 | N/A |

These are T10 and T11. They are both very small Japanese Maple trees. T10 is very small and is proposed for replanting elsewhere in the garden. T11 is also small but has been damaged with poor pruning to removal two existing branches, and this is obstructing the access, so this tree is proposed for removal.

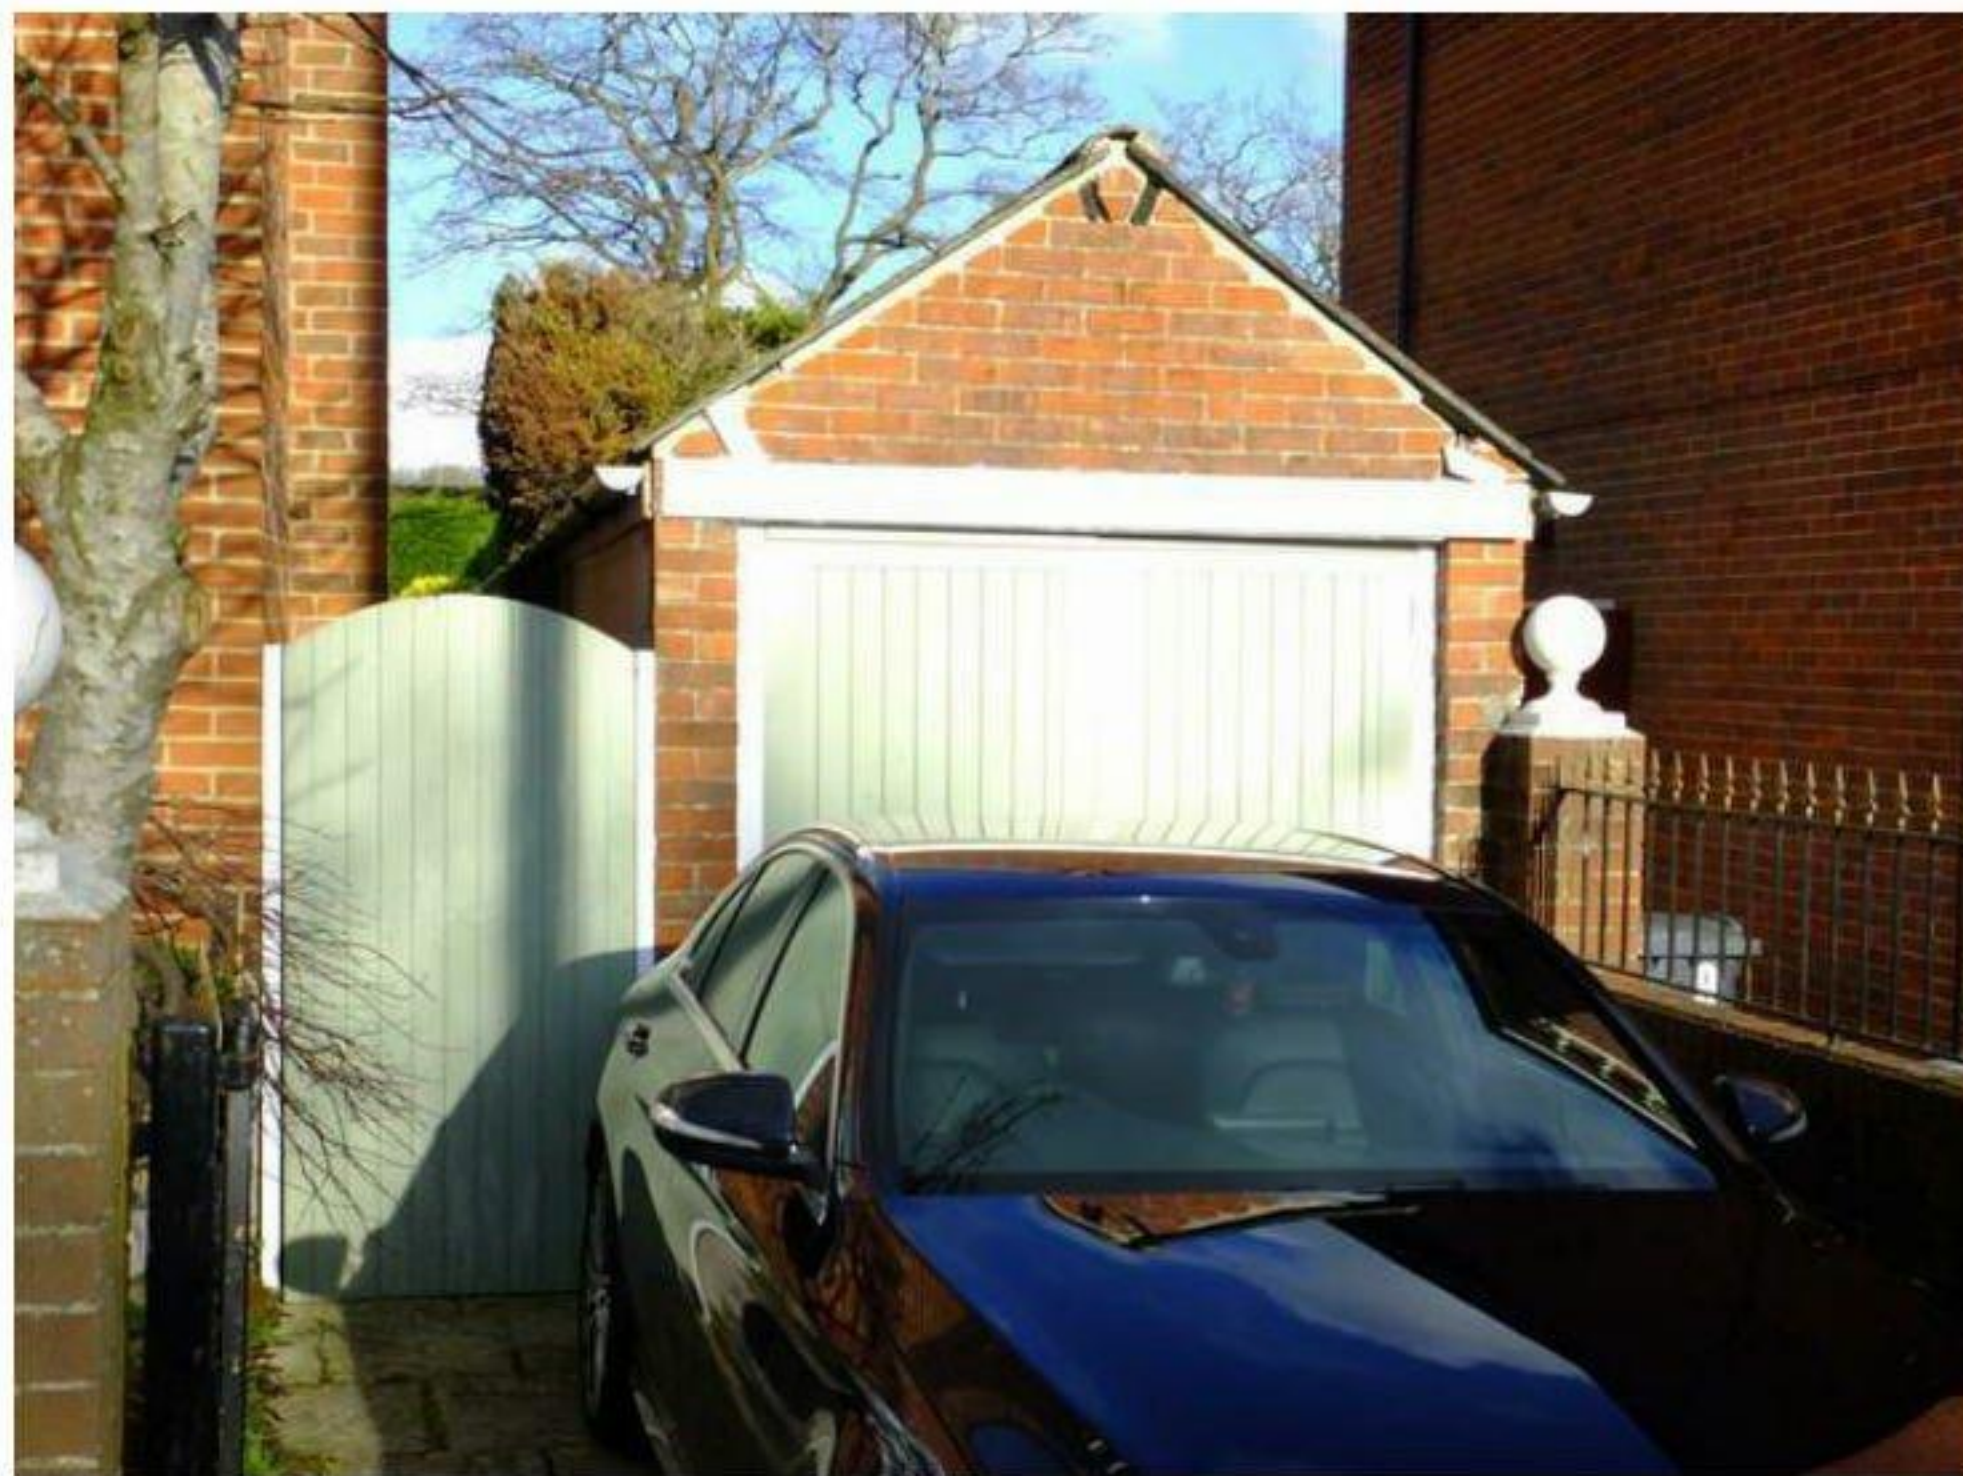
**Image 8** Existing garage building that may be demolished for site access, then rebuilt
