CCTV REPORT FOR: 28 DAMASK GARDENS  
WATERLOOVILLE  
PO7 8QZ

Site Visit: 25-May-23  
Report Date: 28-Jun-23

Address: 28 DAMASK GARDENS, WATERLOOVILLE, PO7 8QZ

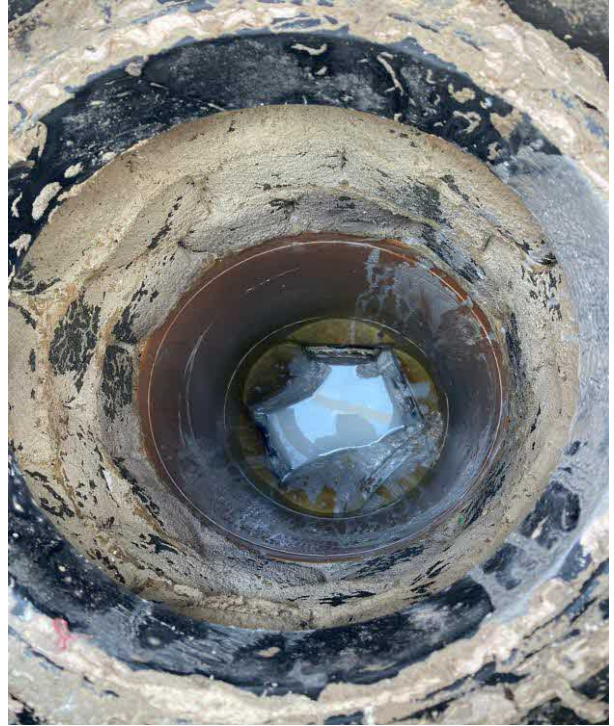
MH1

We identified an inspection chamber beneath an access panel in the floor of the conservatory to the rear of the house. When we accessed this we found the pipework to be approximately 1.0m deep and holding high levels of grease/fat and washing machine residue.

We attempted rodding the clear the debris but this was not successful.

Return to site and carry out high pressure water jetting as required before performing a CCTV survey of the drainage connected to MH1, reporting further on the condition and destination of all pipework.

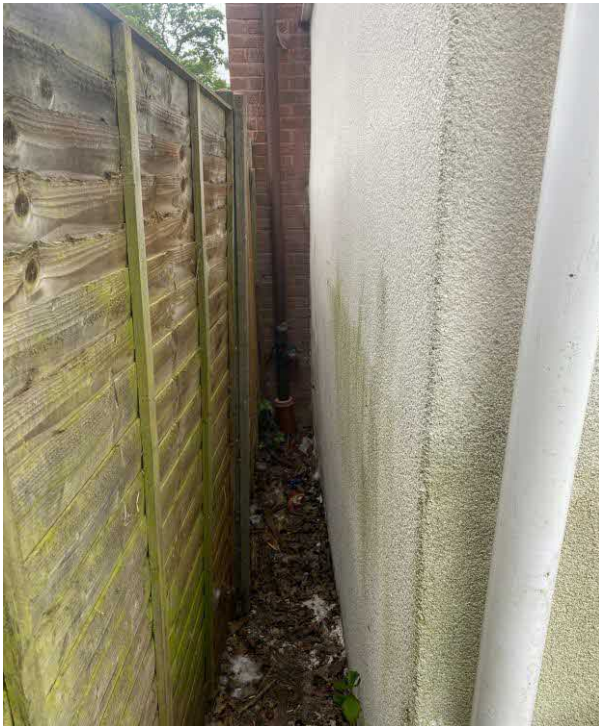
The down pipe is located at the rear right corner of the main house in a narrow gap between the conservatory and the boundary fence. The end panel of the fence is screwed in place and we could not lift this out to gain access to attempt a survey.

Carry out small access excavation at RWP1 and cut into the pipework below ground. Perform a CCTV survey of the drainage downstream, reporting further on the condition and destination of the pipework.

Should the pipework be found to discharge to a soakaway then perform a flow test to determine whether this is functioning adequately.

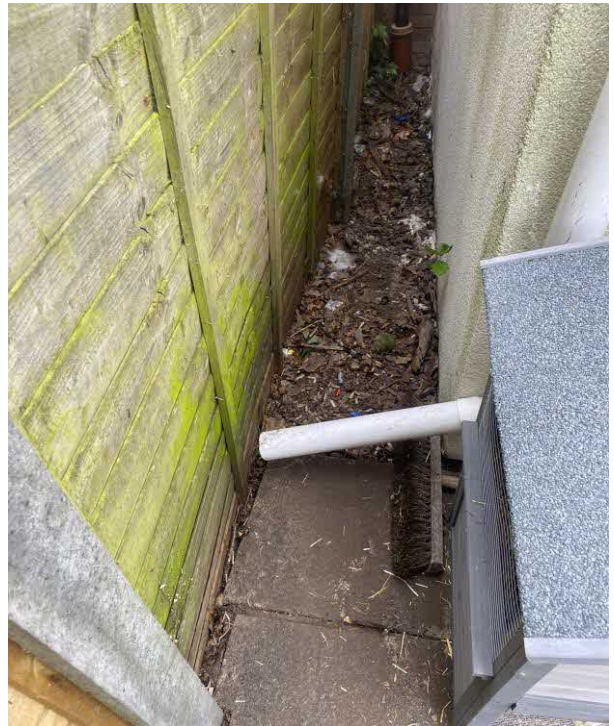
RWP2

The down pipe is located at the rear right corner of the conservatory. It serves the conservatory only and discharges onto the ground against the boundary fence.
