### Subsidence damage investigation report for [REDACTED] Sutton Road, Waterloooville, PO8 8PT

Prepared by **Trevor Heaps** BSc, MICFor, M. Arbor.A.

Prepared for: Trinity Claims

Date: 20<sup>th</sup> December 2023 (previously 22<sup>nd</sup> September 2022)

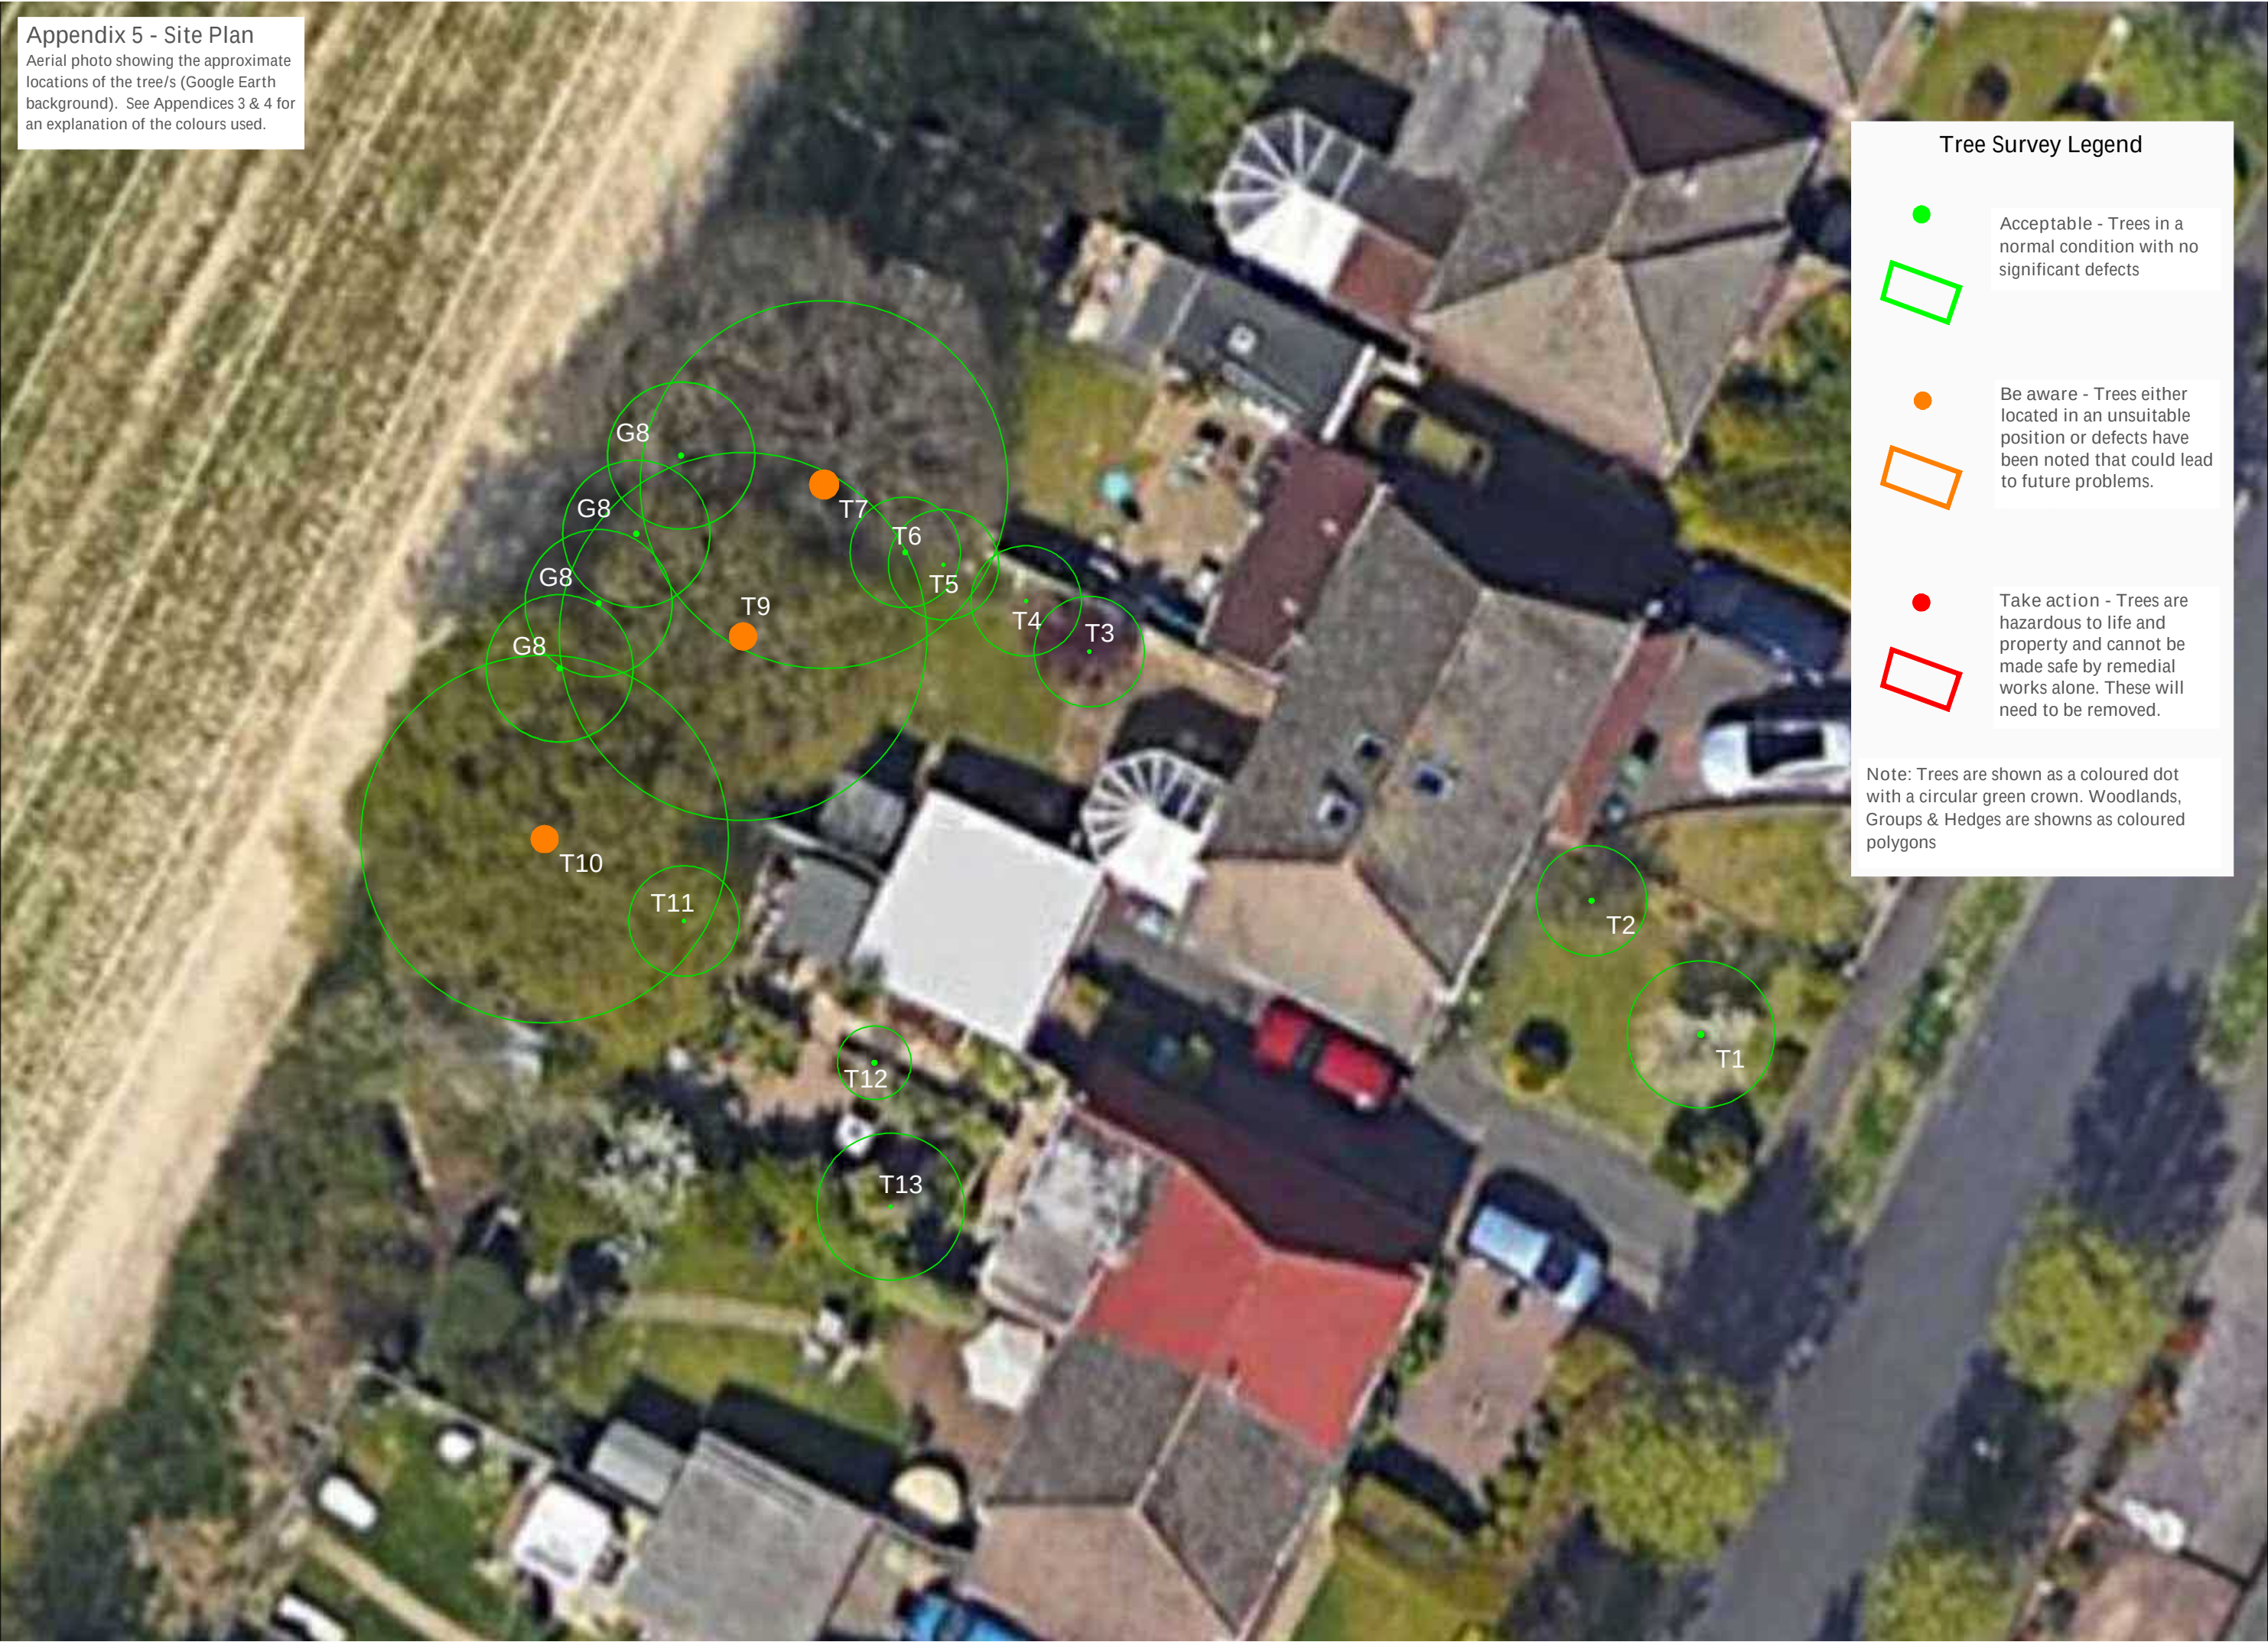
Appendix 5 - Site Plan

14.1 It is more likely than not that Oaks T7, T9 & T10 have contributed to subsidence damage.

Aerial photo showing the approximate locations of the tree/s (Google Earth background). See Appendices 3 & 4 for an explanation of the colours used.
