**Re: Root Induced Clay Shrinkage Subsidence – Formal notification of request for vegetation management as a remedy**

# Arboricultural Appraisal Report

## Subsidence Damage Investigation at:

97 Sutton Road  
Waterlooville  
PO8 8PT

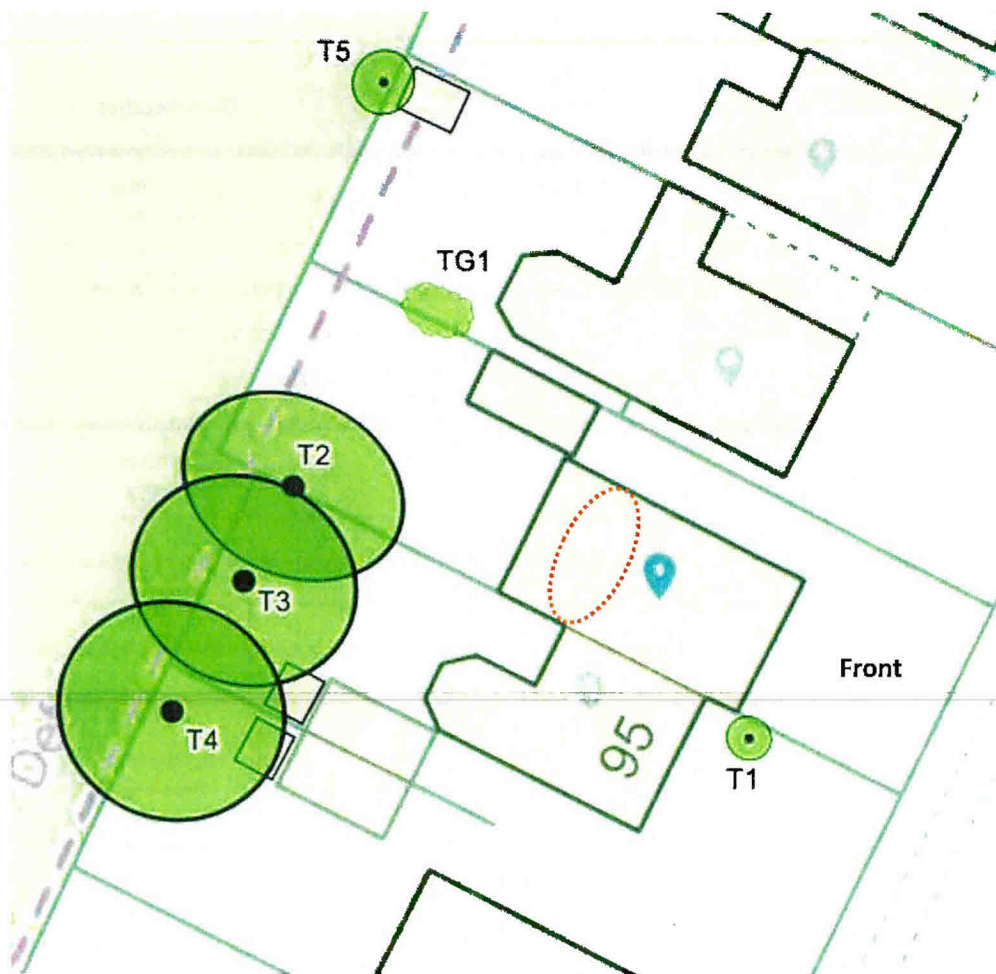
## Site Plan

Plan not to scale – indicative only

Approximate areas of damage

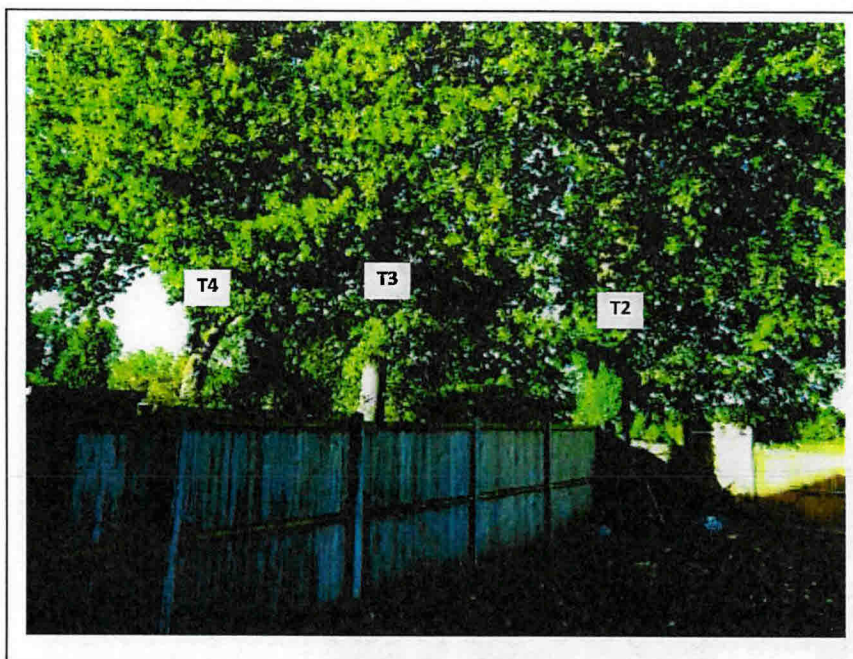
Our survey has identified vegetation within influencing distance of the building with a current potential to influence soil volumes below foundation level. The vegetation considered to be most significant in relation to the current damage is T2, with a potential contribution from T3.

View of T4, T3 and T2

If an arboricultural solution is to be implemented to mitigate the influence of the trees/shrubs considered to be responsible for the damage, we recommend that T2 be removed and T3 reduced. We did consider removing both current claim oaks although the amplitude of damage (BRE Digest 251 slight) indicates that it may be possible to restore stability with T3 retained but subject to crown reduction and regular repeat pruning.

| Tree No. | Species | Ht. (m) | Dia. (mm) | Crown Spread (m) | Dist. to building (m) | Age Classification | Ownership |
|---|---|---|---|---|---|---|---|
| Recommendation | | Remove to ground level removing any regrowth annually. | | | | | |
| Recommendation | | Reduce height to 9m and crown spread to 8m leaving balanced crown. Prune on a biennial cycle to maintain at broadly reduced dimensions. | | | | | |

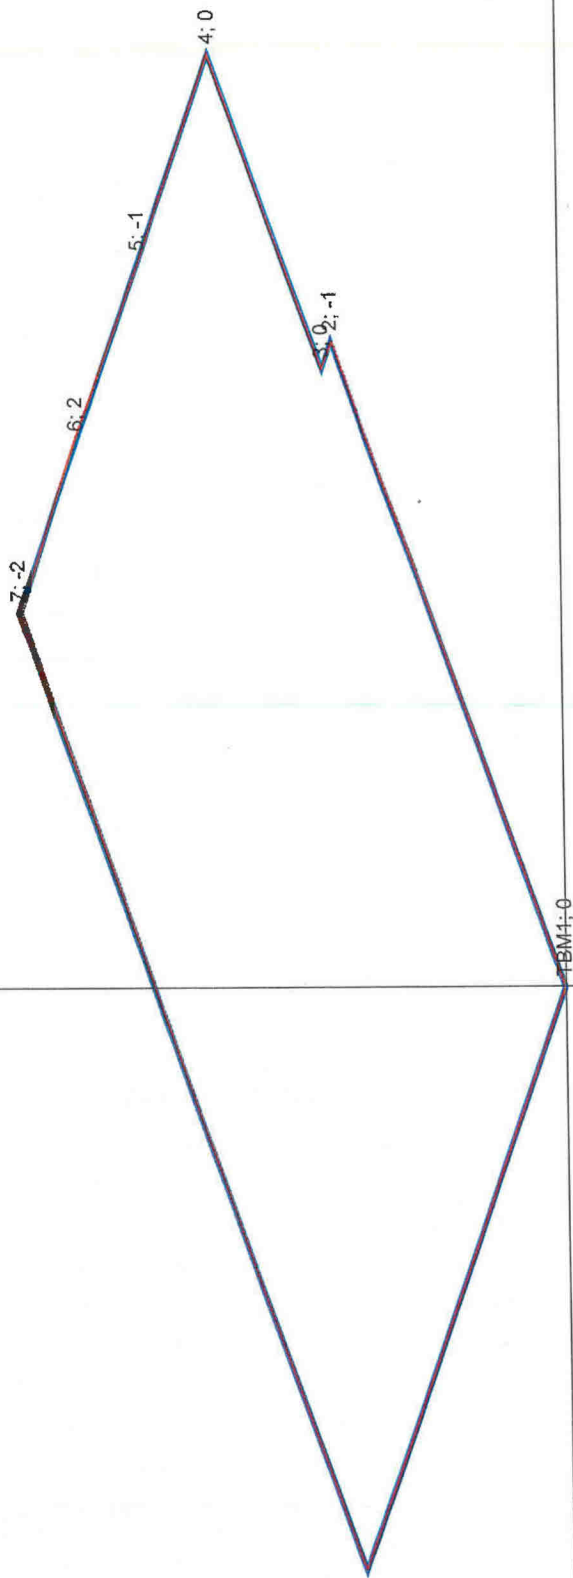
LEVEL MONITORING - RELATIVE MOVEMENT SKETCH

- 28/11/22 Readings taken, 07/10/22 Point 3 refixed Extra point added to rear.
- A common brickcourse could not be followed, subsequently relative data only.
- A further visit is due in late Jan/Feb

Point labels give level difference of last reading from original datum in mm.
