**Subsidence  
Monitoring  
Service**

Monitoring visit 3 of 7

**Monitoring Plus Report**

| Address | 1a Durley Avenue<br>Waterlooville<br><br>PO8 8XA | Principal area of damage | to be advised | Installed | 24/05/2023 |

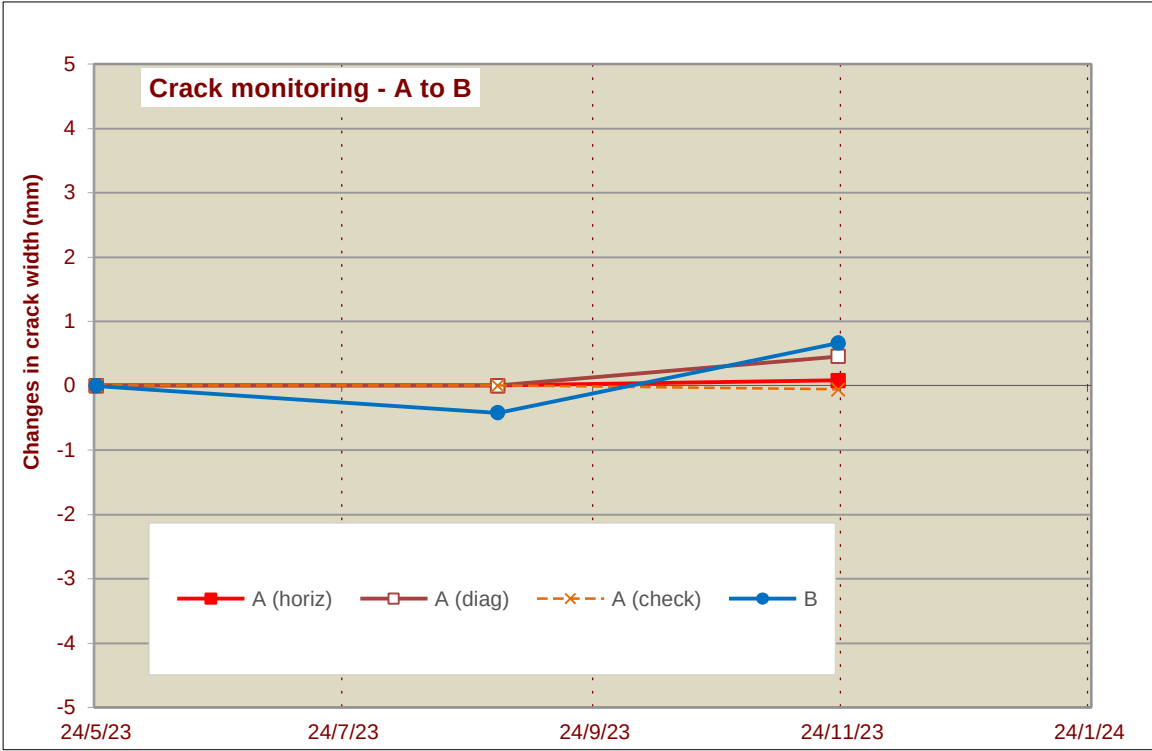
Crack monitoring

| A (horiz) | Demec triplet, external, garage LHS wall |
| B | Demec pair, external, garage rear wall |
