**My Ref:** D1826AIAL2

5<sup>th</sup> June 2018

**RE: 109 LONDON ROAD, COWPLAIN, WATERLOOVILLE PO8 8XJ3  
WORKS NEAR TREES**

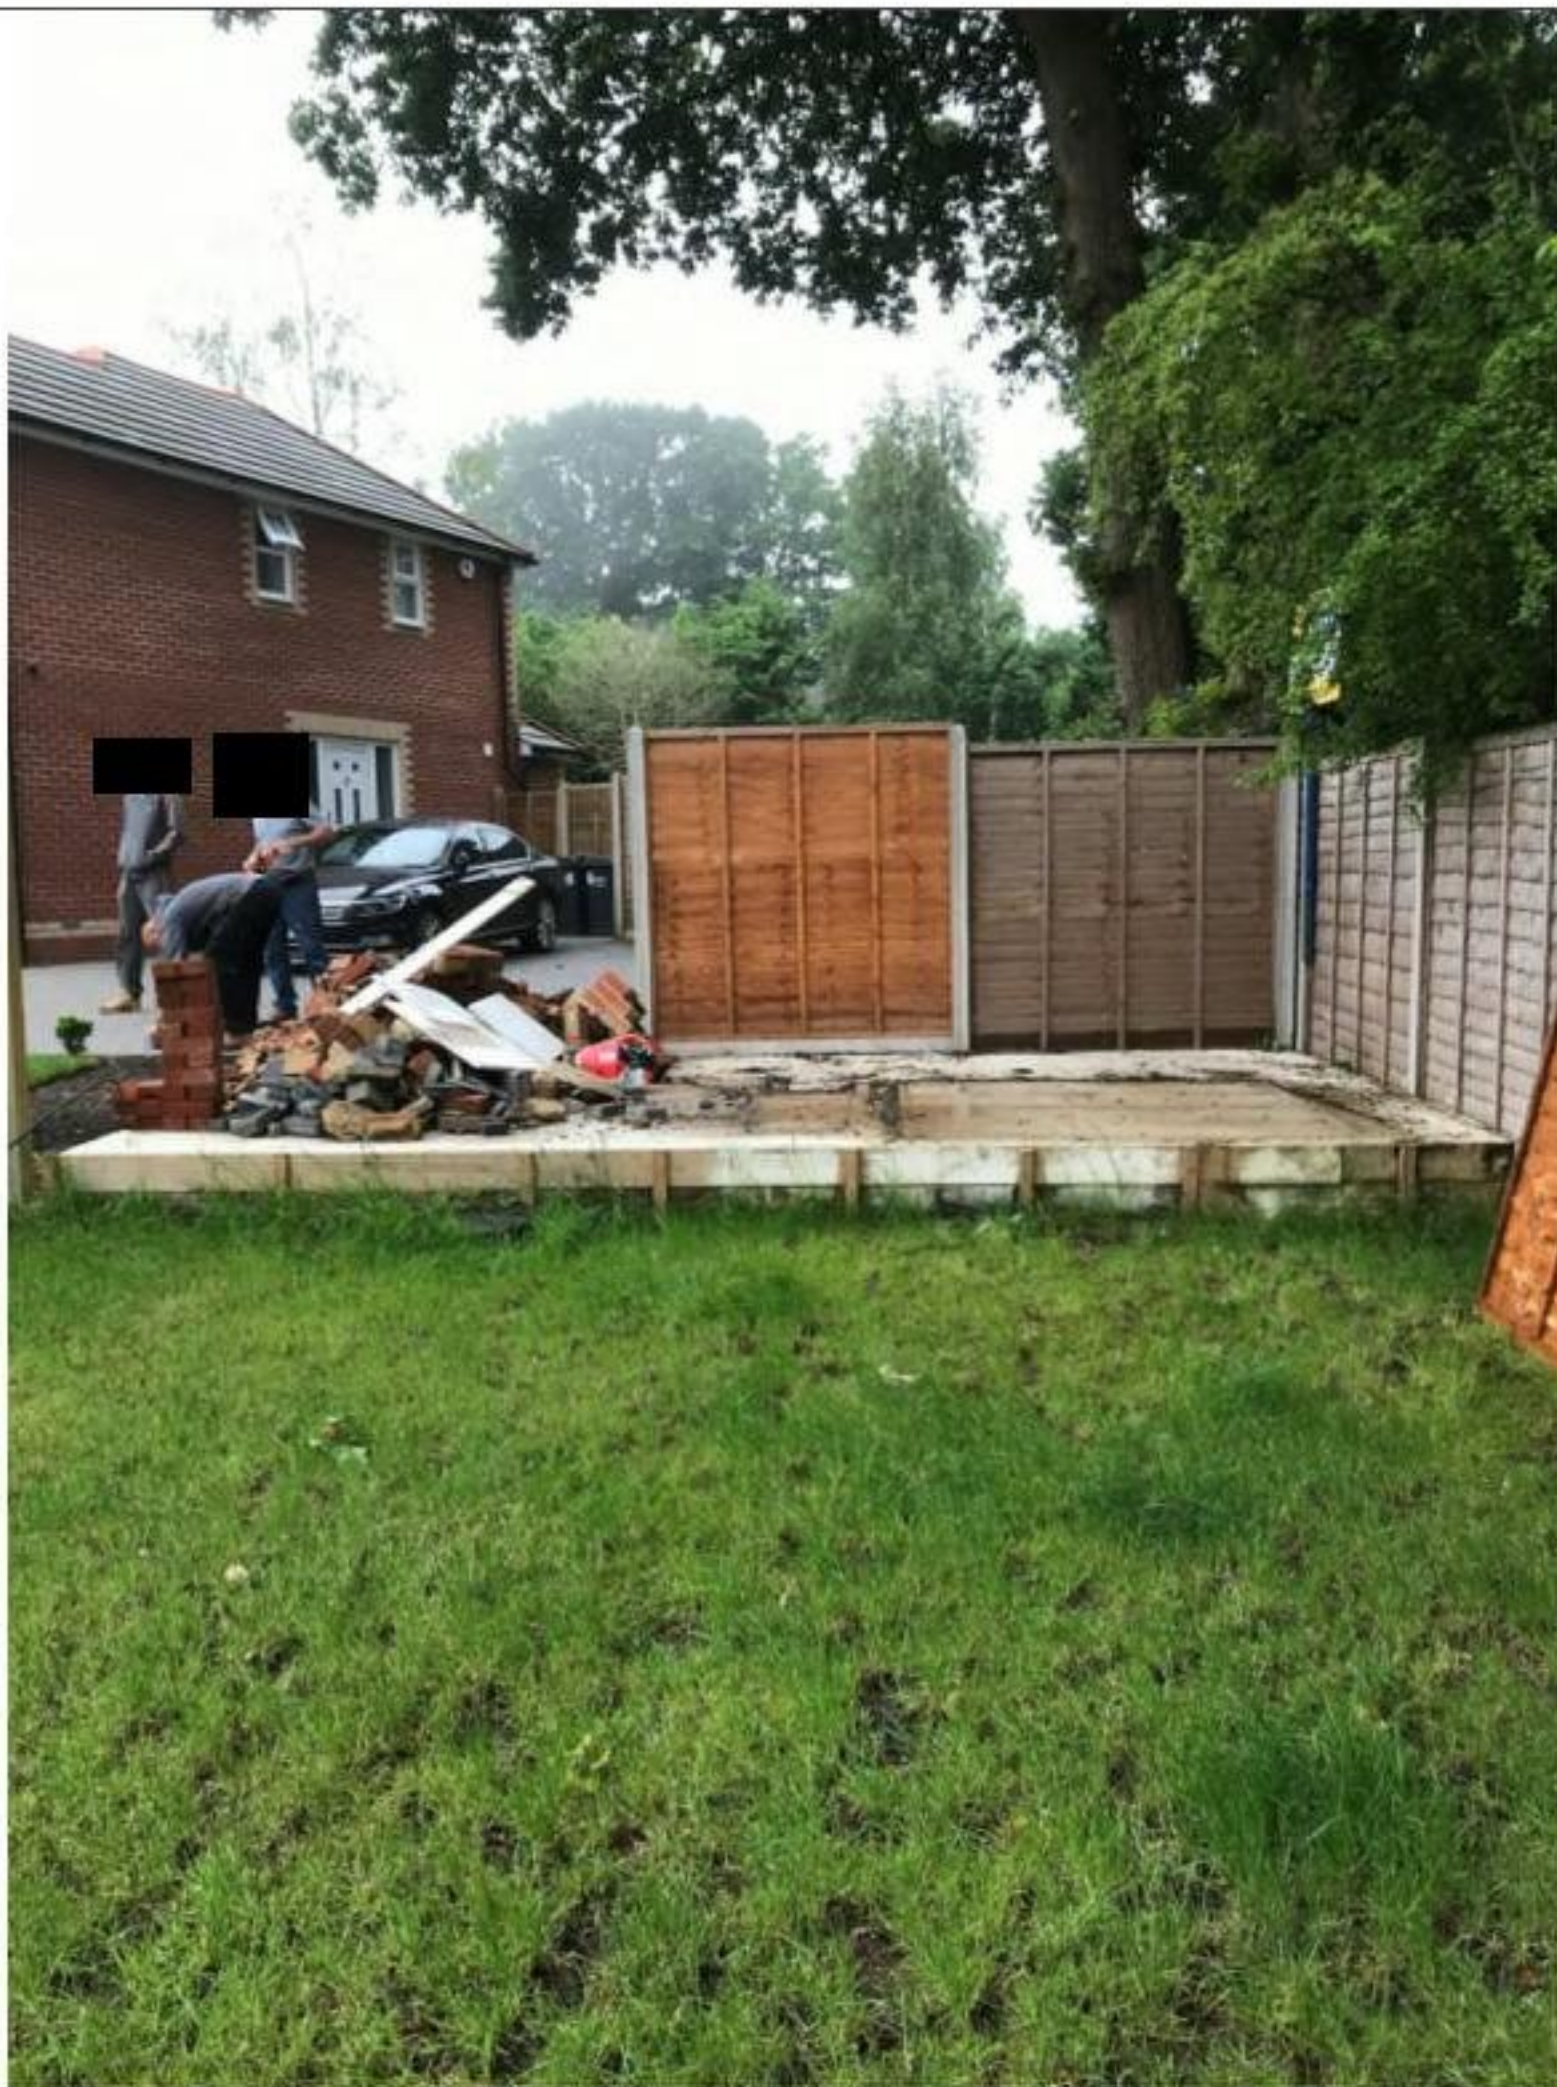
4. In respect of the concrete slab base, it was not practicable to carry out similar preliminary investigations and you had concerns about the method of installation and the impermeable character of the slab. Accordingly, you required the base to be taken up and removed and the ground made good, returning the site to the condition shown in the most recent planning permission.

Photo 1: Concrete slab base prior to the start of removal works

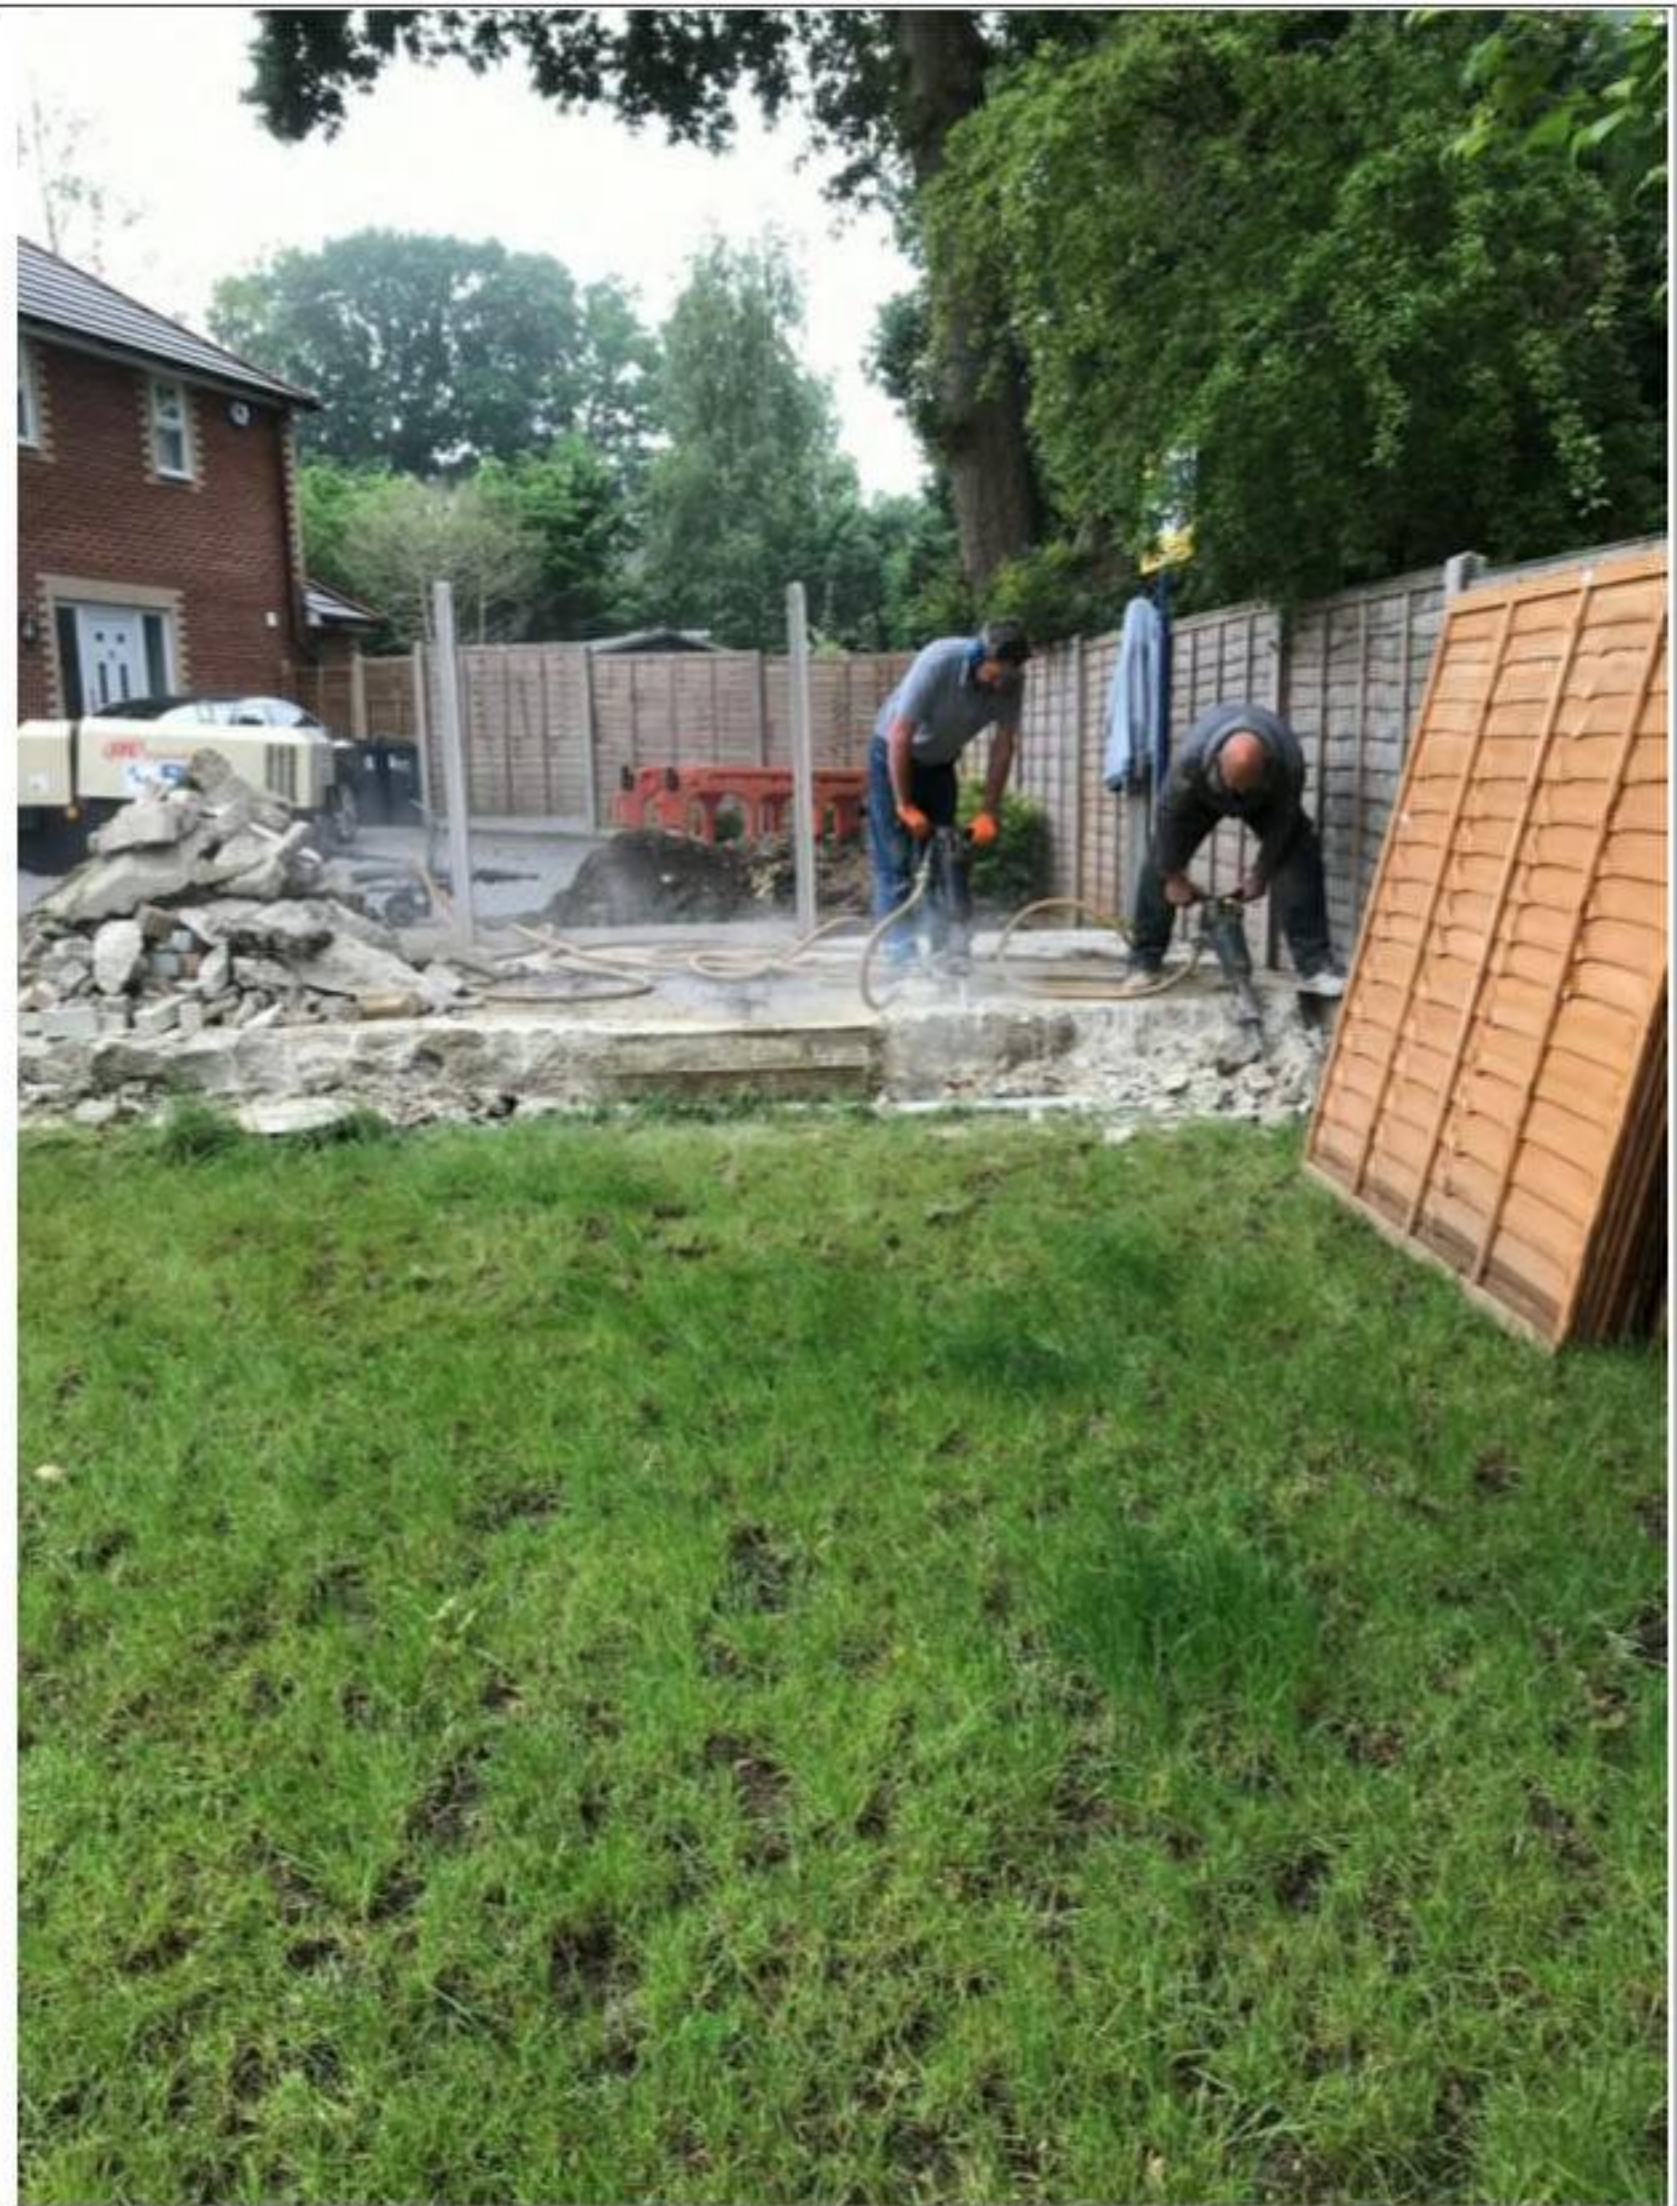
5. The slab removal works were carried out on Friday 1<sup>st</sup> June. Photos 1-5 at Appendix 1 show progress. The slab was broken up using hand-held / hand-operated pneumatic chisels, working from on the slab, with the arisings removed by hand back onto the slab. Priority was given to that part of the slab near the boundary fence and trees, and a 50cm wide strip was removed, allowing investigation using hand tools to reveal the original ground level. I was present from the commencement to monitor the works and you made a site visit just before noon to carry out your own site examination. It was clear from the works to that point that the slab had been installed over the existing ground level with no additional excavation into previously undisturbed ground. Examination of other parts of the slab during removal indicated that this principle applied for the whole slab. There was no evidence of damage to tree roots by severance or abrasion.

Photo 2: Breaking up concrete slab base using hand-held pneumatic chisels and working from the slab

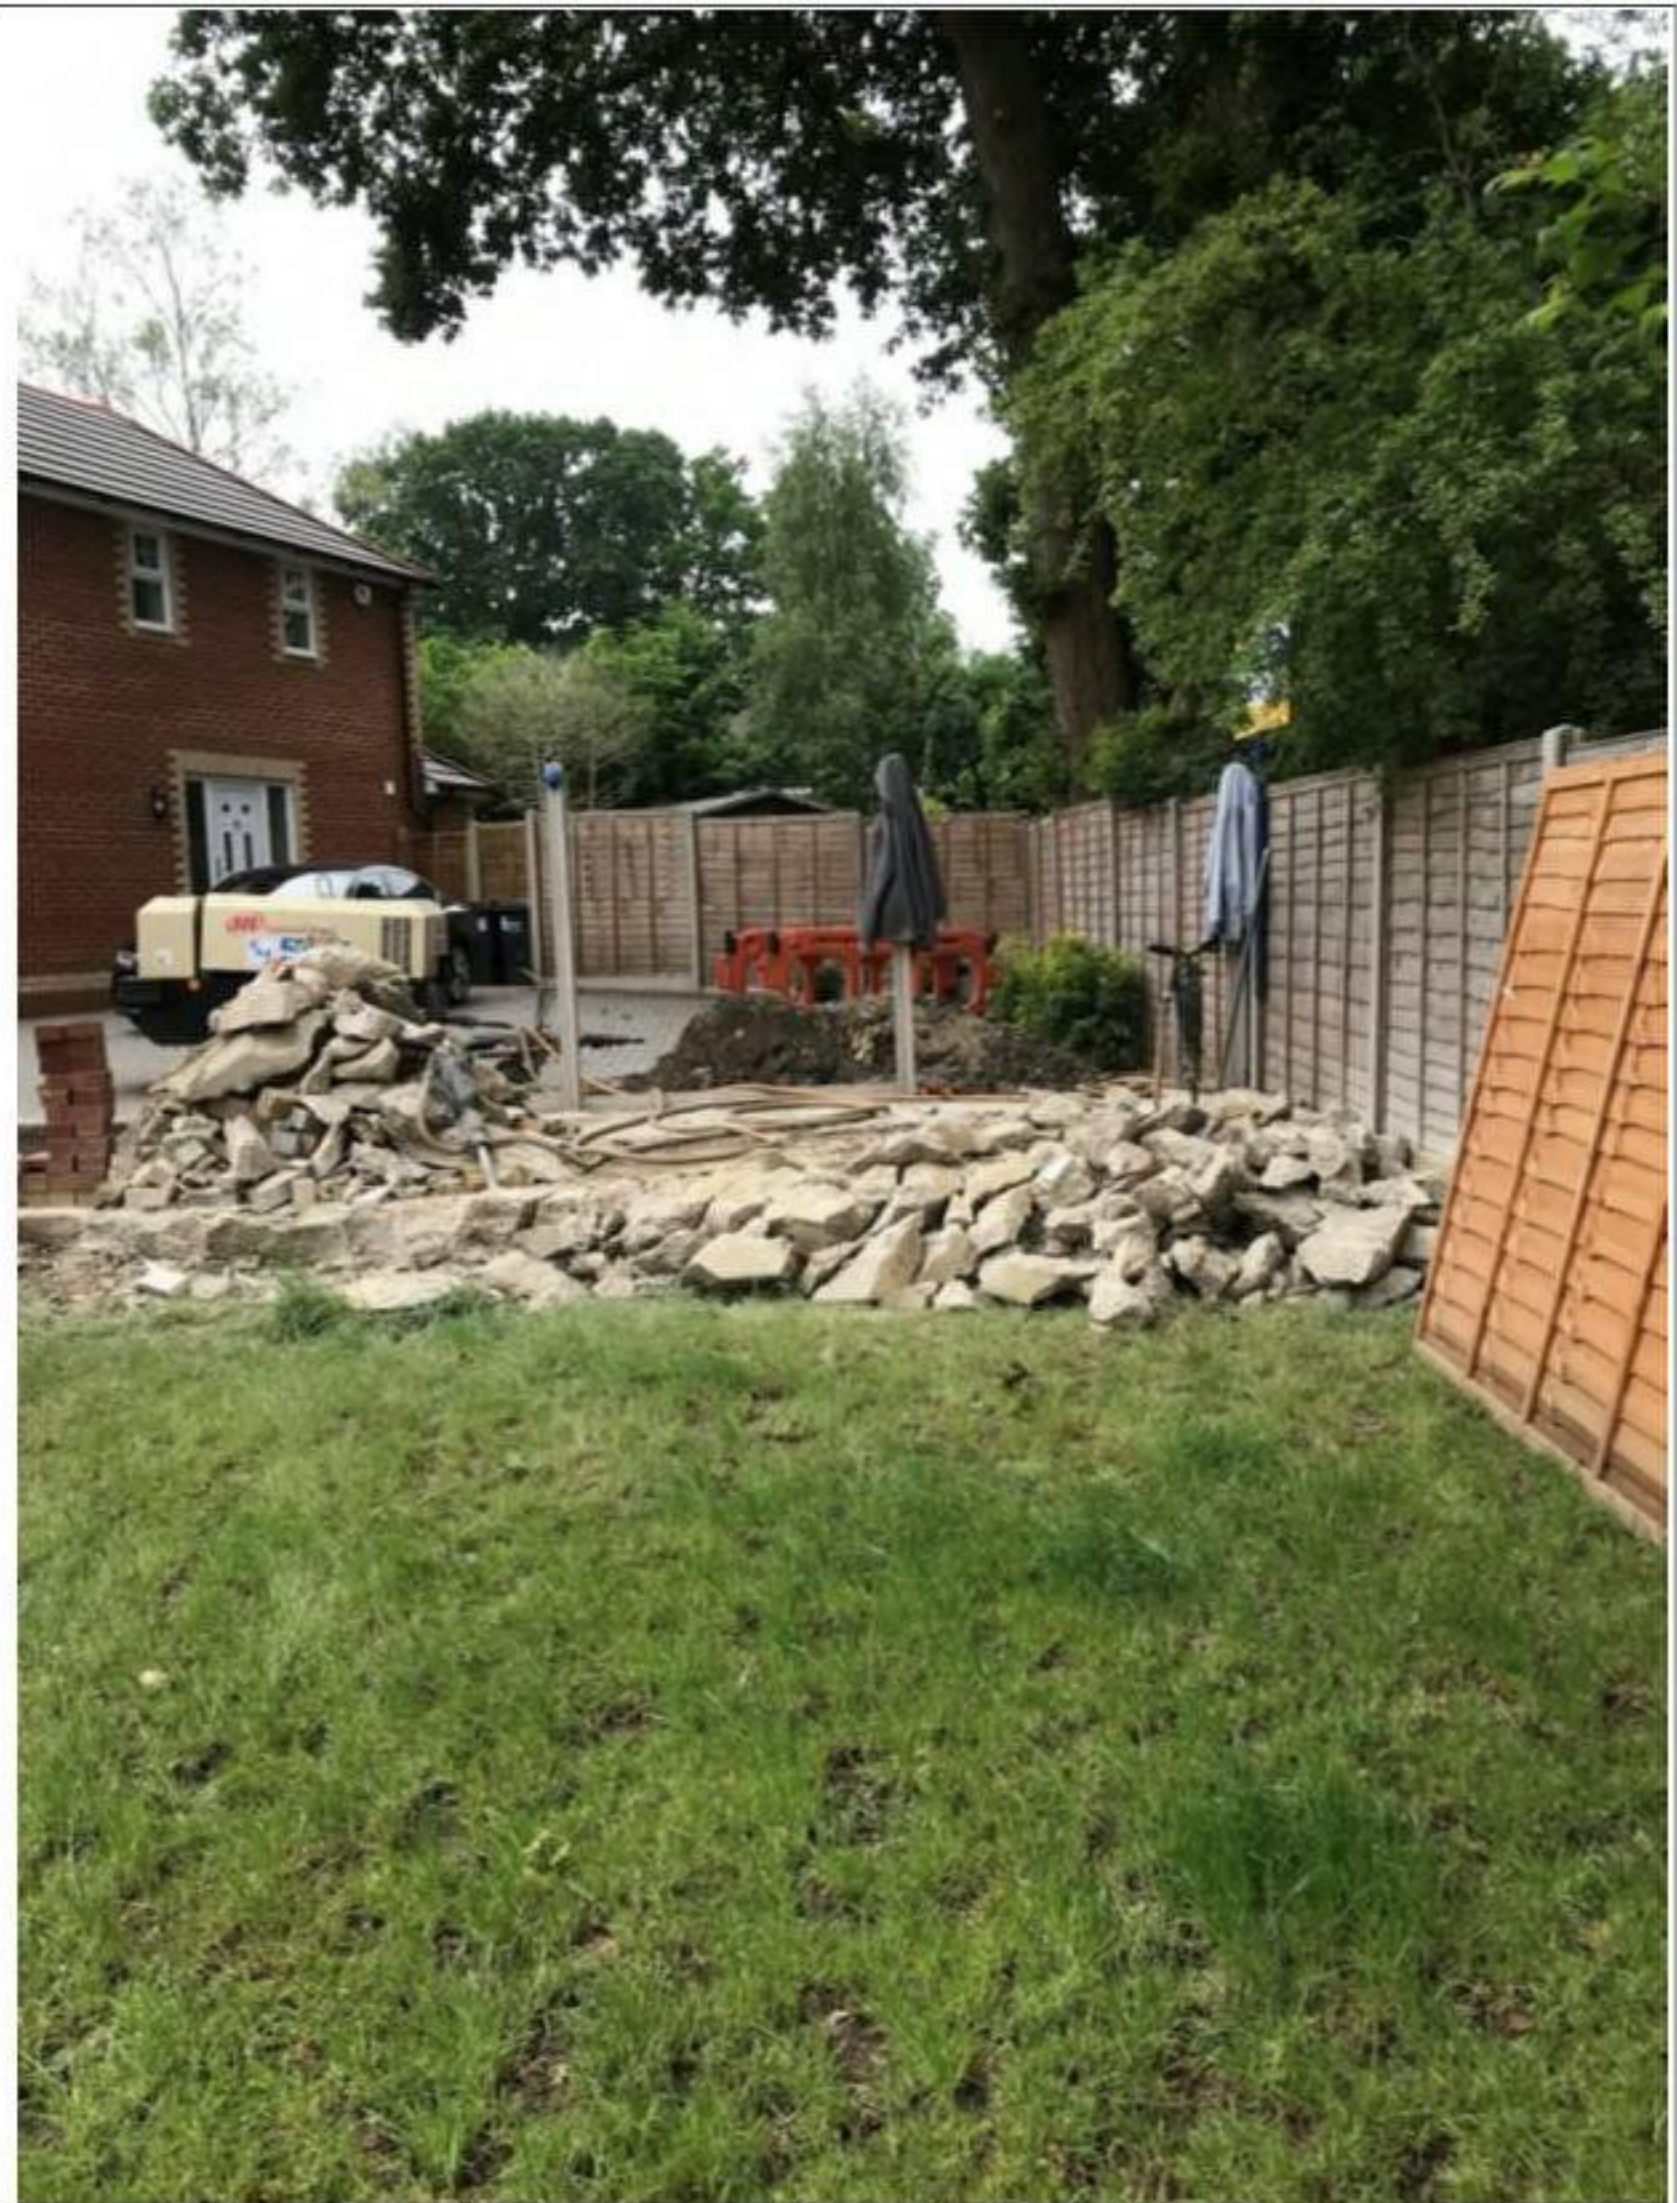
Photo 3: Concrete slab base partly broken up, with arisings beginning to be stacked on remaining part of slab

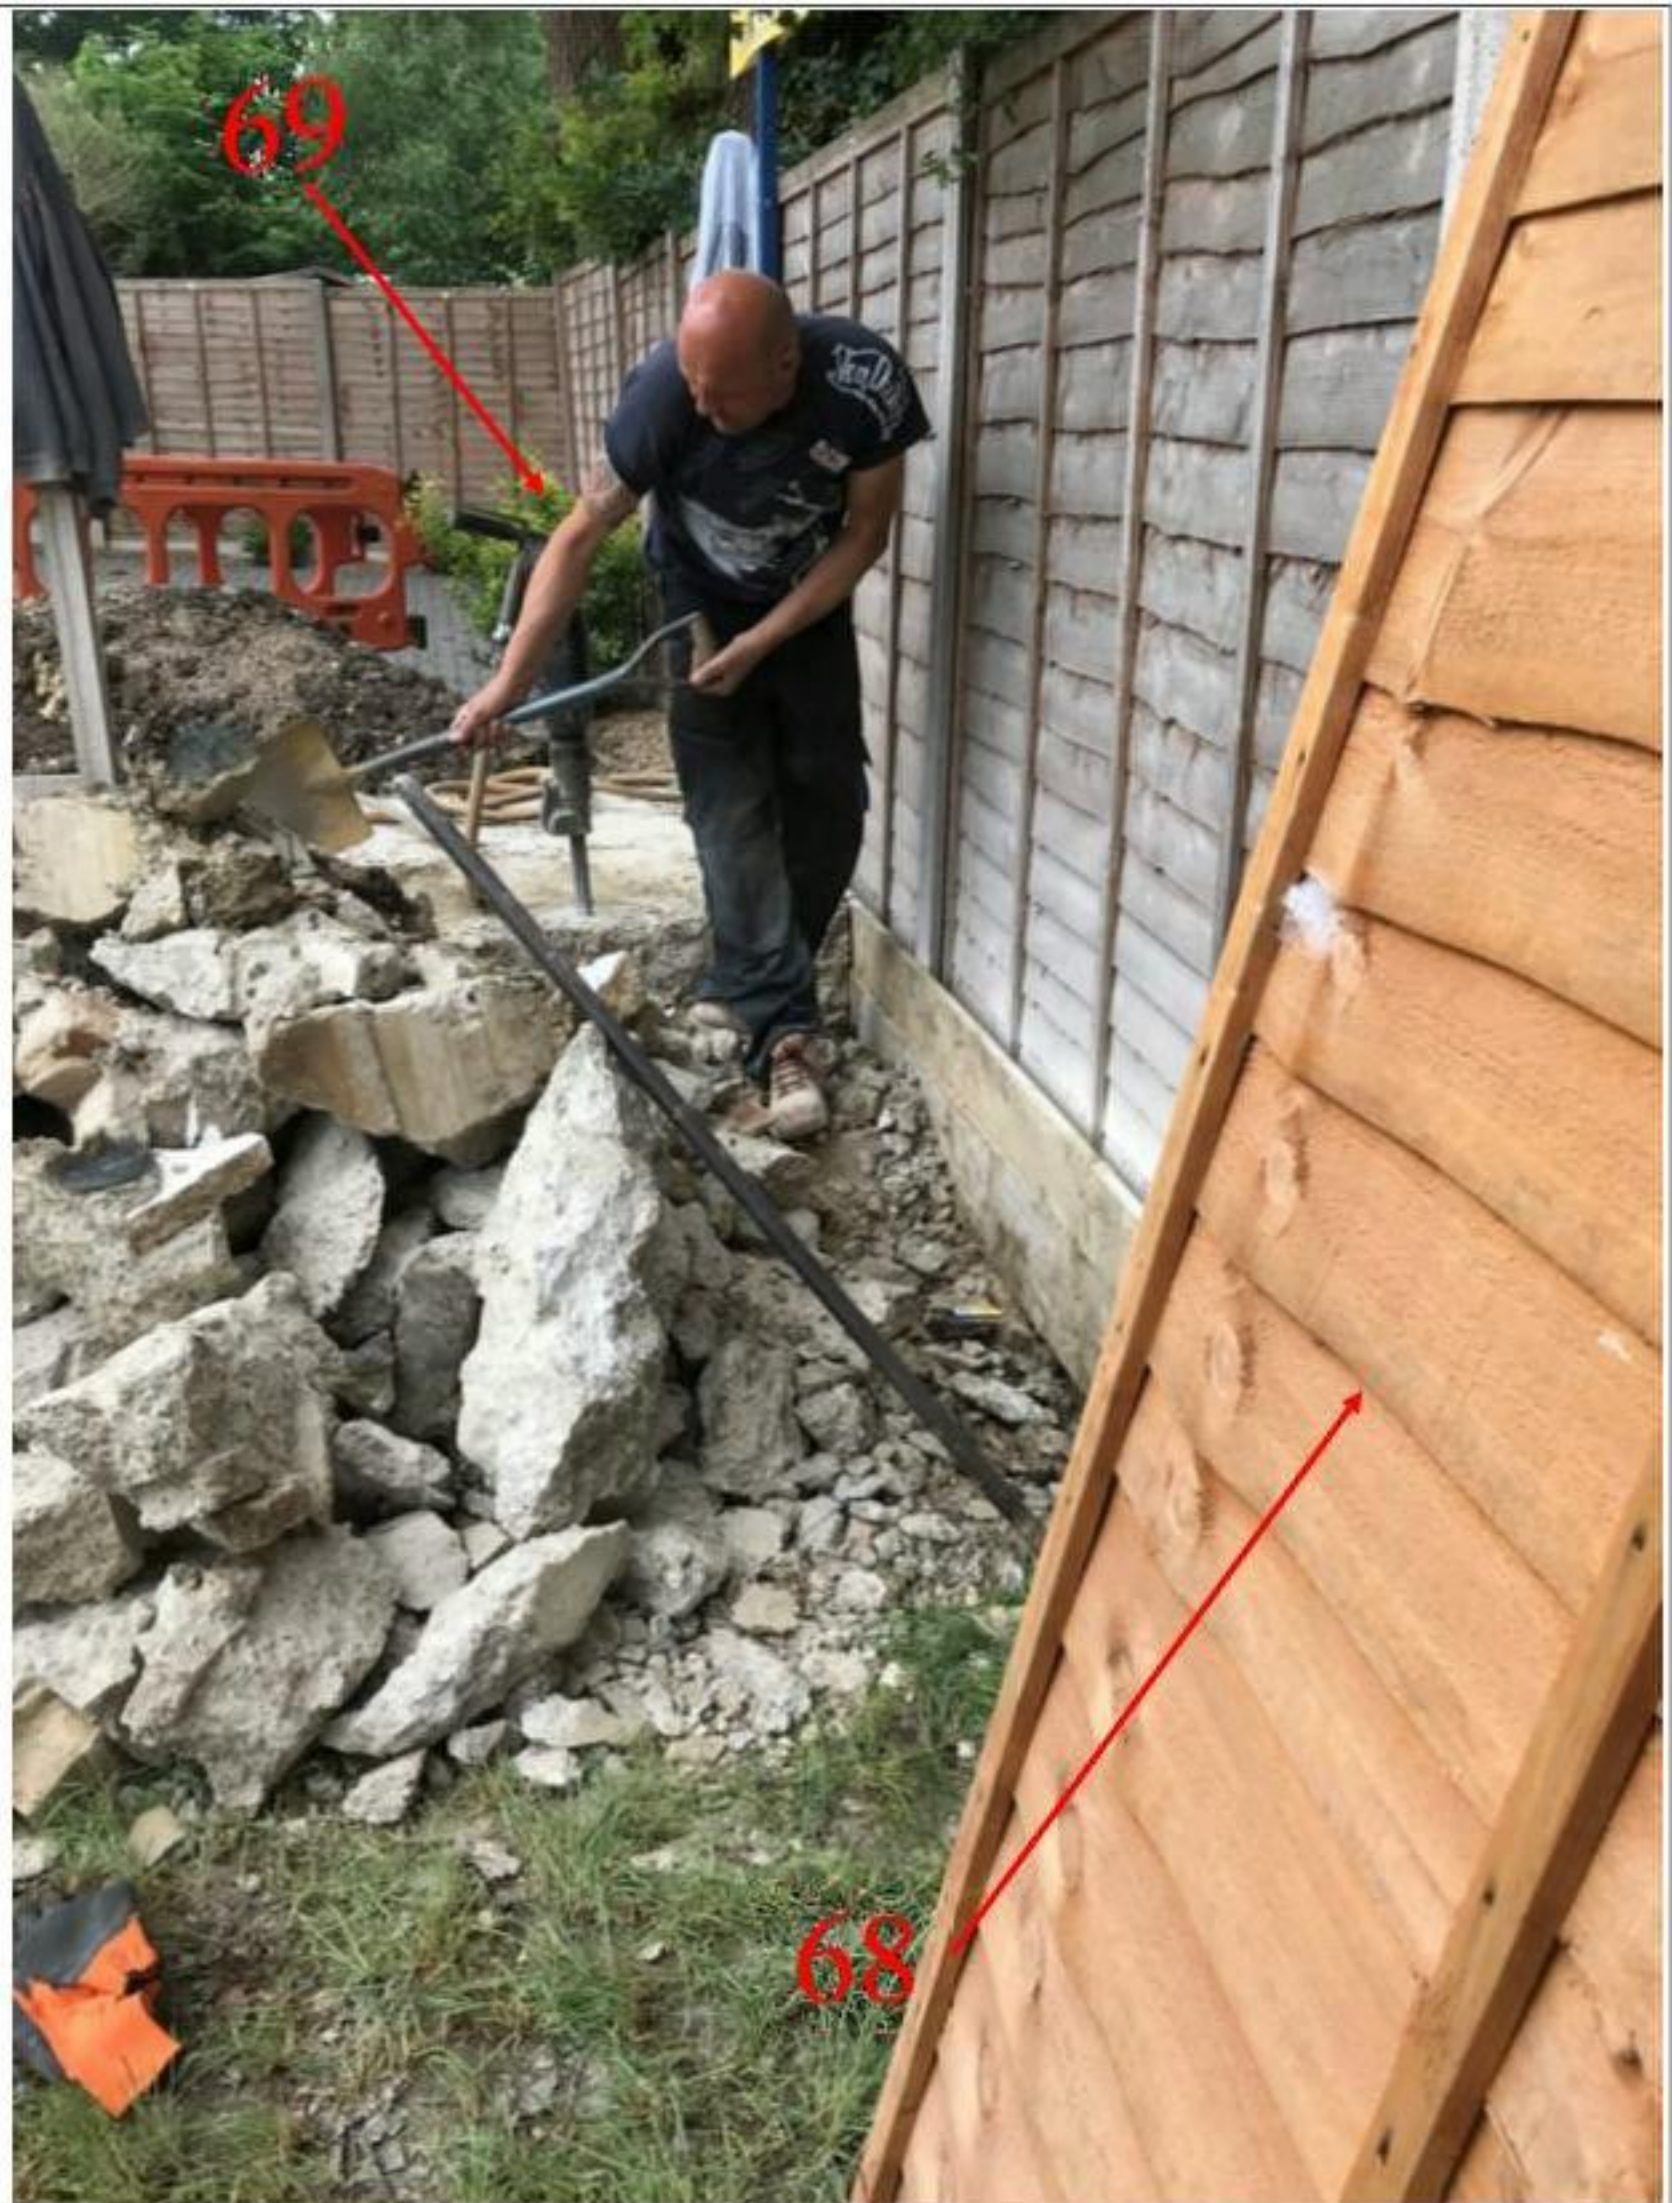
Photo 4: Arisings from the breaking up of the concrete base slab being removed by hand close to boundary fence and trees to investigate potential direct root damage

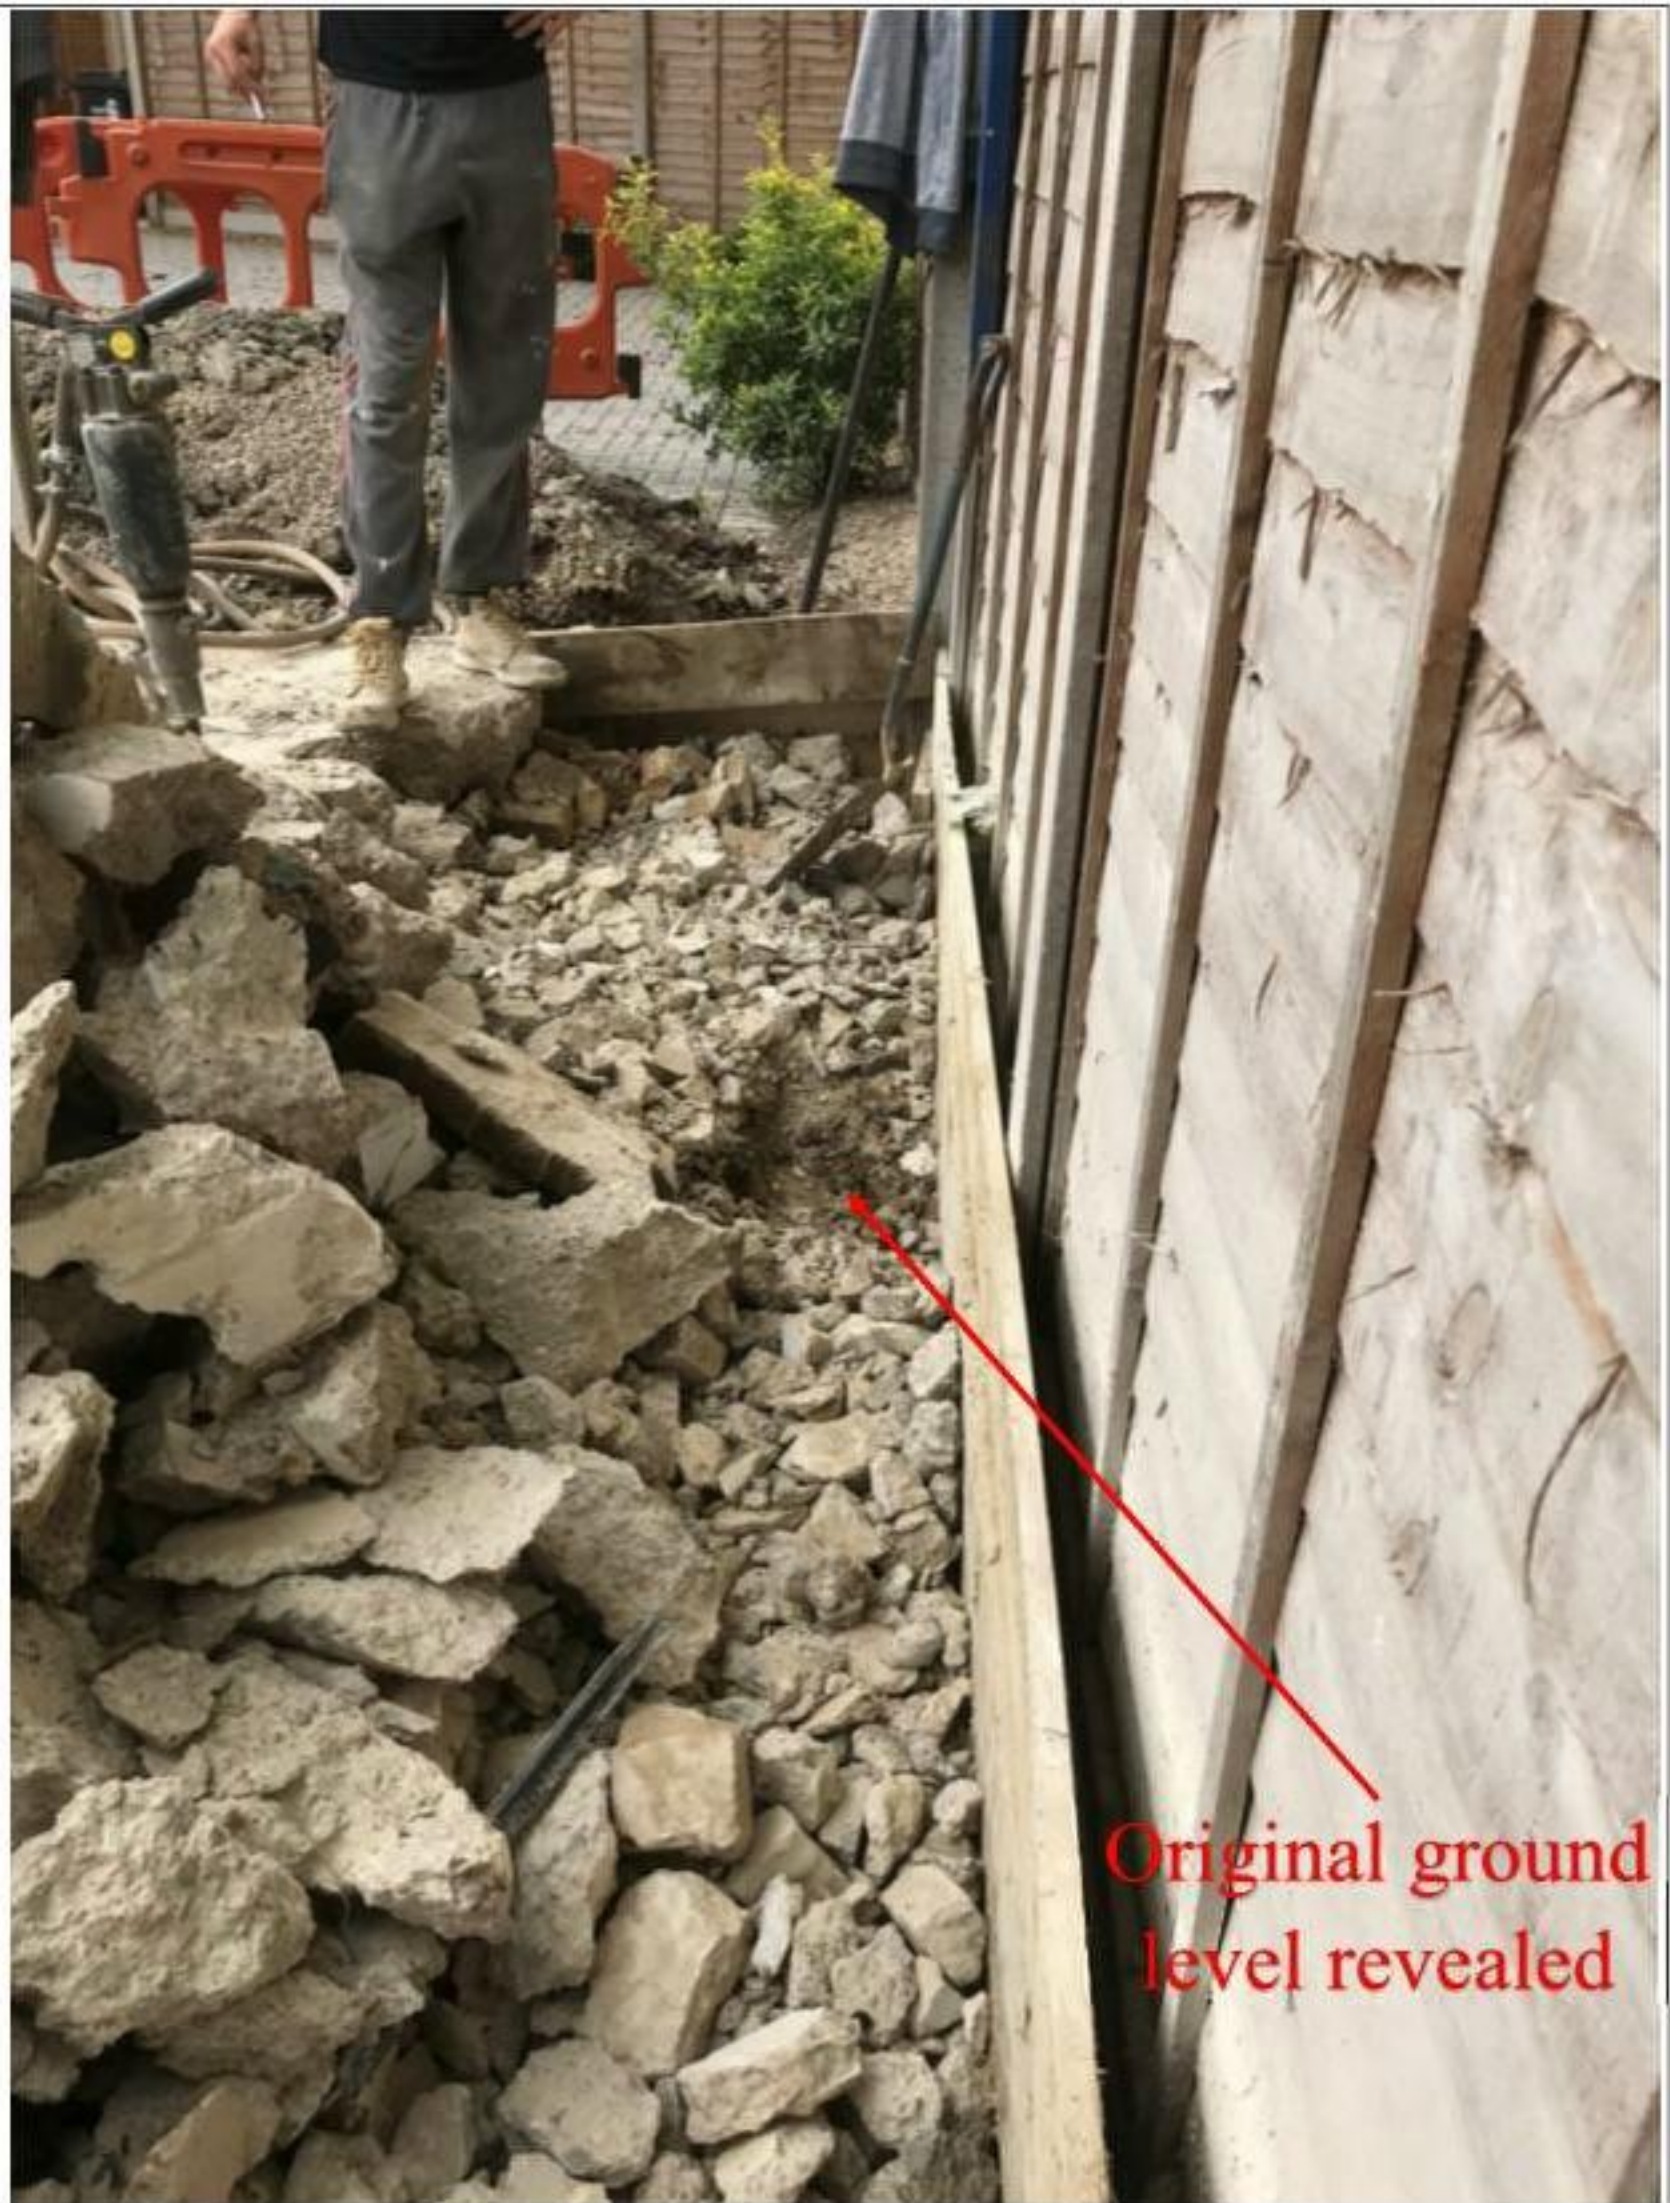
Photo 5: Removal of concrete base slab and arisings close to boundary fence to reveal original ground level
