**TECHNICAL REPORT ON A SUBSIDENCE CLAIM**

[REDACTED]  
**Waterlooville**  
**PO8 8PT**

[REDACTED]  
**SUBSIDENCE CLAIM**

DATE 14 September 2022

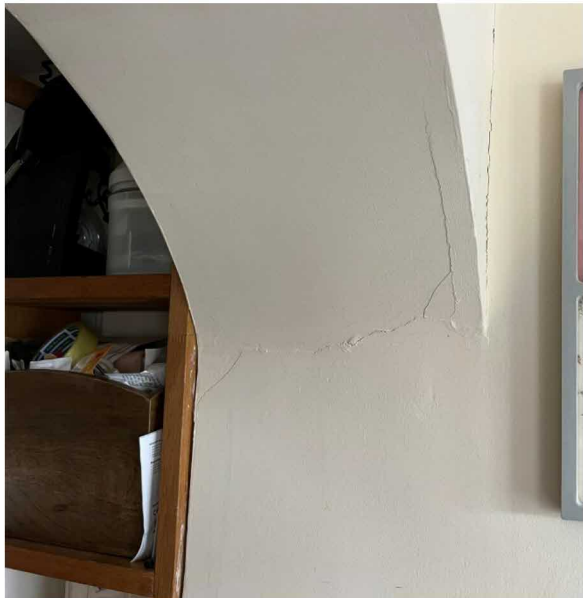
Left junction

Slight vertical crack at left extension junction translating to horizontal crack at base of arch

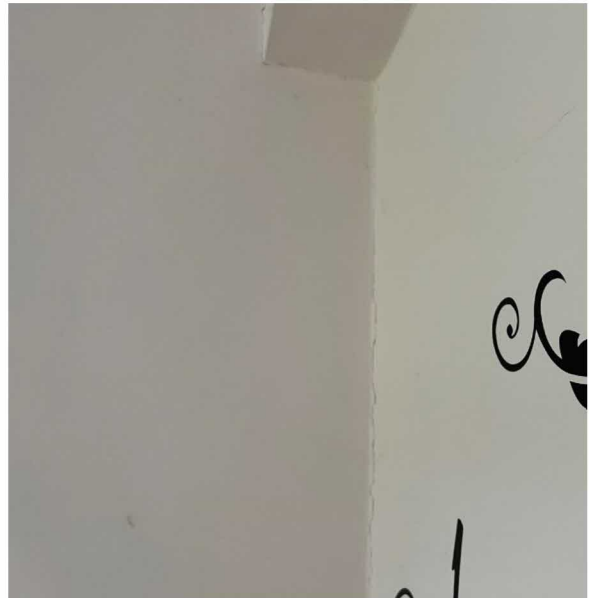
Right junction

Slight vertical crack at right junction

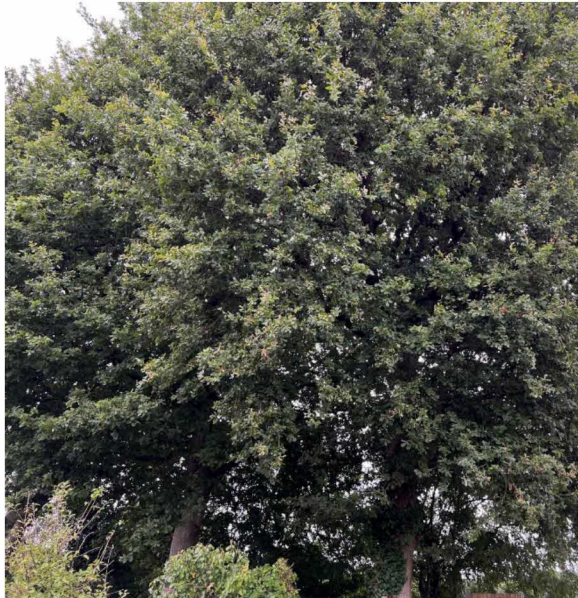
The damage indicates very slight renewed subsidence movement in the same area as the previous claim. The cause will be clay shrinkage exacerbated by moisture extraction by roots from the Oak tree (T1) in the rear garden of No.95 Sutton Road. This was previously reduced to mitigate the subsidence, together with removal of 2 Oaks in the rear garden of 99 Sutton Road. This mitigation had been successful up until this summer, which has been particularly hot and dry. The tree has a full crown and we understand was last reduced around 2019.

Given the minimal damage/movement, we believe a tree management programme (further reduction and then planned regular maintenance) will be sufficient to keep the extension stable and free from further subsidence. However, this will be reviewed by a specialist Arboriculturist. We will also arrange level monitoring to re-start to provide further information for the Arboriculturist to consider when making their recommendations.

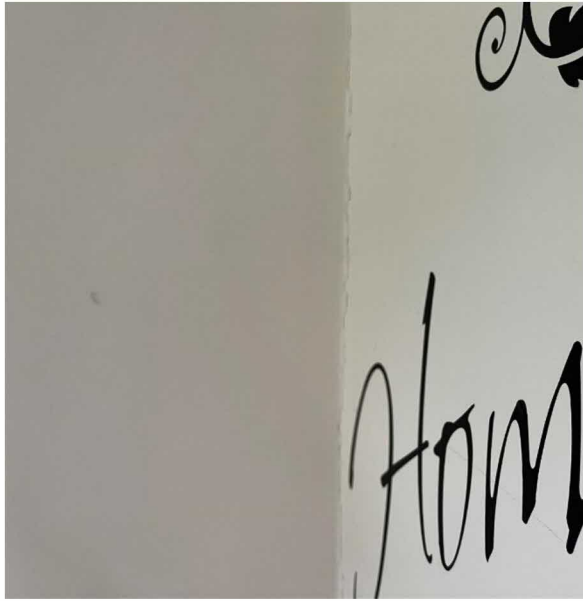
Right junction

Stepped vertical crack at junction

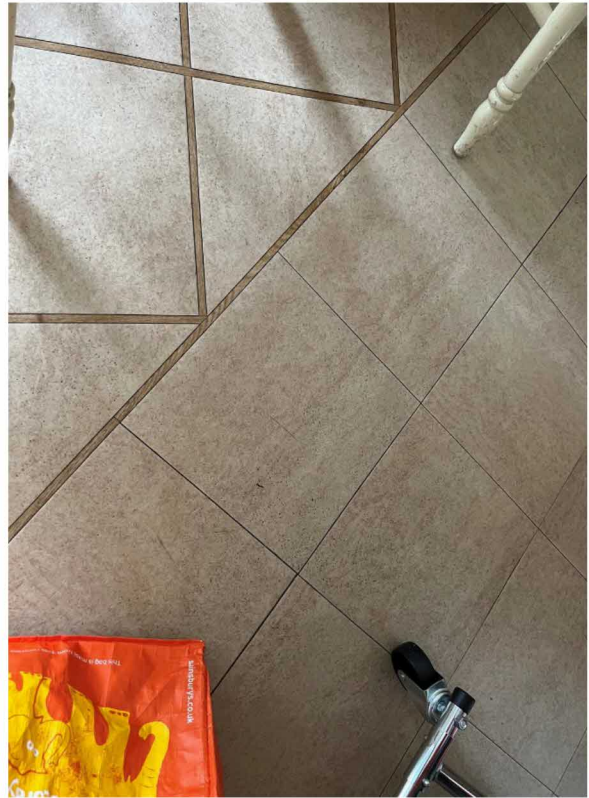
Floor junction

Drop of flooring to the extension causing a slight lip in the flooring at the junction
