Site: No.25-27  
Woodcroft Lane,  
Waterlooville,  
Hampshire, PO8 9QG

Site Visit Date: 11<sup>th</sup> July 2023

Client: Vivid Housing Association

**Prepared by  
Richard Daubeney  
Our Ref 0723-RD  
12th of July 2023**

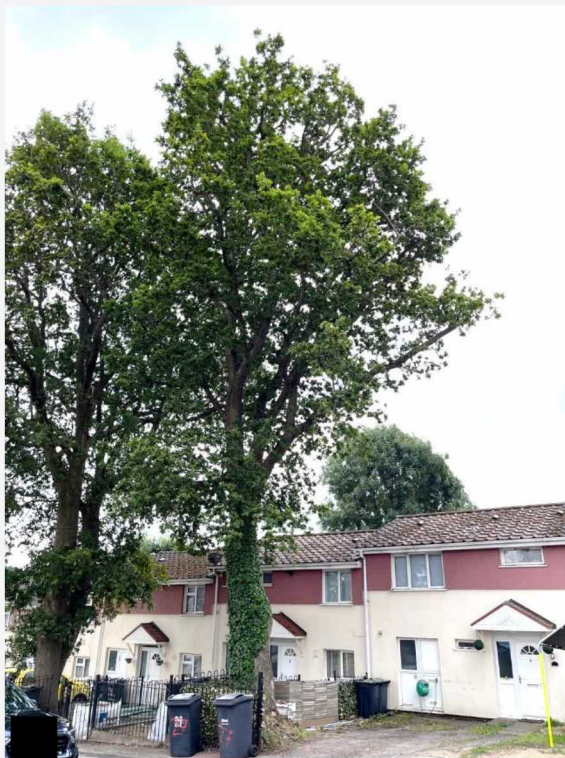
**T1 Looking to South.**

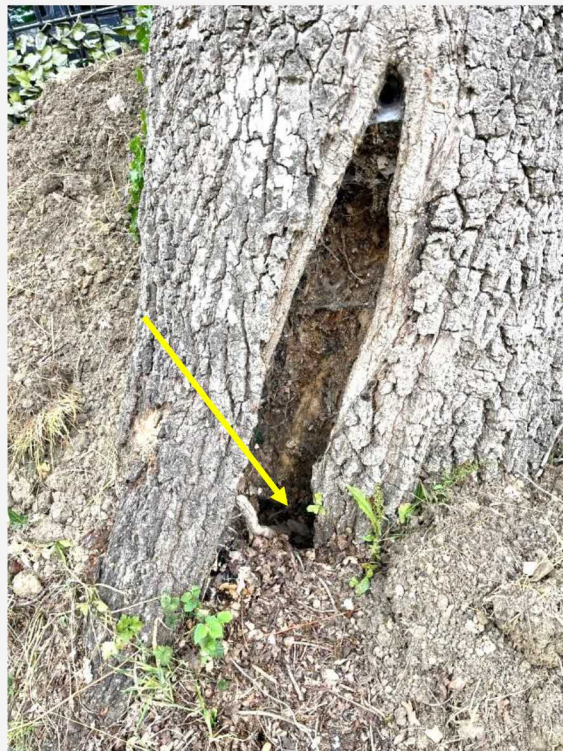
T1 English Oak held gross defect upon resistograph inspection with a T/R ratio of under the industry recommended 30% point. Based on the readings provided it would suggest that the likelihood of failure at test point is significant, even under normal climatic circumstances. It should be noted that T/R ratio does not take into account tree height, and as such does not define the user's preliminary recommendations. The resistograph readings taken suggest a column of decay based to the West and Southwest sides, both in depth and height which coincides with the basal cavity. The remaining live holding wood based to the East side is not sufficient to withstand the weight and pressure of the canopy on the stem.

**T1 Extensive basal cavity to Northwest side.**

Based on the above evidence, a crown reduction of 5-6m all round. The tree will then have a significantly reduced and compact canopy, reducing the risk to the public, public footpath and main road. I also advise the removal of the soil around the base of stem, including the removal of the raised drive to the East of the stem. A further tree inspection is advised within 3 years from the date of this report, to ensure no further change to health or condition.

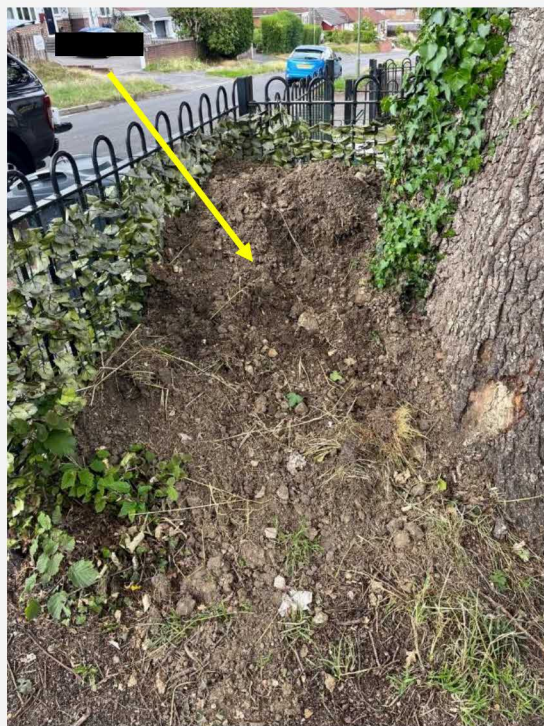
**T1 soil mound against stem.**

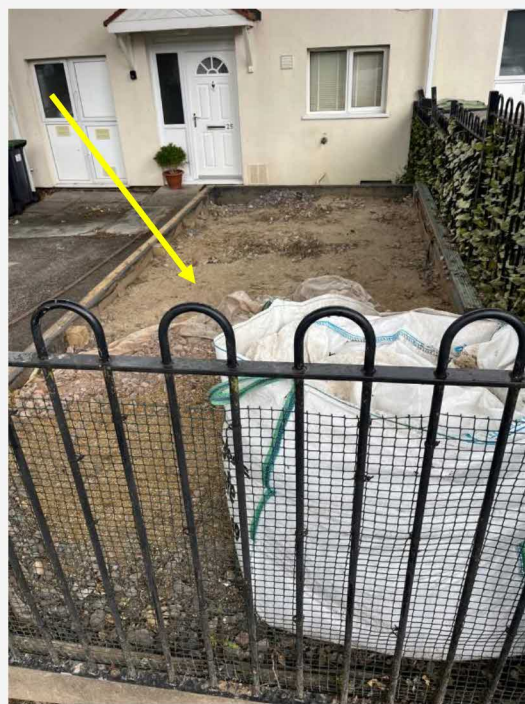
**T1 Looking to the East to loose raised driveway**

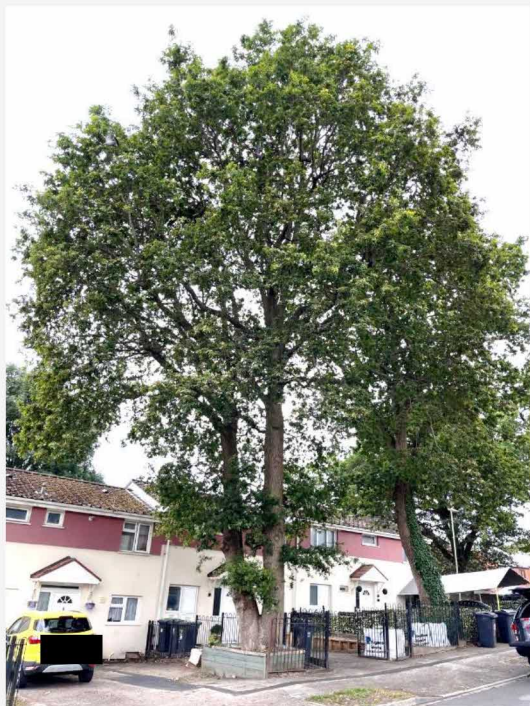
**T2 Looking Southwest**

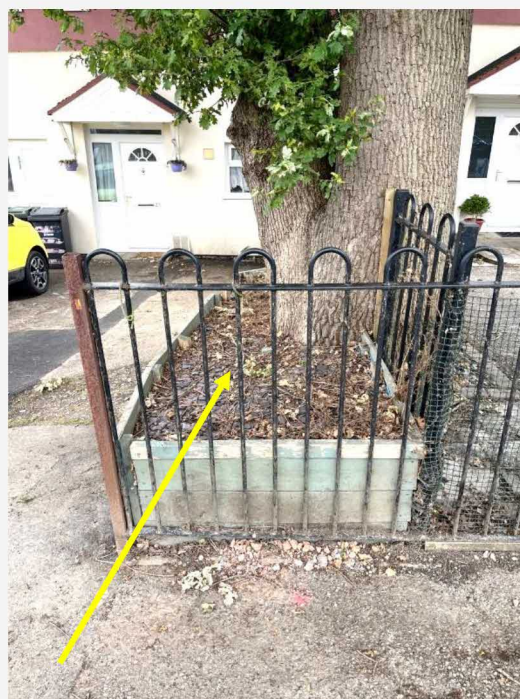
**T2 Raised soil planter against stem.**

The tree is twin stemmed with historic reduction to the crown. Like T1, T2 has also had excavation works carried out to the public footpath within the canopy spread of the tree, with likely chance of root severance linked to T2. Given the above information, it would be therefore advisable to crown reduce by 3m all round. The tree can then be retained at a lower height with a reduced risk to the public, public footpath and main road. I would recommend a further inspection 3 years from the date of this report to ensure there are no further changes to the tree's health and condition.

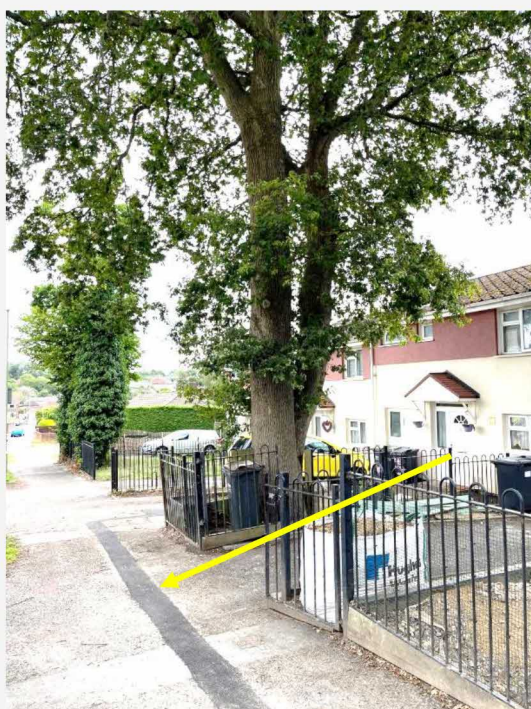
**T2 Looking East note the footpath excavation.**

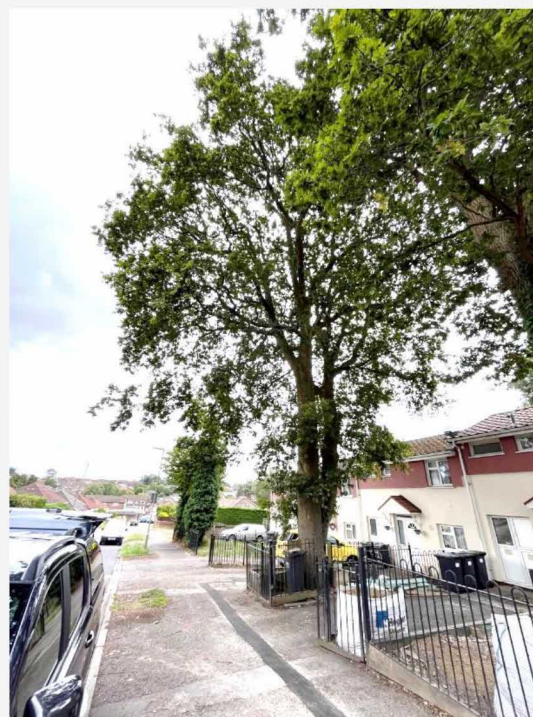
**T2 looking East.**
