DESK STUDY REPORT  
FOR THE SITE OF:

Hayling Billy Public House  
117 Elm Grove  
Hayling Island  
Hampshire  
PO11 9ED

**REPORT NO:** 15-67729

**DATE:** 08 January 2016

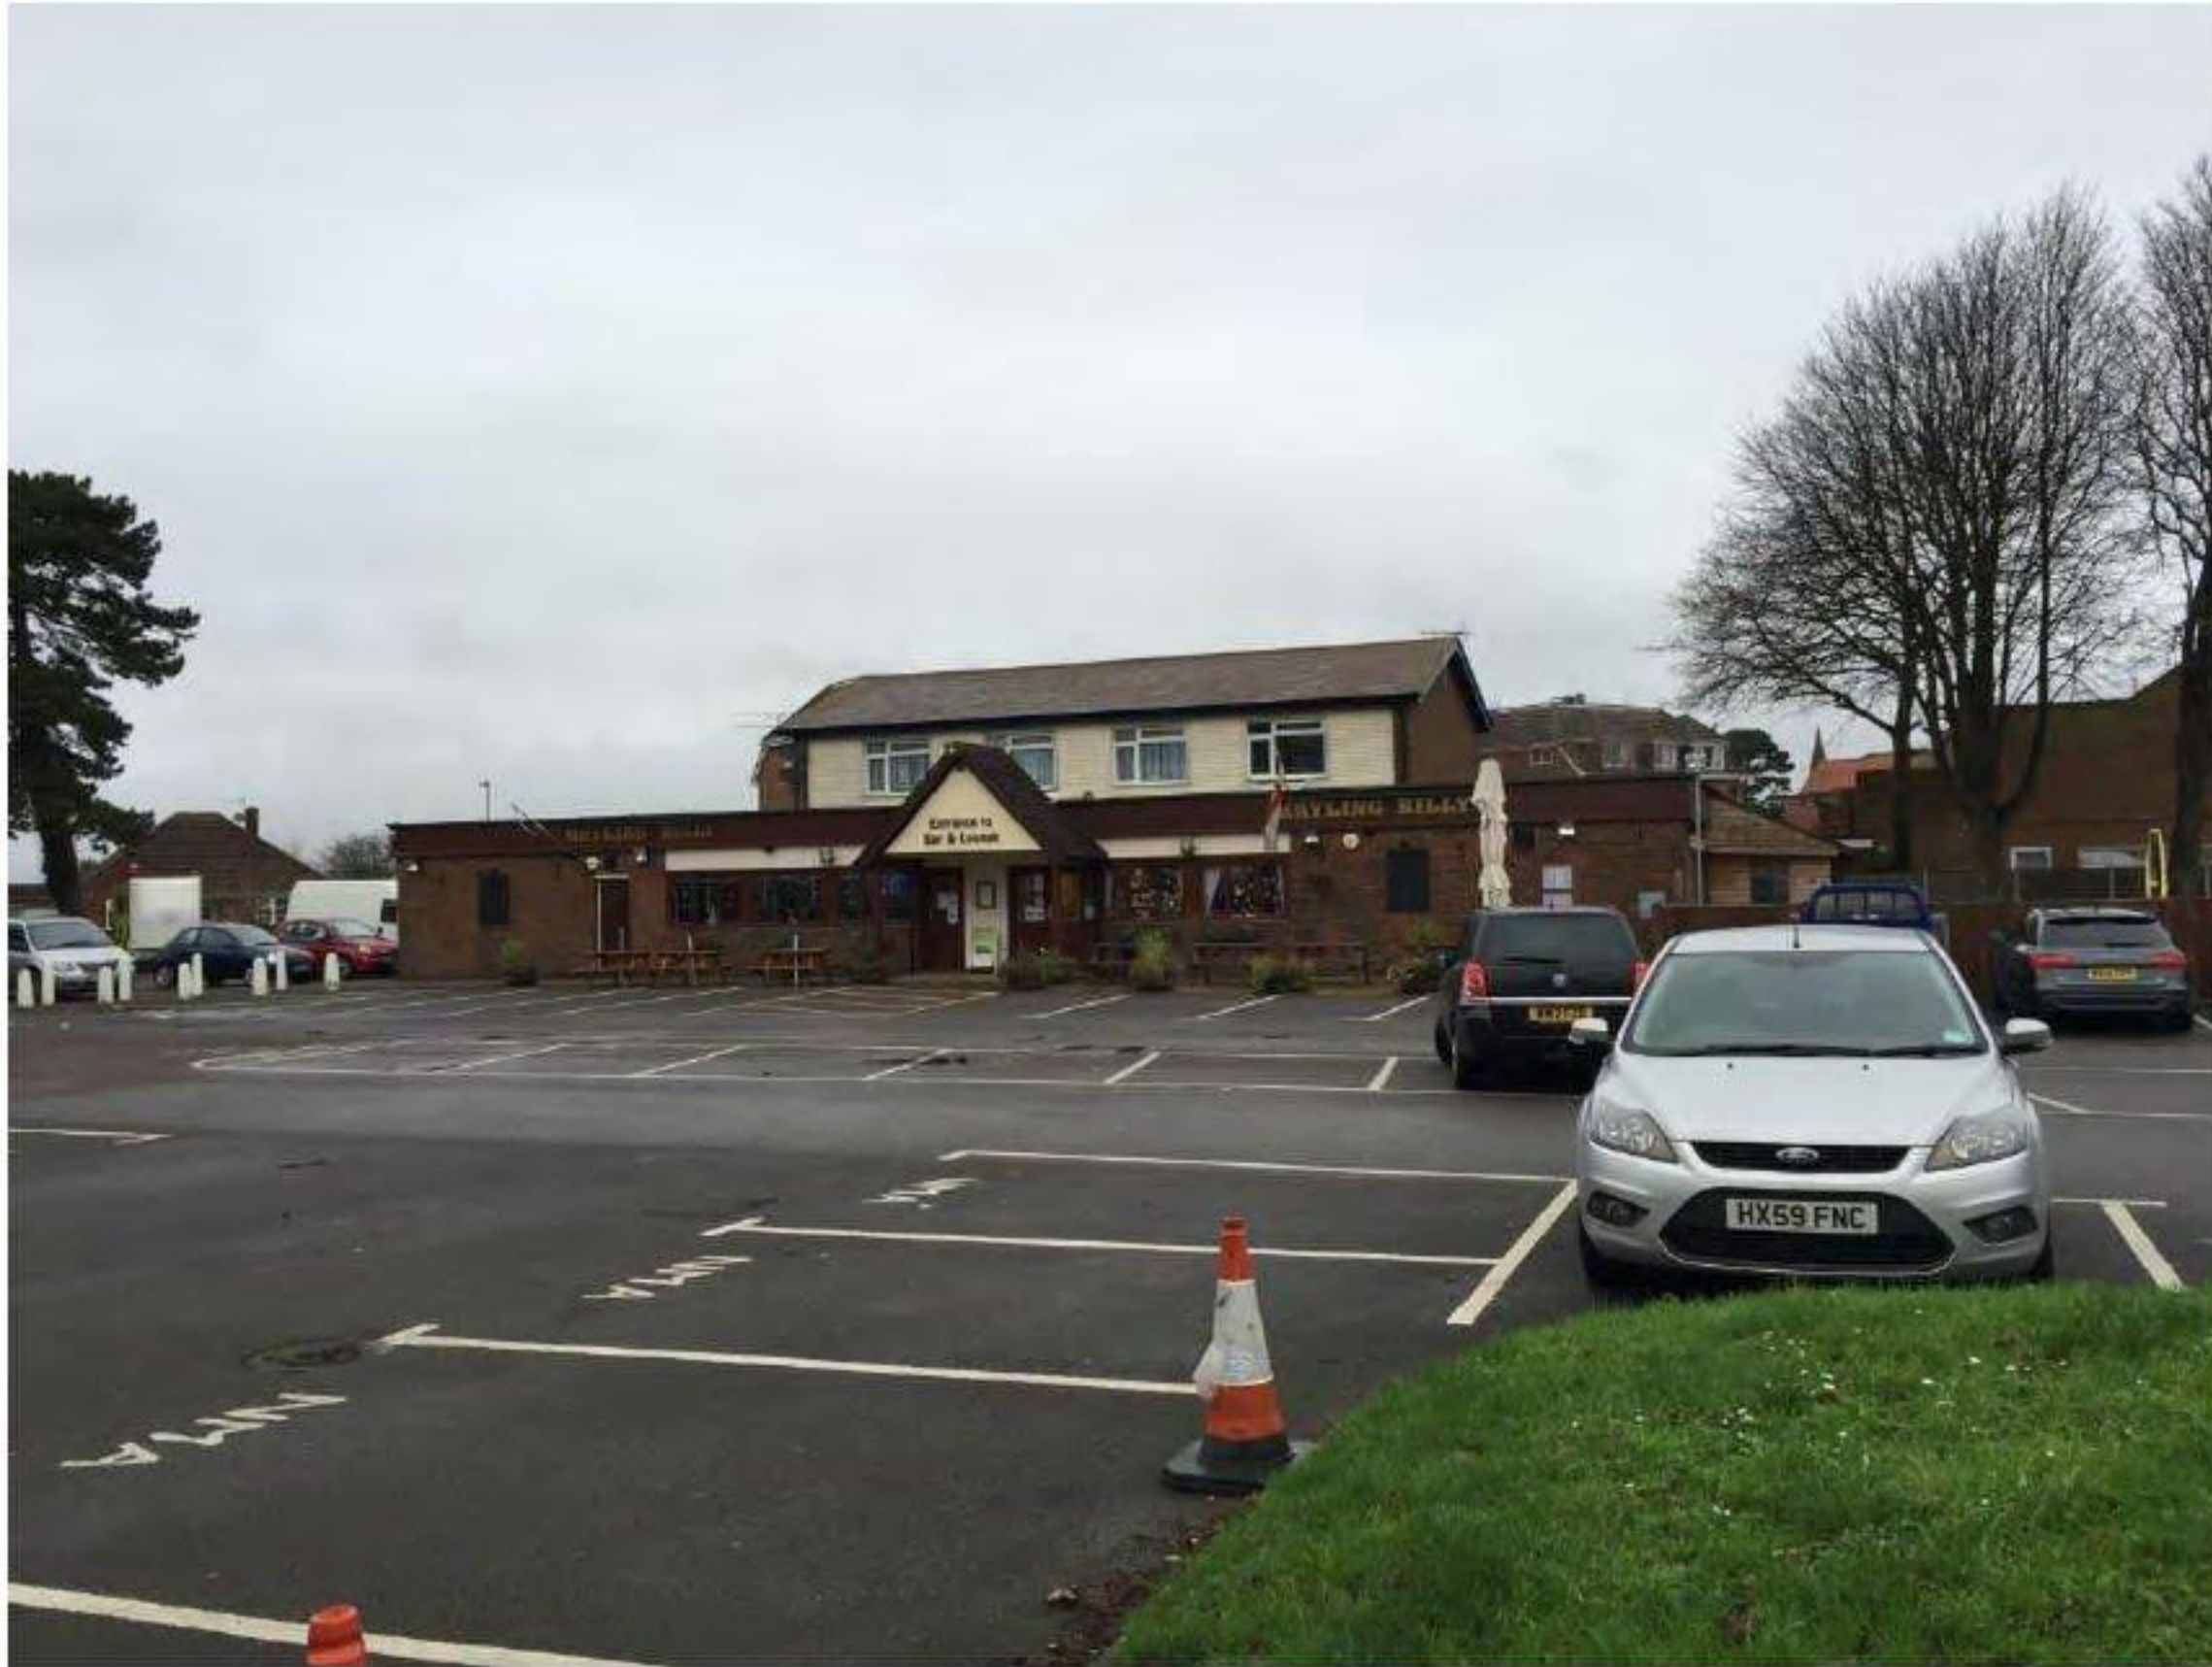
Plate 1: View of the site north from the southern boundary

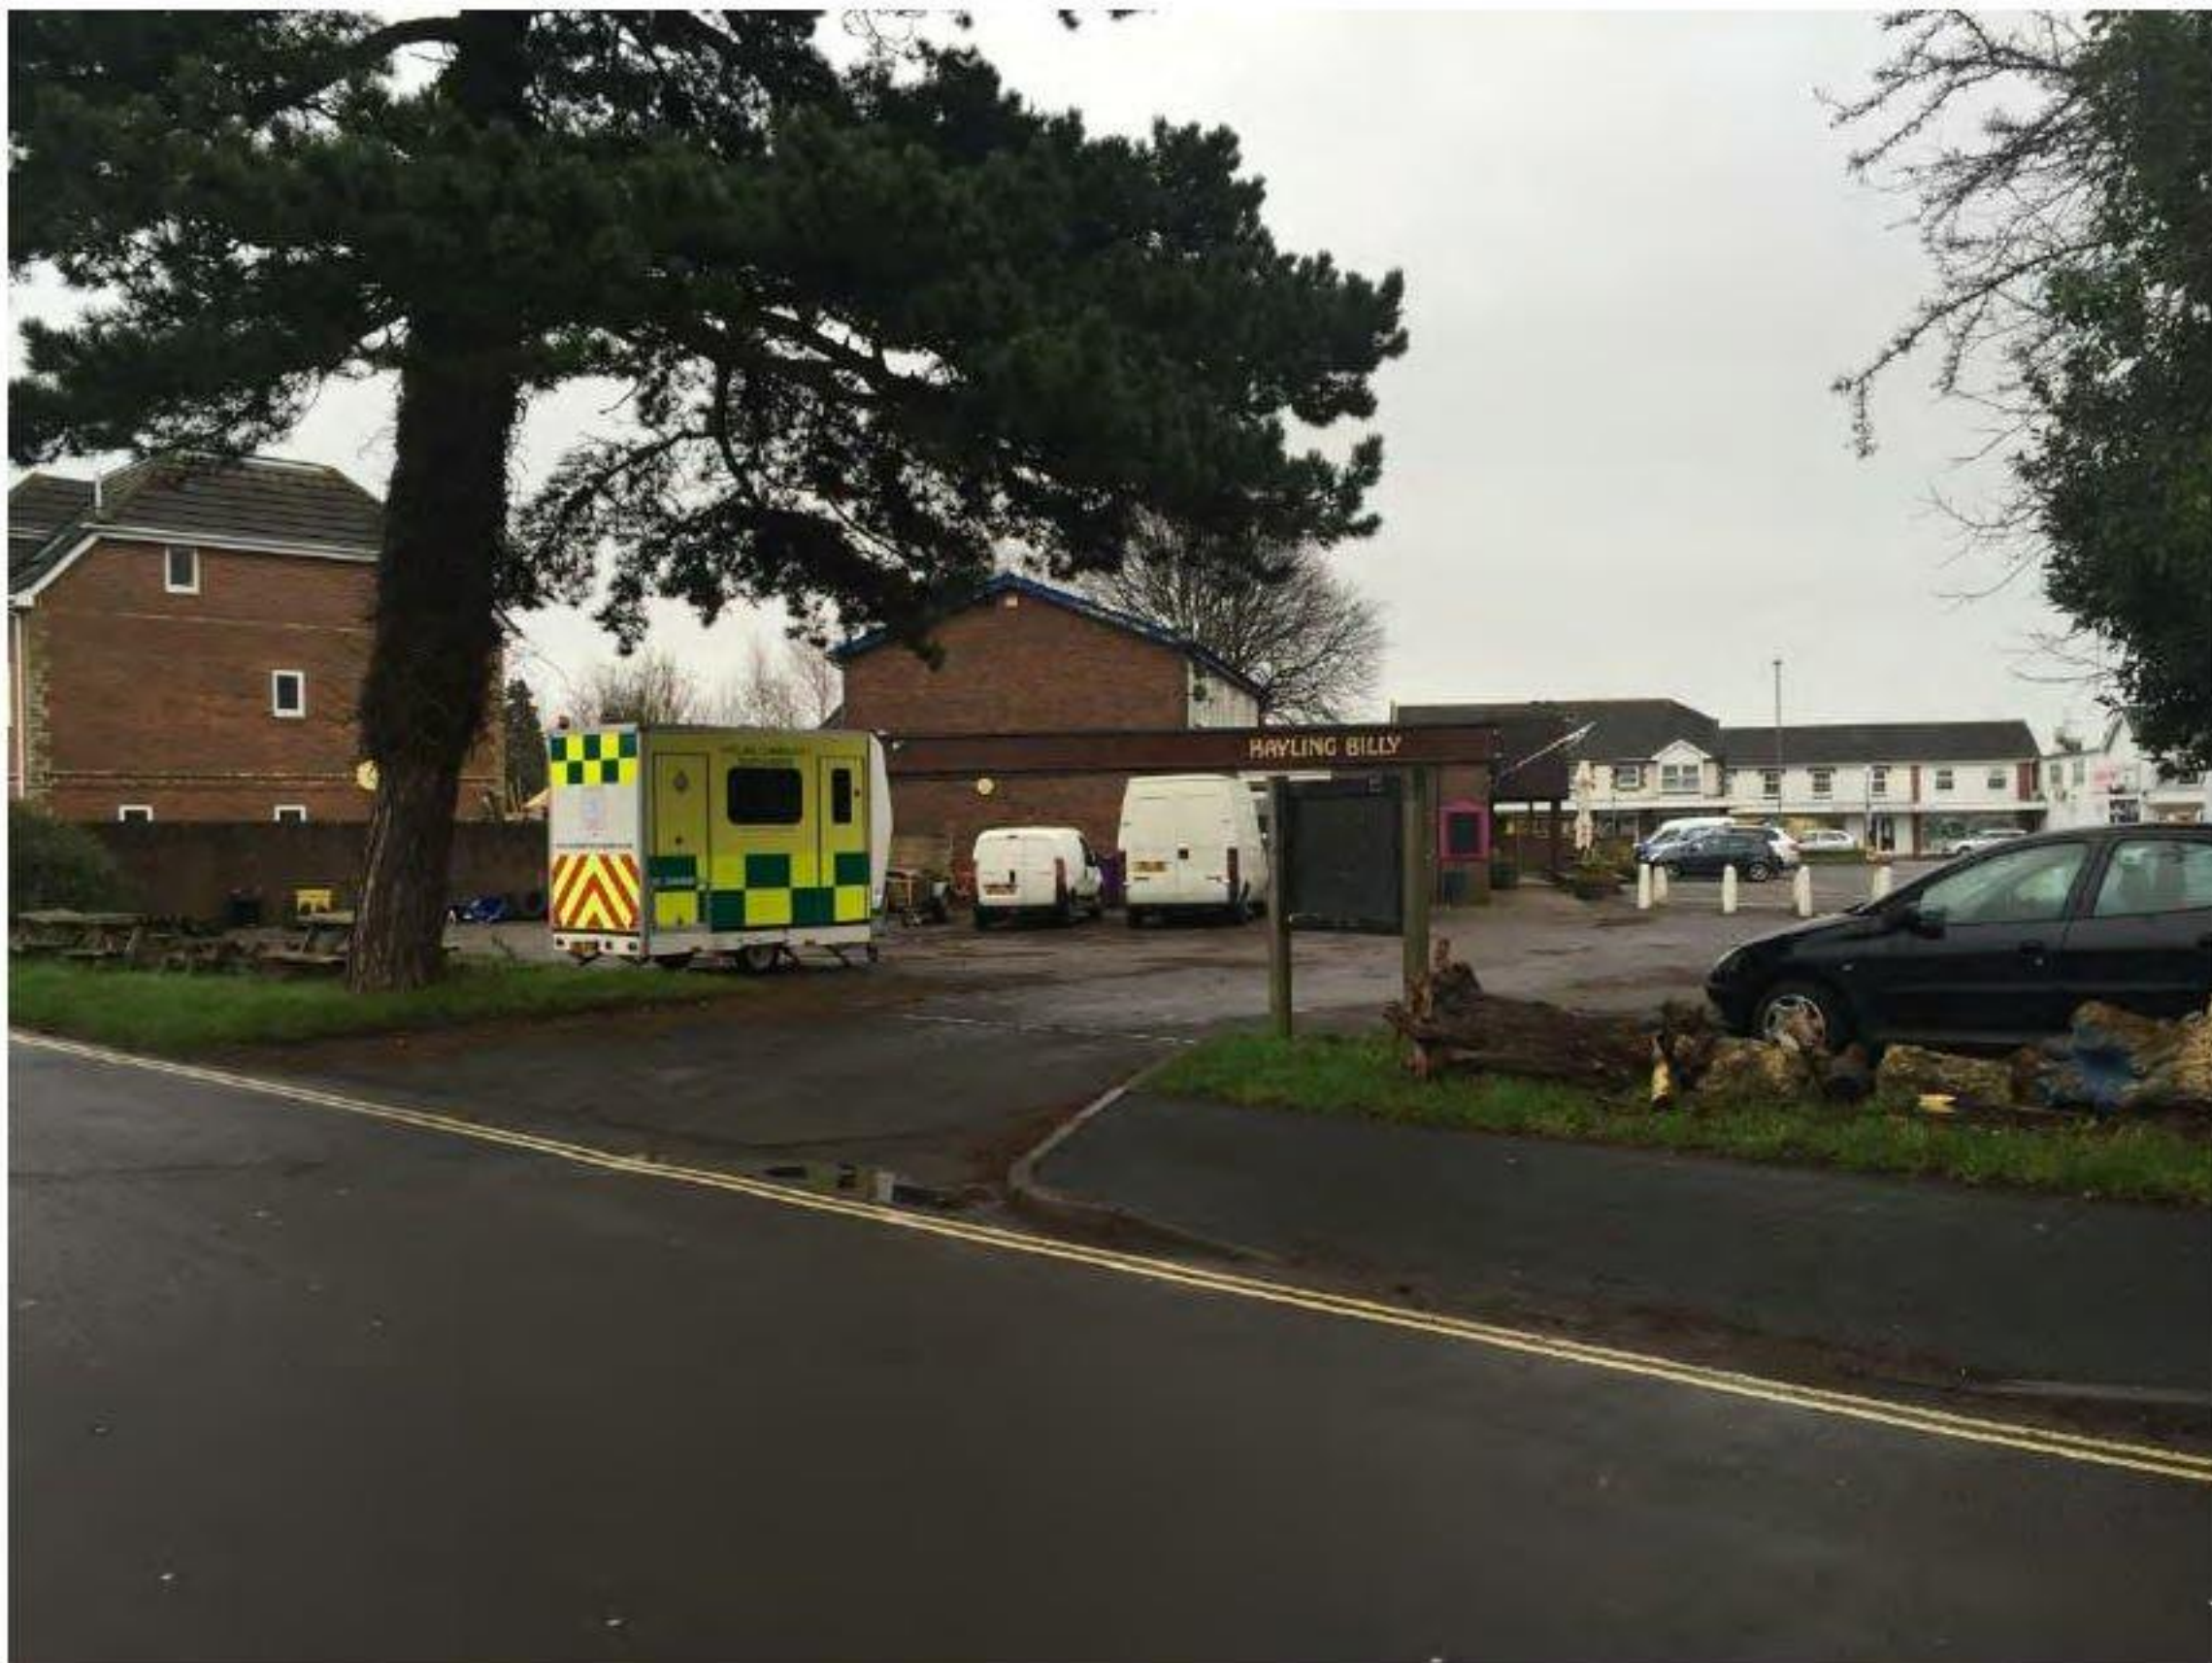
Plate 2: View of the site from St Mary's Road to the west

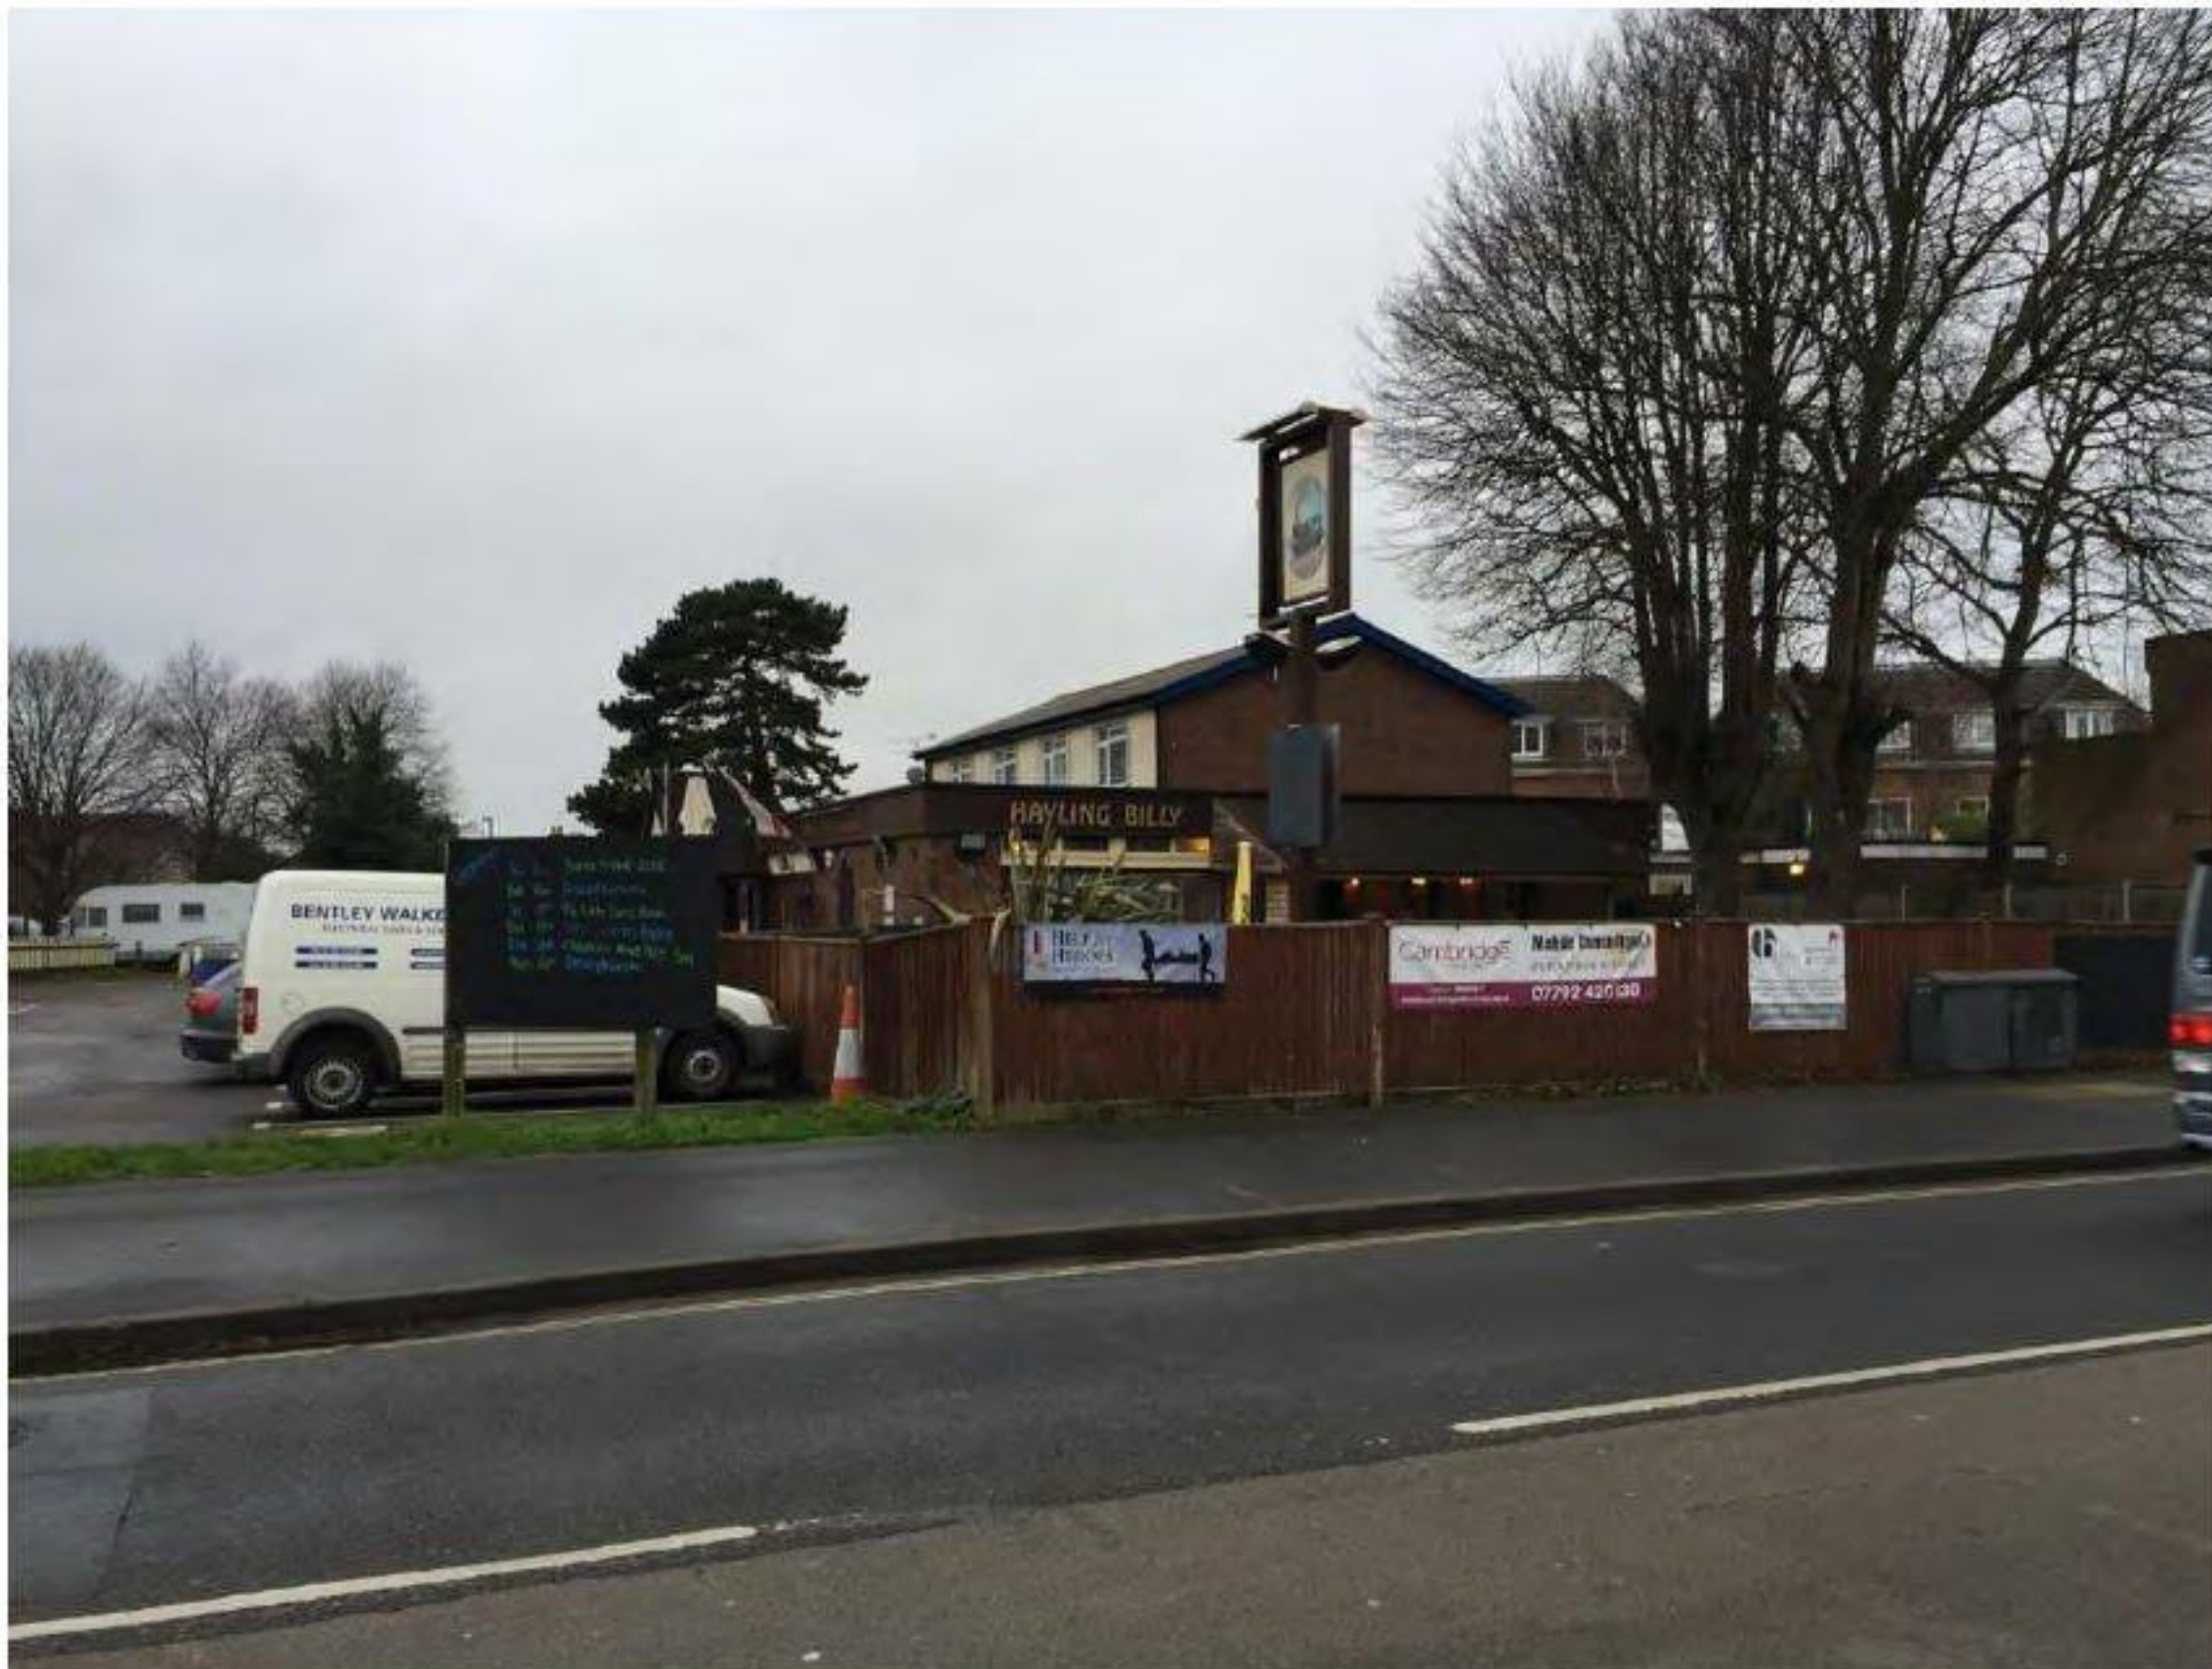
Plate 3: View of the site from Elm Grove to the east

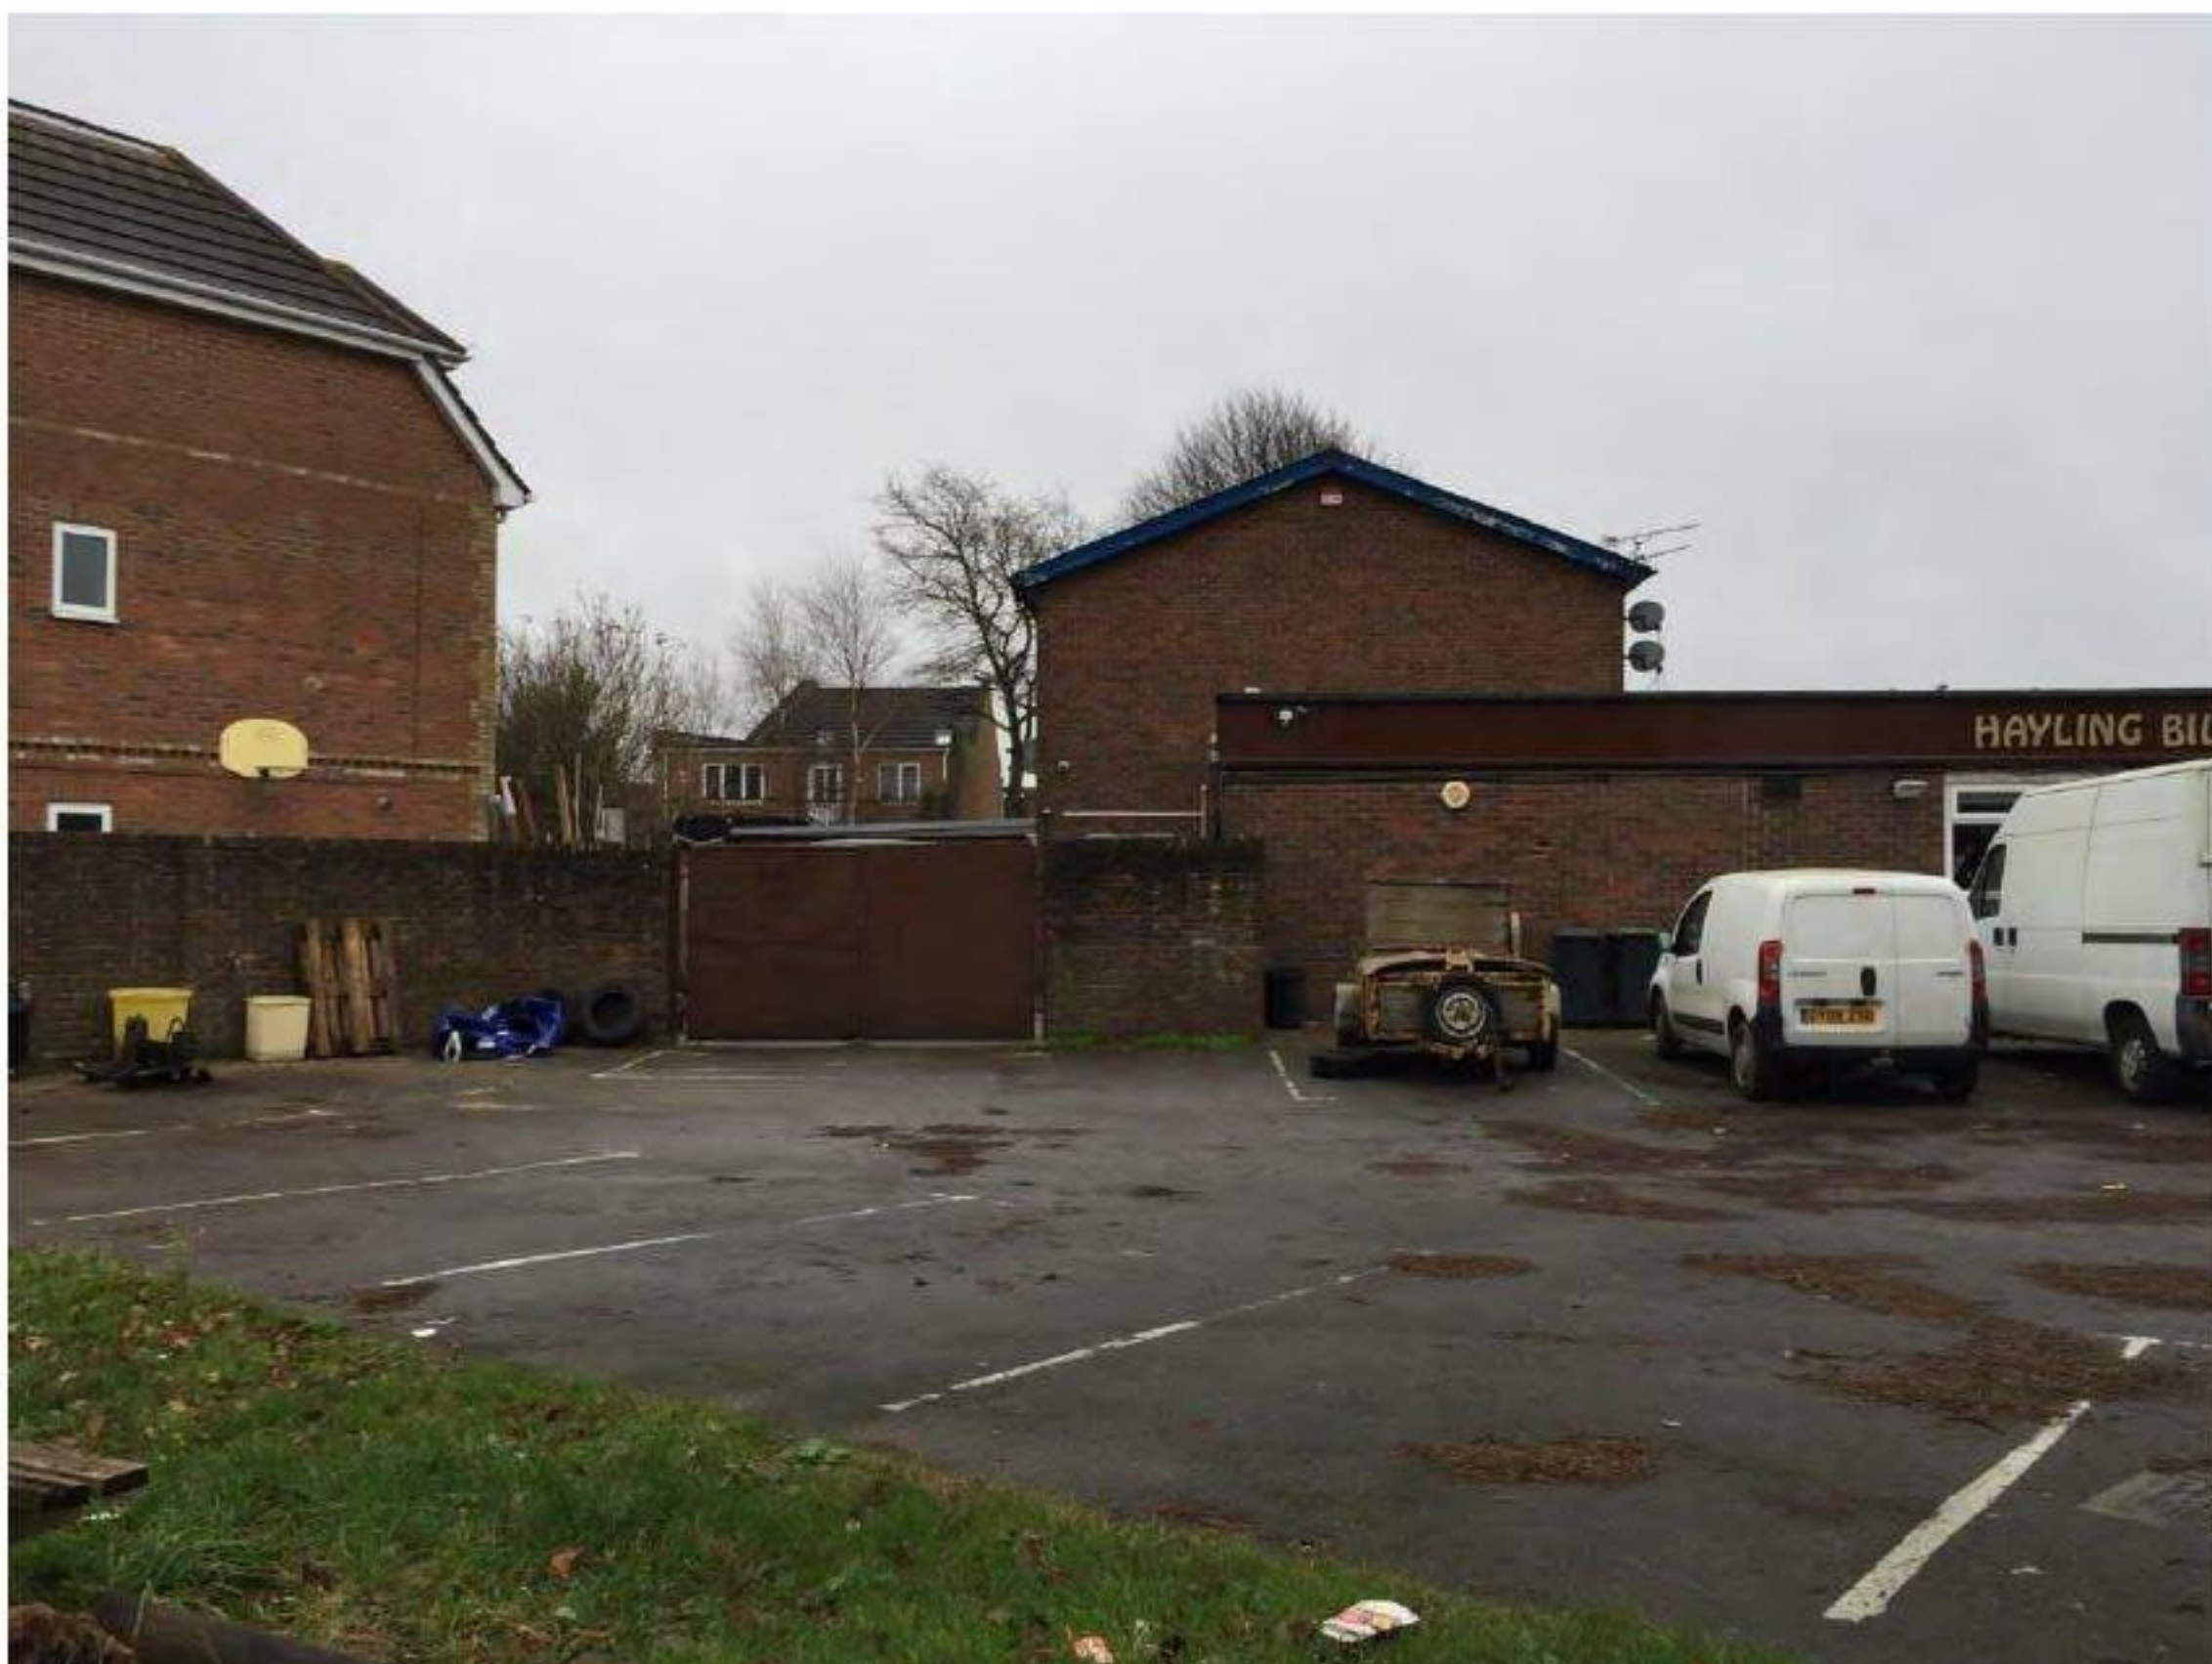
Plate 4: An area of car parking on macadam surfacing in the west of the site

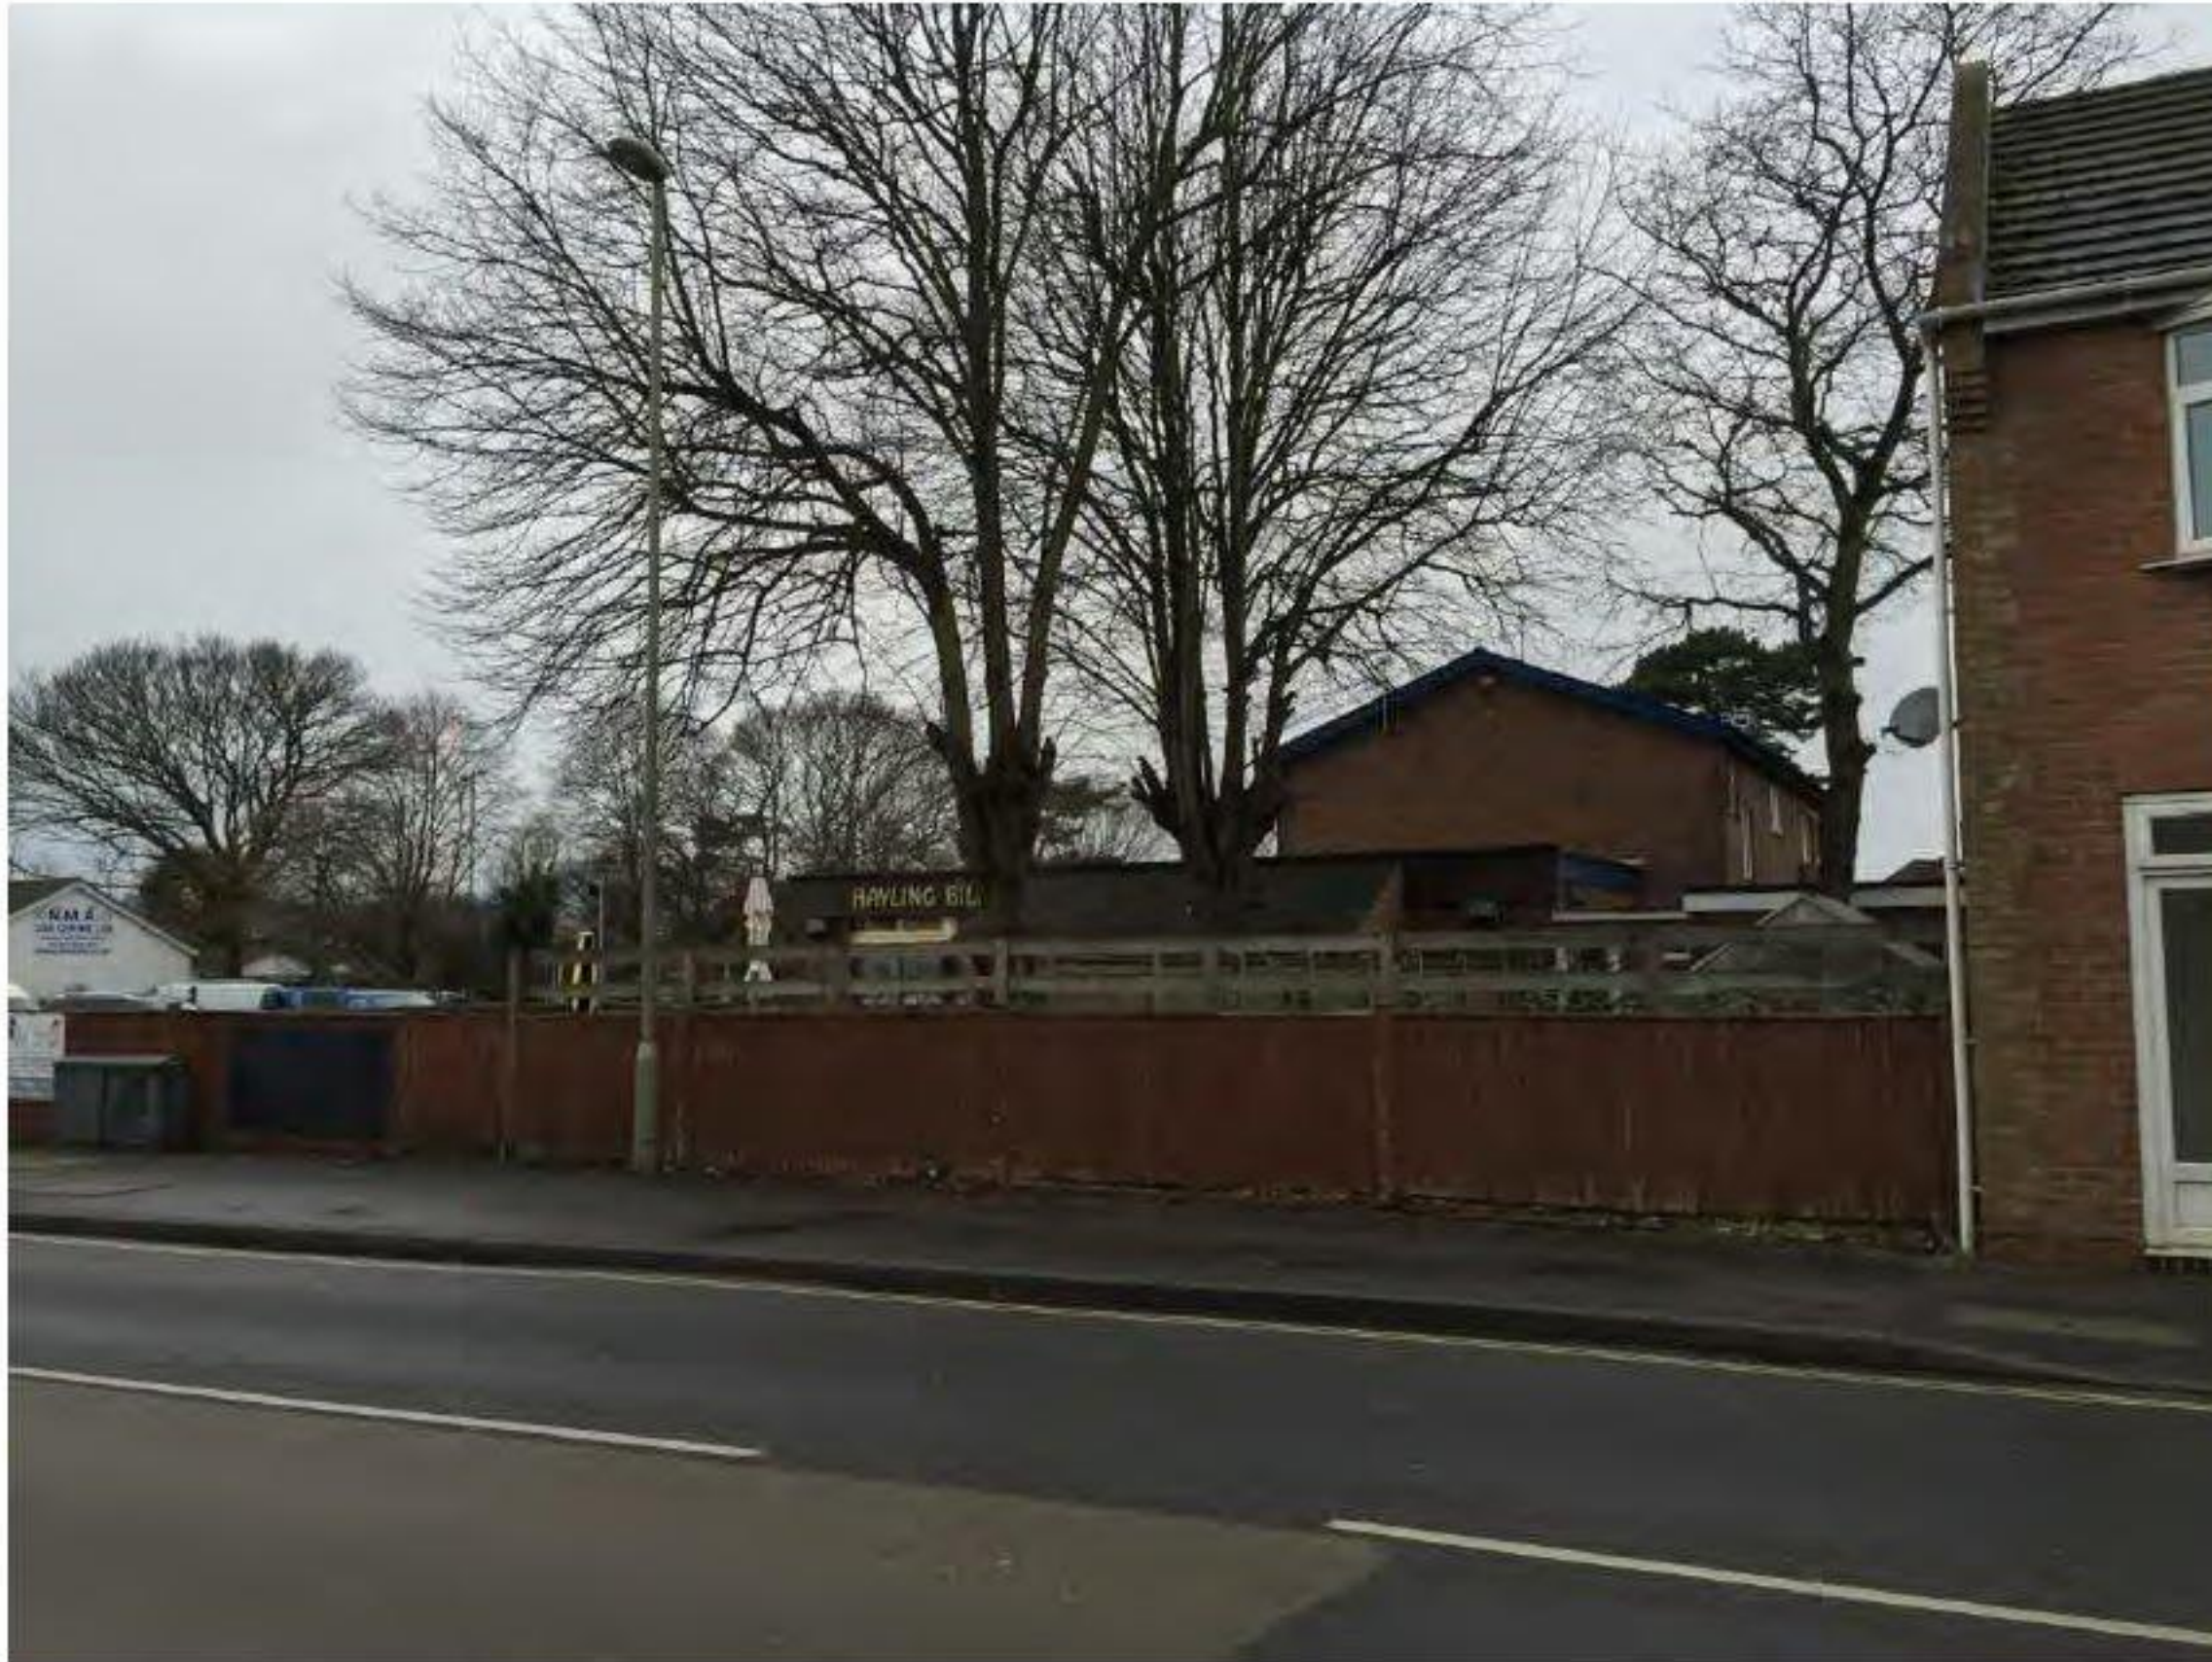
Plate 5. Three trees in the north-west of the site believed to have Tree Protection Orders

- 9.4.1 It is recommended that the status of the trees on site is established as soon as possible as if the Tree Protection Orders are confirmed on site this may represent a constraint to redevelopment. There may be restrictions to the excavation of foundations in close proximity to some of the mature trees.

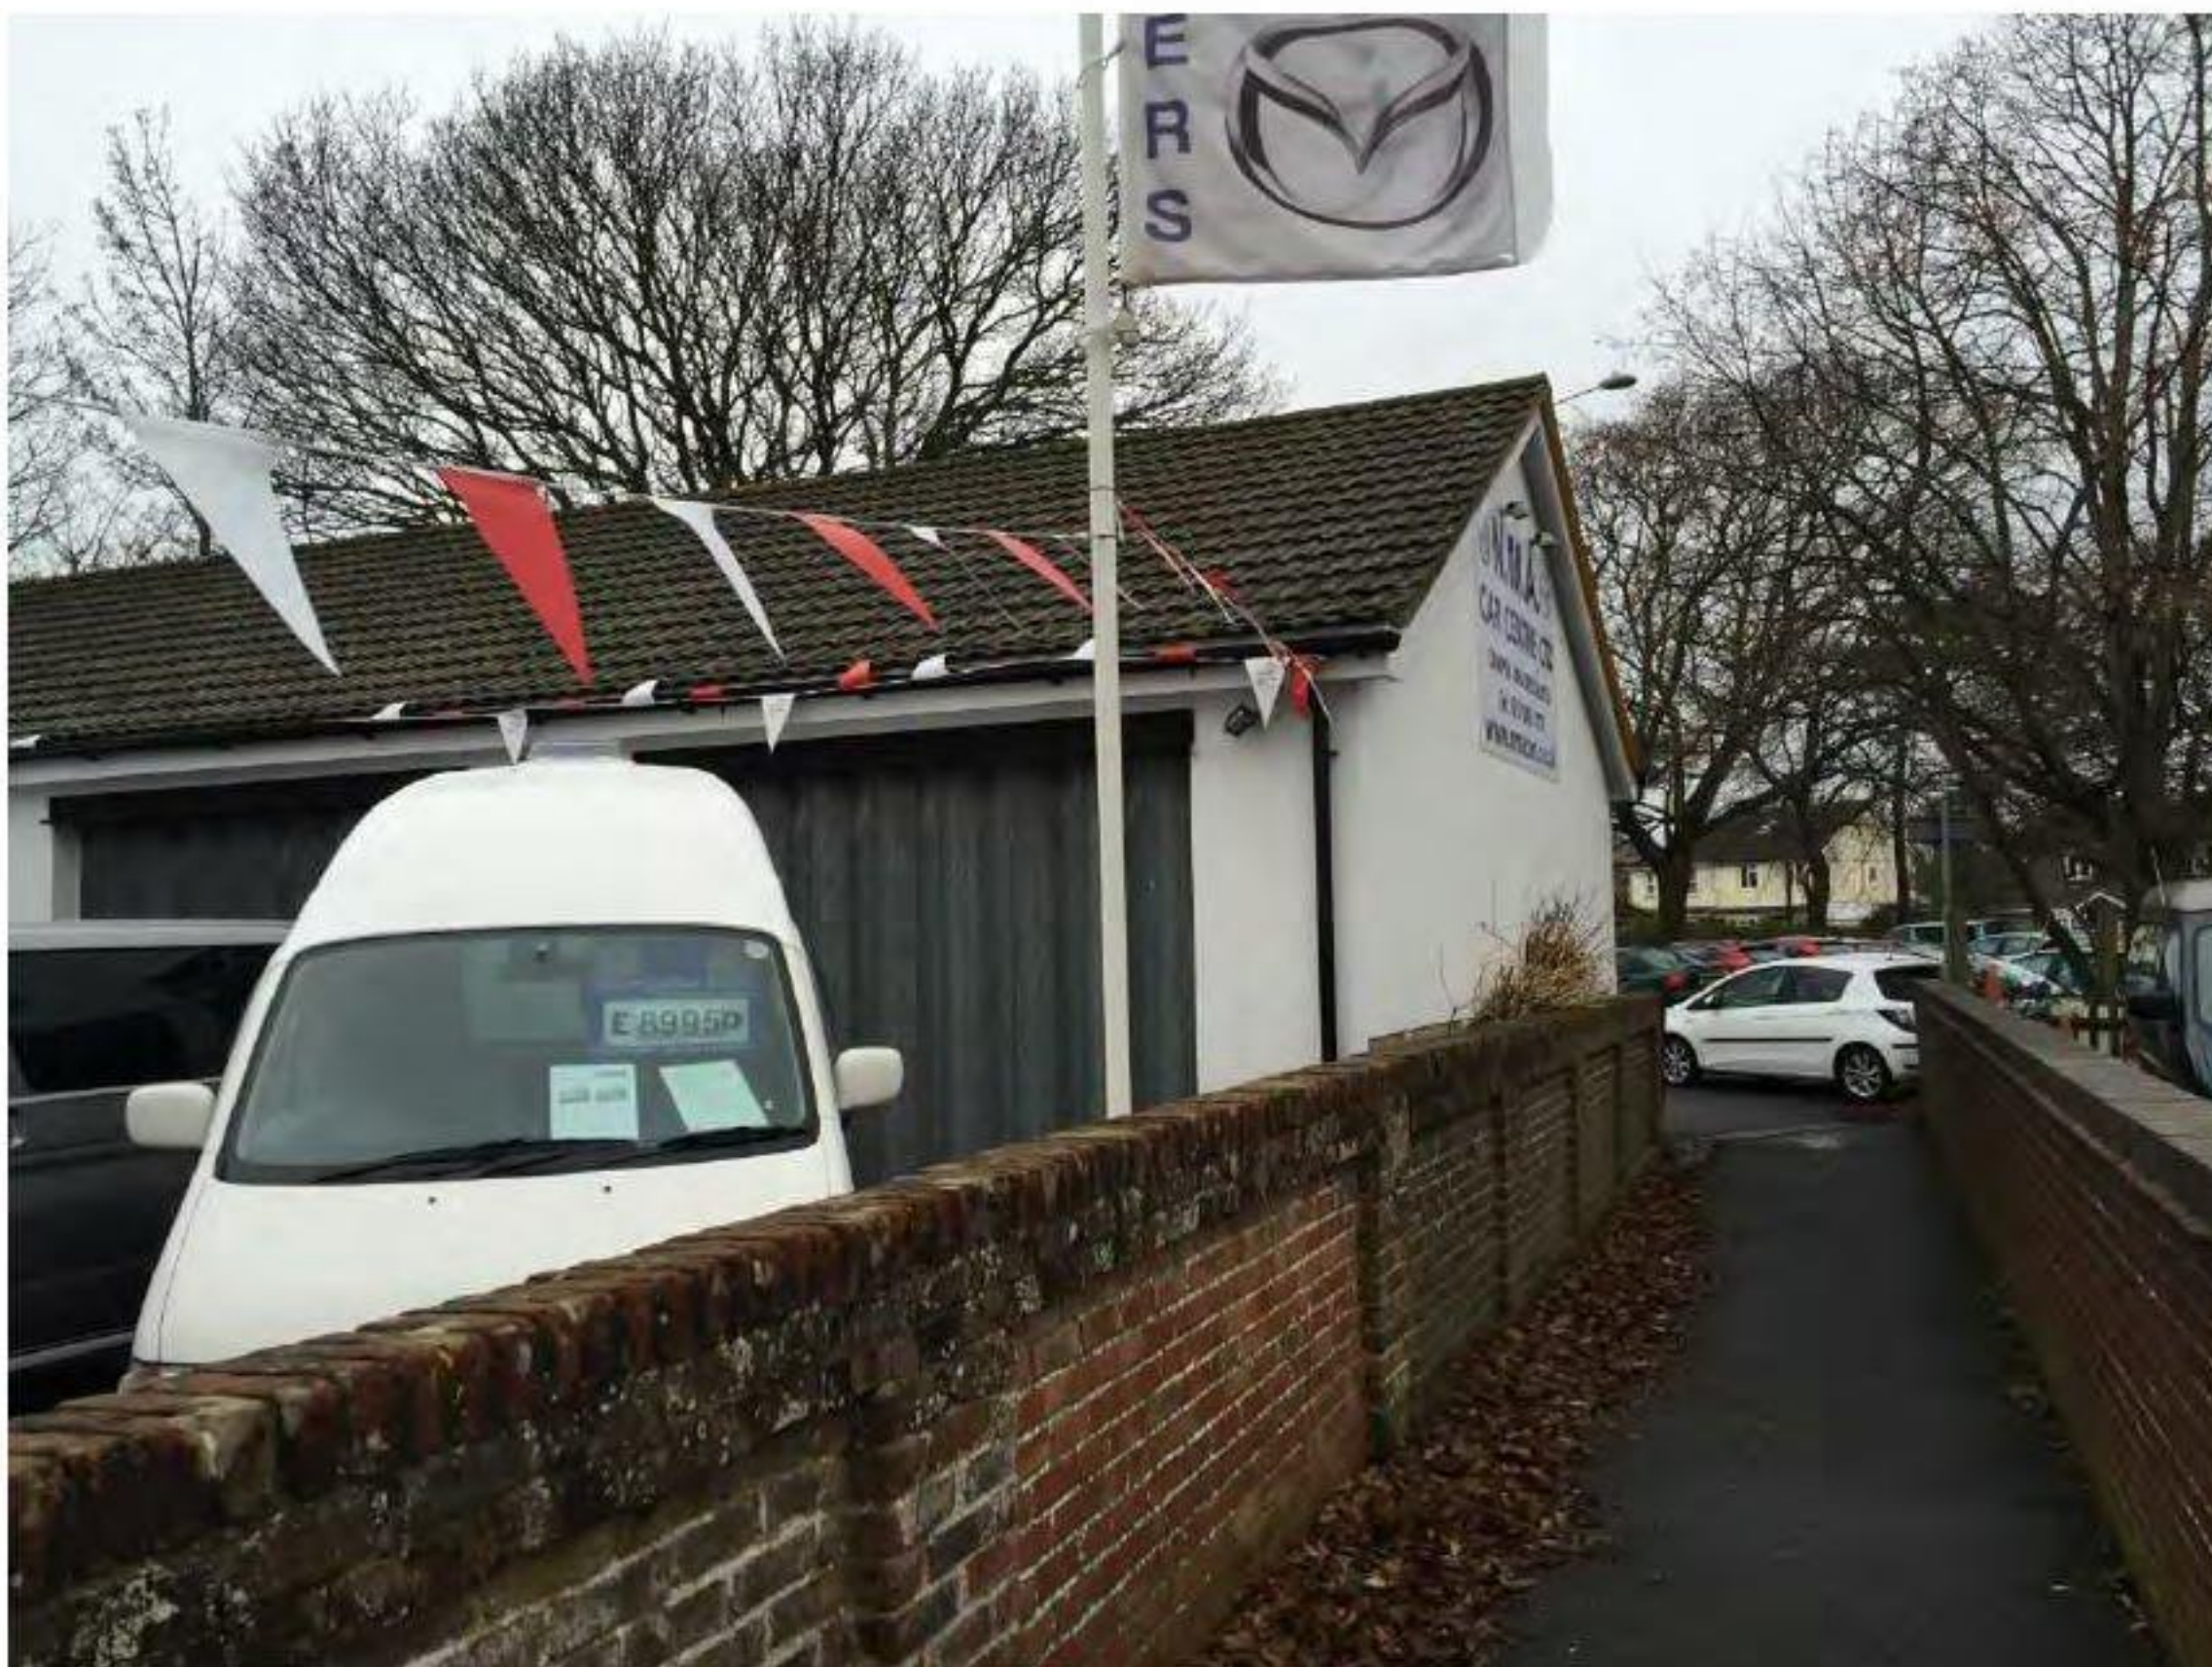
Plate 6: A walkway beside the southern boundary linking Elm Grove to the Car Park to the west
