DESK STUDY REPORT  
FOR THE SITE OF:

Hayling Billy Public House  
117 Elm Grove  
Hayling Island  
Hampshire  
PO11 9ED

**REPORT NO:** 15-67729

**DATE:** 08 January 2016

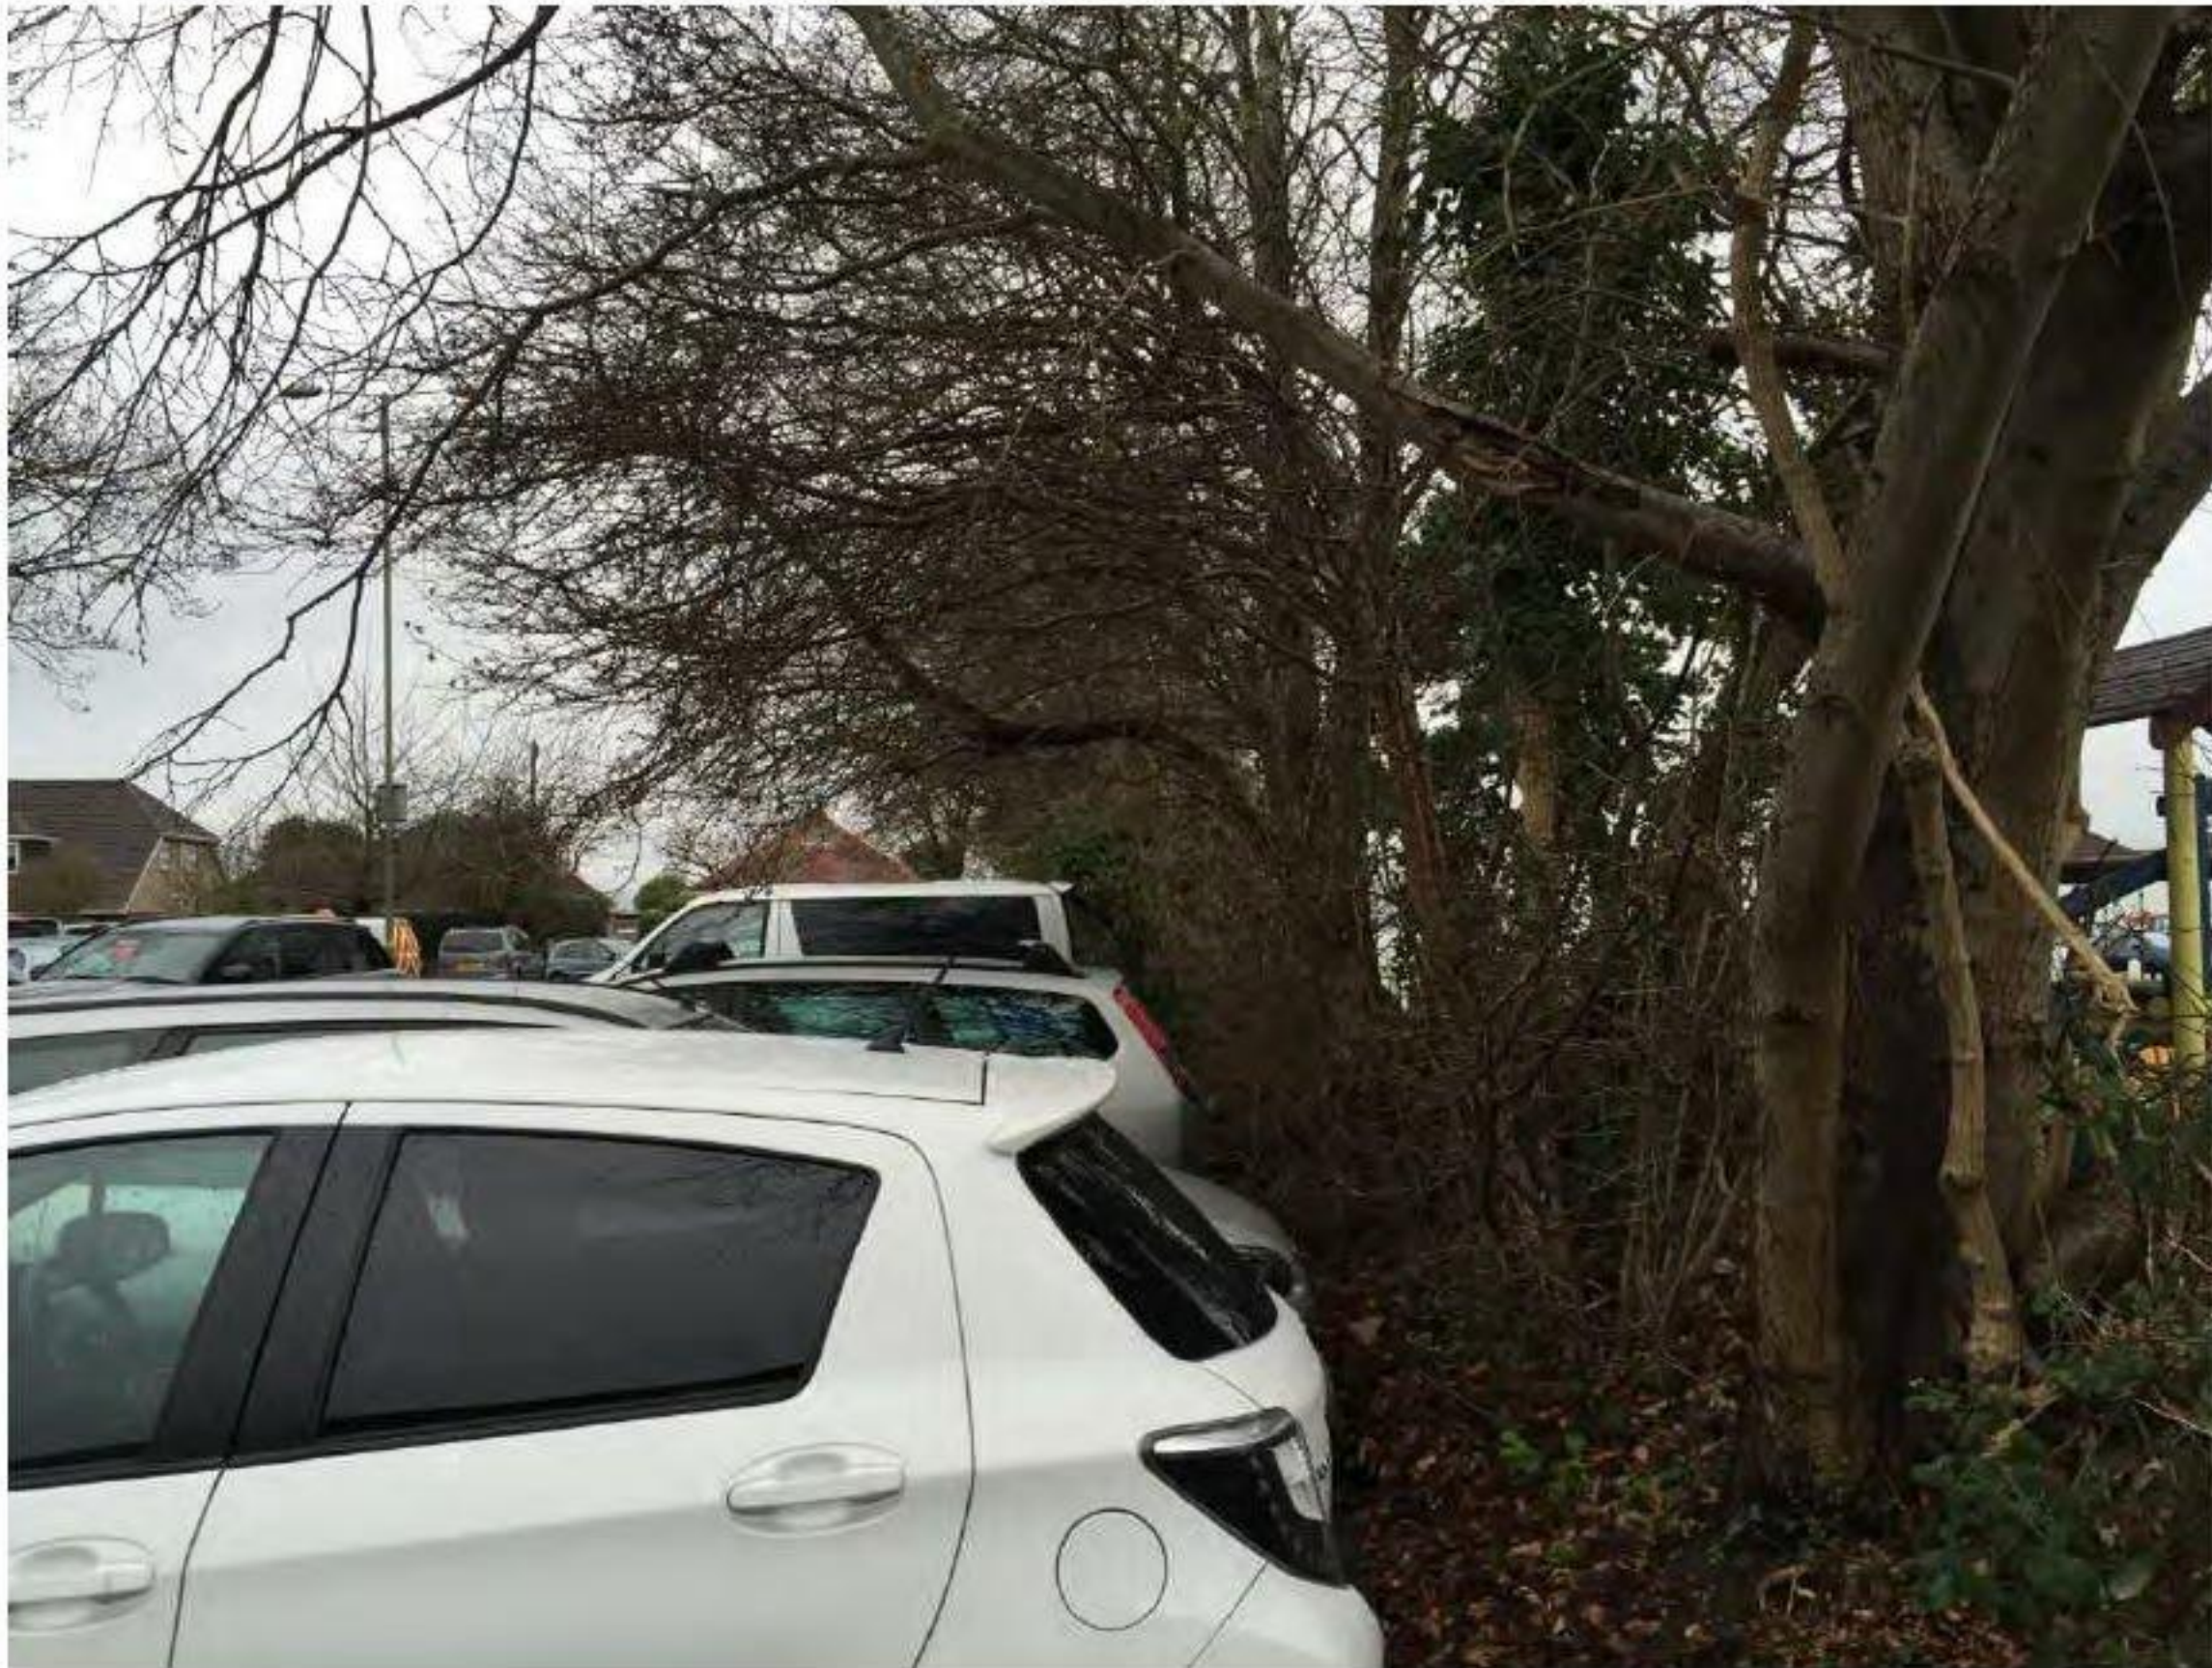
Plate 7: Row of trees along the south-west boundary
