Site: No.25-27  
Woodcroft Lane,  
Waterlooville,  
Hampshire, PO8 9QG

Site Visit Date: 11<sup>th</sup> July 2023

Client: Vivid Housing Association

**Prepared by  
Richard Daubeney  
Our Ref 0723-RD  
12th of July 2023**

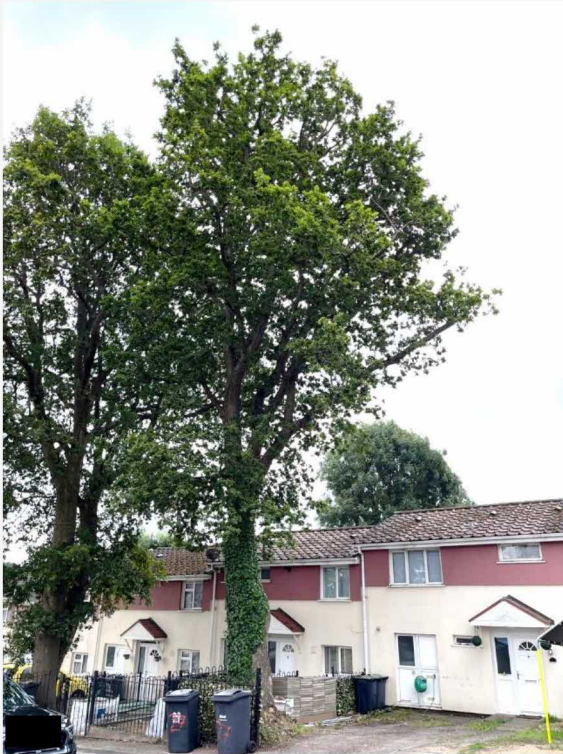
**T1 Looking to South.**

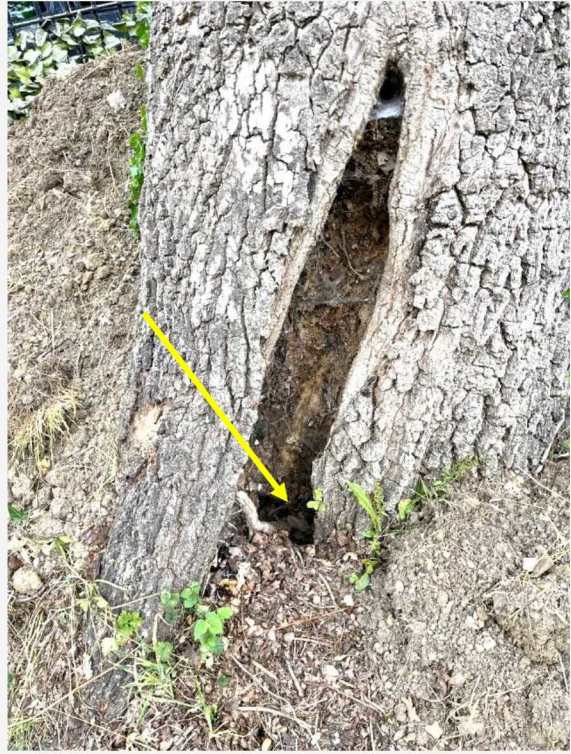
T1 English Oak held gross defect upon resistograph inspection with a T/R ratio of under the industry recommended 30% point. Based on the readings provided it would suggest that the likelihood of failure at test point is significant, even under normal climatic circumstances. It should be noted that T/R ratio does not take into account tree height, and as such does not define the user's preliminary recommendations. The resistograph readings taken suggest a column of decay based to the West and Southwest sides, both in depth and height which coincides with the basal cavity. The remaining live holding wood based to the East side is not sufficient to withstand the weight and pressure of the canopy on the stem.

**T1 Extensive basal cavity to Northwest side.**

Based on the above evidence, a crown reduction of 5-6m all round. The tree will then have a significantly reduced and compact canopy, reducing the risk to the public, public footpath and main road. I also advise the removal of the soil around the base of stem, including the removal of the raised drive to the East of the stem. A further tree inspection is advised within 3 years from the date of this report, to ensure no further change to health or condition.

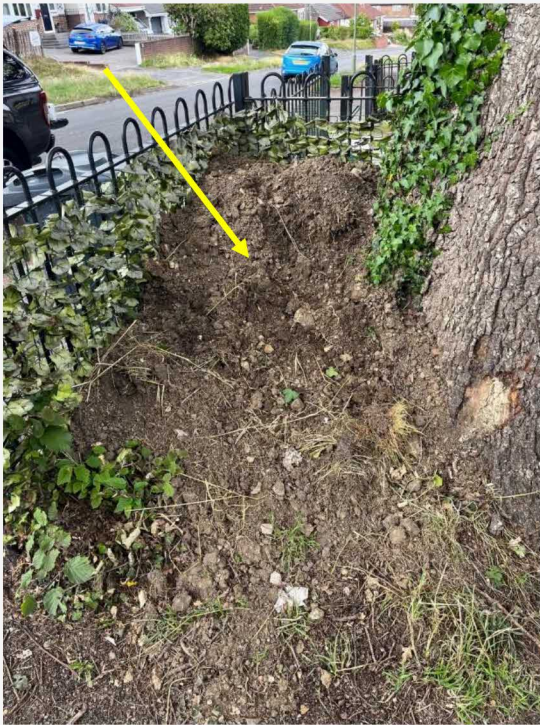
**T1 soil mound against stem.**

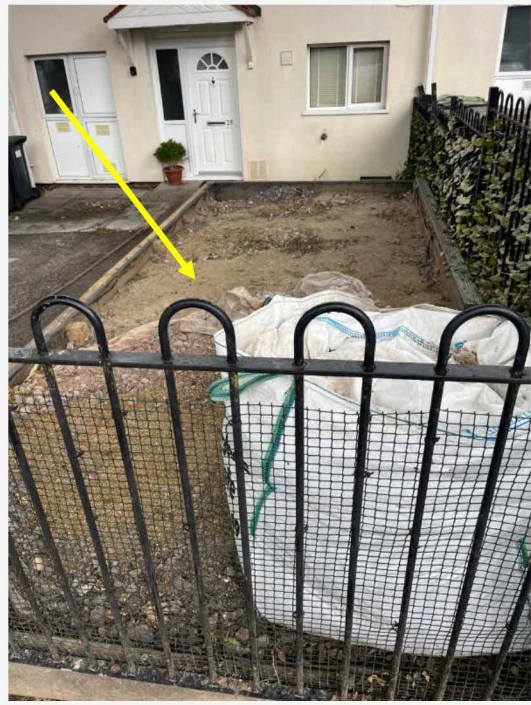
**T1 Looking to the East to loose raised driveway**

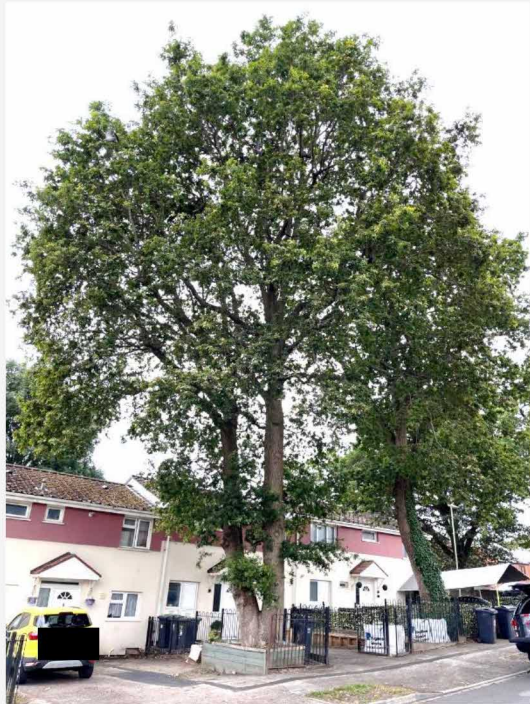
**T2 Looking Southwest**

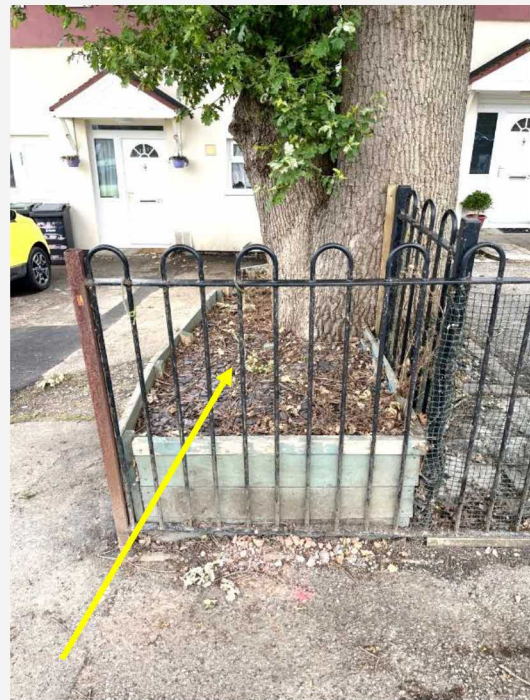
**T2 Raised soil planter against stem.**

The tree is twin stemmed with historic reduction to the crown. Like T1, T2 has also had excavation works carried out to the public footpath within the canopy spread of the tree, with likely chance of root severance linked to T2. Given the above information, it would be therefore advisable to crown reduce by 3m all round. The tree can then be retained at a lower height with a reduced risk to the public, public footpath and main road. I would recommend a further inspection 3 years from the date of this report to ensure there are no further changes to the tree's health and condition.

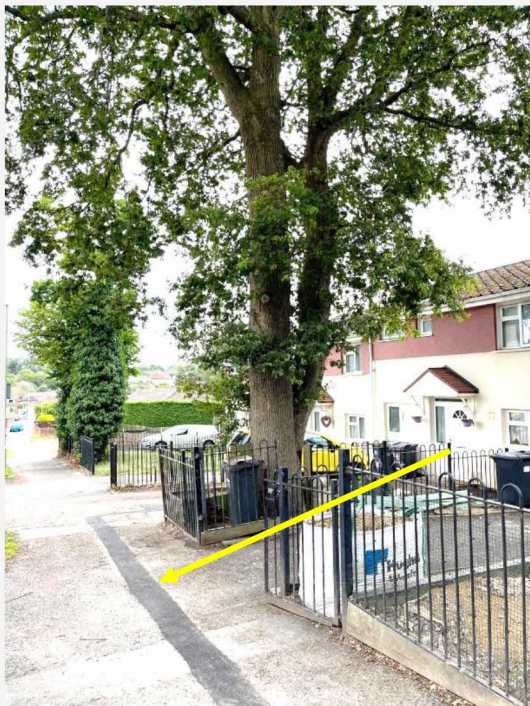
**T2 Looking East note the footpath excavation.**

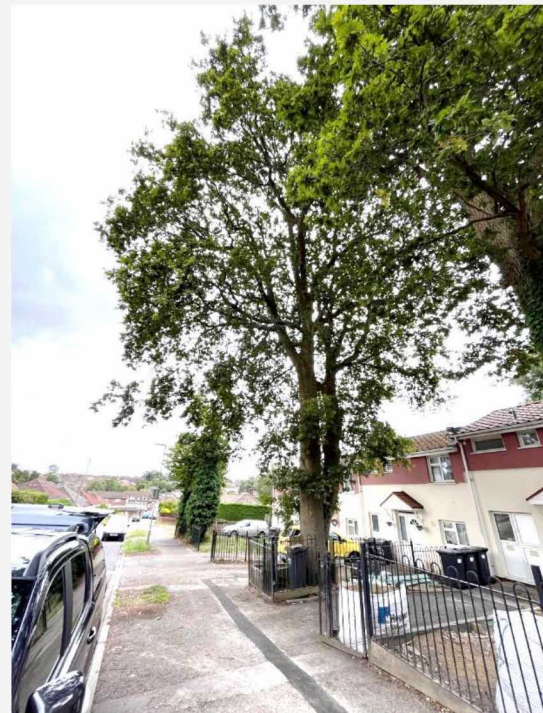
**T2 looking East.**

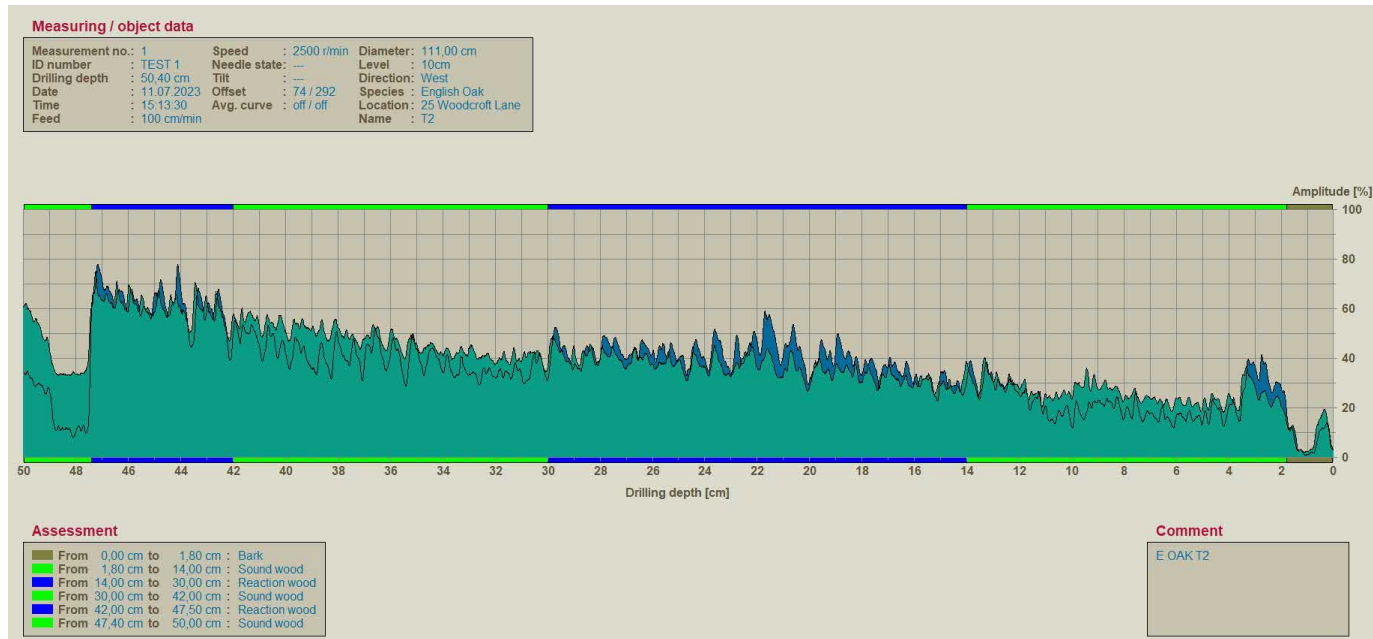
## T2, Measurement 1

T2 English Oak held no gross defect upon resistograph inspection with a T/R ratio of over the industry recommended 30% point. Based on the readings provided it would suggest that the likelihood of failure at test point is not significant. The testing carried out by the resistograph shows that the tree had very minor areas of decay within the stem, which would indicate that the tree is showing good areas of live holding wood throughout the stem.
