**INSURANCE CLAIM: ENGINEERING APPRAISAL REPORT**

49 Park Lane, Cowplain, WATERLOOVILLE, Hampshire, PO8 8BB

Date: 09/10/2023

Out Ref: 9637588

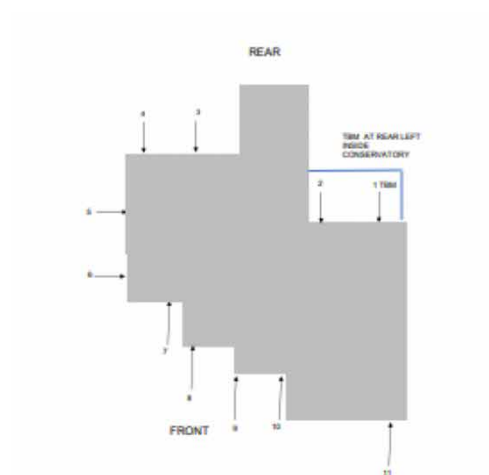
Monitoring readings were instructed in November 2022 to cover a yearly cycle. The points have been added to the property as below:

We currently have 5 readings which show 10mm of ground recovery during the winter period. Readings during the summer 2023 show up to 7mm of downwards movement to the front/front left of the main house. This strongly correlates with cyclical clay shrinkage with the influence of active tree roots found in the trial hole located to the front left. This indicates seasonal clay shrinkage due to the influence of the nearby Oak.

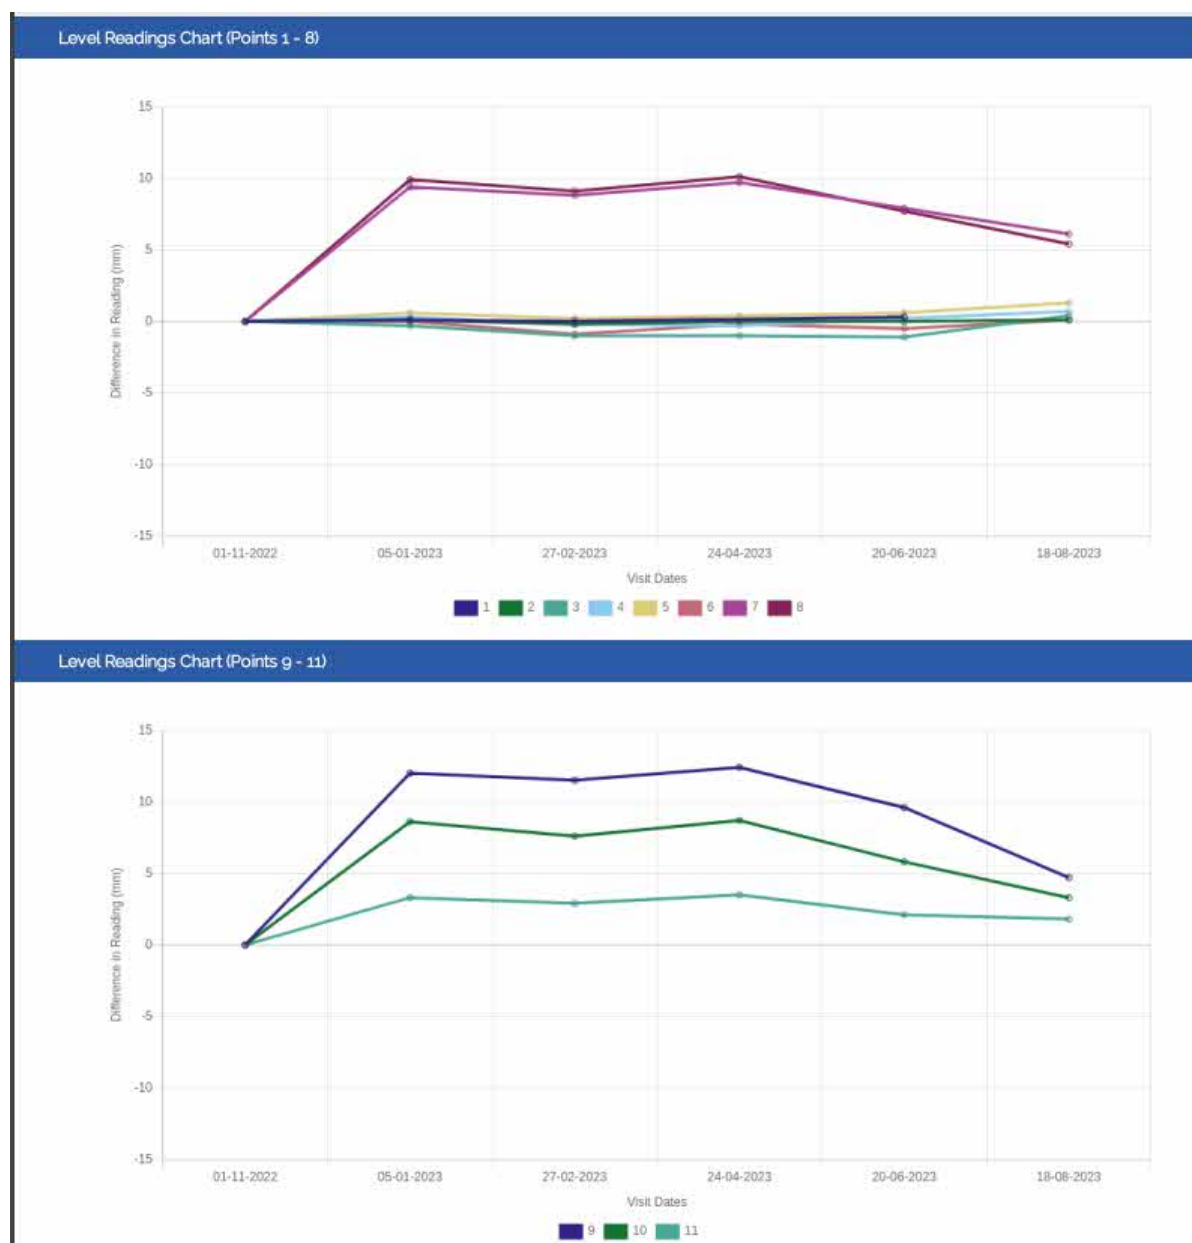
Below is the plotted cyclical graph completed thus far:
