# Arboricultural Consultancy for Lloyds Bank

| Insured | Mr Andrew Hunnibal | Address | Longacre, Emsworth, PO10 7UR | | |
| ES Ref | SA-247622 | Consultant | Giles Mercer | Contact No. | 0330 380 1036 |
| Report Date | 09/02/2021 | | | | |

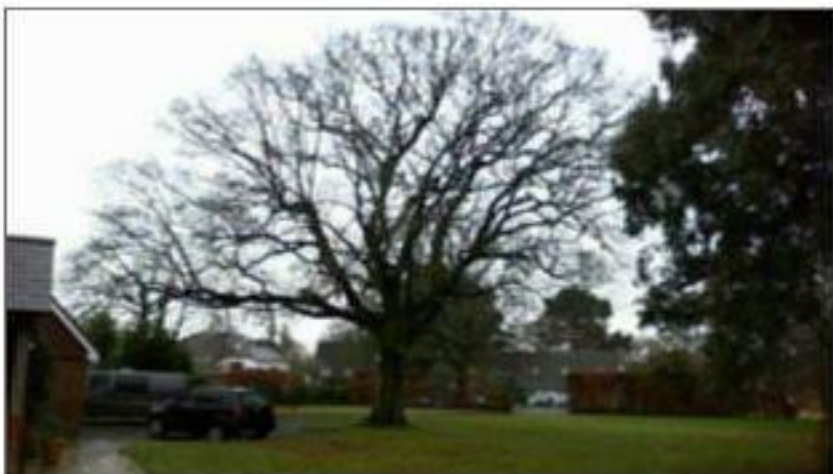
T7 - Oak

Site Investigations revealed the presence of roots below foundation level in TP/BH1. These roots were identified (using anatomical analysis) as having emanated from the genus *Quercus* spp. (Oak). Roots were also found in TP/BH2 and they were identified as *Populus* spp (Poplar)

Our survey of the site identified T4 (Poplar) & T7 (Oak), given their position relative to the damage it is our opinion that the roots identified emanate from this vegetation.

Based on our site investigations, and taking account of vegetation location, relative to the focal area of movement/ damage, it is our opinion that, T3 (Prunus), T4 (Poplar) & T7 (Oak) are considered the dominant feature(s) and accordingly we have identified them as the principal cause of the subsidence damage.

Removal of T3, T4 & T7 will offer the most certain and reliable Arboricultural solution likely to restore long-term stability.

| Tree No. | Species | Age Cat | Approx. Height (m) | Distance to Building (m) * | Ownership | Action | Requirement |
|---|---|---|---|---|---|---|---|
| T7 | Oak | 3 | 17 | 16.4 | C - Insured | Remove | Remove close to ground level and treat stumps to inhibit regrowth. |

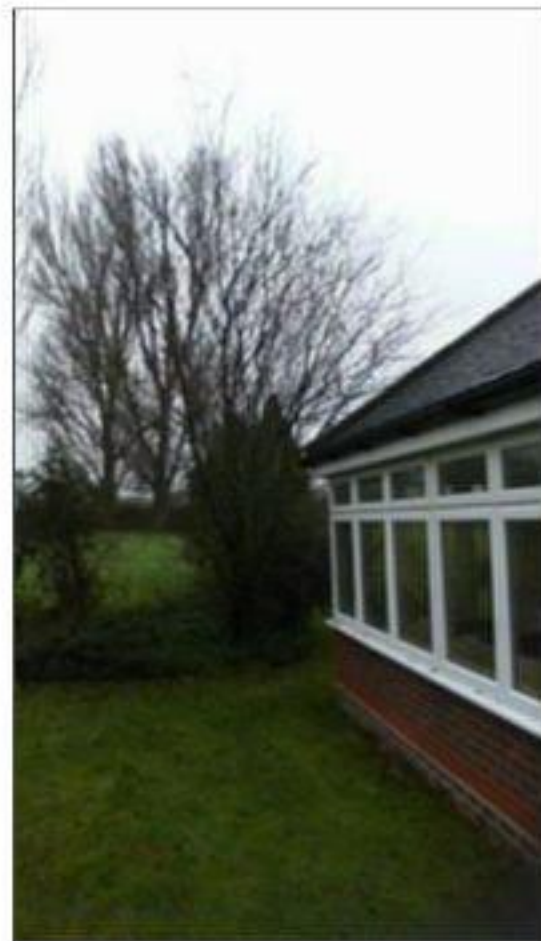
T3 - Prunus

Whilst not directly implicated by positive root analysis, based on our site investigations, and taking account of vegetation location, relative to the focal area of movement / damage, it is our opinion that T3 (Prunus) also retain the capacity to be extending roots below the focal areas of movement. The influence of this vegetation is determined by their size and proximity relative to the area of damage; it is our opinion on balance of probability that roots from this vegetation will be in proximity to footings of the insured property.

| Tree No. | Species | Age Cat | Approx. Height (m) | Distance to Building (m) * | Ownership | Action | Requirement |
|---|---|---|---|---|---|---|---|
| T3 | Prunus | 2 | 7.9 | 1.9 | C - Insured | Remove | Remove close to ground level and treat stumps to inhibit regrowth. |

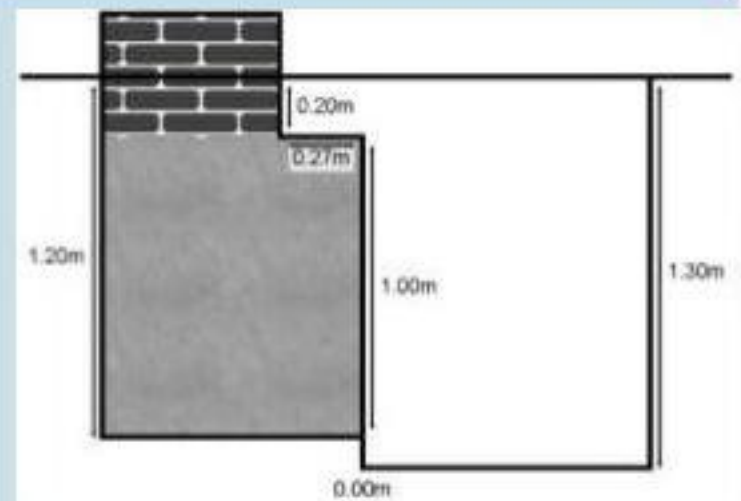
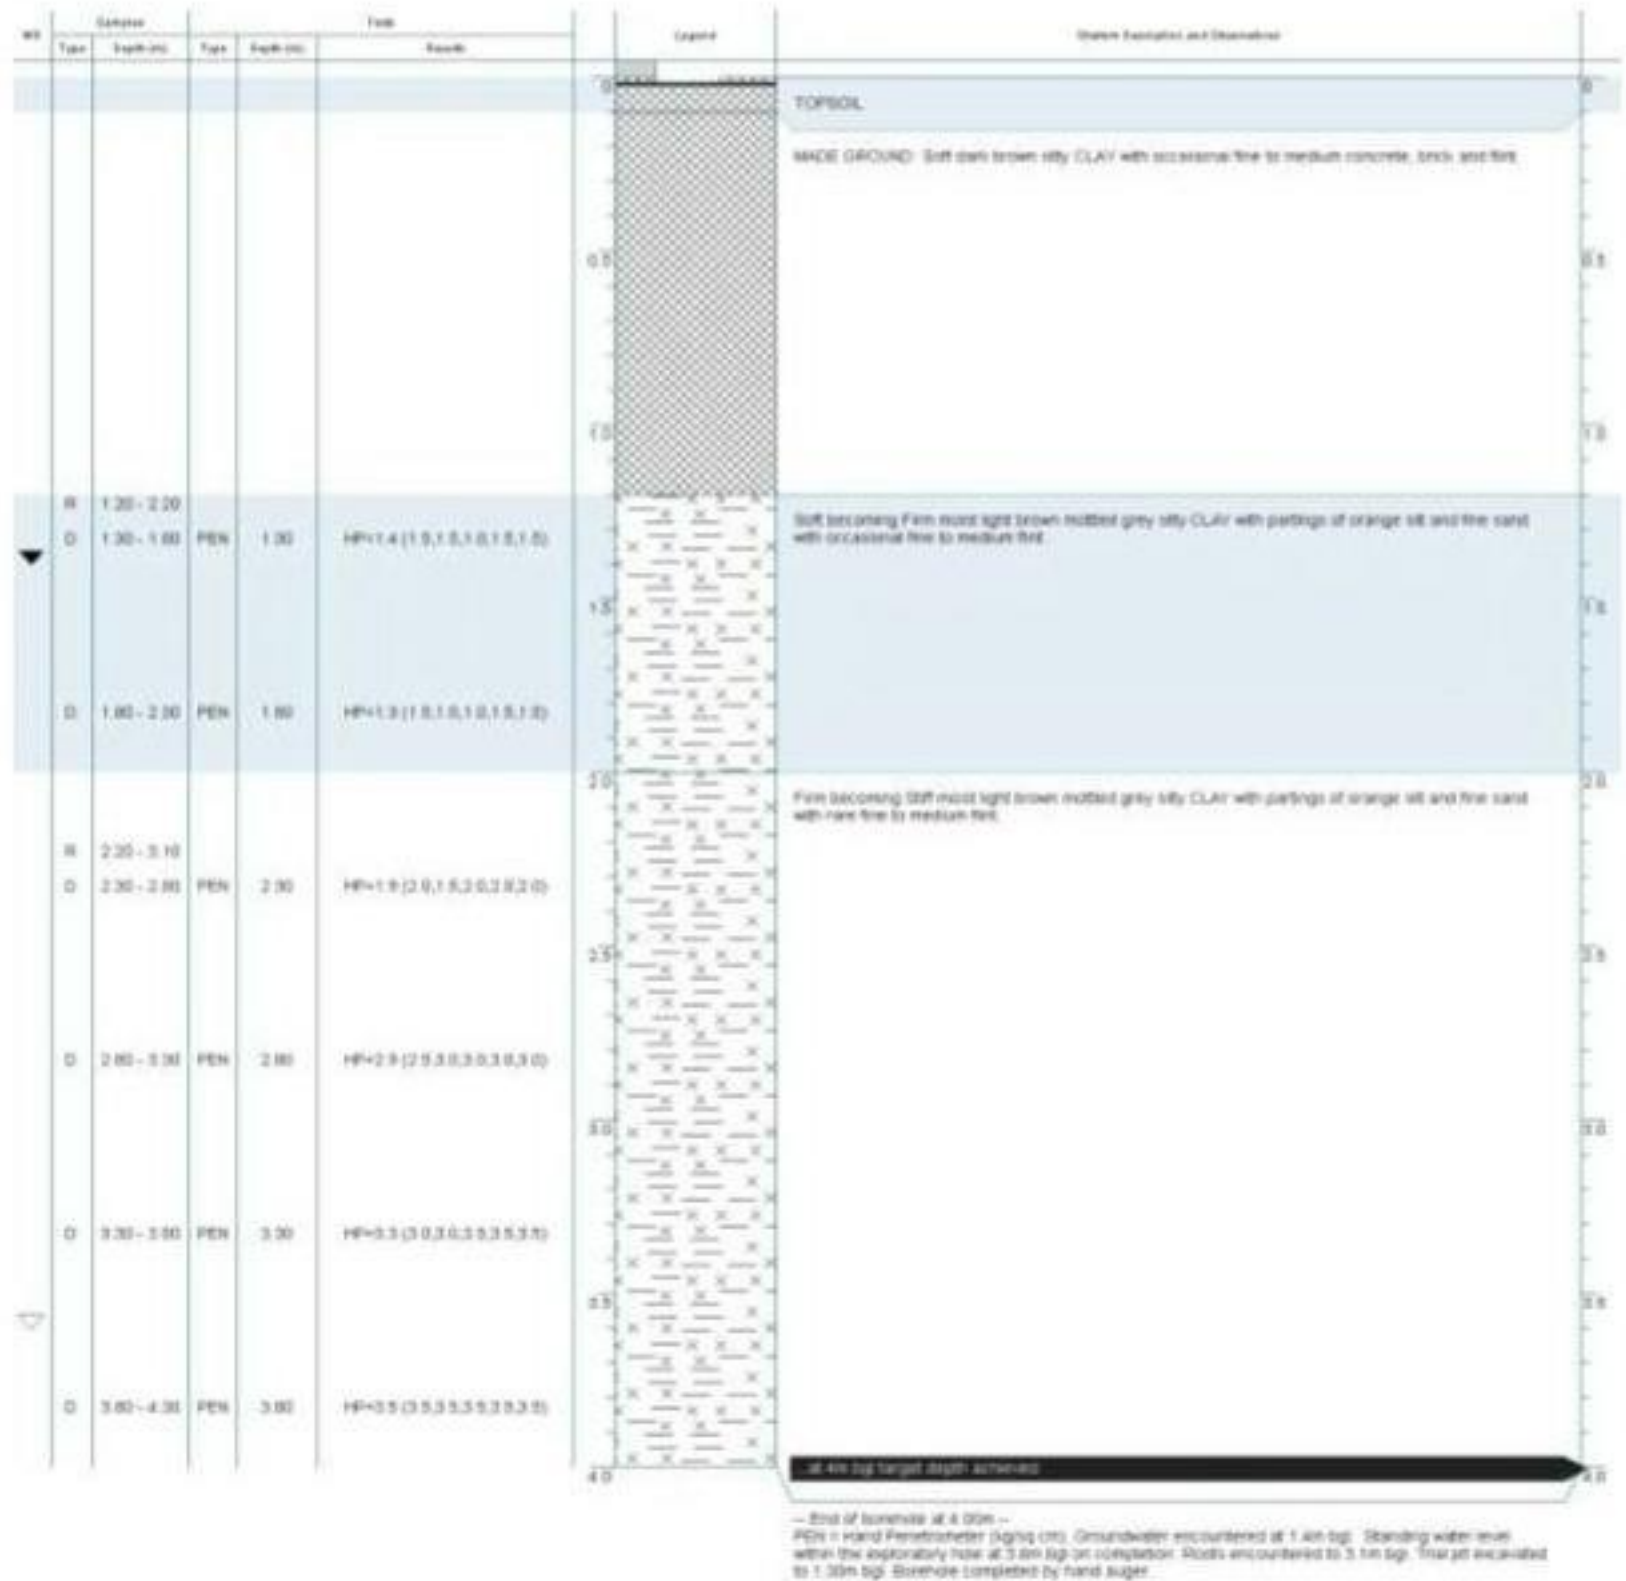
## TP/BH1 Foundation Detail and Borehole Log

Porch foundation comprised of brick wall to 200mm bgl, bearing on concrete to an estimated depth of 1200mm bgl, with a total projection of 270mm from the elevation. Underside of foundation (USF) was estimated by pushing a probe, approximately 160mm back from the face of the foundation, at an angle with no apparent contact with the face of the foundation beyond the estimated depth.
