**TREES AT HARVEY BROWN HOUSE, REST-A-WYLE AVENUE, HAYLING ISLAND,  
PO11 0PQ**

**Brief:** To inspect the trees at Harvey Brown House, Rest-A-Wyle Avenue, Hayling Island, comment on their condition, suitability for retention and any impact that the proposals for re-surfacing and refurbishment of hard surfaces etc may have upon them.

**Date of Inspection:** 7 August 2019

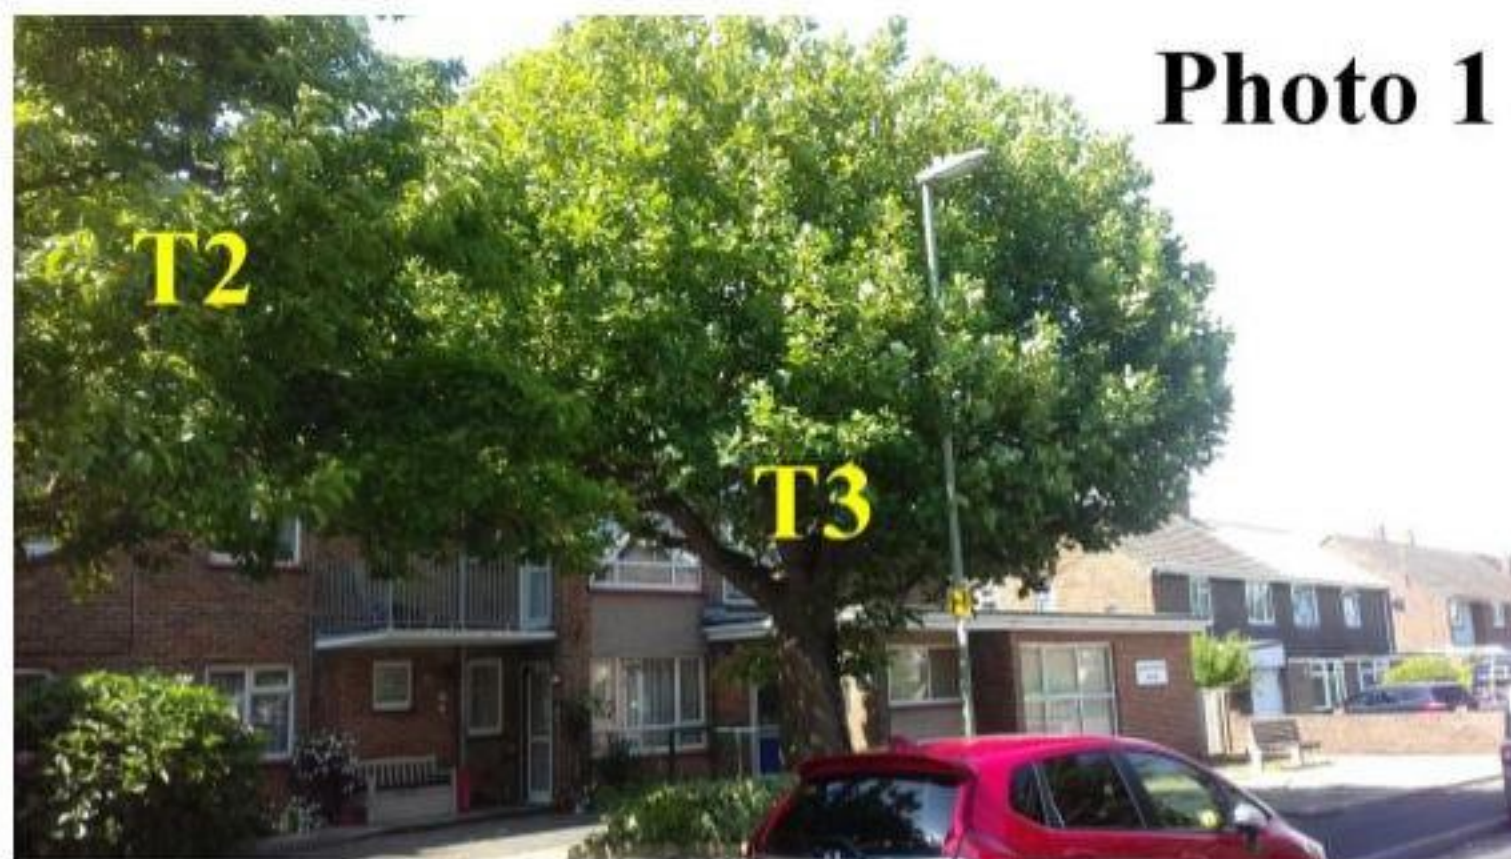
**Photo 1**

| T | Name & Species | Hgt | Dbh | RPA | B/S | C/C | Age | R/C | Cat | General Observations |
|---|---|---|---|---|---|---|---|---|---|---|
| 2 | Magnolia | | | | N<br>E<br>S<br>W<br>FSB | | | | A | Photo 1 |
| 3 | Tulip Tree<br><i>Liriodendron tulipifera</i> | 7 | 700 | | N5<br>E5<br>S5<br>W5<br>FSB | 4<br>4<br>4<br>4 | M | 20-40 | B | Previously reduced, Photo 1, some indication that it is lifting adjacent paving slabs. – Photo 2 |

T3 is a mature Tulip Tree which has previously been heavily reduced. The tree is standing in a slightly raised bed. Tree Protection Barriers will have to be erected all around the edge of the exposed bed during paving refurbishment works as shown on the enclosed plan.

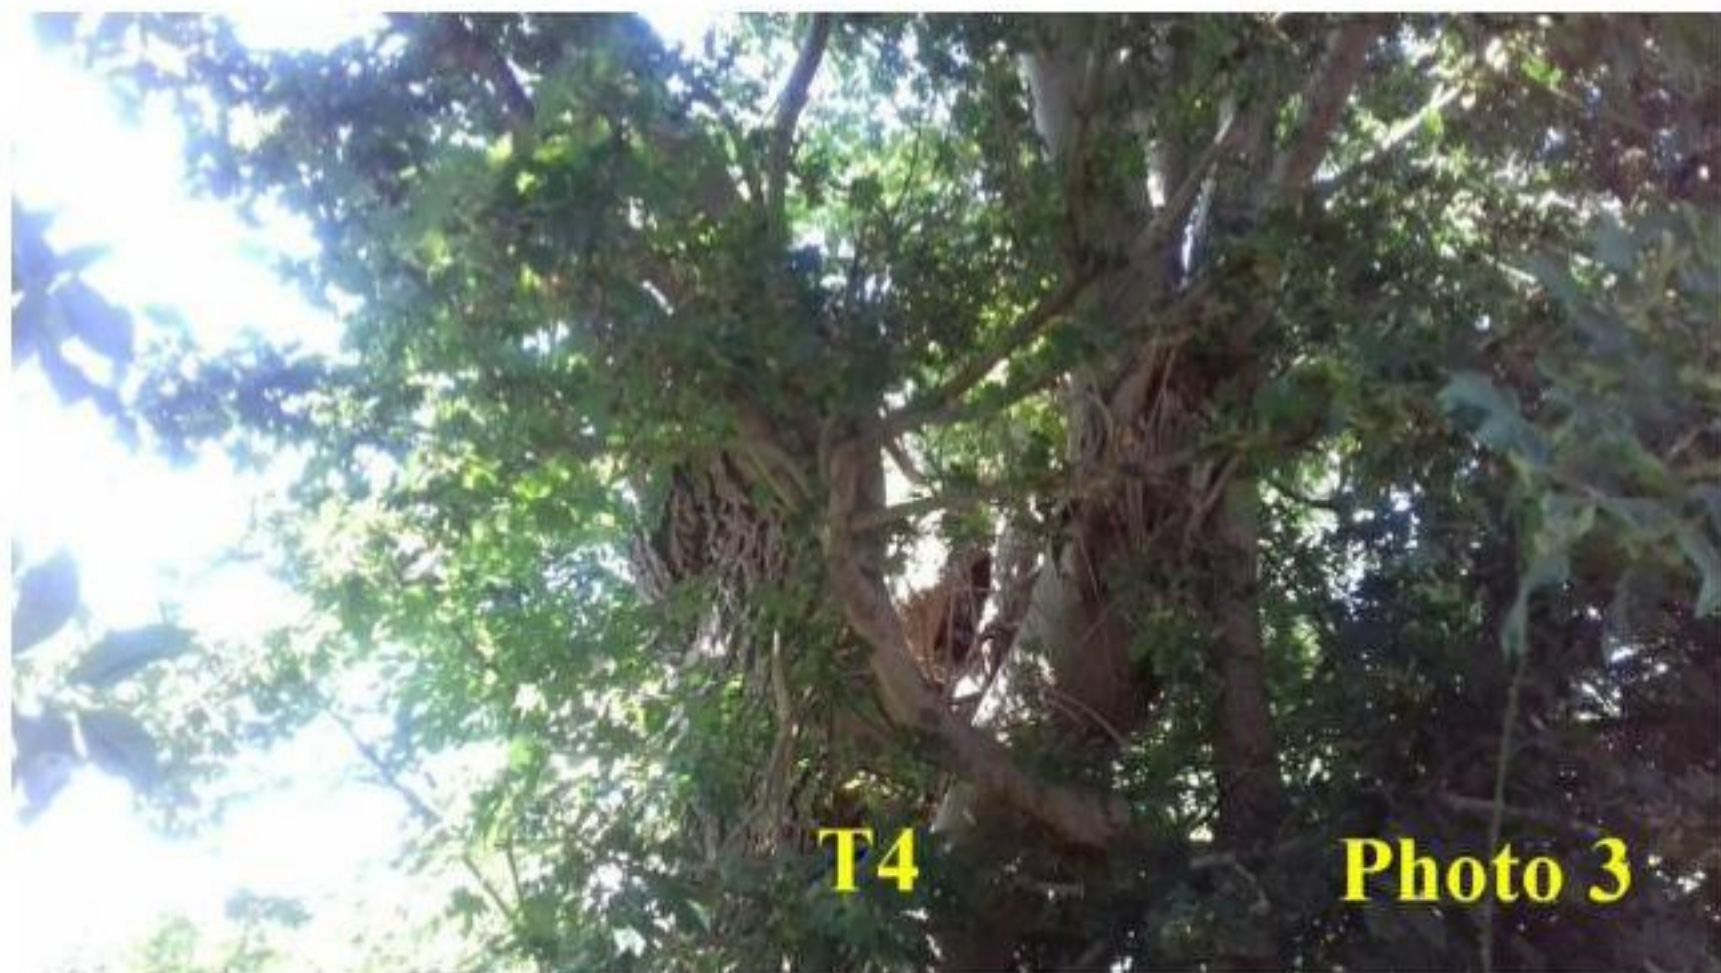
| T | Name & Species | Hgt | Dbh | RPA | B/S | C/C | Age | R/C | Cat | General Observations |
|---|---|---|---|---|---|---|---|---|---|---|
| 4 | Ash & Field Maple<br><i>Fraxinus excelsior</i> & <i>Acer campestre</i> | | | | N<br>E<br>S<br>W<br>FSB | | | | U | Offsite specimens. Severe decay. Risk of failure. Notify owner of potential liability. Photo 3. |

T4 is a severely decayed, previously collapsed, mature Ash Tree on land to the rear, which has a Field Maple growing up through it. We have noted this tree simply because, in our opinion, it represents an unreasonable risk to the safety of people and property on the survey site and we strongly recommend that the owners are requested to commission their own survey of it and deal with it.

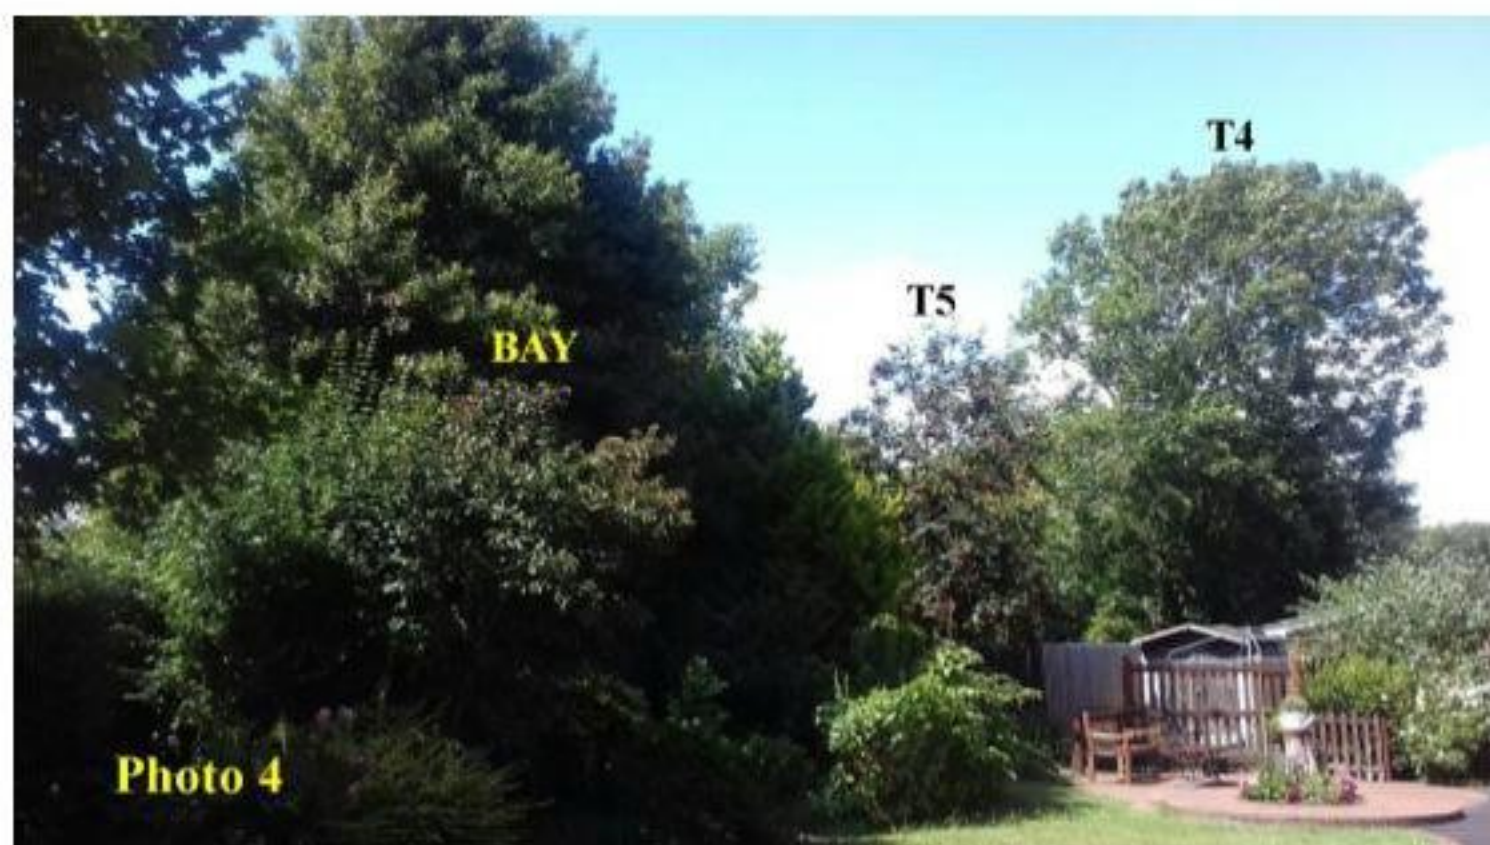
| T | Name & Species | Hgt | Dbh | RPA | B/S | C/C | Age | R/C | Cat | General Observations |
|---|---|---|---|---|---|---|---|---|---|---|
| 5 | <i>Sorbus sp</i> | 5 | 100 | | N2<br>E2<br>S2<br>W2<br>FSB | 1.5<br>1.5<br>1.5<br>1.5 | SM | 40+ | C | Semi-mature. Photo 4 |

T5 is a Rowan that is adjacent to one of the brick paved circles that are to be refurbished. A panel of Tree Protection Barrier will be erected tangentially to the circle between the tree and the bricks to keep operatives off the unprotected ground adjacent to the tree whilst works are in progress

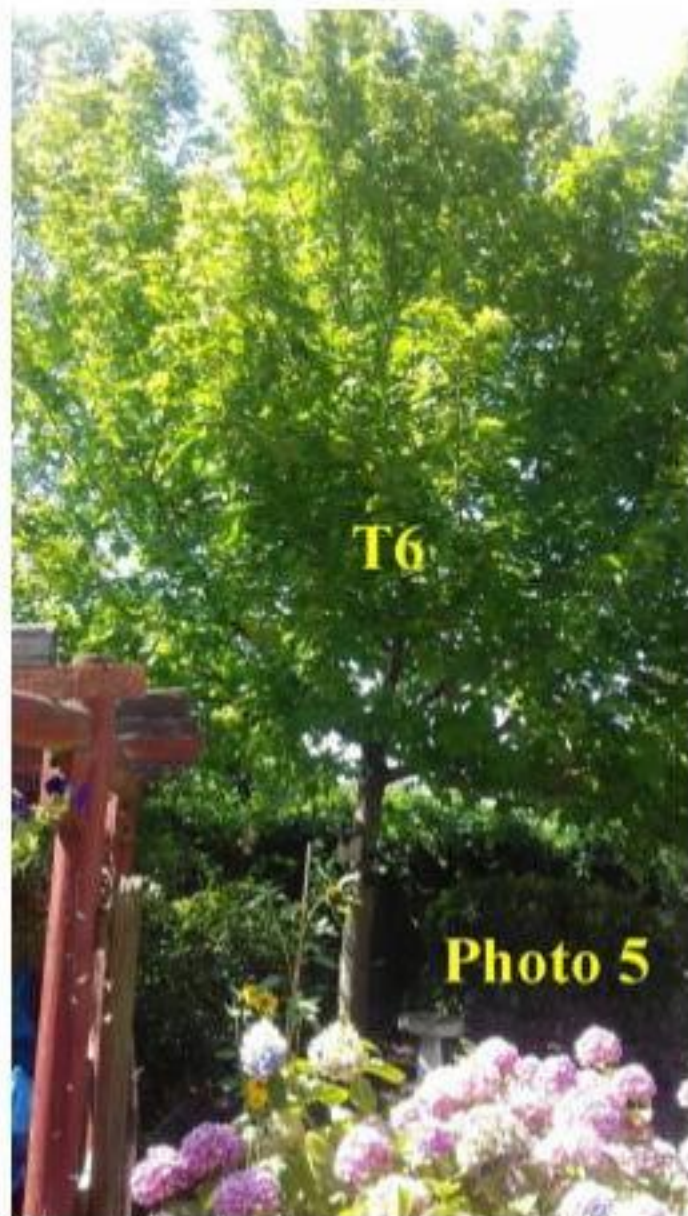
| T | Name & Species | Hgt | Dbh | RPA | B/S | C/C | Age | R/C | Cat | General Observations |
|---|---|---|---|---|---|---|---|---|---|---|
| 6 | Norway Maple<br><i>Acer platanoides</i> | 9 | 210 | | N6<br>E6<br>S6<br>W6<br>FSB | 2<br>2<br>2<br>2 | YM | 40+ | A | Good condition. Photo 5. |

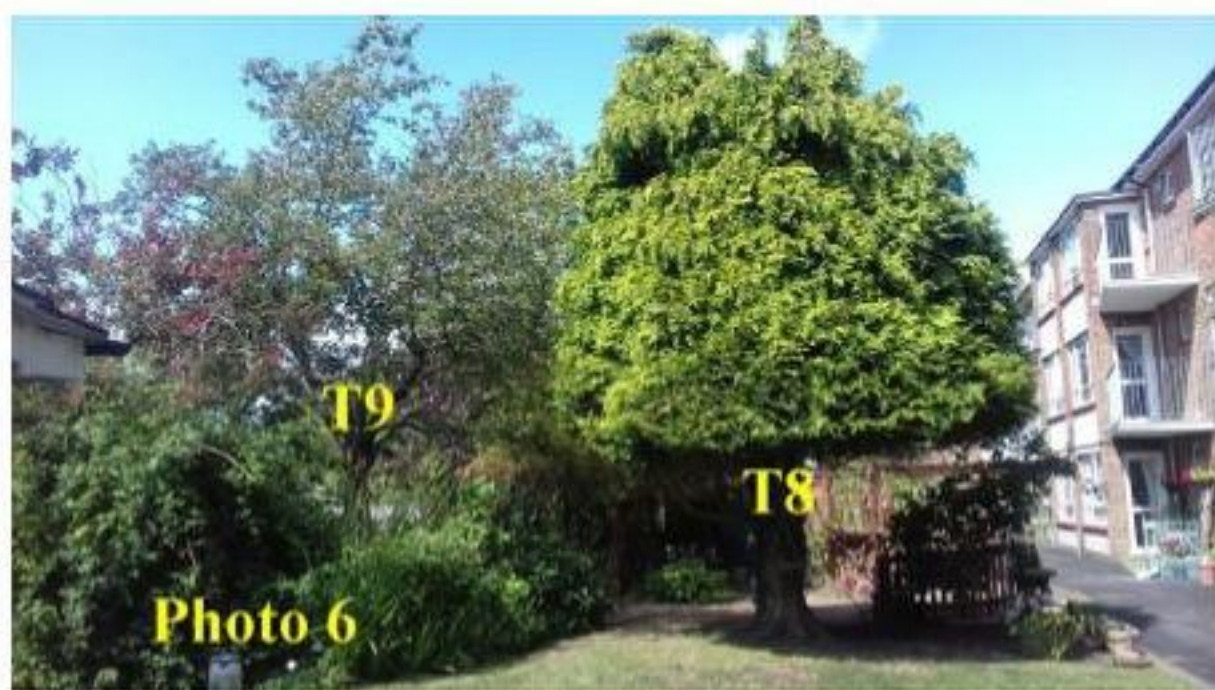
| T | Name & Species | Hgt | Dbh | RPA | B/S | C/C | Age | R/C | Cat | General Observations |
|---|---|---|---|---|---|---|---|---|---|---|
| 8 | Golden Lawson Cypress<br><i>Chamaecyparis lawsoniana</i> | 6 | n/a | | N<br>E<br>S<br>W<br>FSB | | | | C | Hedge remnant. Photo 6. |
| 9 | Cherry<br><i>Prunus</i> | 6 | 350 | | N<br>E<br>S<br>W<br>FSB | | | | U | Dieback. Photo 6. |
