**Project Name**  
50 Silvester Road**Project Number****Project Date**  
14/10/2019

**Company:** 24/7 Drainage Solutions Ltd  
**Contact:** Lee Moore  
**Street:** 27 Murray Road  
**Town or City:** Waterlooville  
**County:** Hampshire  
**Post Code:** PO8 9JE  
**Phone:** 02392429417

### CCTV SURVEY SUMMARY

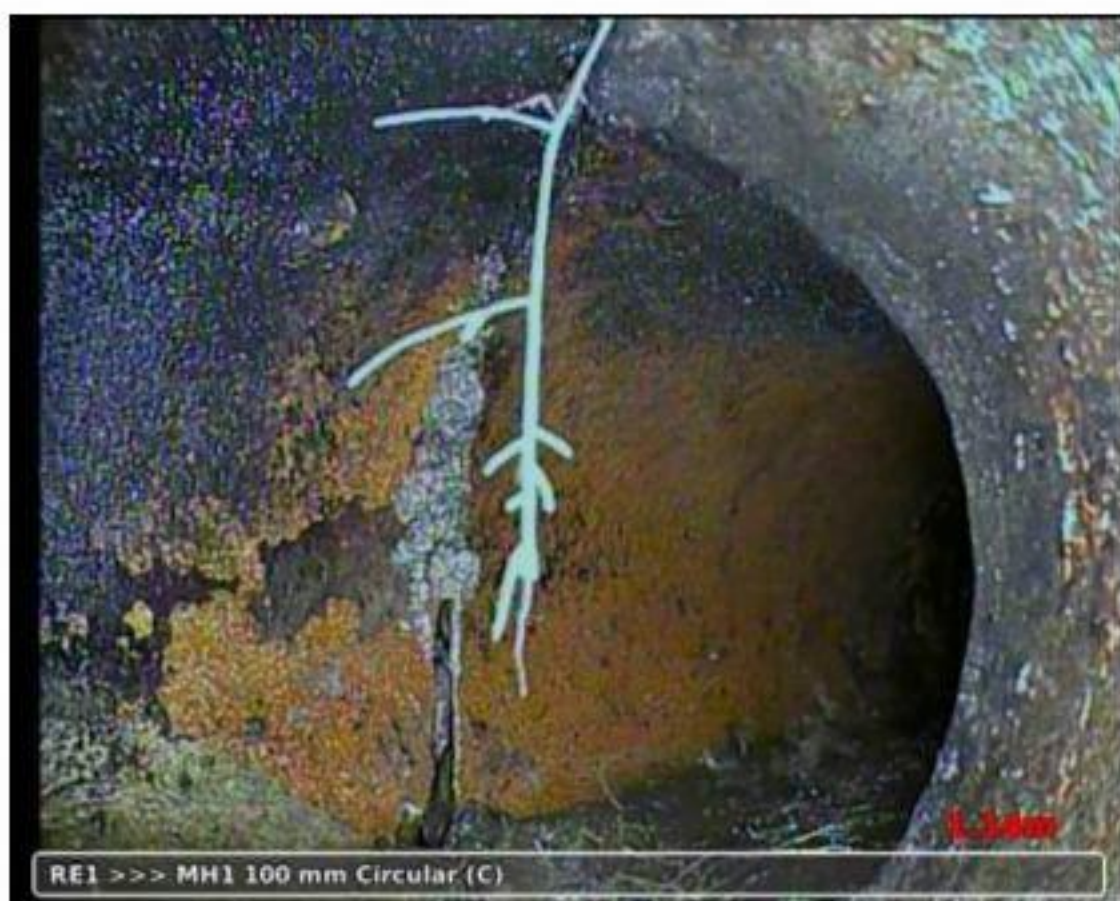
20191010-084757-snap0003.jpg, 00:00:59, 1.14 m  
 Roots, fine

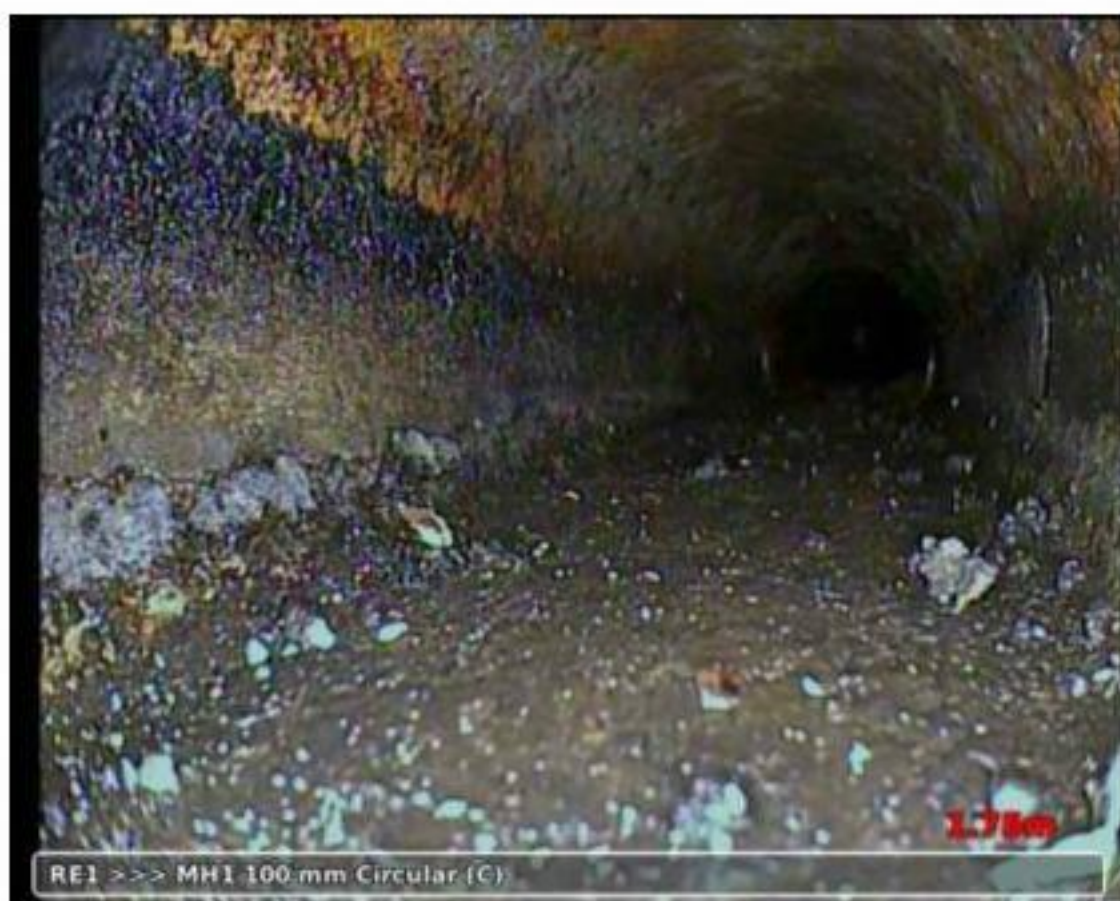
SVP to MH1 debris was found sitting in line so high pressure jetting will be needed to remove this debris to restore full flow, the survey had to be abandoned as i could not round one of the 90 bends.

| No. | m+ | Code | Observation |
|---|---|---|---|
| 6 | 1.75 | SA | Survey abandoned, UNABLE TO PASS BEND DEBRIS ALSO IN LINE |

20191010-084757-snap0005.jpg, 00:01:48, 1.75 m  
 Survey abandoned

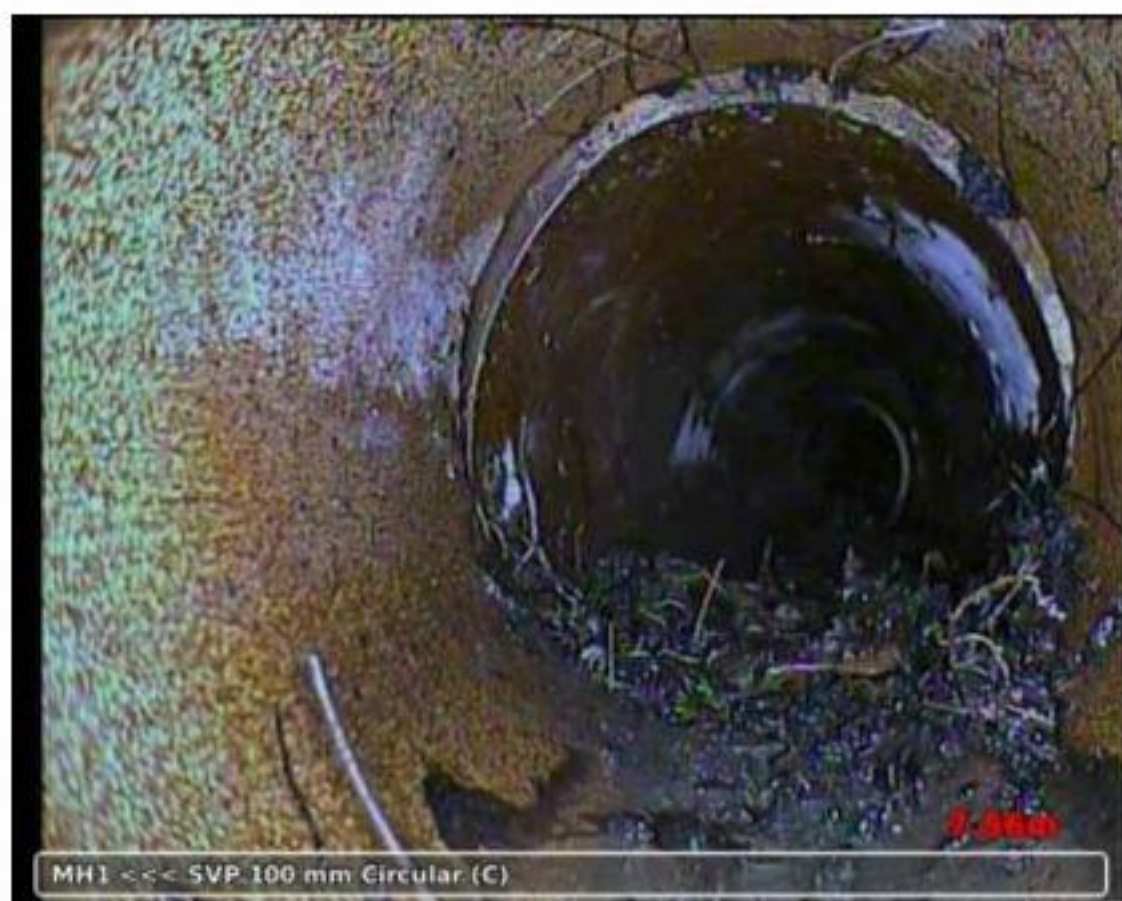
| 7.56 | RM | Roots, mass, 10 % cross-sectional area loss | 00:01:29 | | 3 |

20191010-085806-snap0003.jpg, 00:01:29, 7.56 m  
 Roots, mass, 10 % cross-sectional area loss

Survey continued from MH1 upstream and found there to be sevral points of roots ingress and cracks in this line, This line would benefit from having a chamber installed on the 90 bend where the survey had to be abandoned this will give beter access to the drain to carry out the needed works, This line needs a root cut and a 16m liner.

SVP to MH1 carry root cut on drain in prep for the 16m liner, supply and install new 300mm osma inspection chamber at front of property. once chamber is in place the 16m liner can be installed.

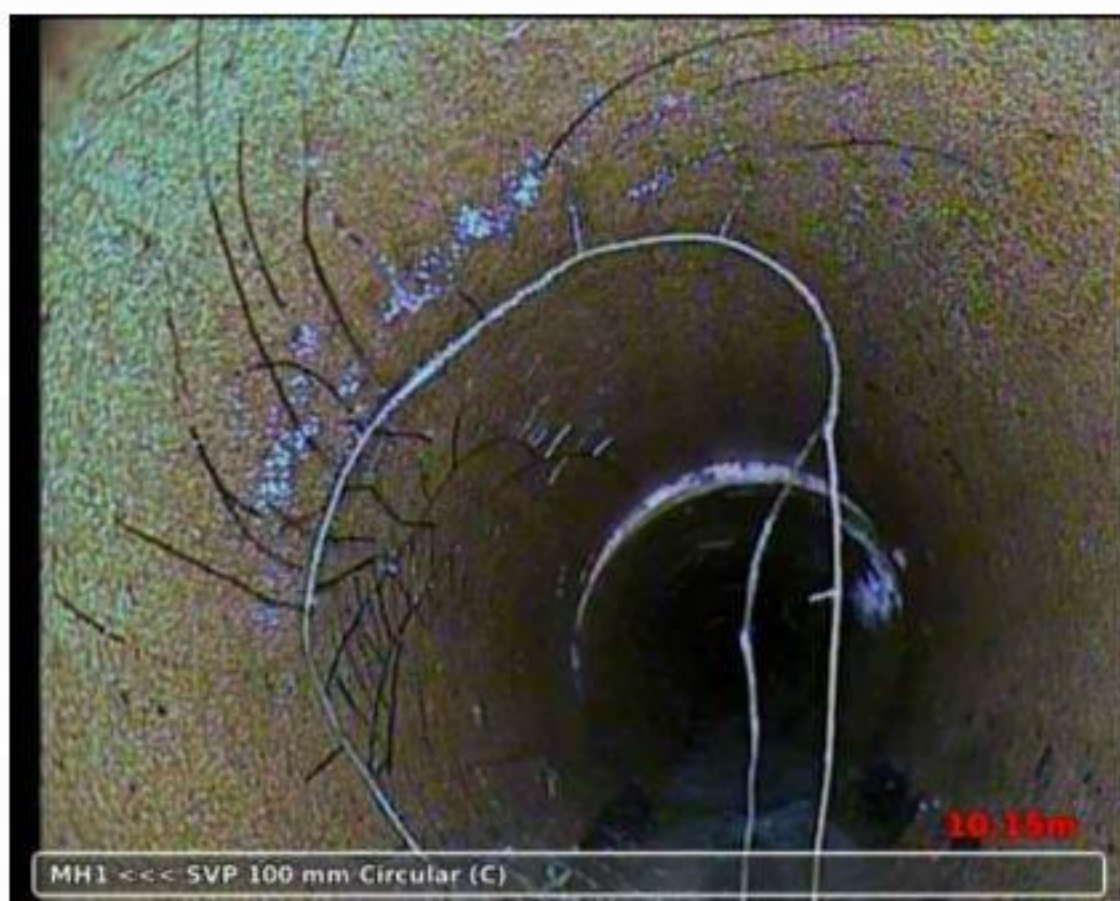
20191010-085806-snap0005.jpg, 00:02:32, 10.15 m  
 Roots, fine

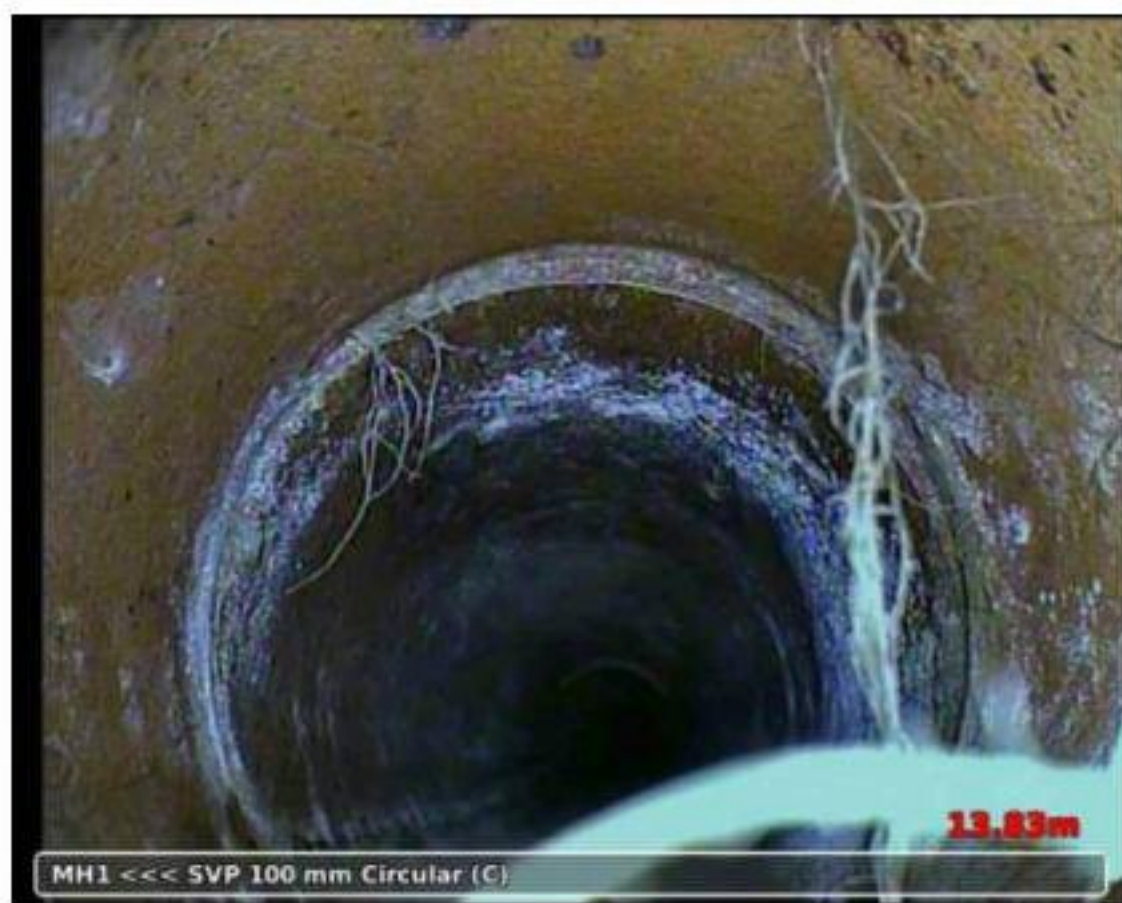
20191010-085806-snap0006.jpg, 00:03:15, 13.83 m  
 Roots, fine

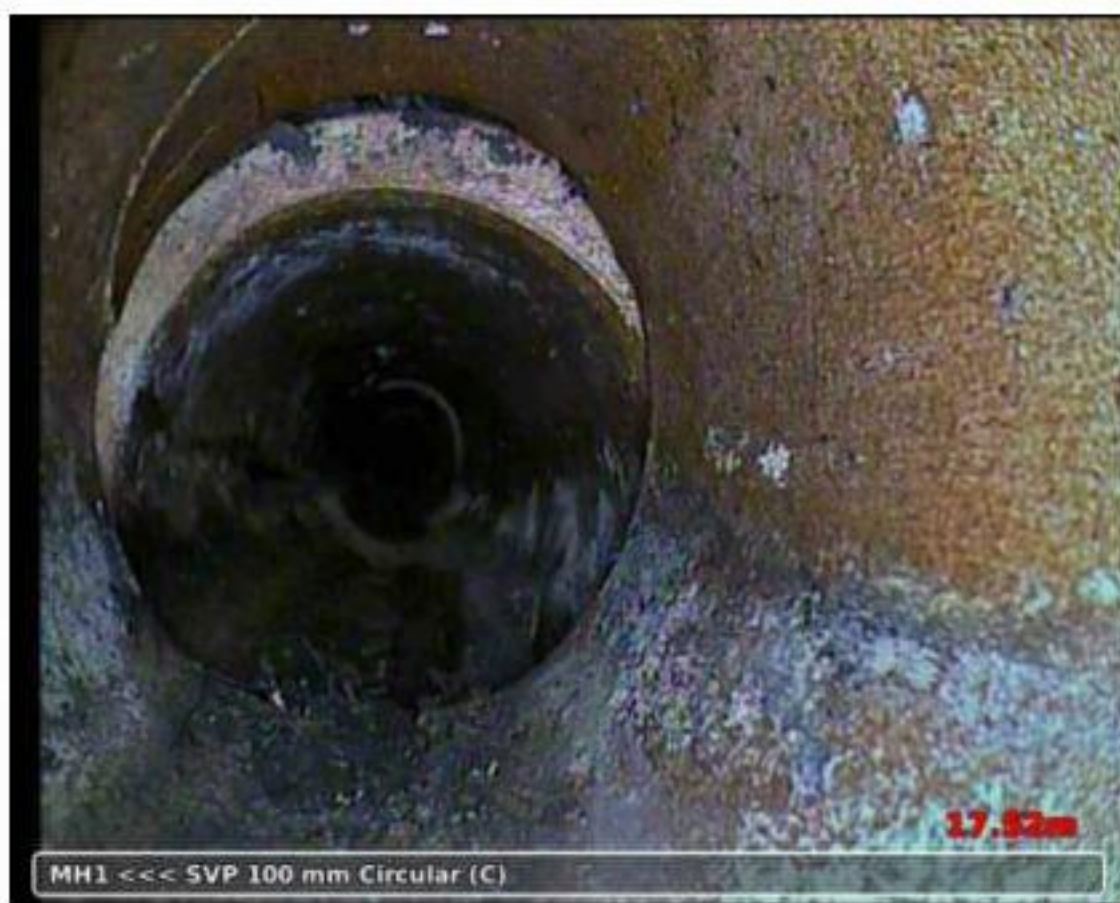
20191010-085806-snap0008.jpg, 00:04:25, 17.52 m  
 Joint displaced, 10 mm displacement

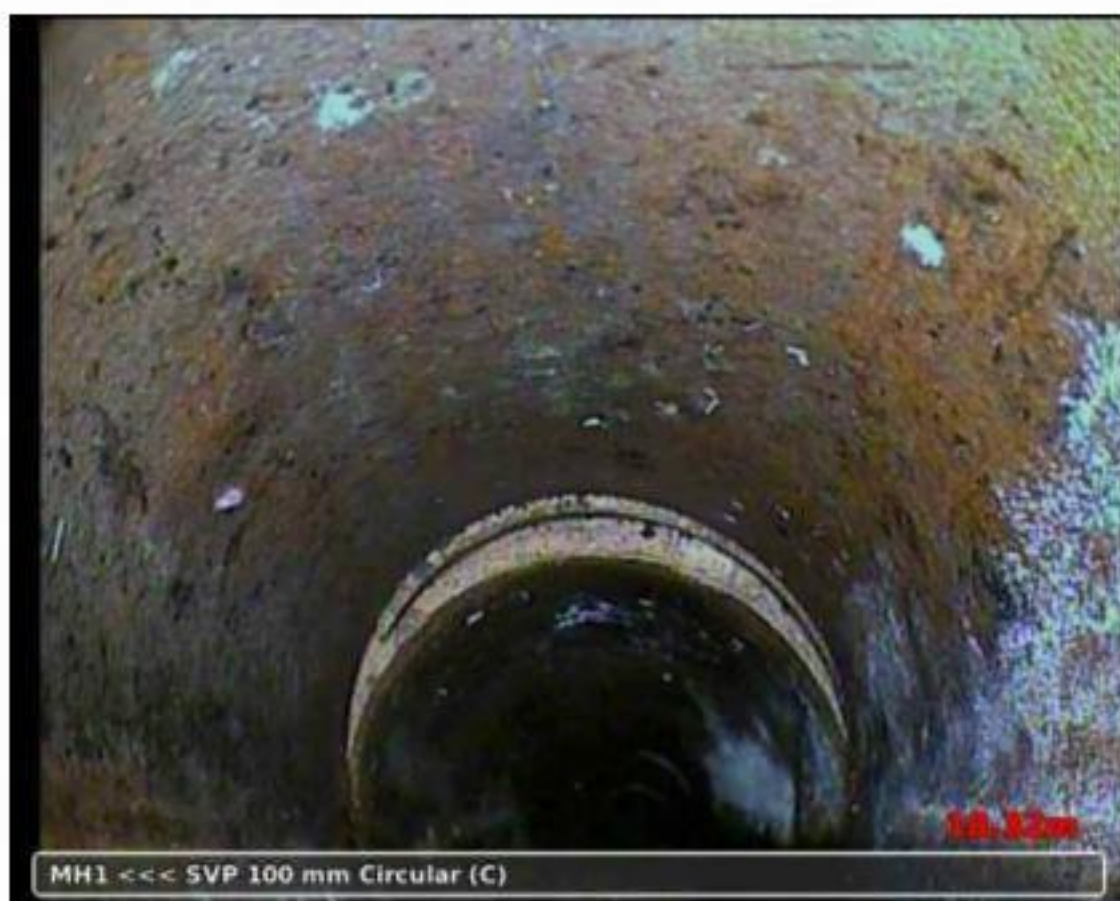
20191010-085806-snap0009.jpg, 00:05:11, 18.32 m  
 Joint displaced, 10 mm displacement

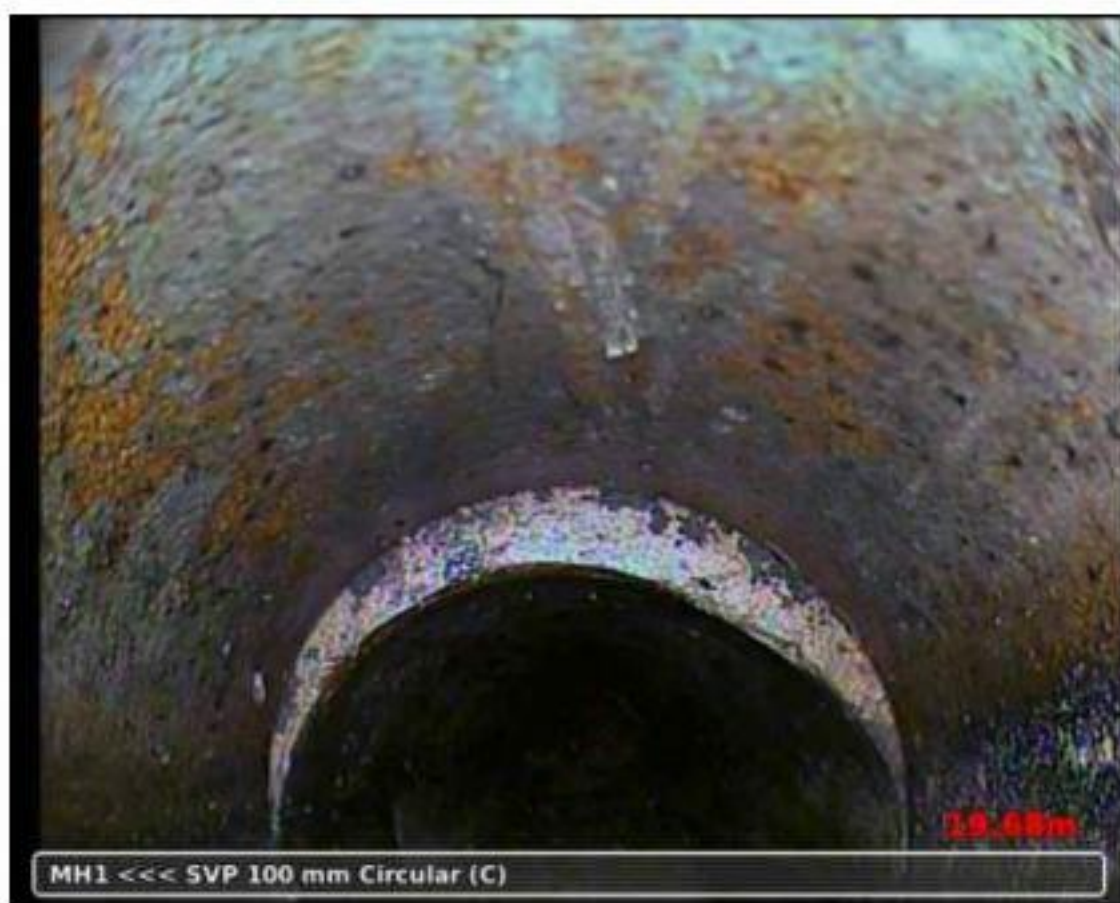
20191010-085806-snap0010.jpg, 00:05:58, 19.68 m  
 Joint displaced, 10 mm displacement

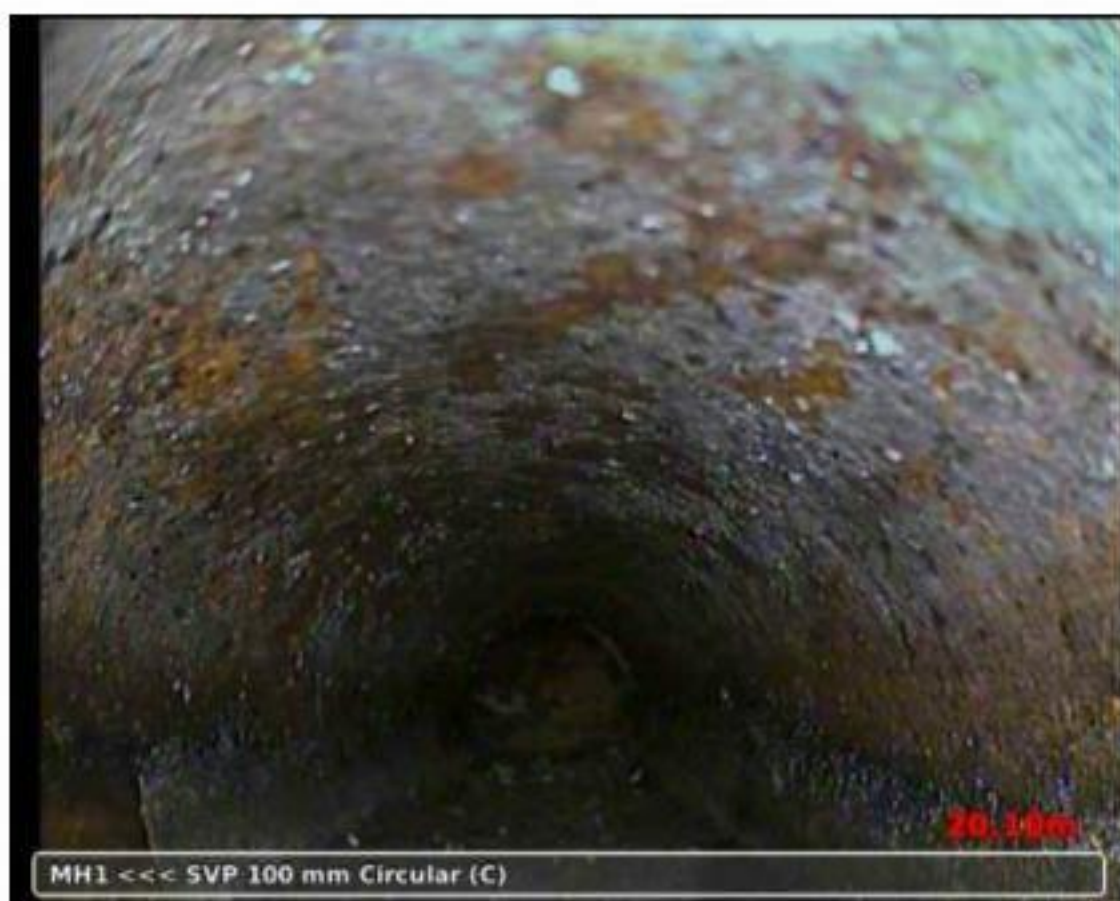
| No. | m+ | Code | Observation |
|---|---|---|---|
| 12 | 20.10 | SA | Survey abandoned, UNABLE TO PASS DEBRIS |

20191010-085806-snap0011.jpg, 00:06:23, 20.10 m  
 Survey abandoned

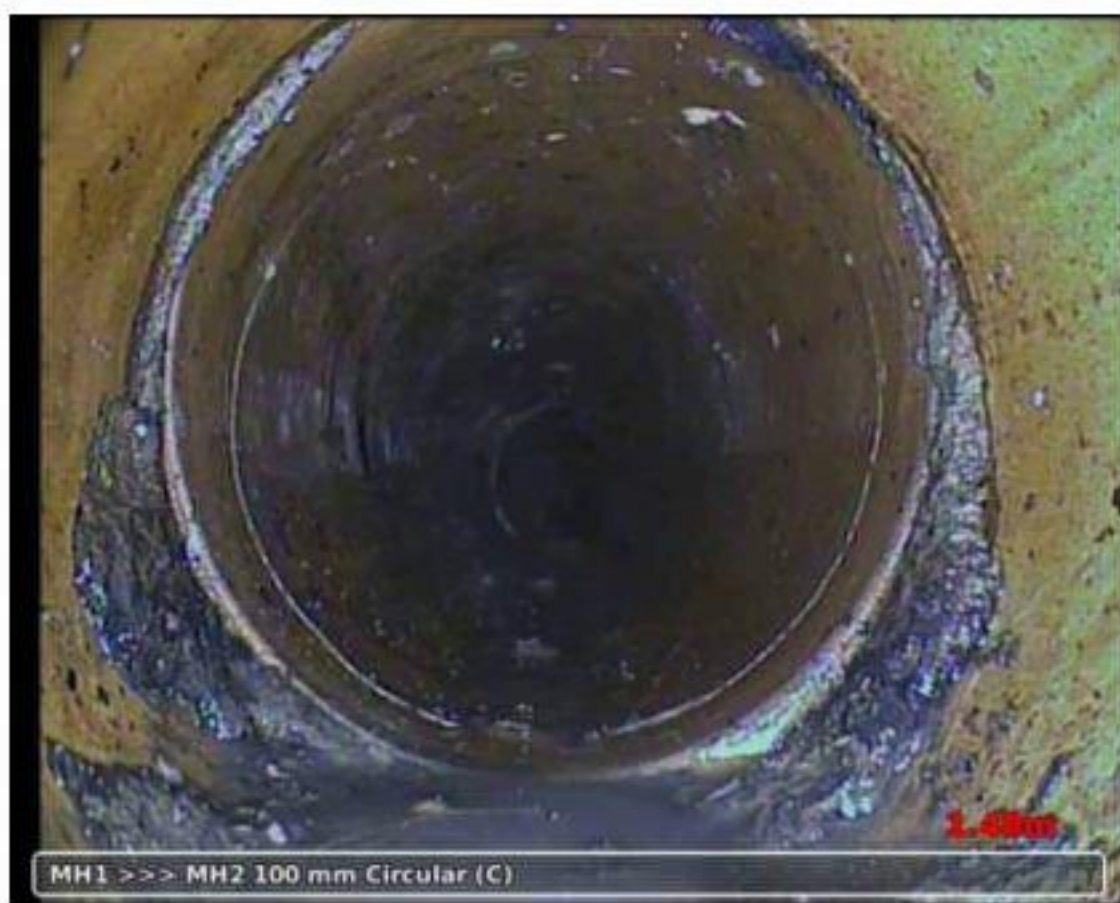
20191010-090906-snap0002.jpg, 00:00:26, 1.48 m  
 Crack, circumferential, from 03 to 10 o'clock

MH1 to MH2 was found to have a large amounts of cracks and sevral points of root ingress this line will need high pressure jetting to remove all of the roots and debris and then install a 19m liner to prevent any of the roots from coming back and to prevent the cracks getting any worse.

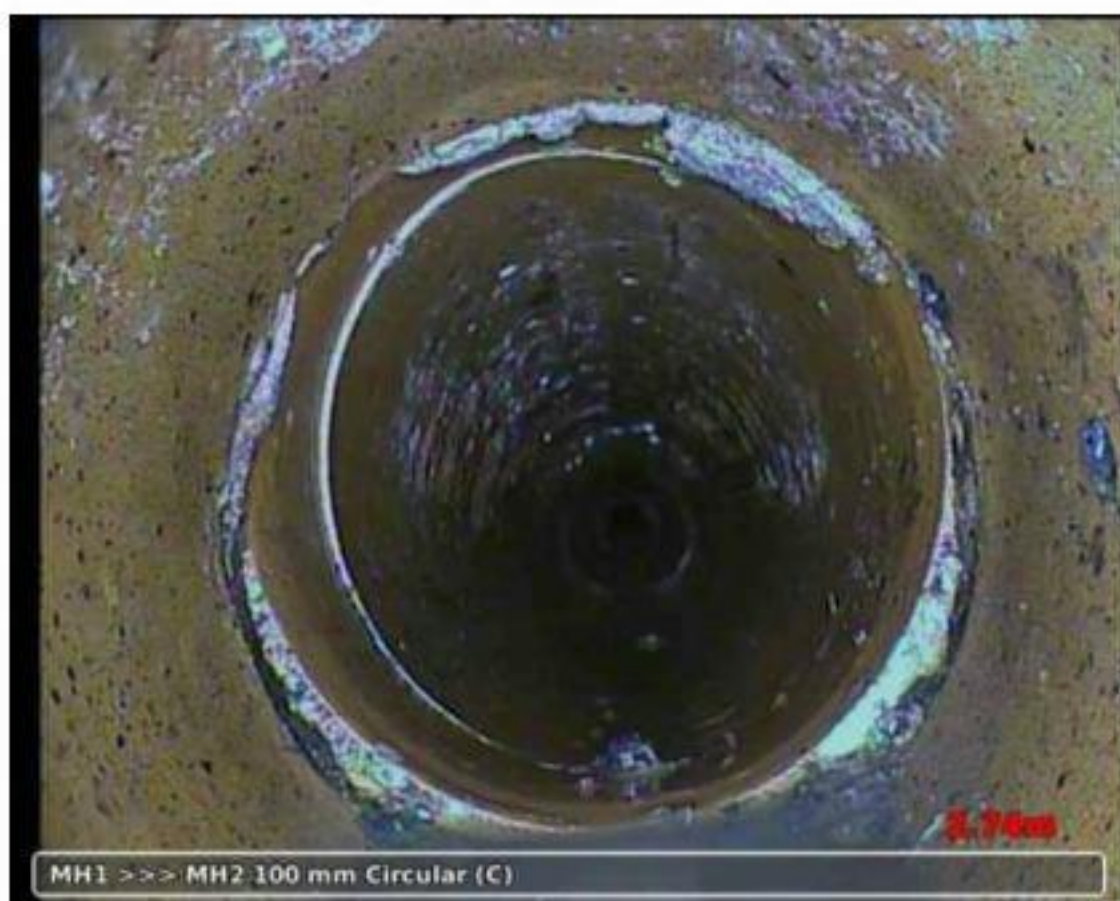
20191010-090906-snap0003.jpg, 00:00:47, 2.70 m  
 Crack, circumferential, from 06 to 12 o'clock

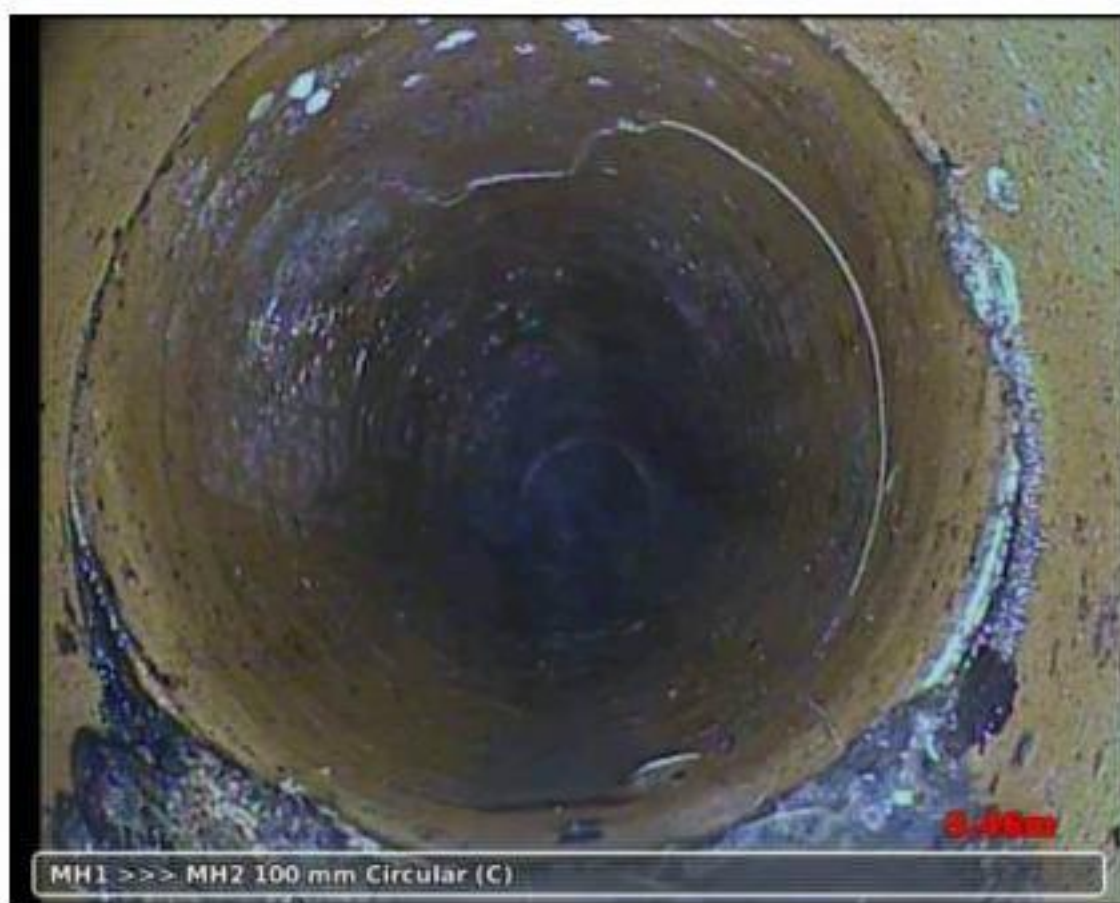
20191010-090906-snap0004.jpg, 00:01:19, 3.46 m  
 Crack, circumferential, from 12 to 06 o'clock

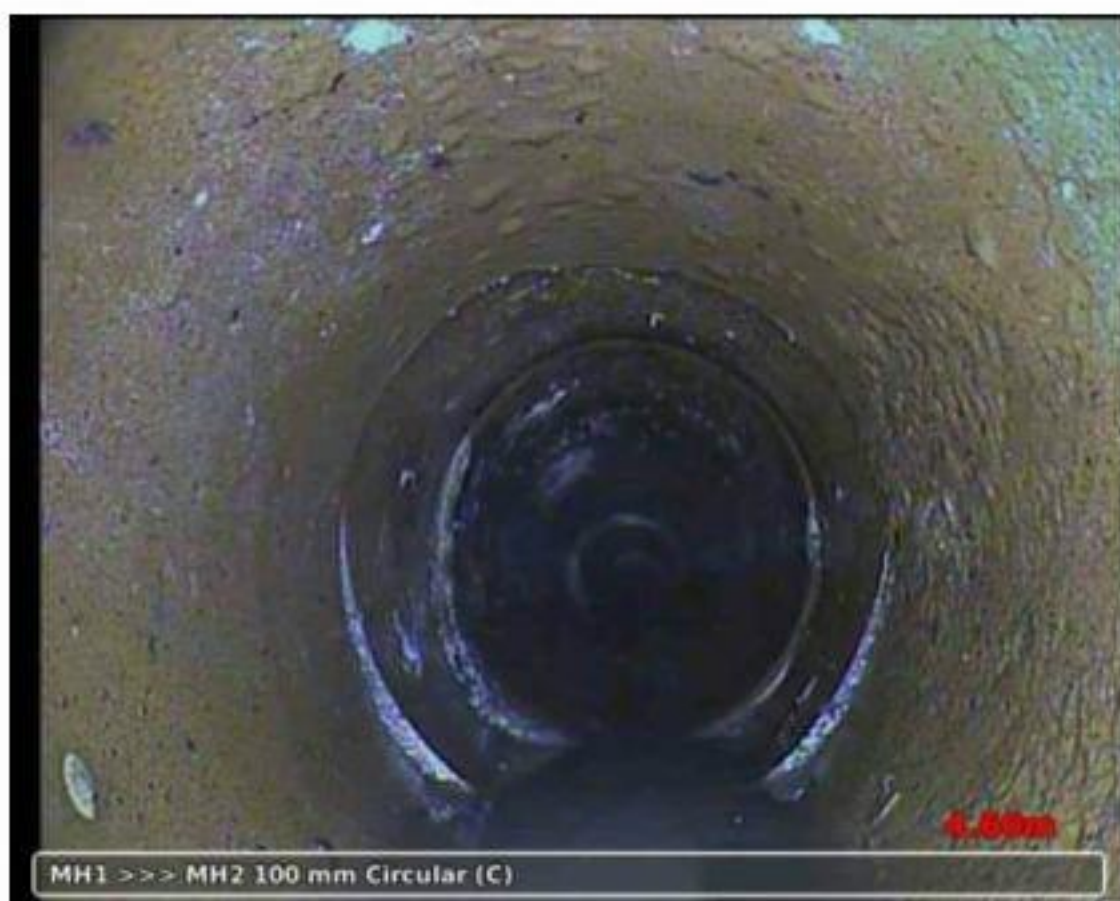
20191010-090906-snap0005.jpg, 00:01:42, 4.60 m  
 Crack, circumferential, from 12 to 12 o'clock

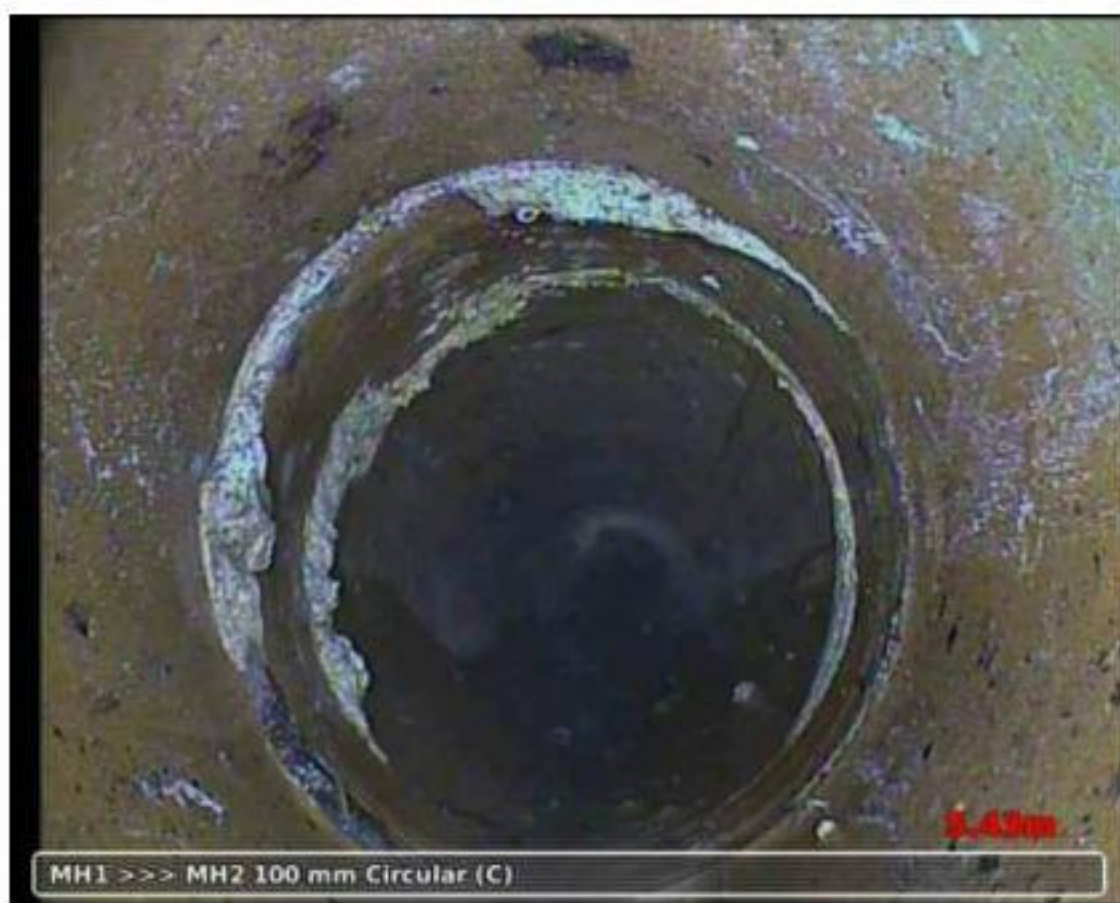
20191010-090906-snap0006.jpg, 00:02:01, 5.43 m  
 Crack, circumferential, from 12 to 12 o'clock

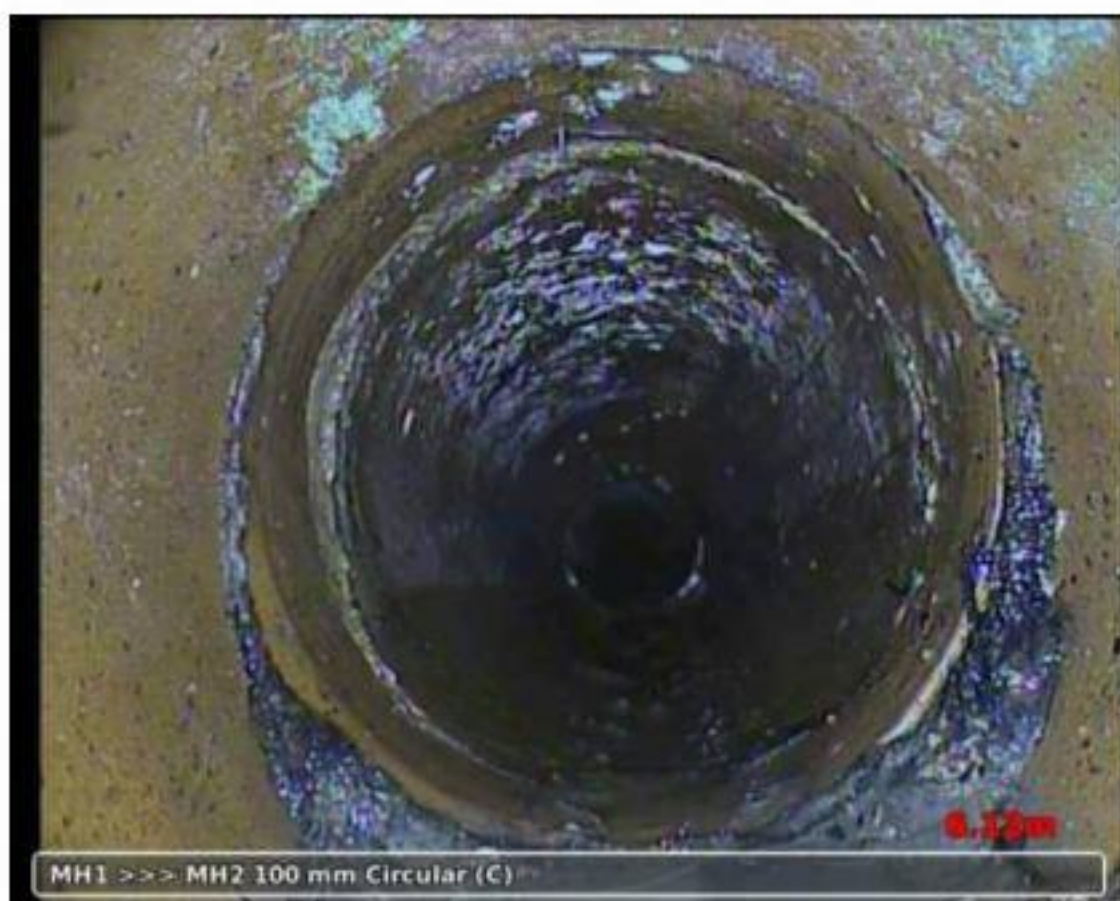
20191010-090906-snap0007.jpg, 00:02:24, 6.12 m  
 Crack, circumferential, from 12 to 12 o'clock

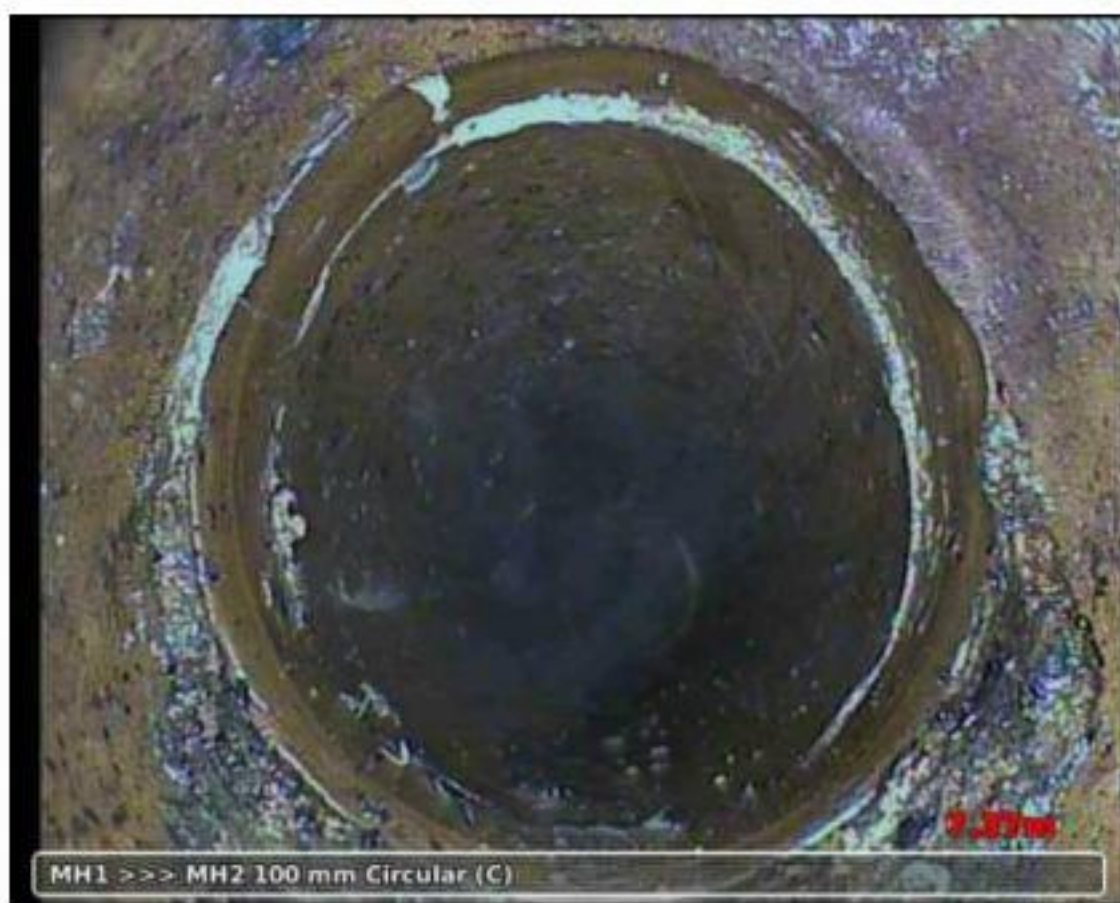
20191010-090906-snap0008.jpg, 00:02:44, 7.37 m  
 Crack, circumferential, from 12 to 12 o'clock

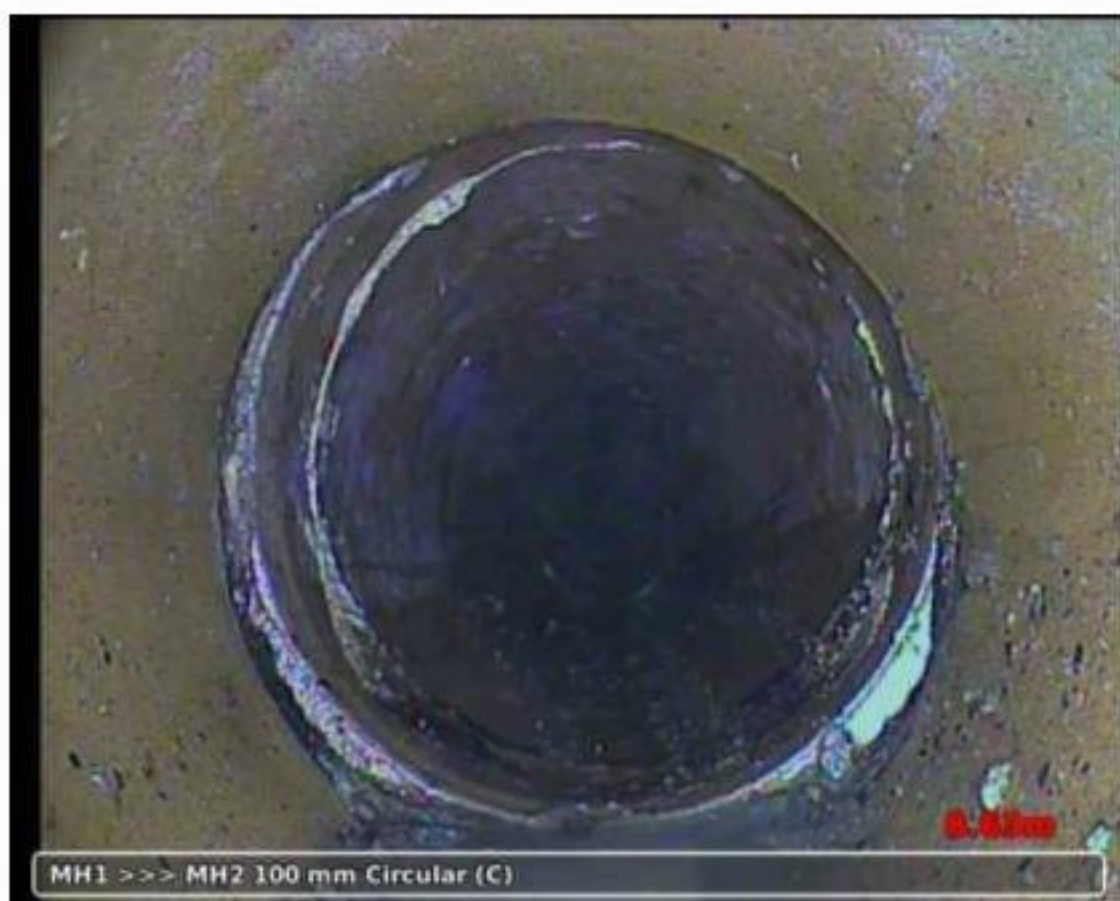
20191010-090906-snap0009.jpg, 00:03:05, 8.63 m  
 Crack, circumferential, from 12 to 12 o'clock

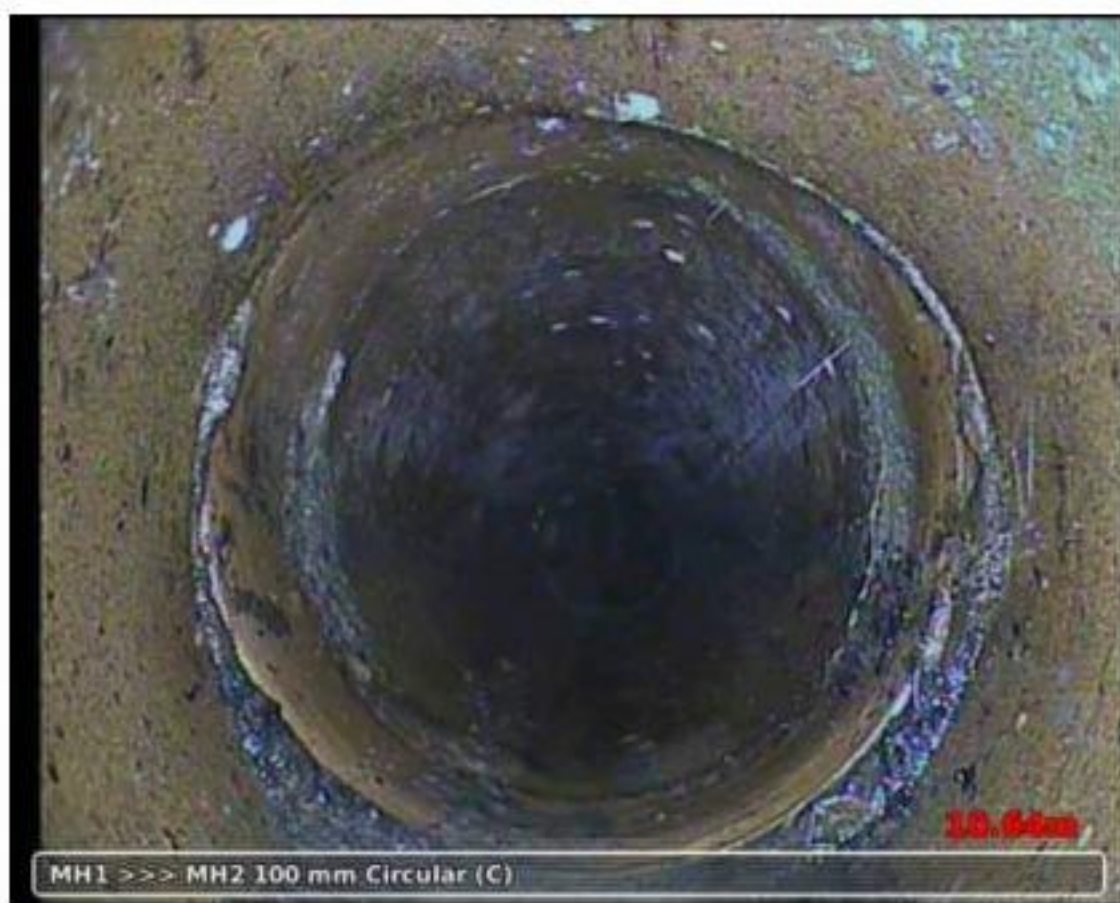
20191010-090906-snap0010.jpg, 00:03:32, 10.64 m  
 Crack, circumferential, from 12 to 12 o'clock

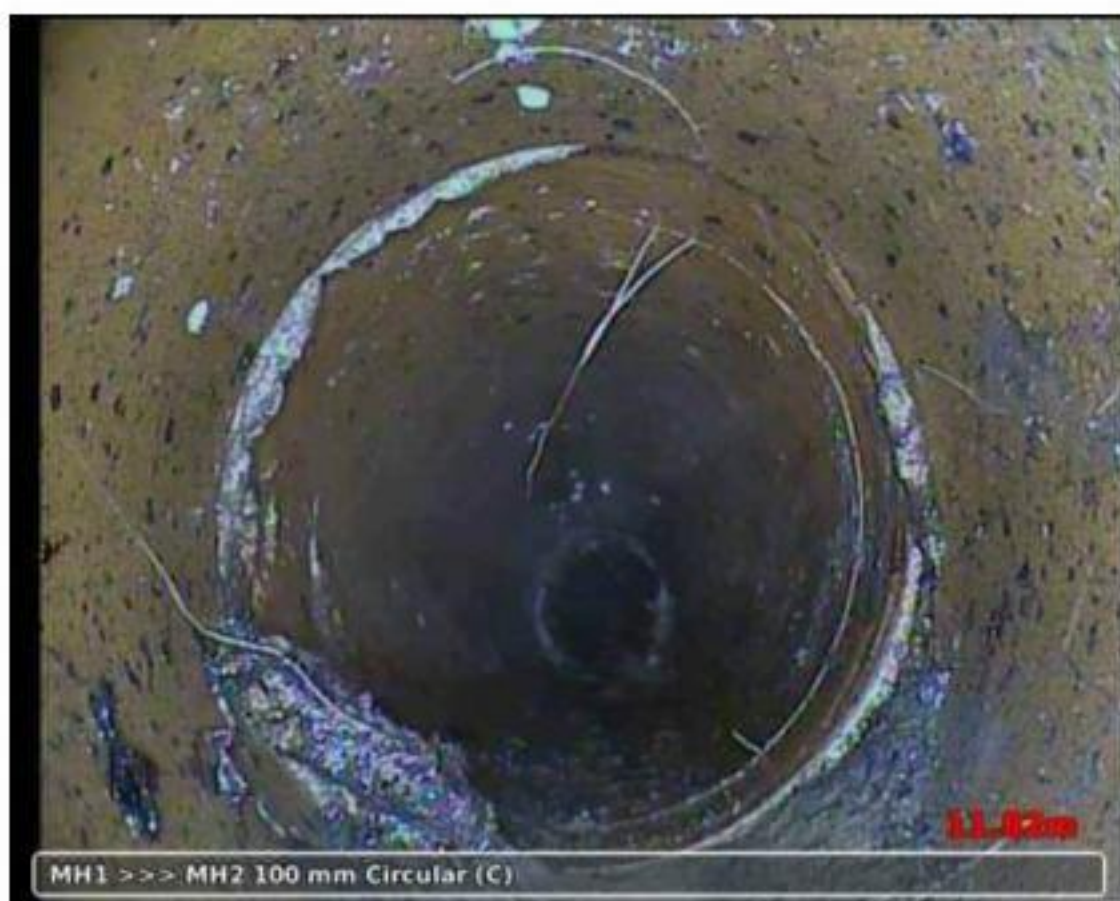
20191010-090906-snap0011.jpg, 00:03:56, 11.82 m  
 Crack, circumferential, from 12 to 12 o'clock

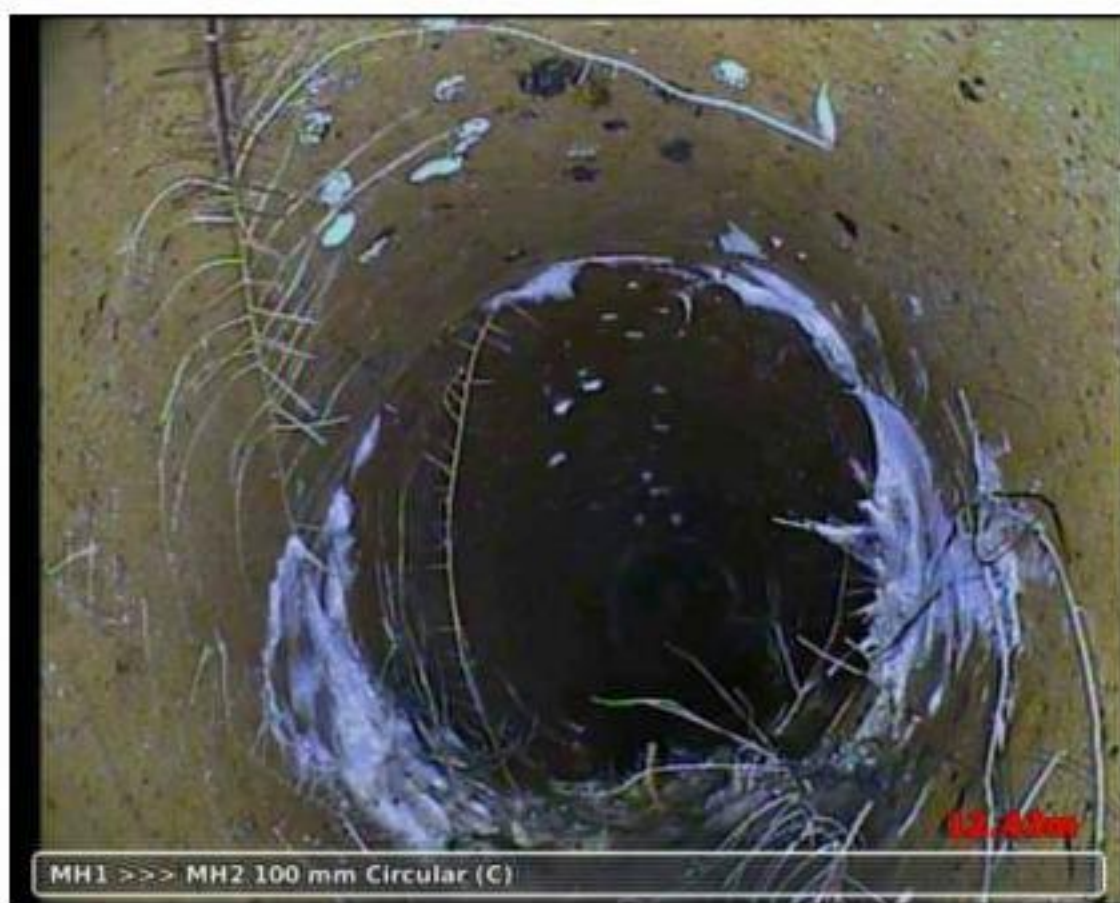
20191010-090906-snap0012.jpg, 00:04:12, 12.43 m  
 Roots, fine

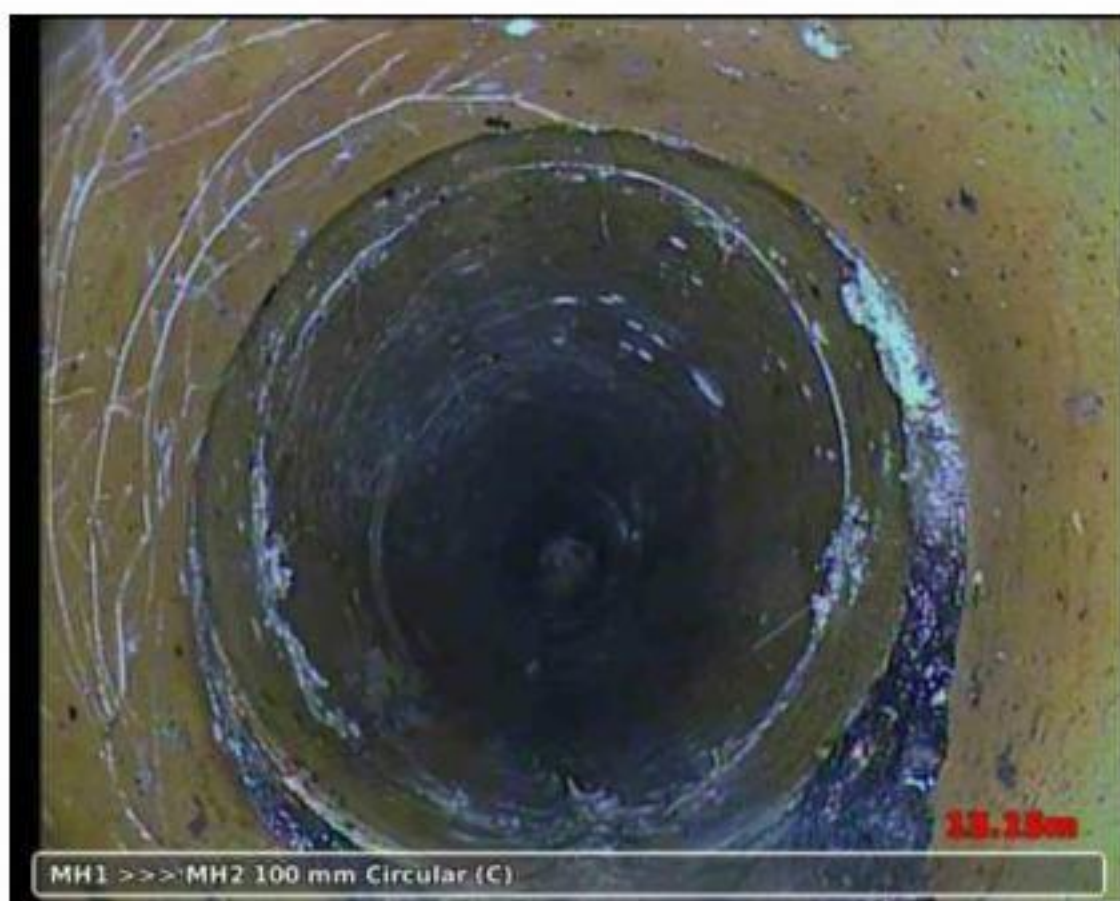
20191010-090906-snap0013.jpg, 00:04:23, 13.15 m  
 Roots, fine

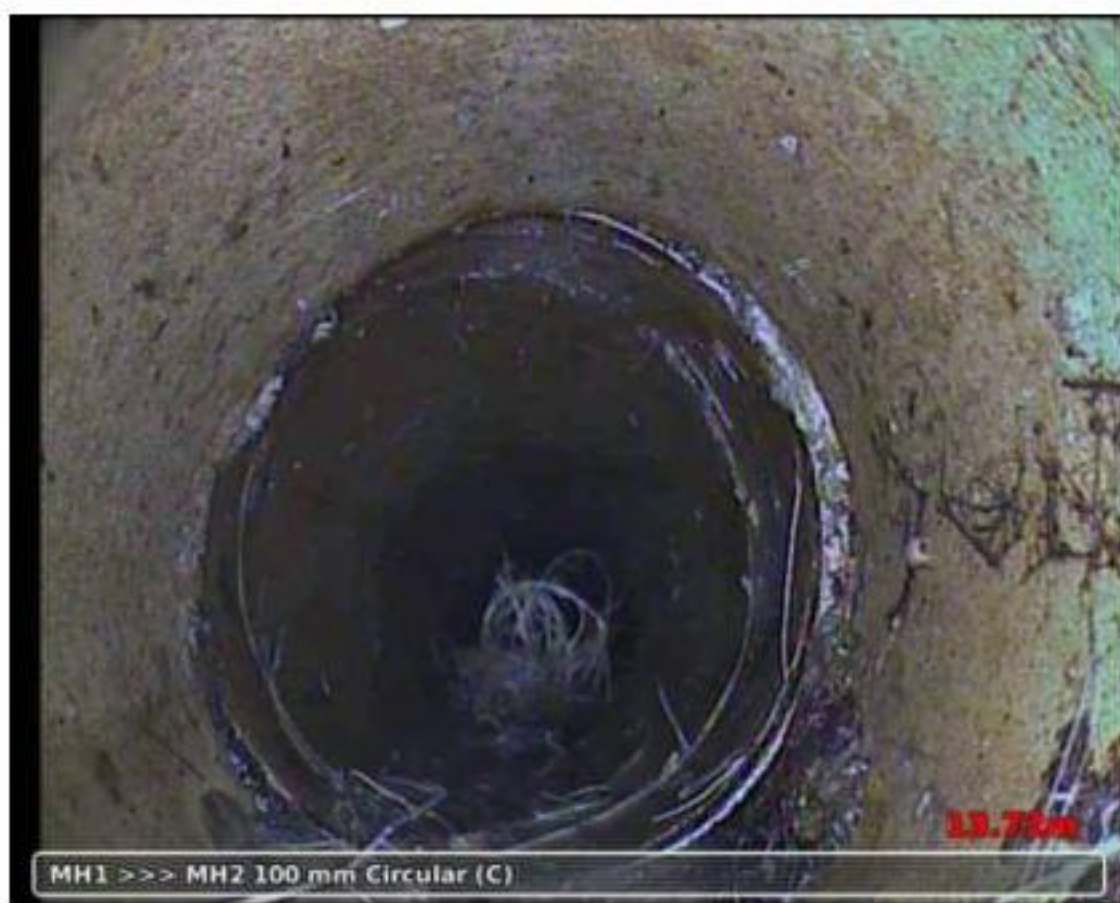
20191010-090906-snap0014.jpg, 00:04:35, 13.72 m  
 Roots, fine
