**Project Name**  
50 Silvester Road**Project Number****Project Date**  
14/10/2019

**Company:** 24/7 Drainage Solutions Ltd  
**Contact:** Lee Moore  
**Street:** 27 Murray Road  
**Town or City:** Waterlooville  
**County:** Hampshire  
**Post Code:** PO8 9JE  
**Phone:** 02392429417

### CCTV SURVEY SUMMARY

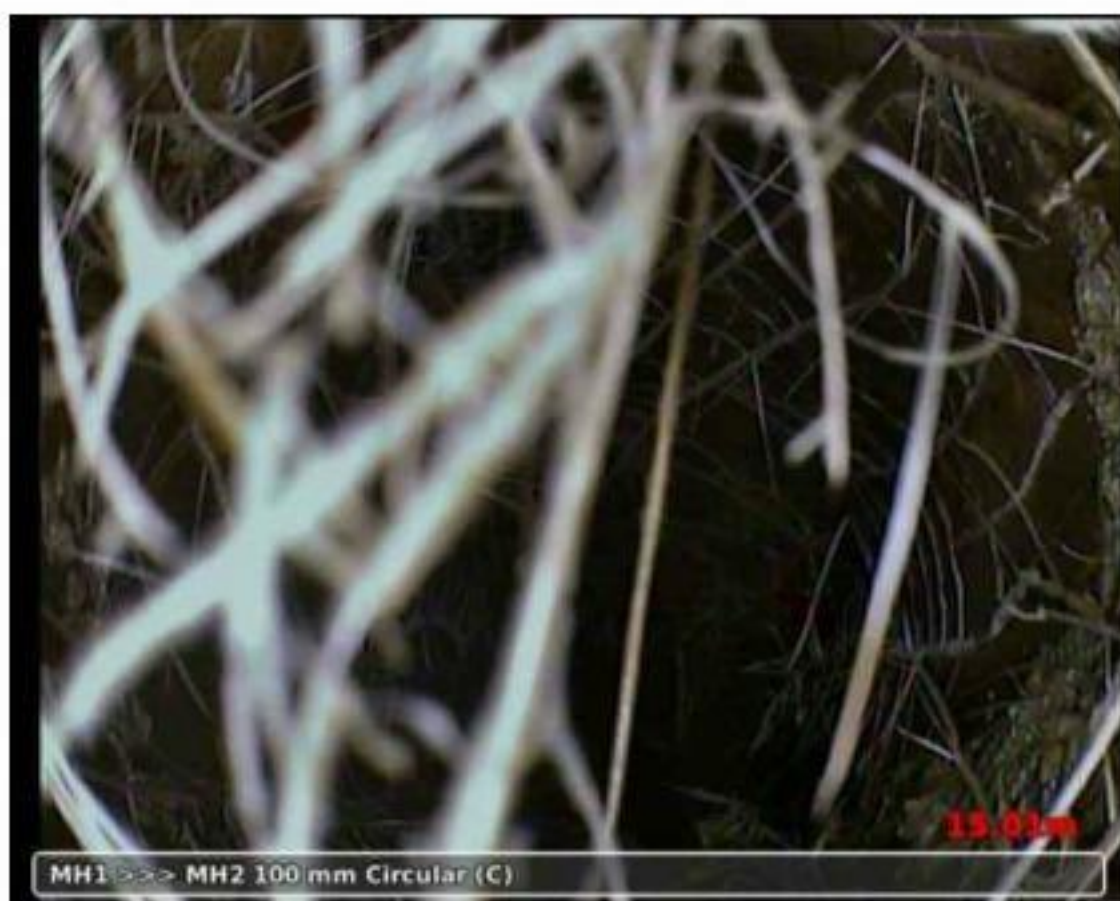
| No. | m+ | Code | Observation |
|---|---|---|---|
| 17 | 15.01 | RM | Roots, mass, 40 % cross-sectional area loss |

20191010-090906-snap0015.jpg, 00:05:03, 15.01 m  
 Roots, mass, 40 % cross-sectional area loss

MH1 to MH2 was found to have a large amounts of cracks and sevral points of root ingress this line will need high pressure jetting to remove all of the roots and debris and then install a 19m liner to prevent any of the roots from coming back and to prevent the cracks getting any worse.

MH1 to MH2 will also require a root cut in prep for the 19m liner once high pressure jetting has been used to fully clear lines the liner can be installed.

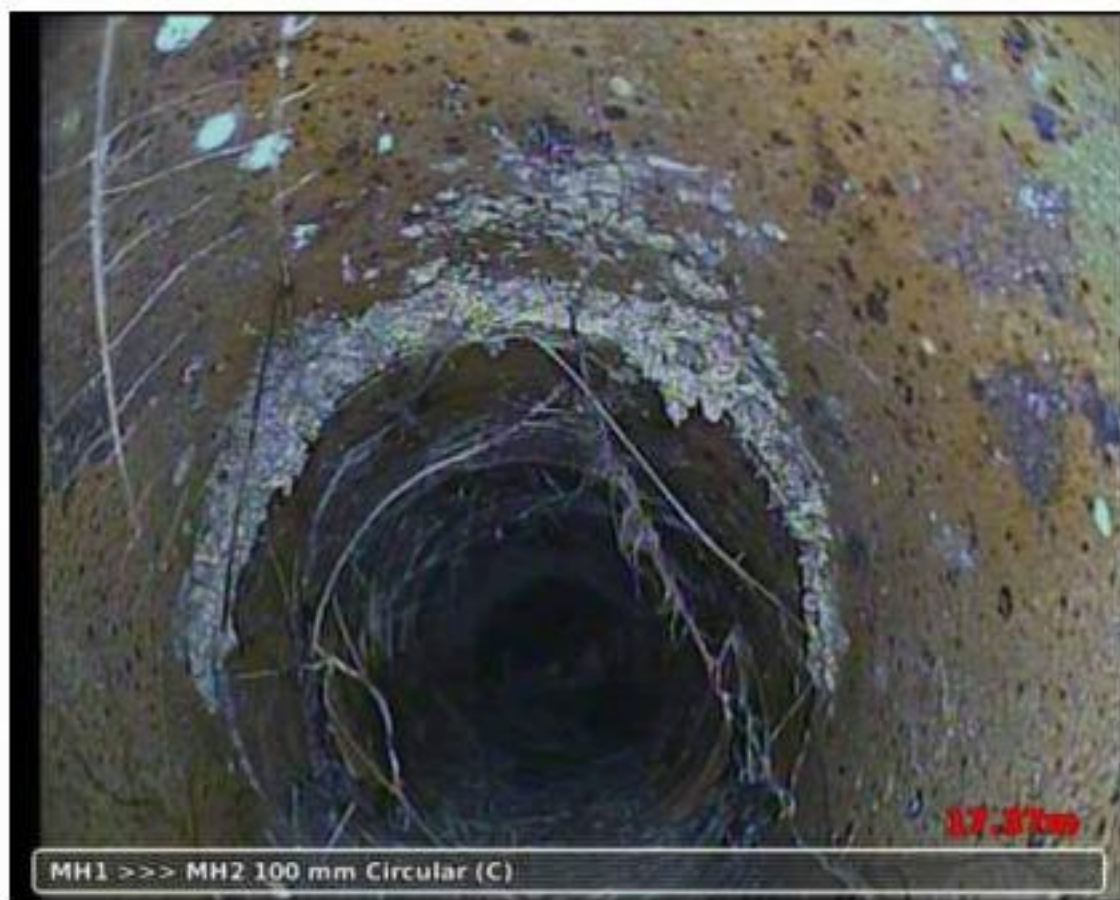
20191010-090906-snap0016.jpg, 00:05:31, 17.37 m  
 Roots, fine

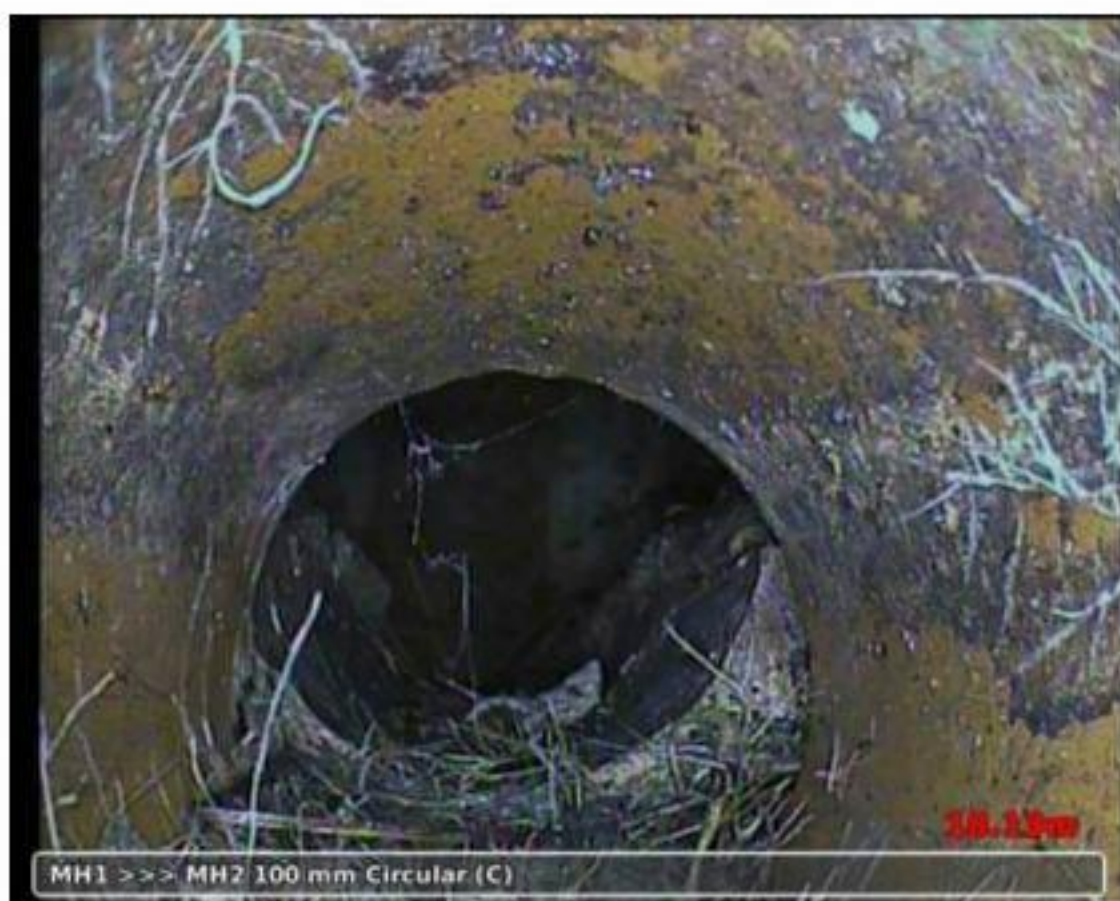
| No. | m+ | Code | Observation |
|---|---|---|---|
| 19 | 18.09 | JD | Joint displaced, 20 mm displacement, DISPLACED INTO MANHOLE |

20191010-090906-snap0017.jpg, 00:05:52, 18.09 m  
 Joint displaced, 20 mm displacement

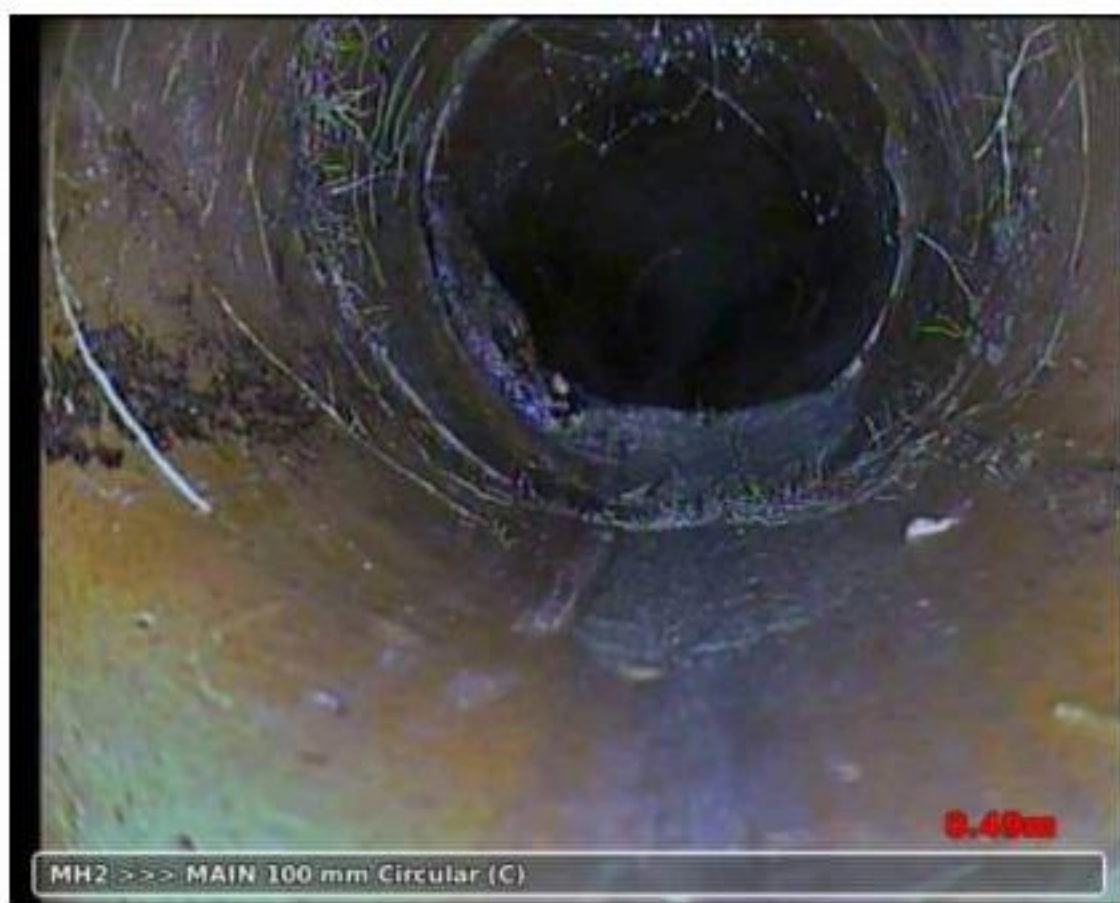
20191010-092247-snap0002.jpg, 00:00:33, 0.49 m  
 Roots, fine
