**Procter & Gamble**

**Phase 2  
Site Investigation**

Procter & Gamble Product Supply (UK) Ltd,  
Havant

August 2003

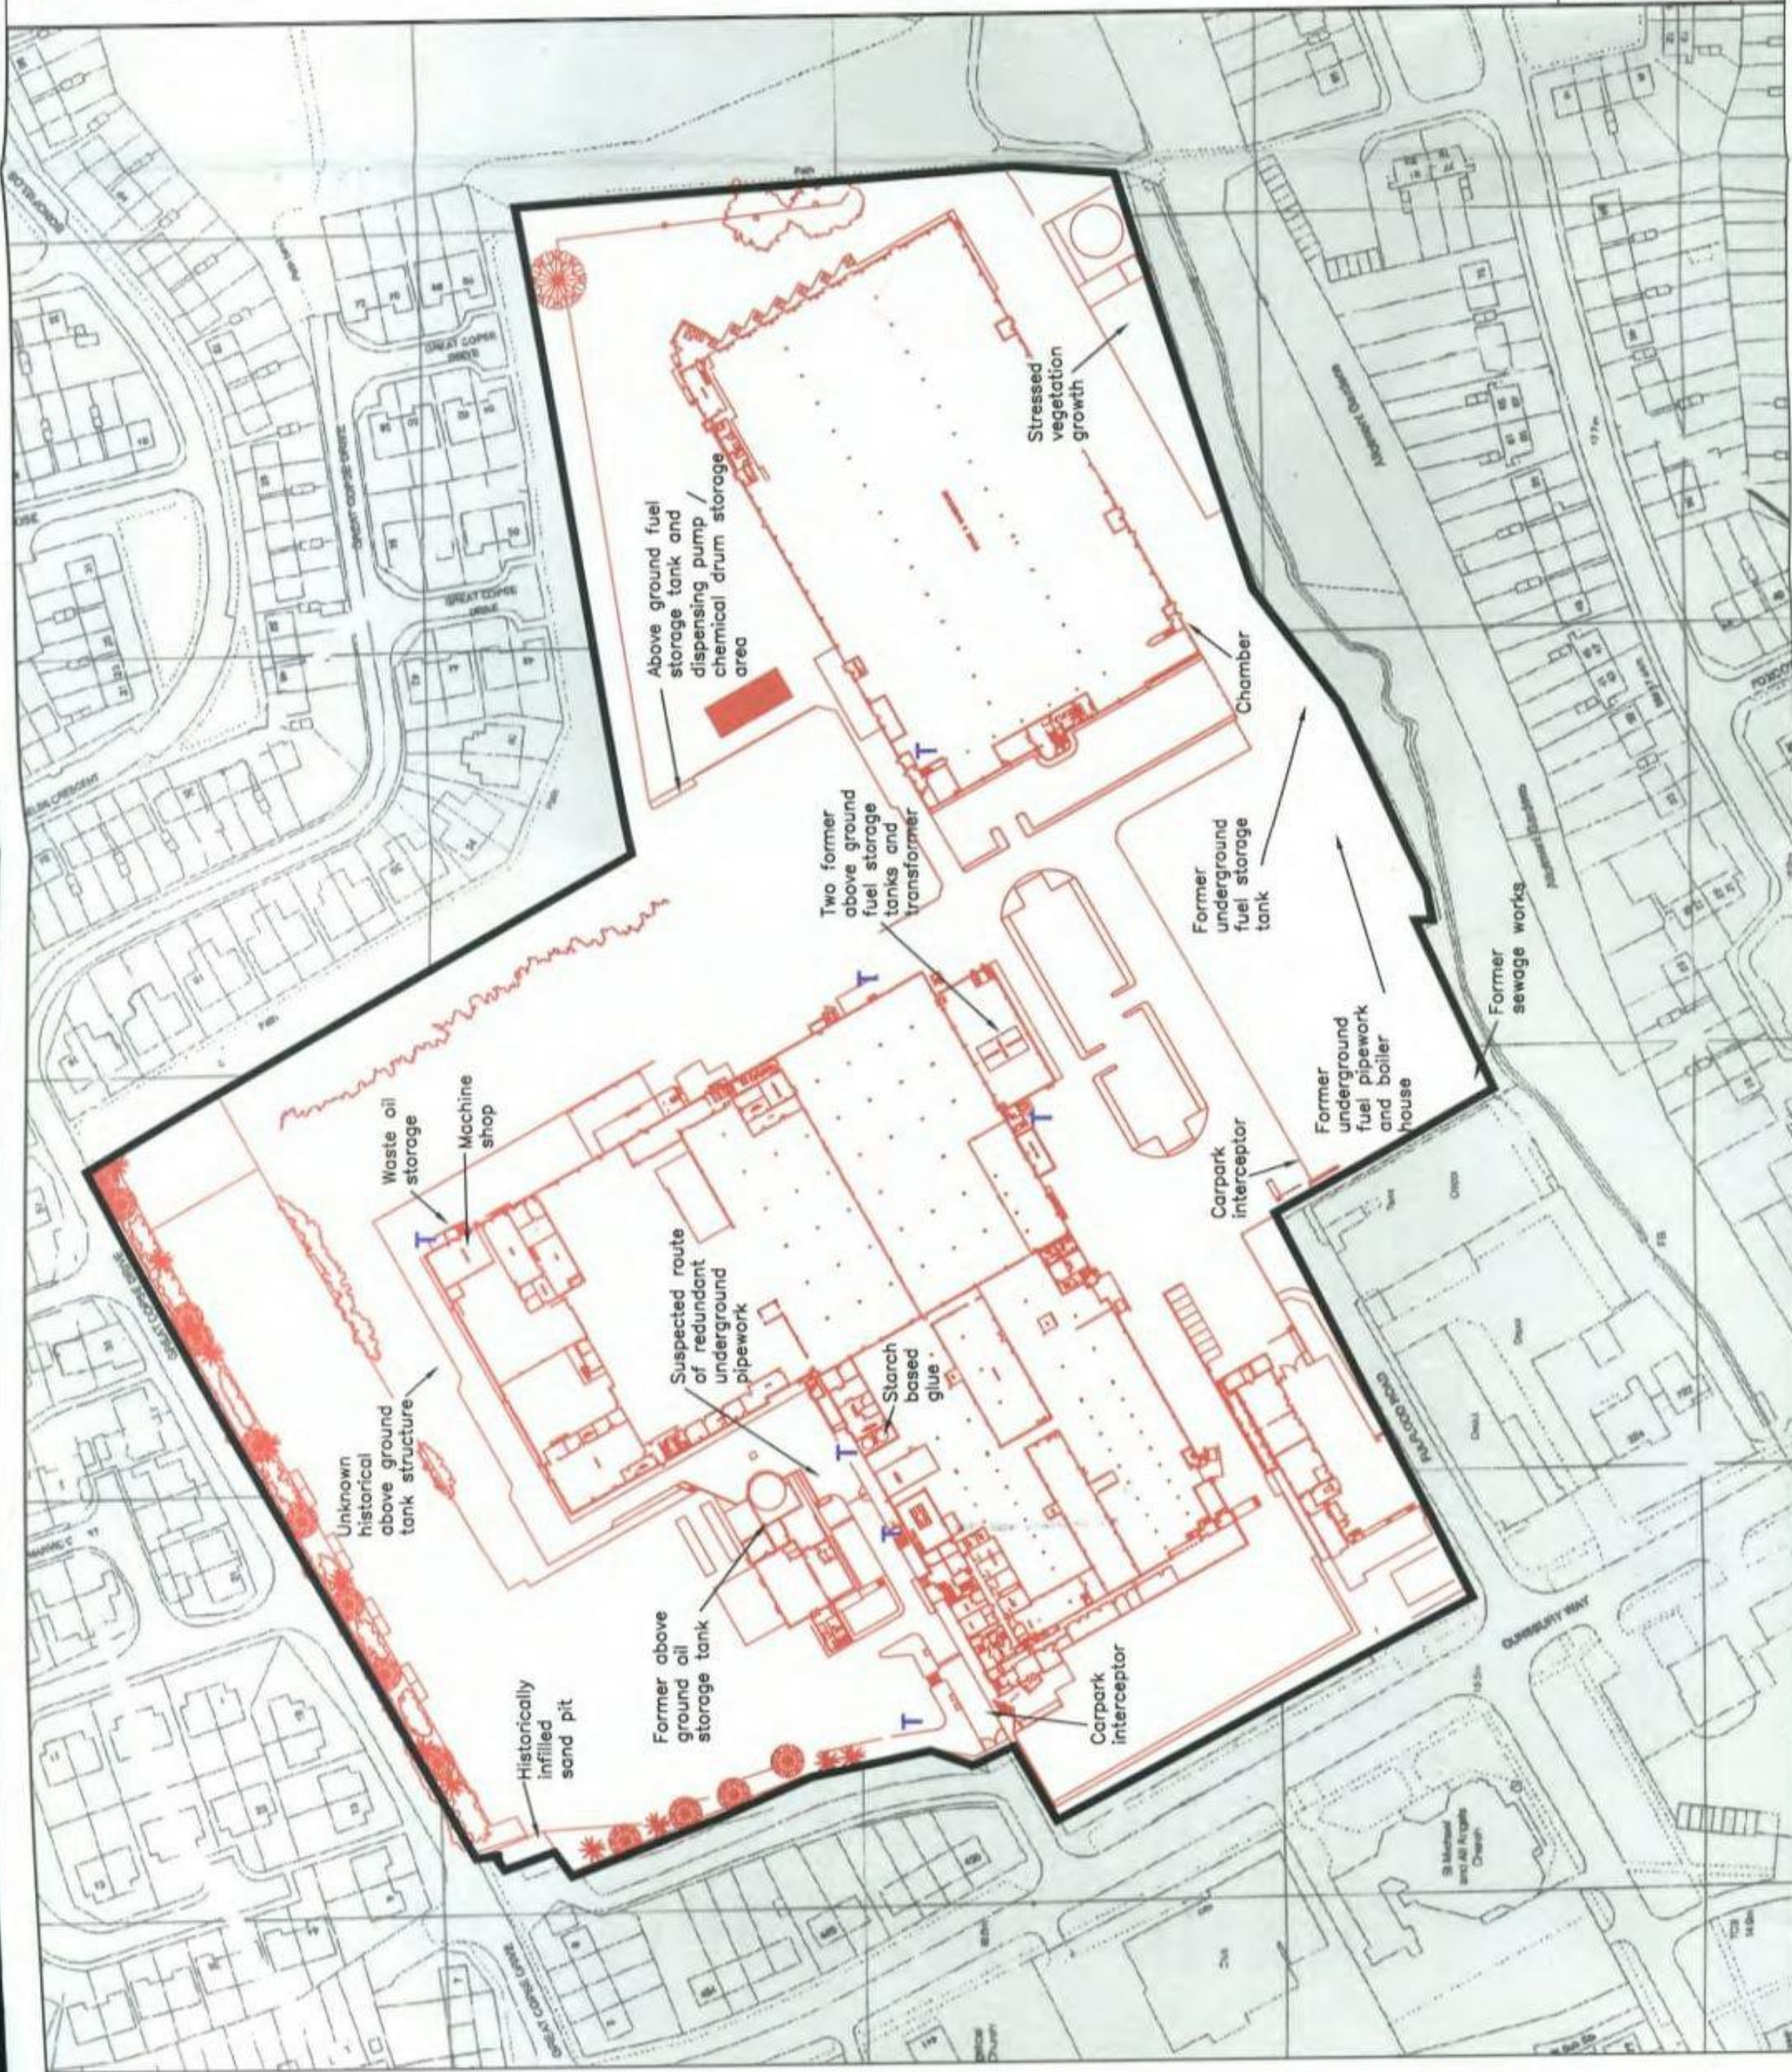
Figure 1.2  
Potentially Contaminative Issues

- oil spillage evident in the stream prior to the removal of the underground fuel oil storage tank;
- an historical sewage treatment works;
- oil spillage inside a cable duct;
- an historical infilled sand pit;
- historical above ground tanks of unknown usage;
- Former electrical transformer and aboveground fuel tanks;
- Current diesel fuelling point;
- Made Ground (infill material) quality under former Scalextric site;
- Redundant underground fuel pipes.

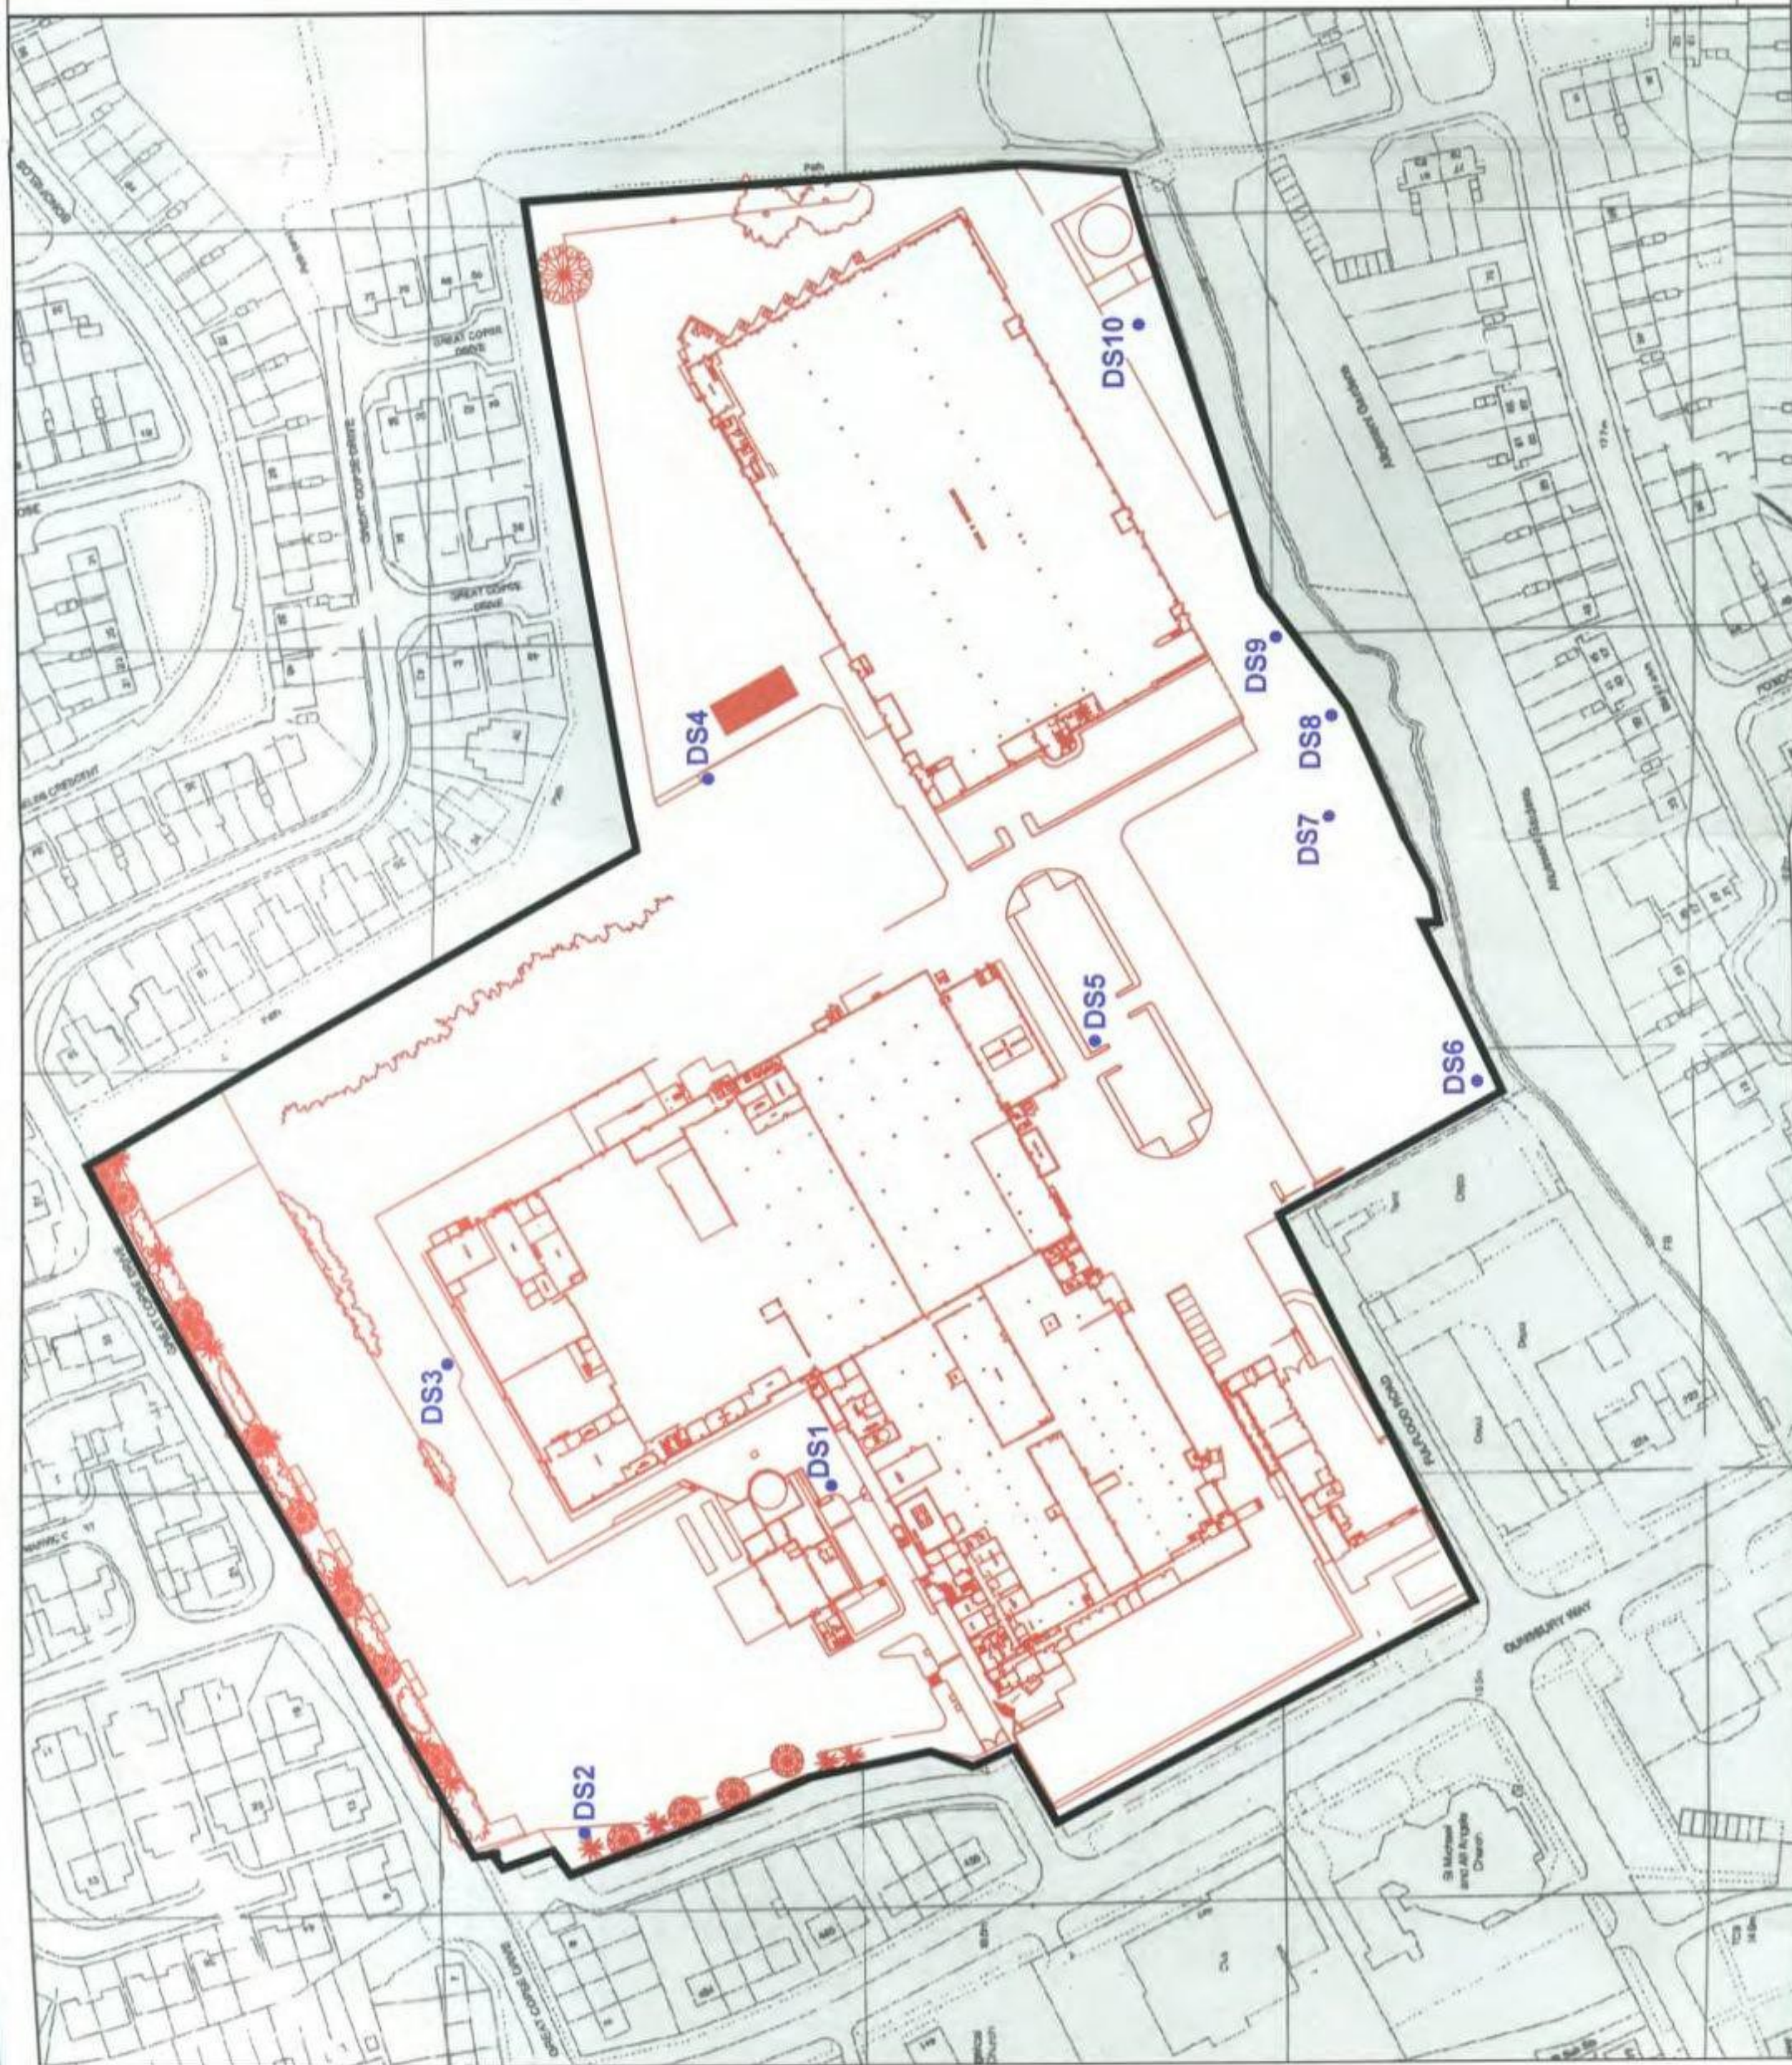
Figure 3.1  
Sample Locations

Slight elevations in PAH concentrations in soil were observed above generic guideline values in sample location DS10. (See Figure 3.1 for details of sampling locations)

- DS1, 1.1 to 1.5 m bgl; Slight hydrocarbon odour in Made Ground, small pockets of oil within fissures in clay causing discolouring. Slight film on groundwater seepage.
- DS4, 0.25 m bgl; Broken asbestos cement tile recovered from Made Ground
- DS5, 0.5 m bgl; very slight hydrocarbon odour in ground
- DS8, 1.55 to 1.85 bgl; slight hydrocarbon odour
- DS9, at around 3 m bgl; strong hydrocarbon odour
