DESK STUDY REPORT  
FOR THE SITE OF:

The Orchard House  
Western Avenue  
Emsworth  
Hampshire  
PO10 7LP

## DESK STUDY REPORT

**REPORT NO:**    16-73762/GW/DSReport

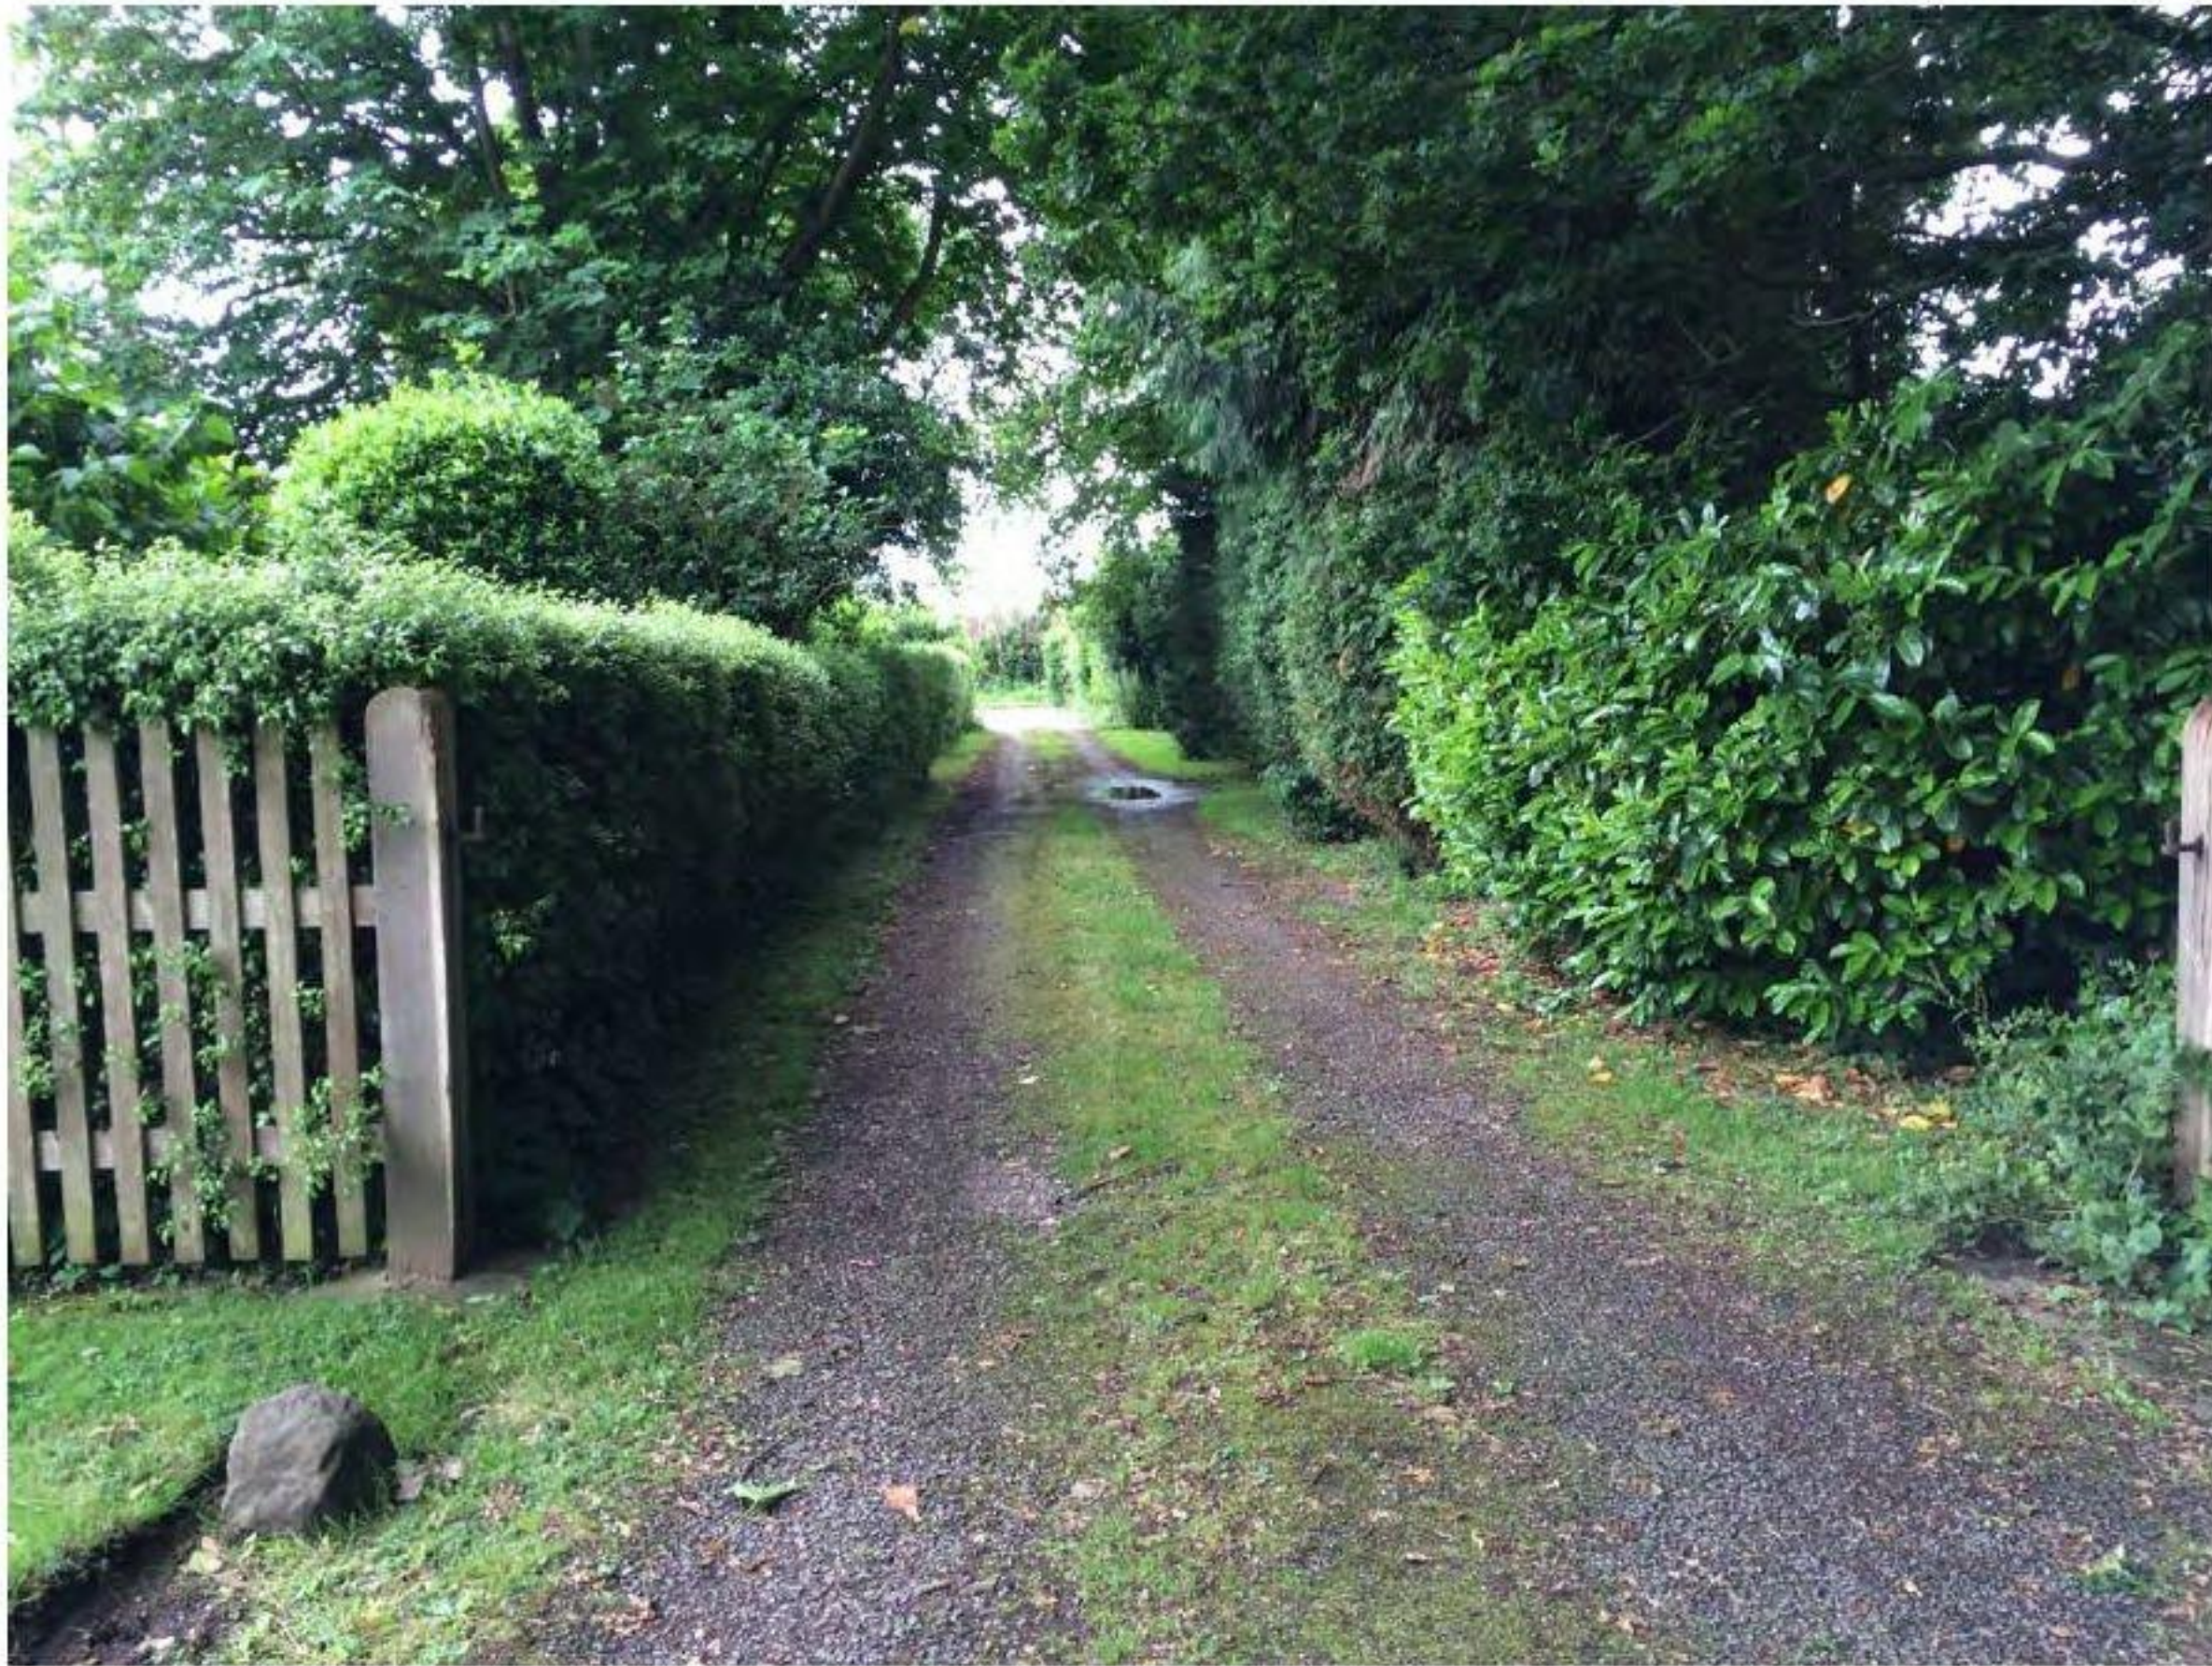
Plate 1: Access to Vine House beside the western site boundary.

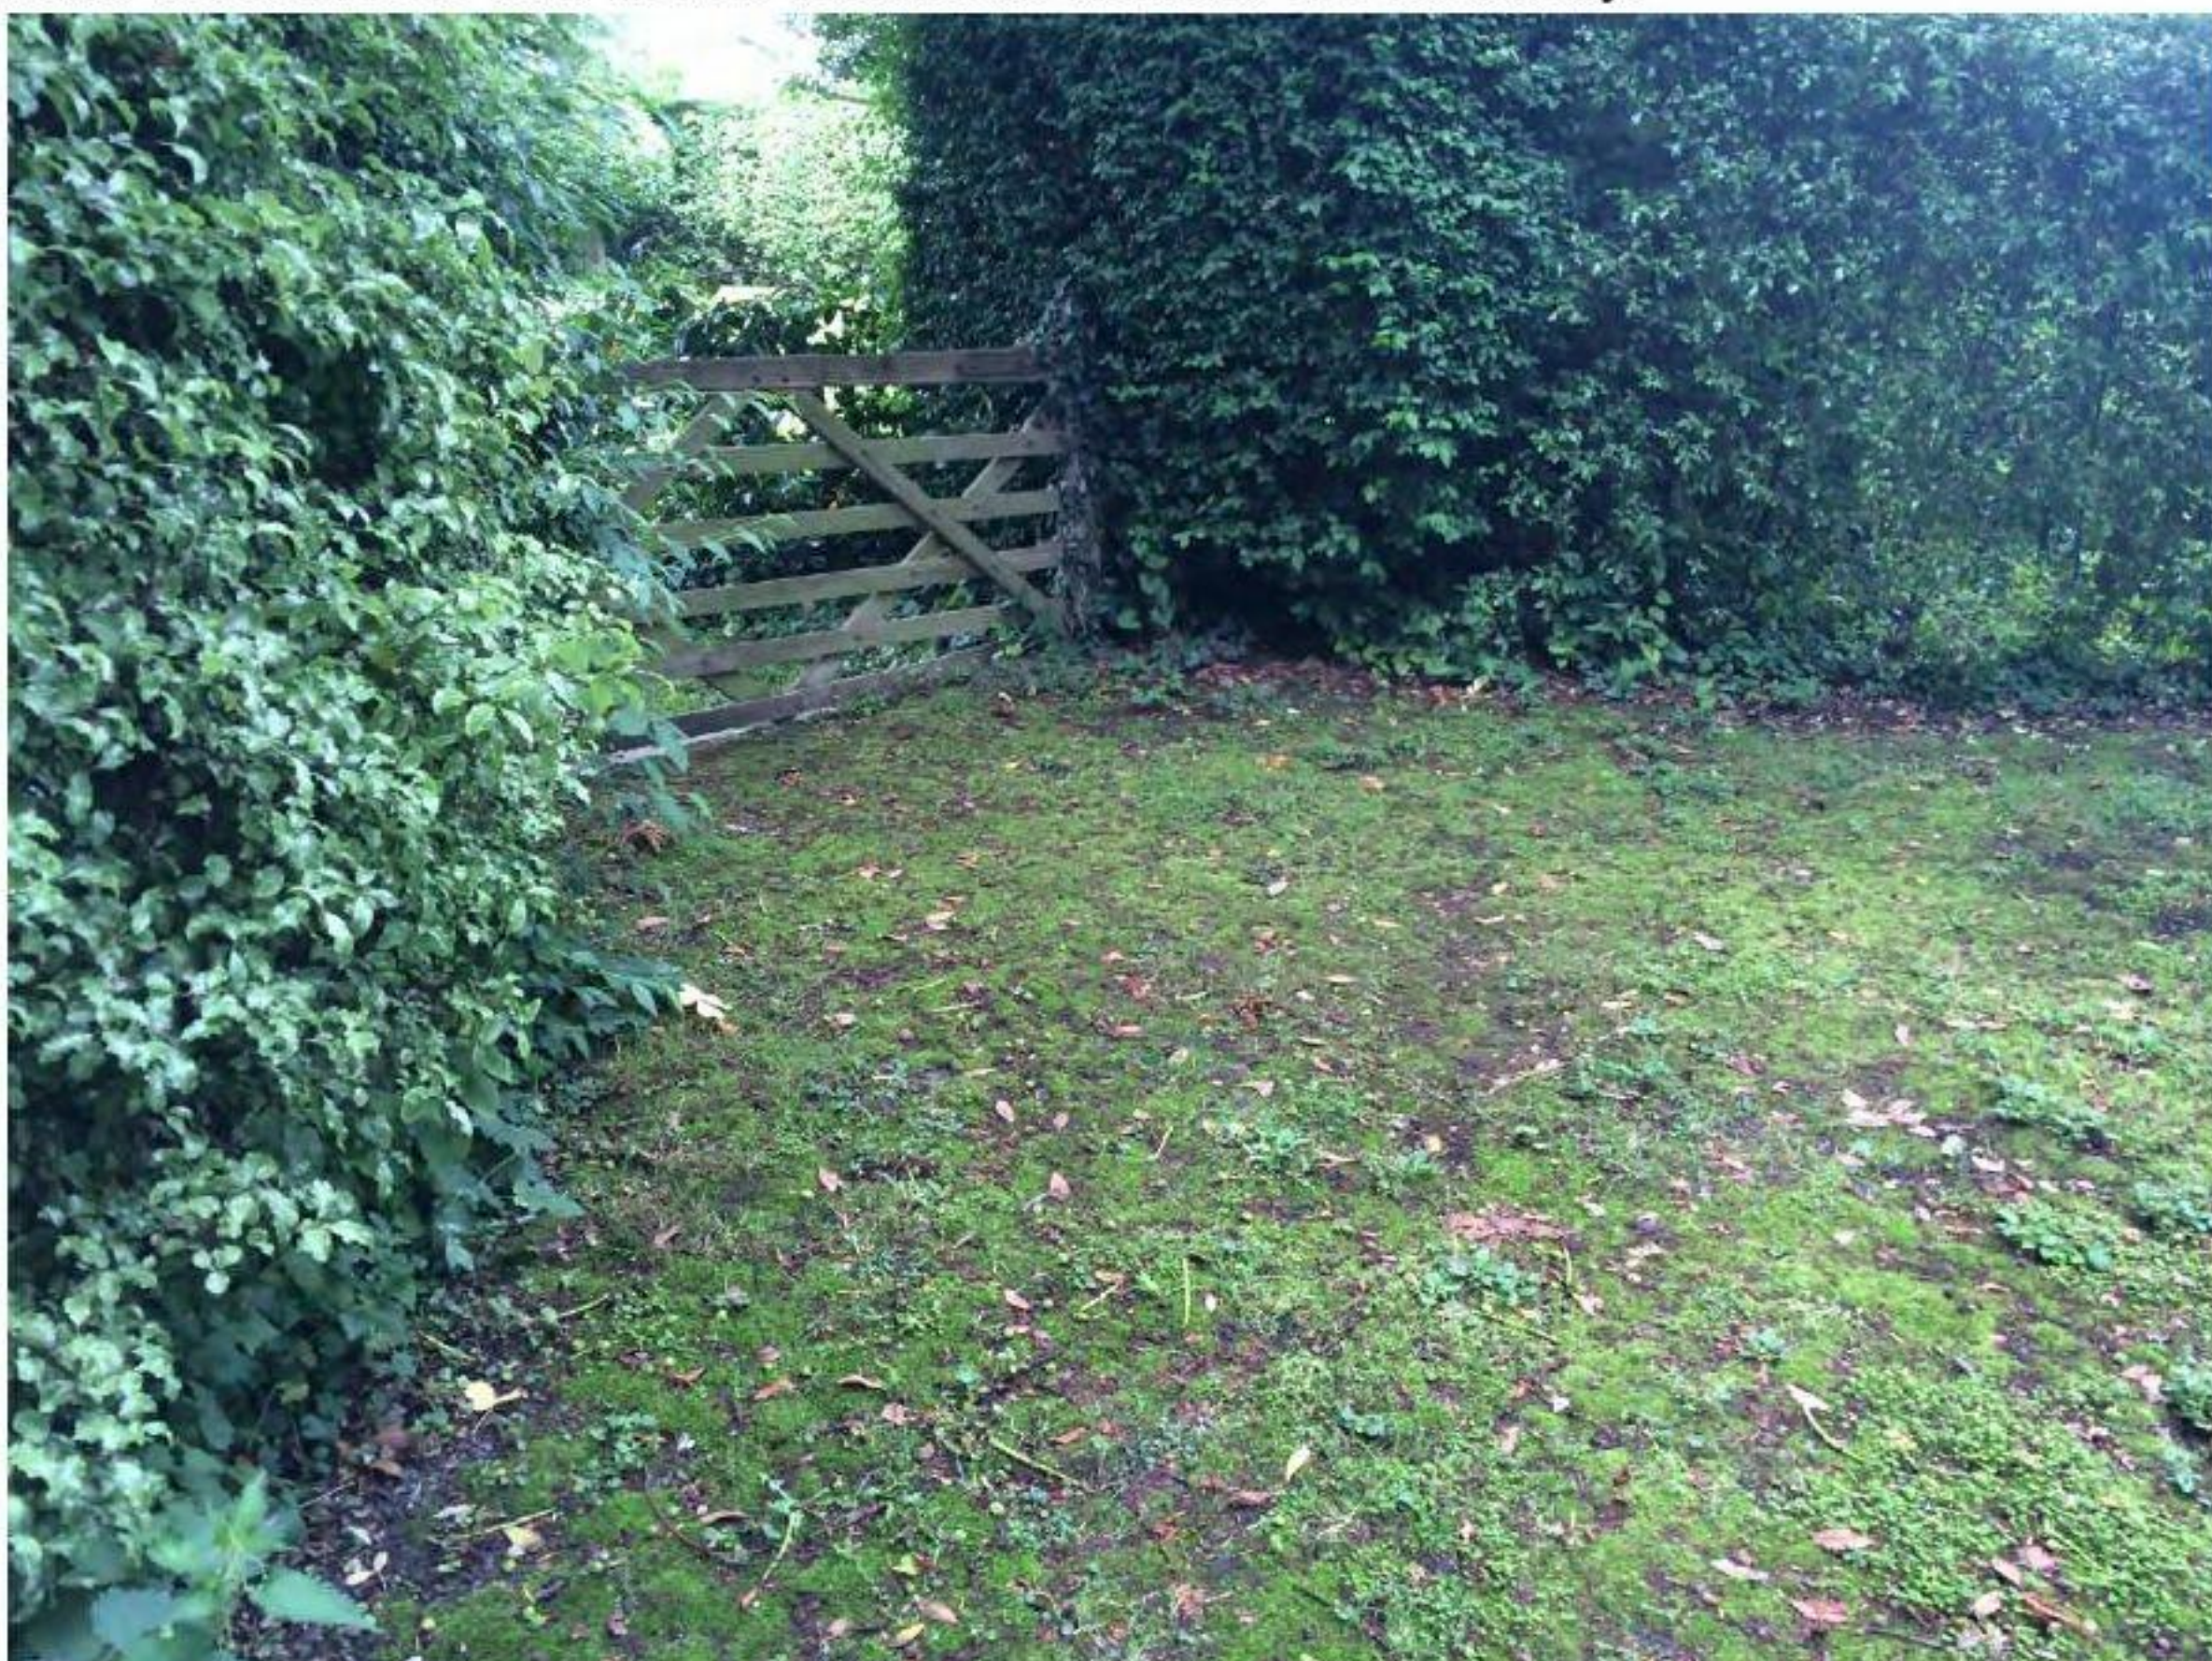
Plate 2: Secondary access to the property via Western Avenue

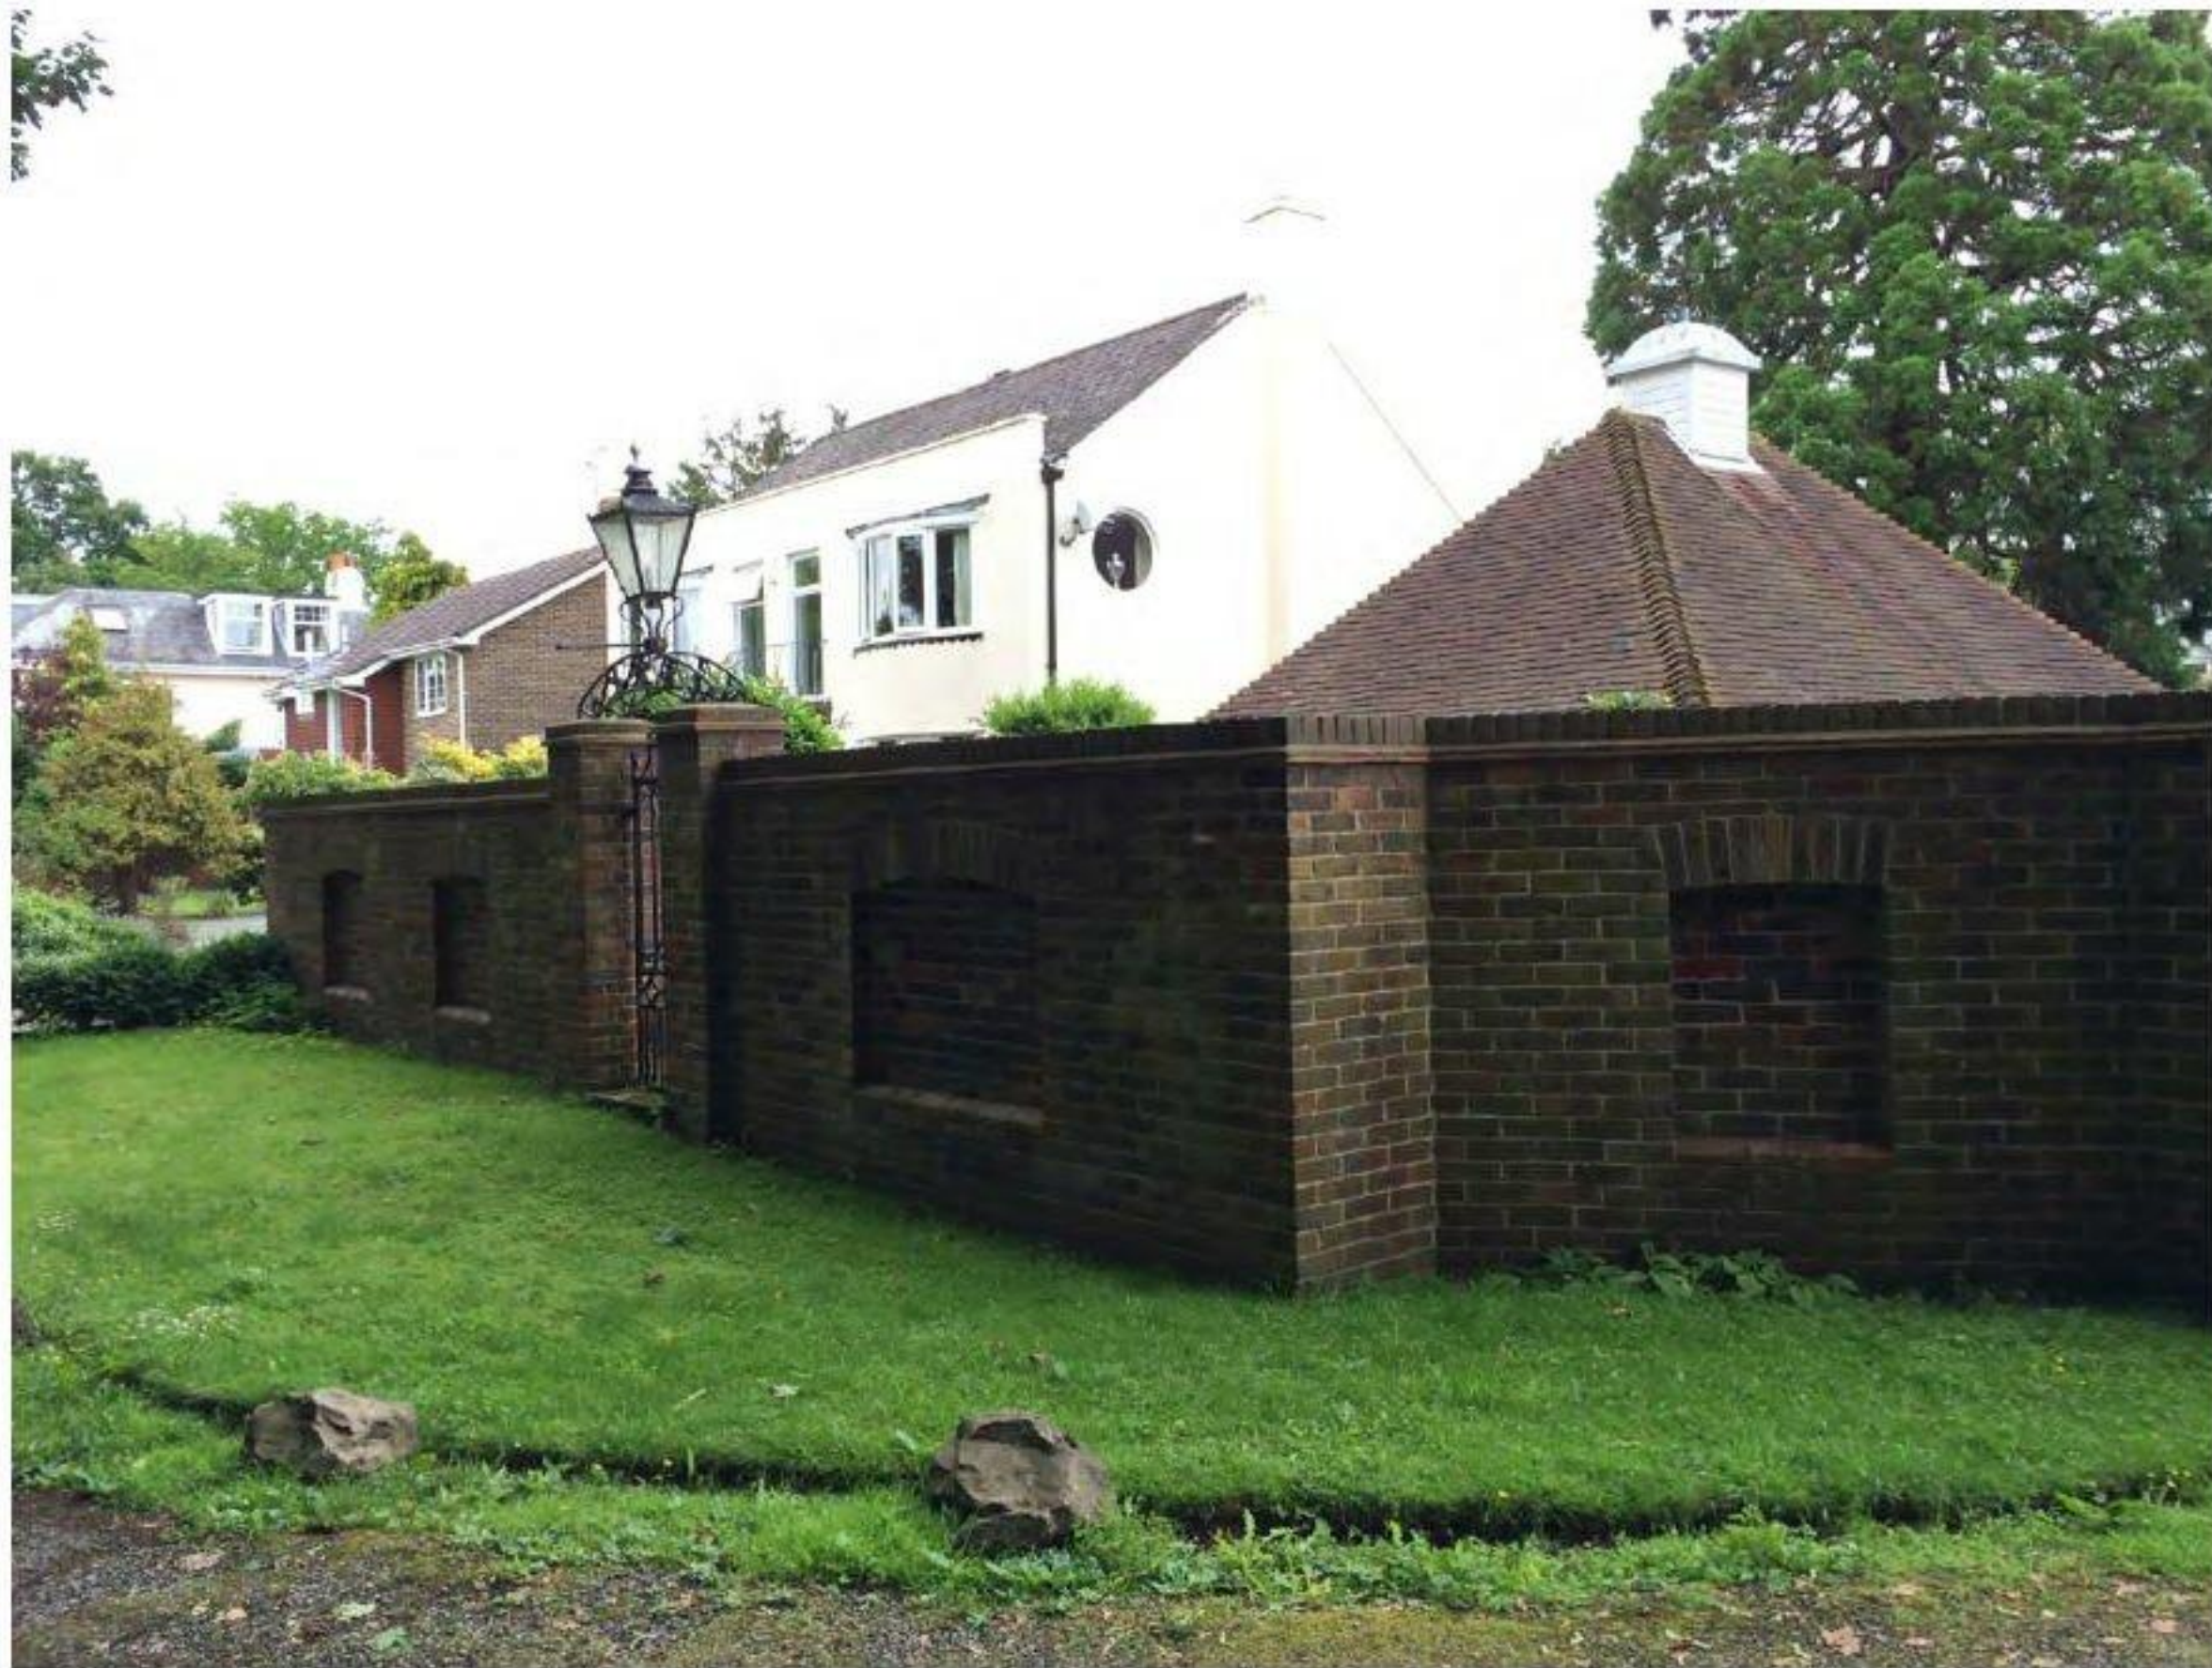
Plate 3: North-western corner of the site with brick boundary wall.

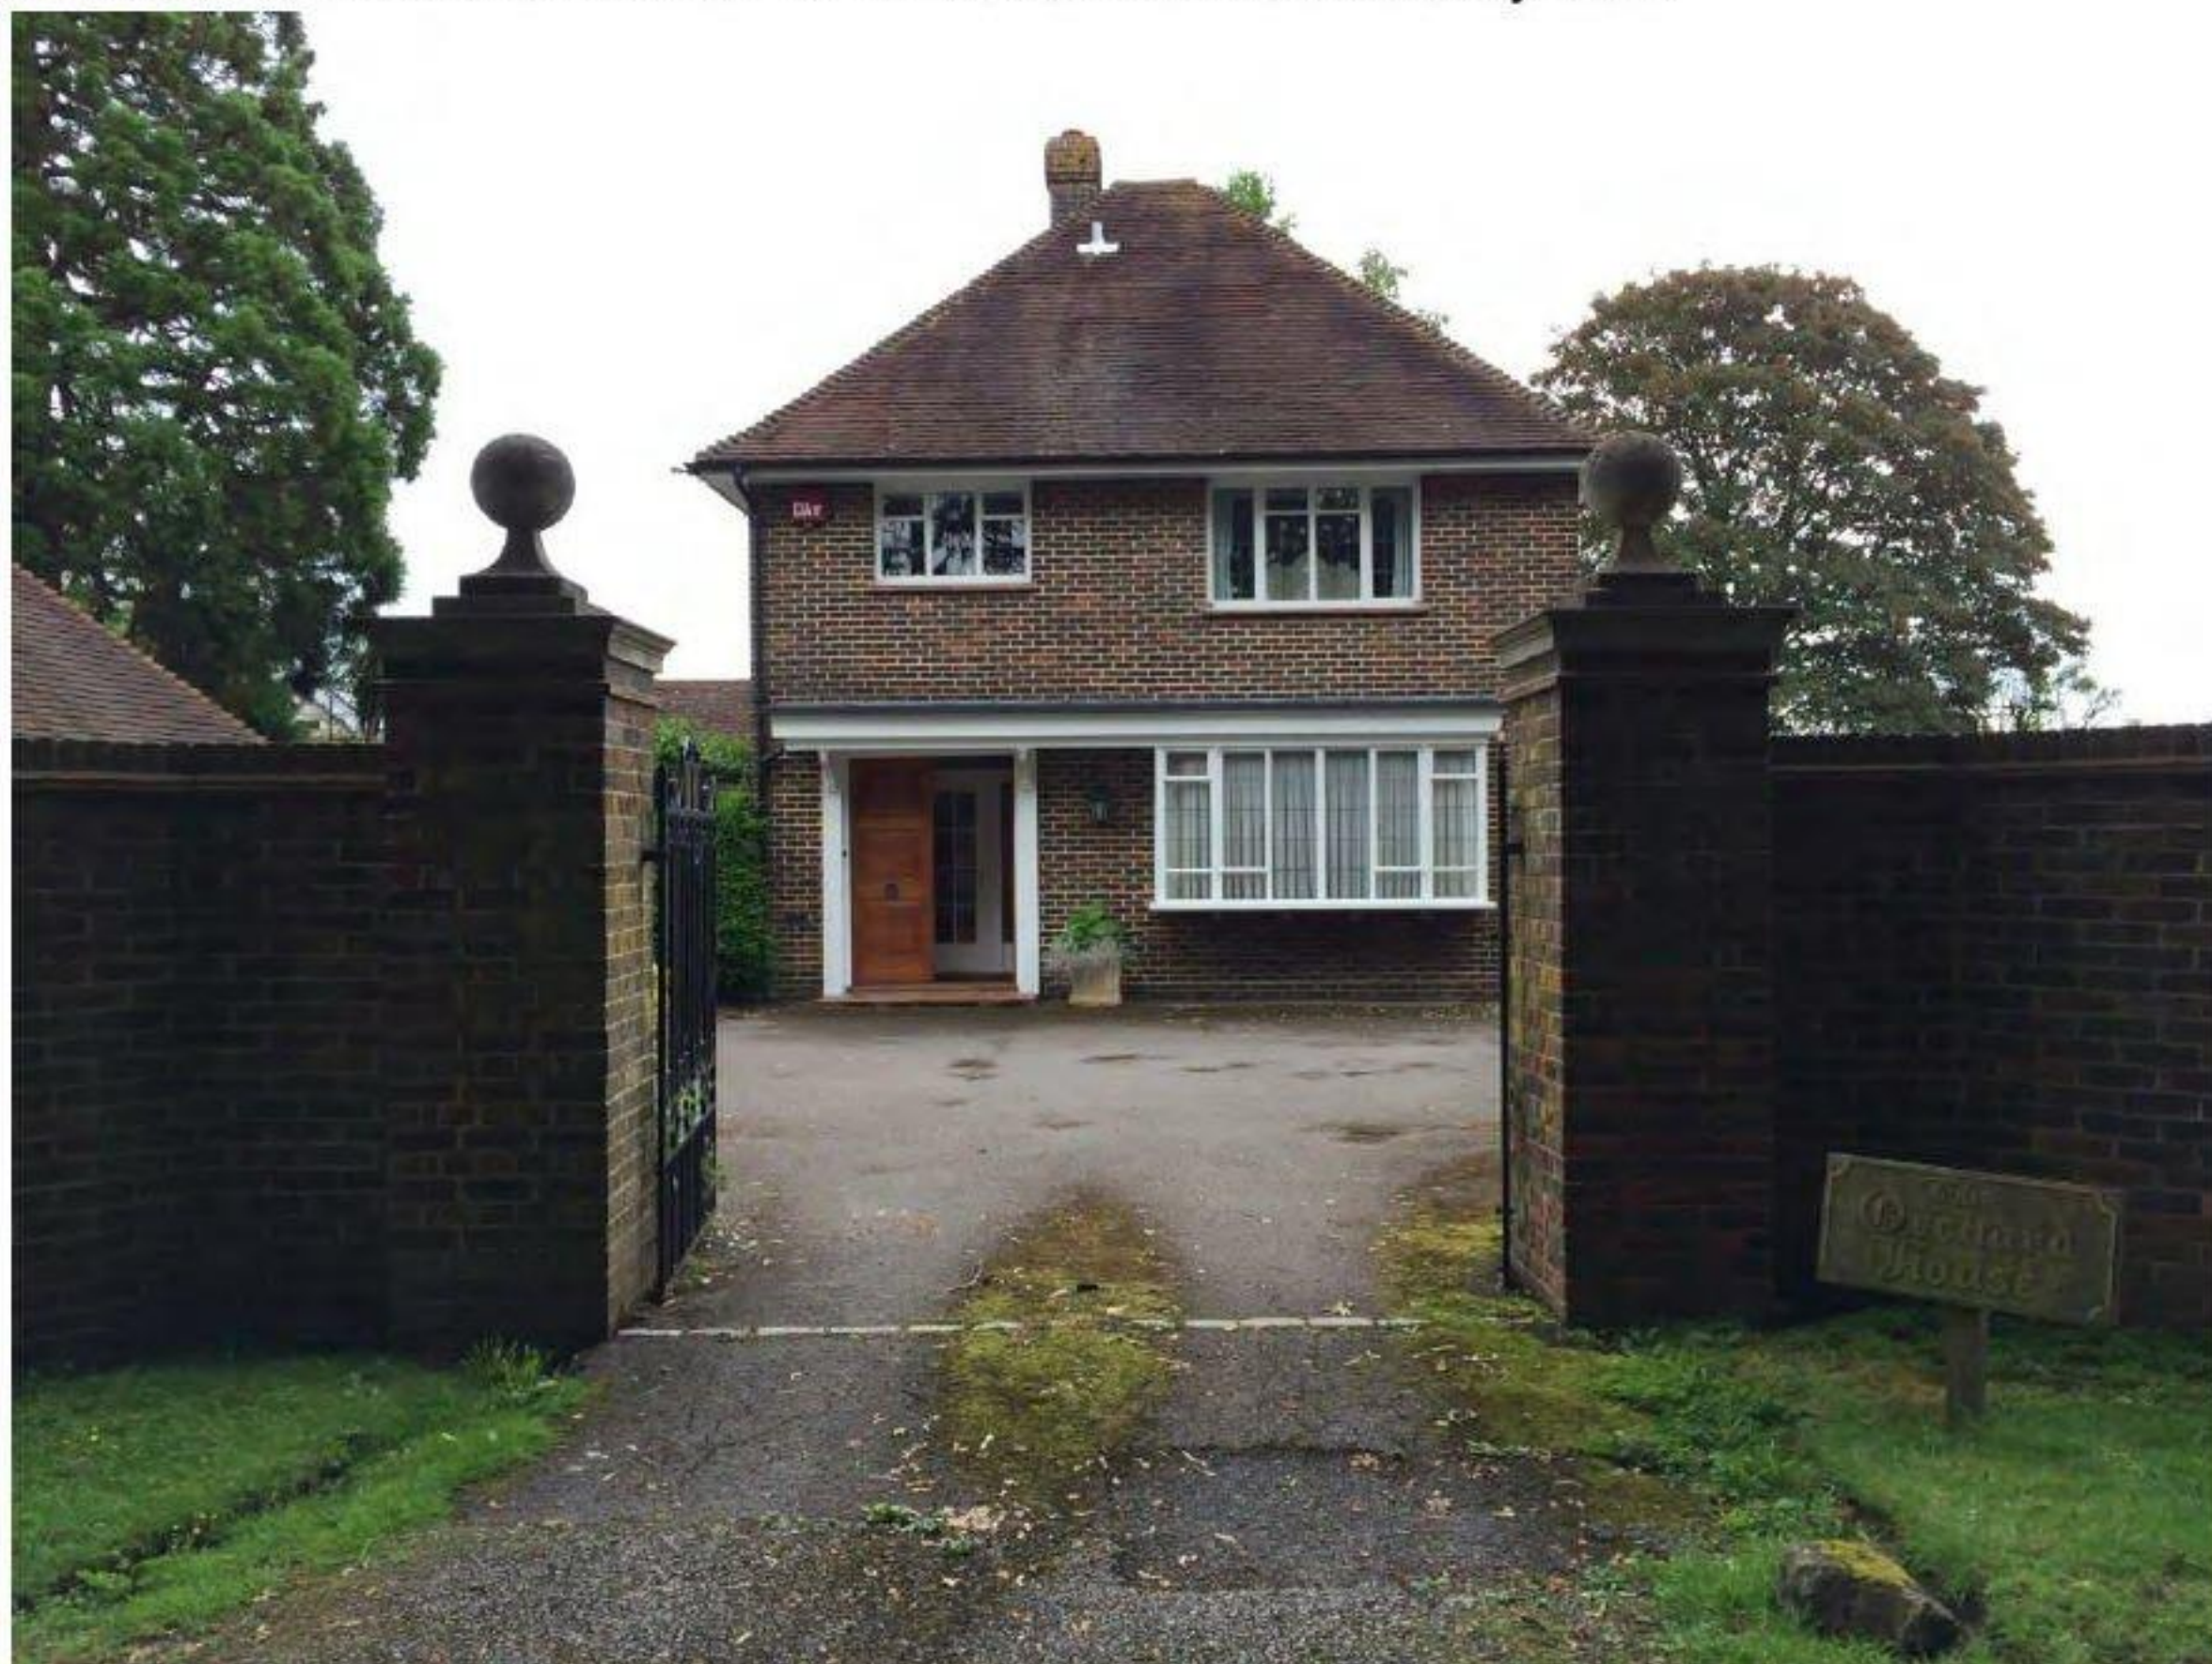
Plate 4: The main site access from Western Avenue.

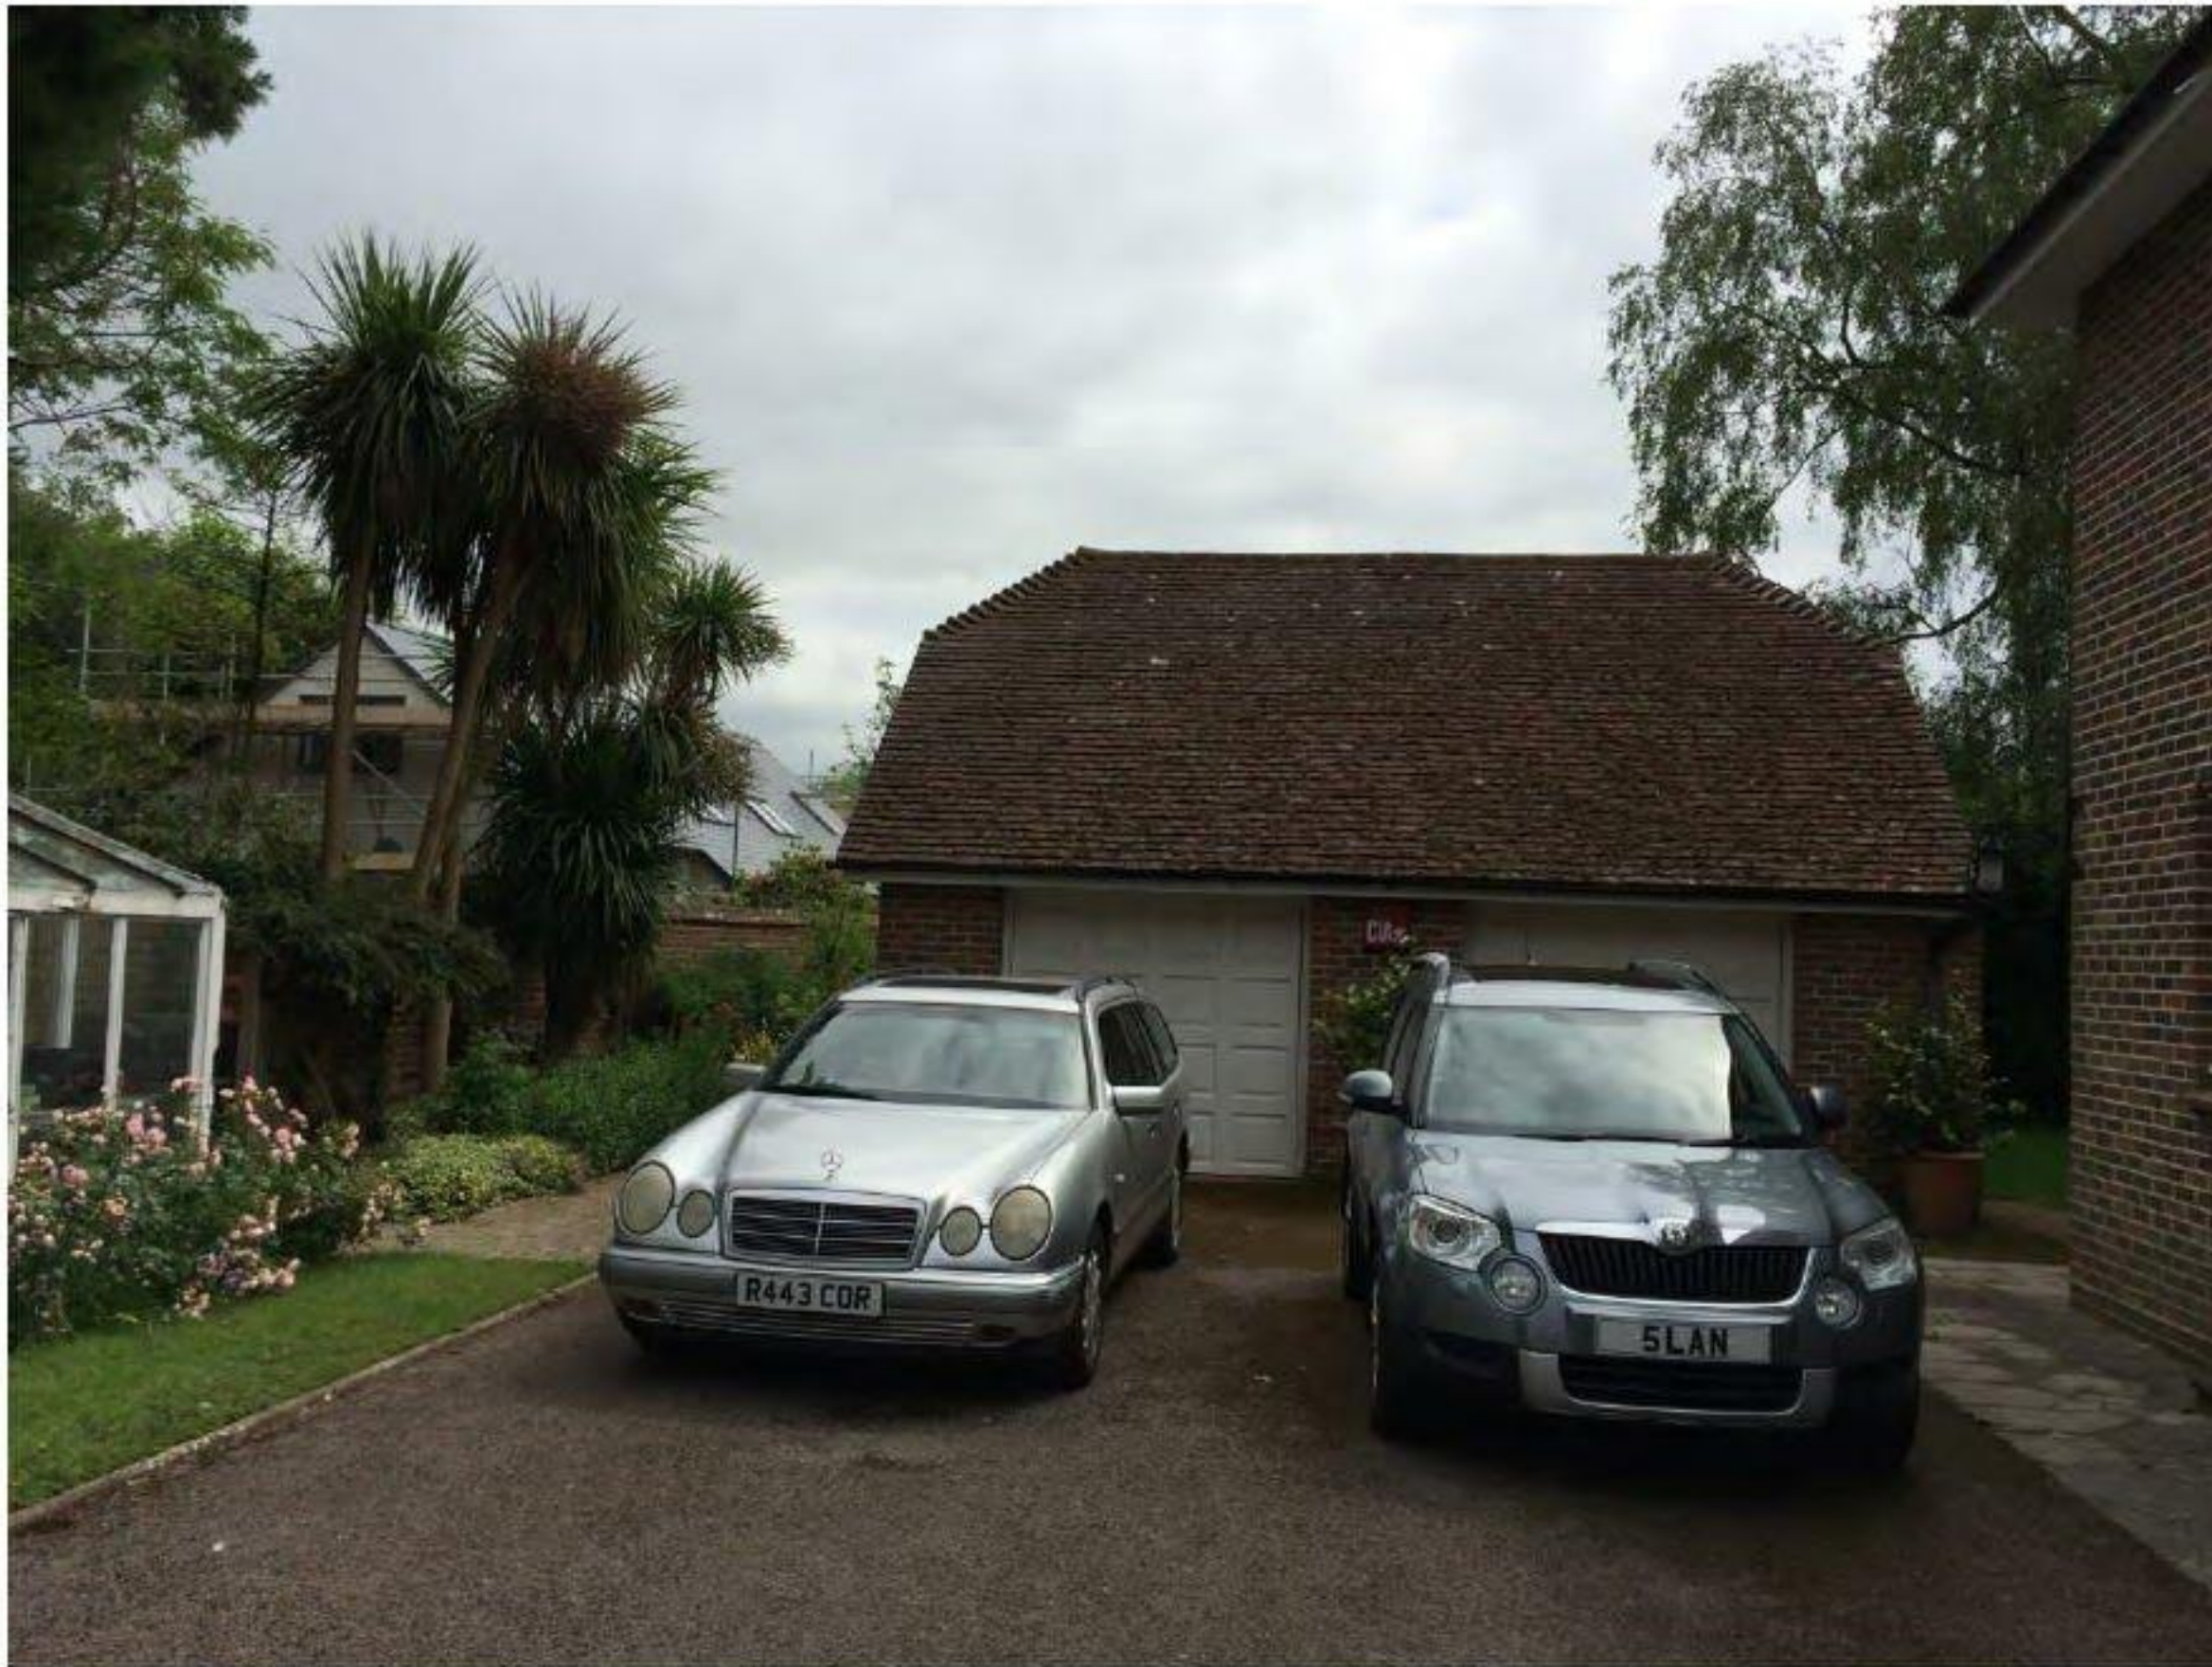
- 2.8 A double garage is present in the north-western corner of the site, which has brick elevations and a pitched tiled roof. It was noted that an extension to the Garage was completed extending the centre of the garage further to the northern site boundary. The northern site boundary wall forms part of the garage.

Plate 5. Double Garage in the northern part of the site.

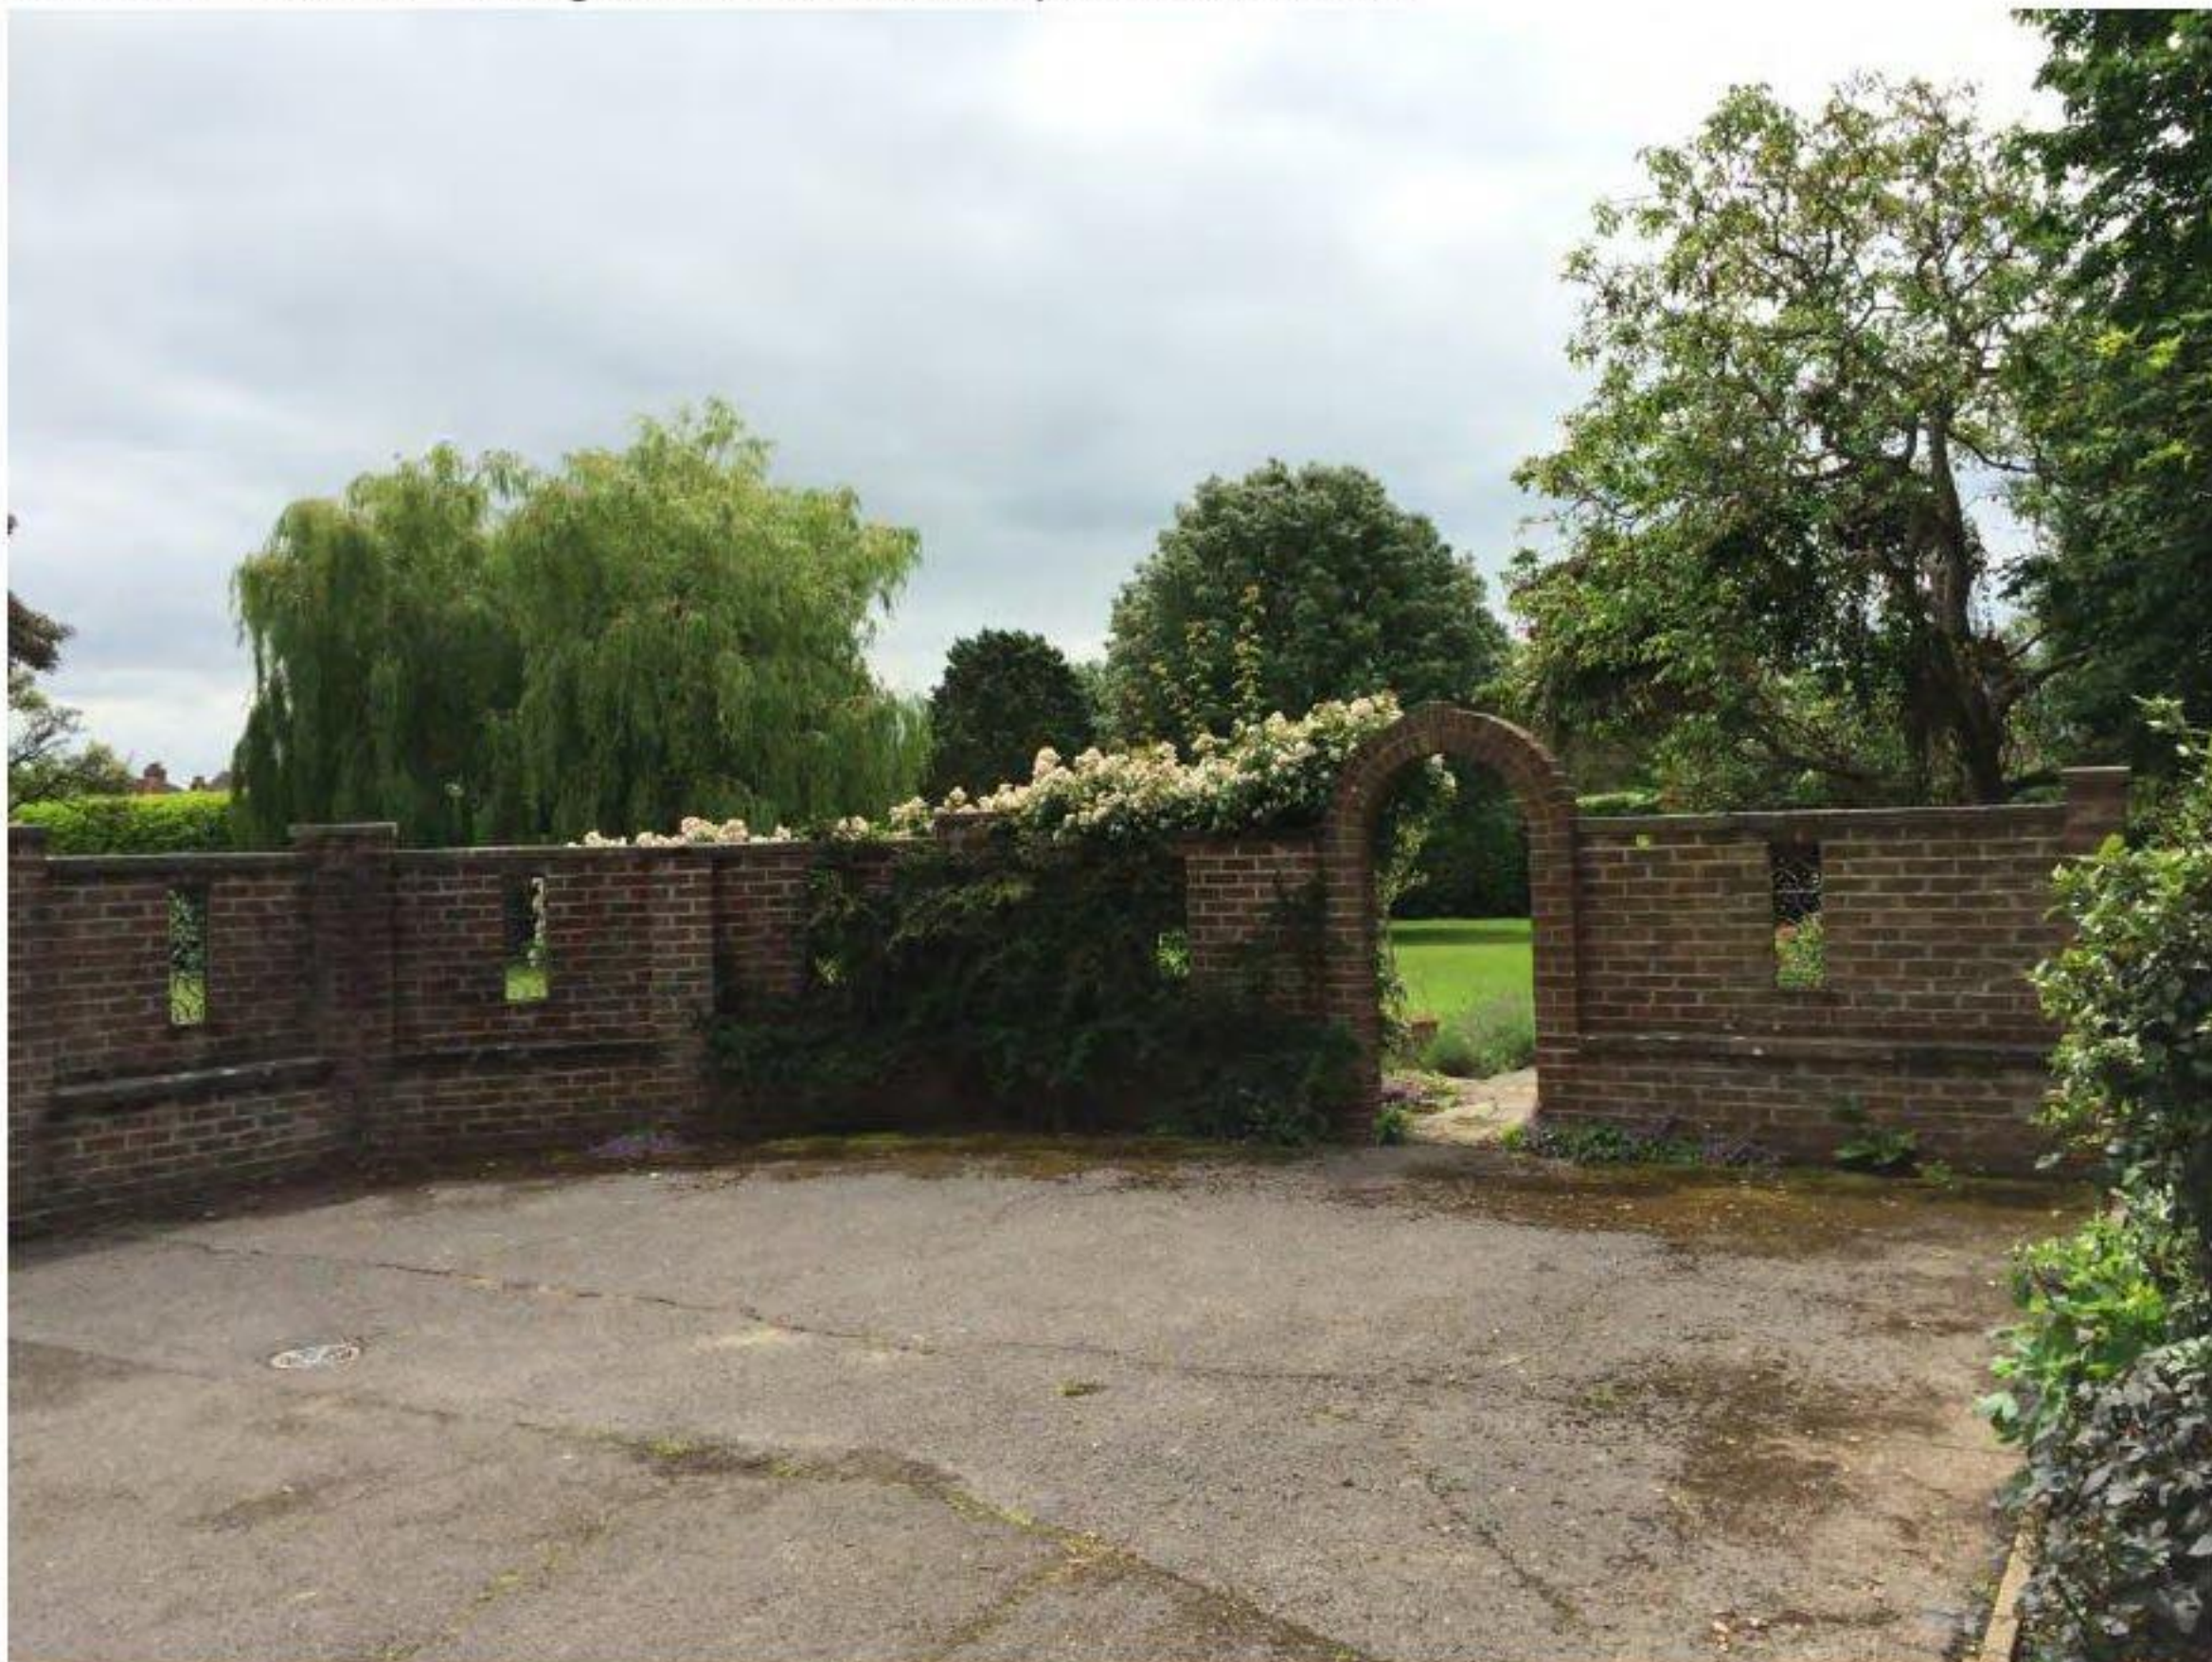
- 2.7 Access to the site is gained from Western Avenue in the north-western corner of the site. A macadam driveway leads from the road and a small car parking area is present beside the property. A gully is noted in the centre of this area.

Plate 6: Macadam driveway area in north-western corner of the site.
