DESK STUDY REPORT  
FOR THE SITE OF:

The Orchard House  
Western Avenue  
Emsworth  
Hampshire  
PO10 7LP

## DESK STUDY REPORT

**REPORT NO:**    16-73762/GW/DSReport

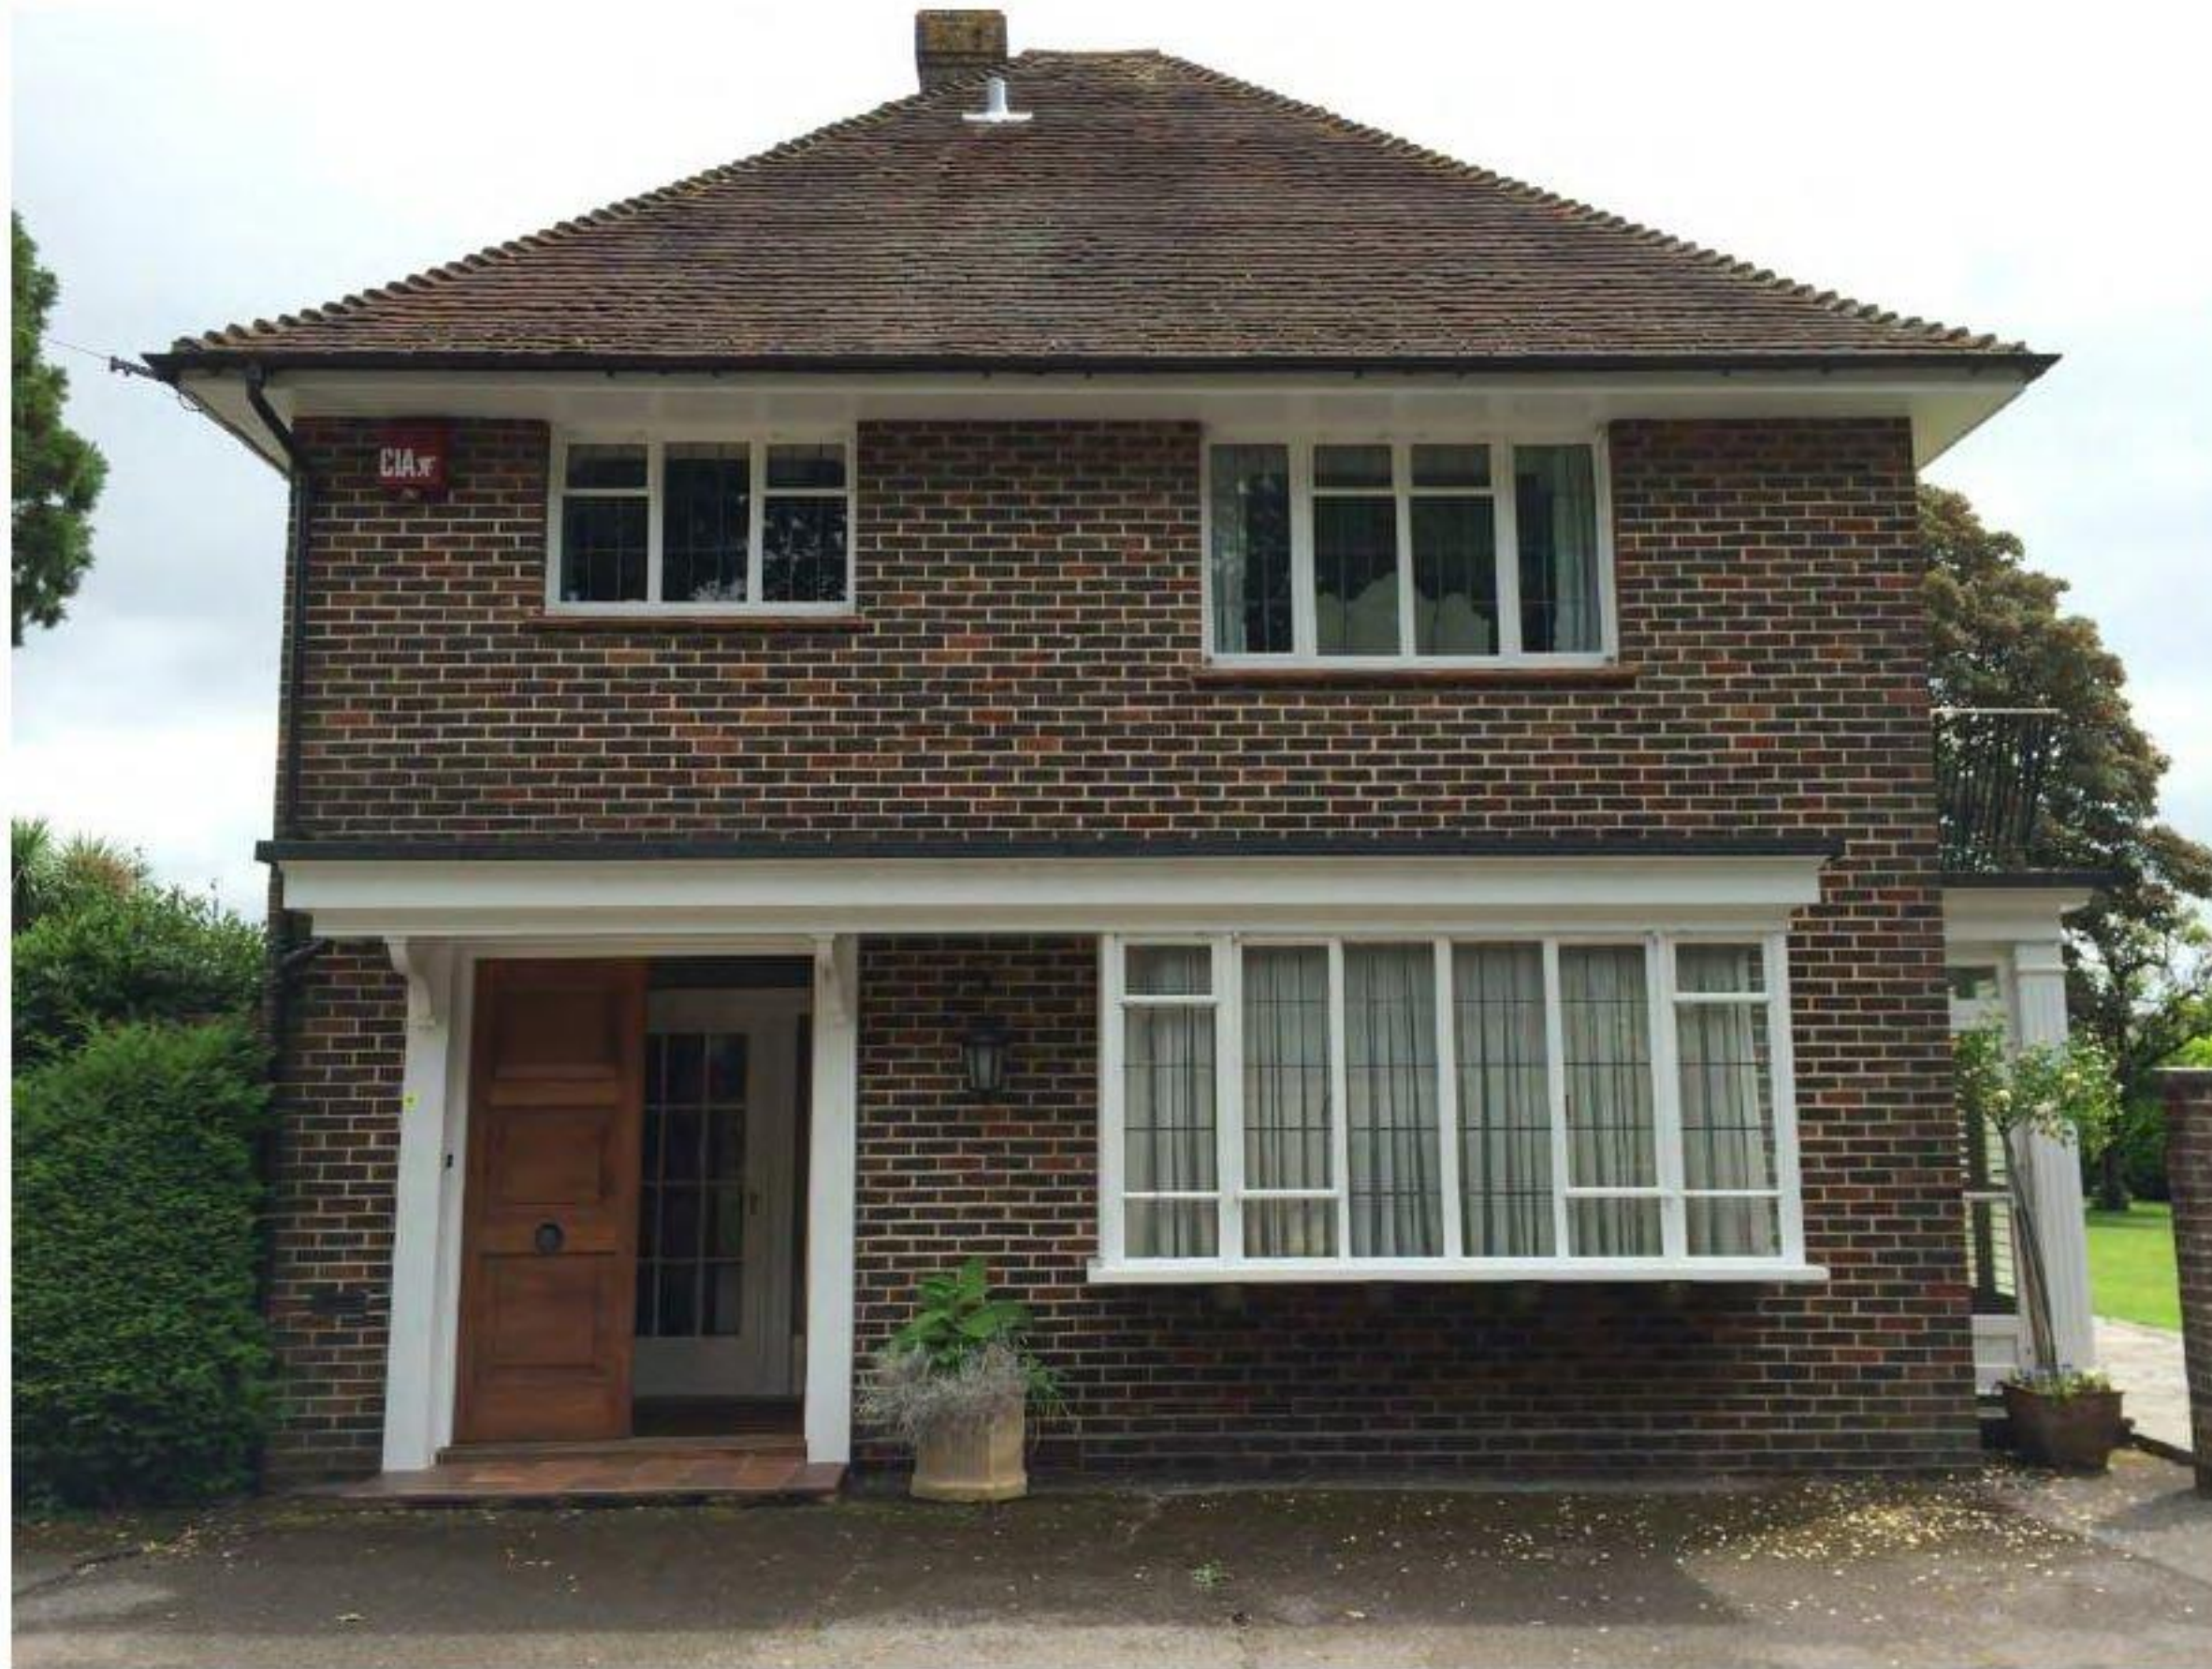
Plate 7: Western elevation of The Orchard House.

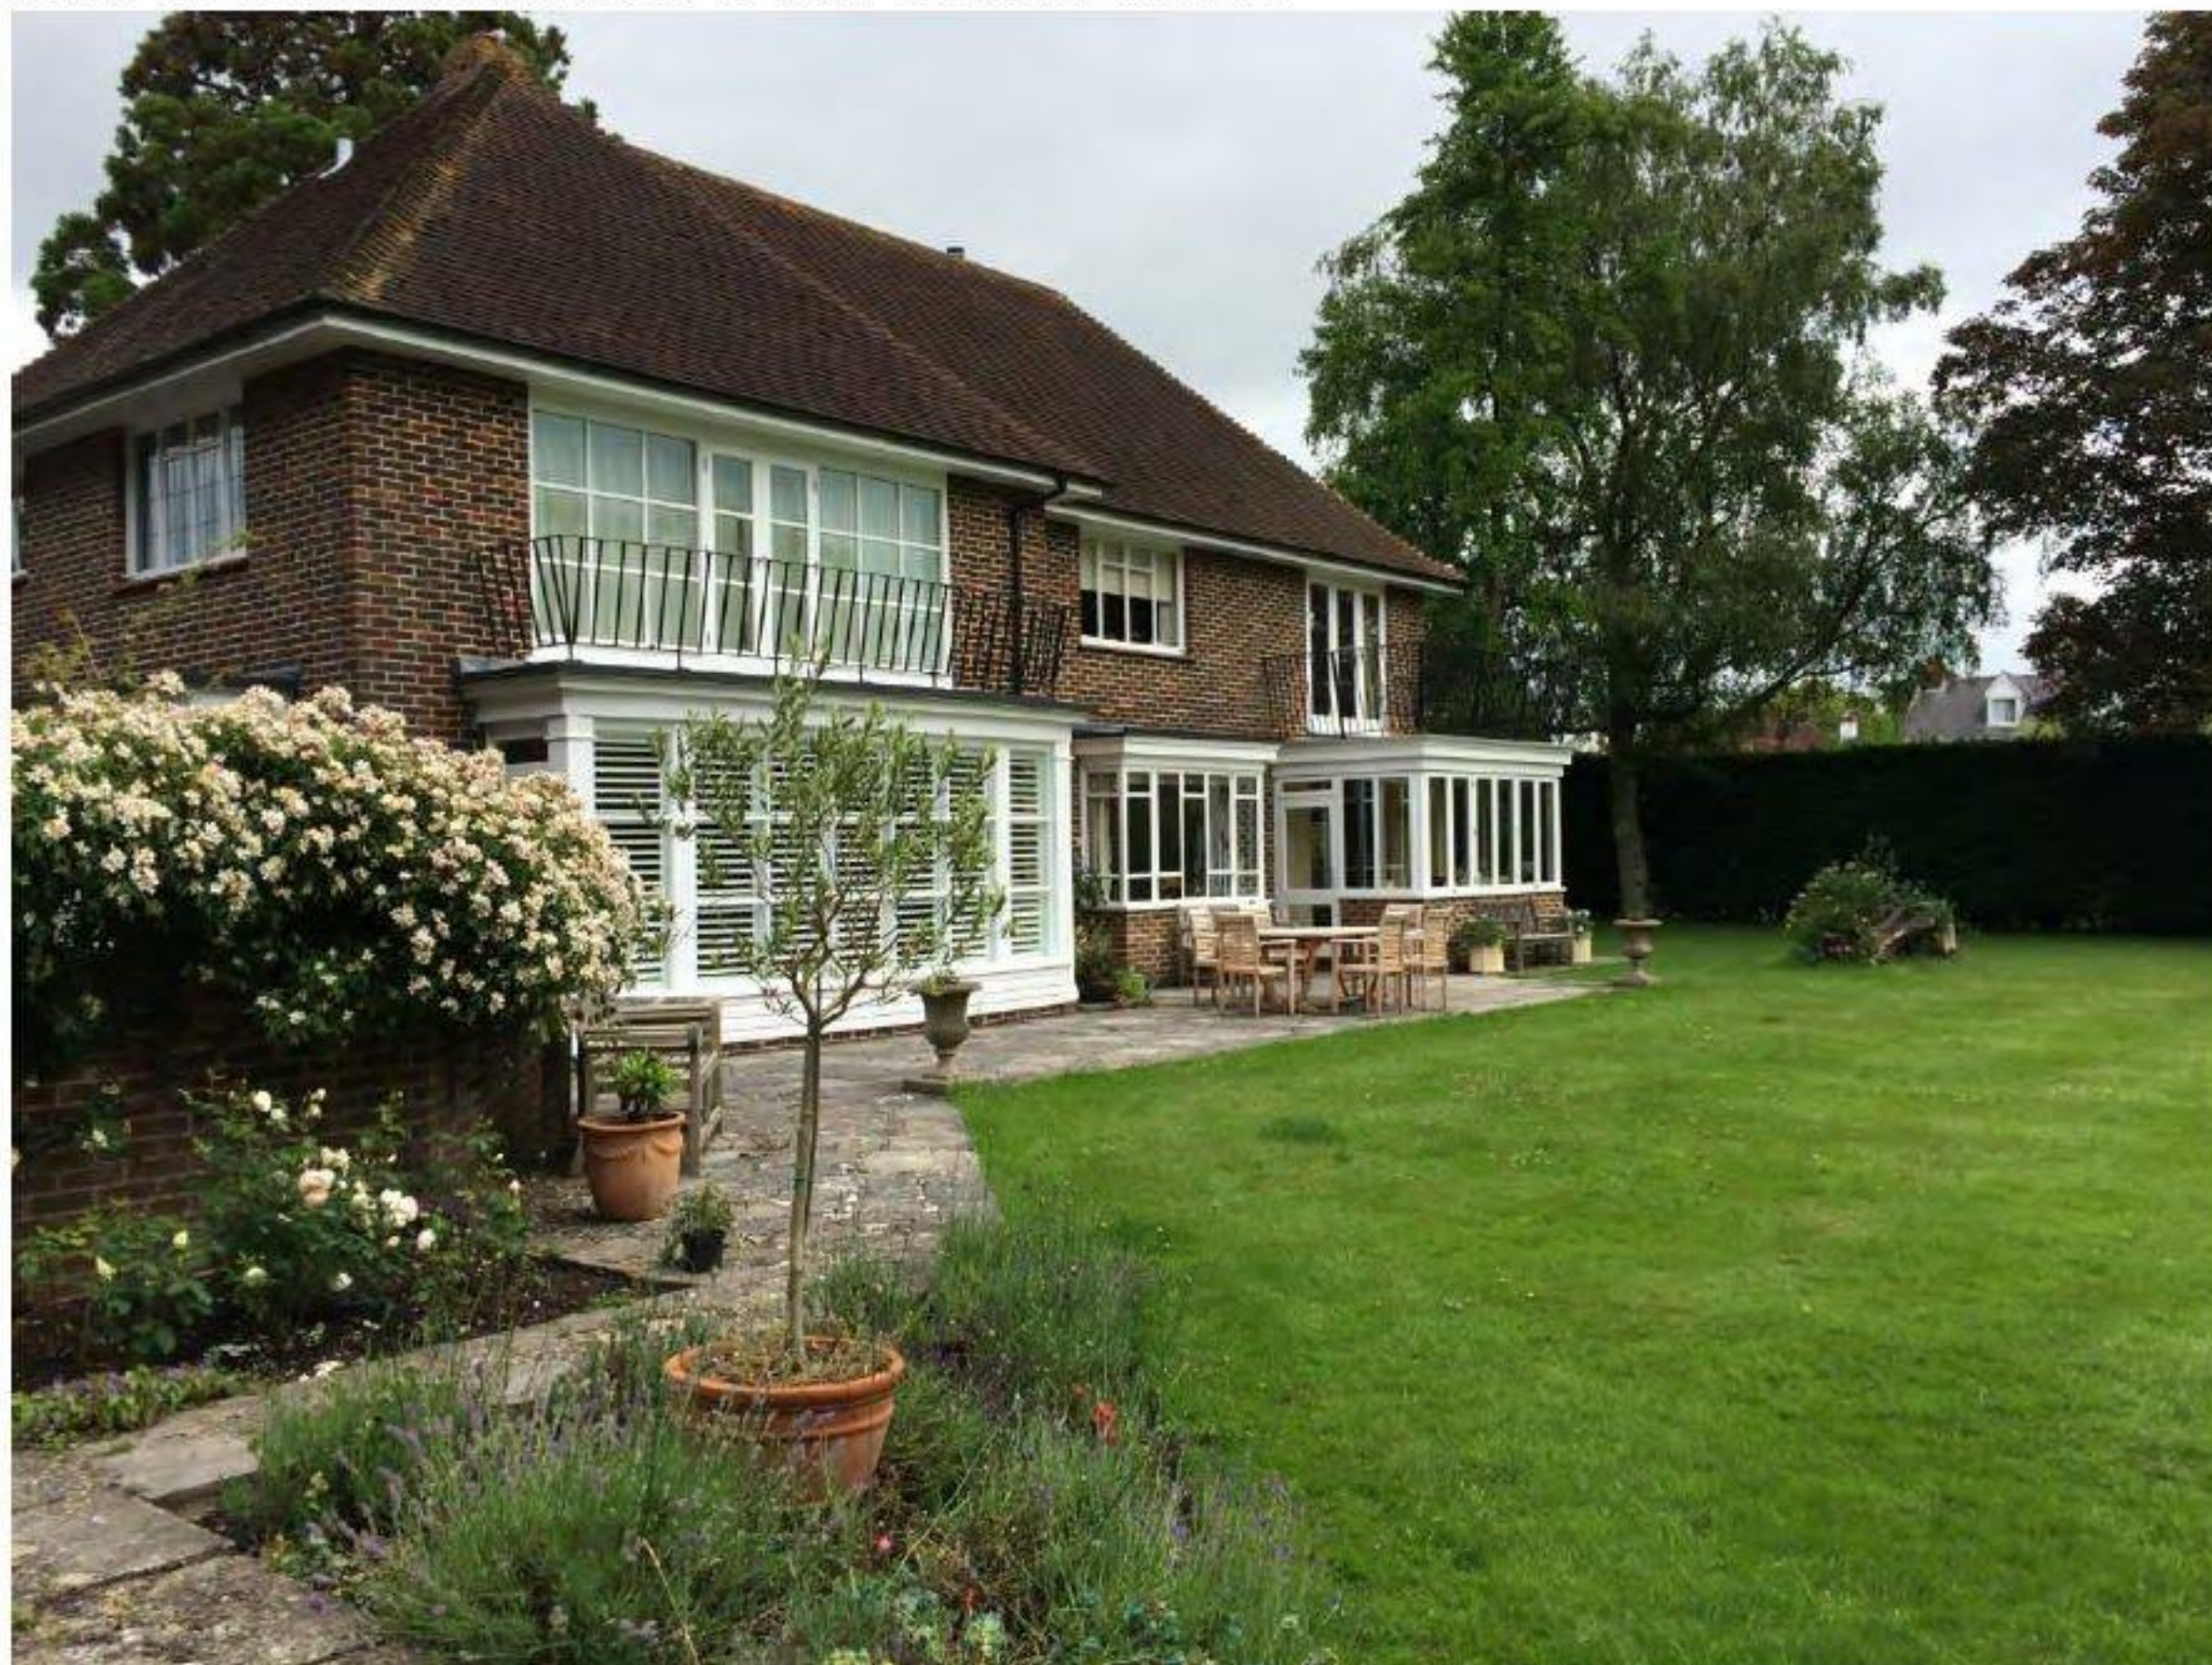
Plate 8: Southern elevation of the dwelling.

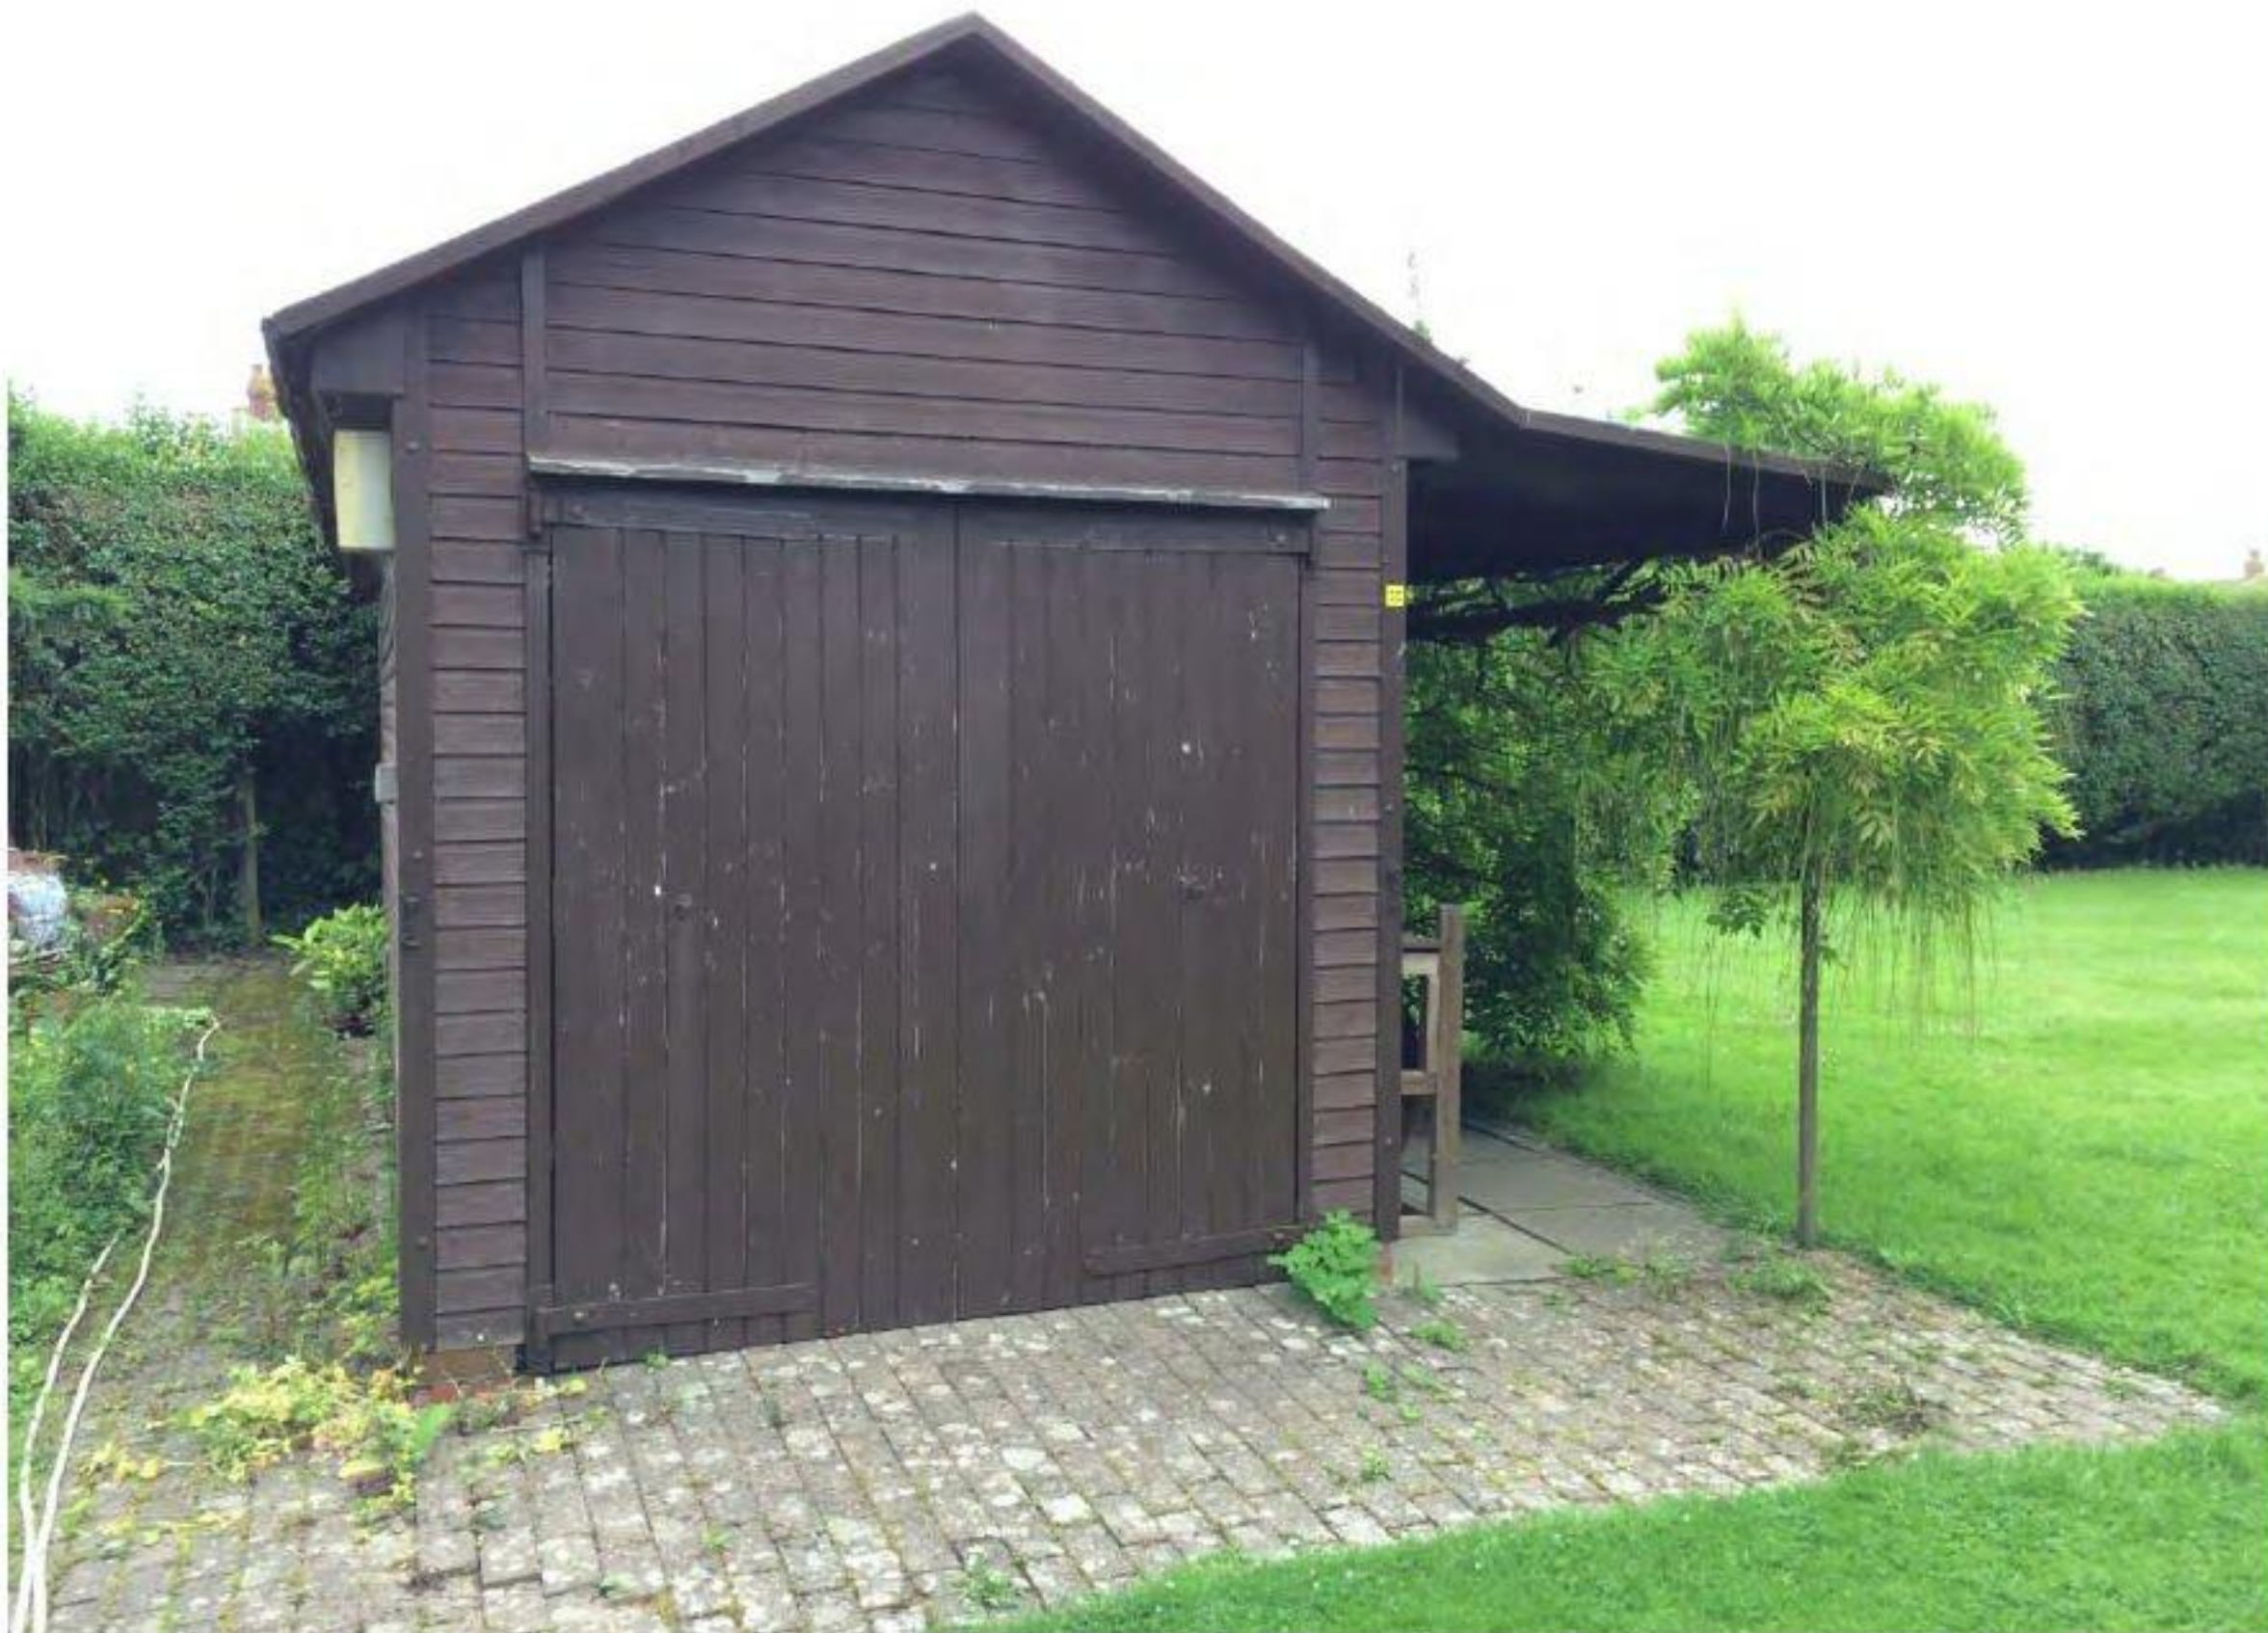
Plate 9. Timber Garden Store present in north-eastern corner of site.

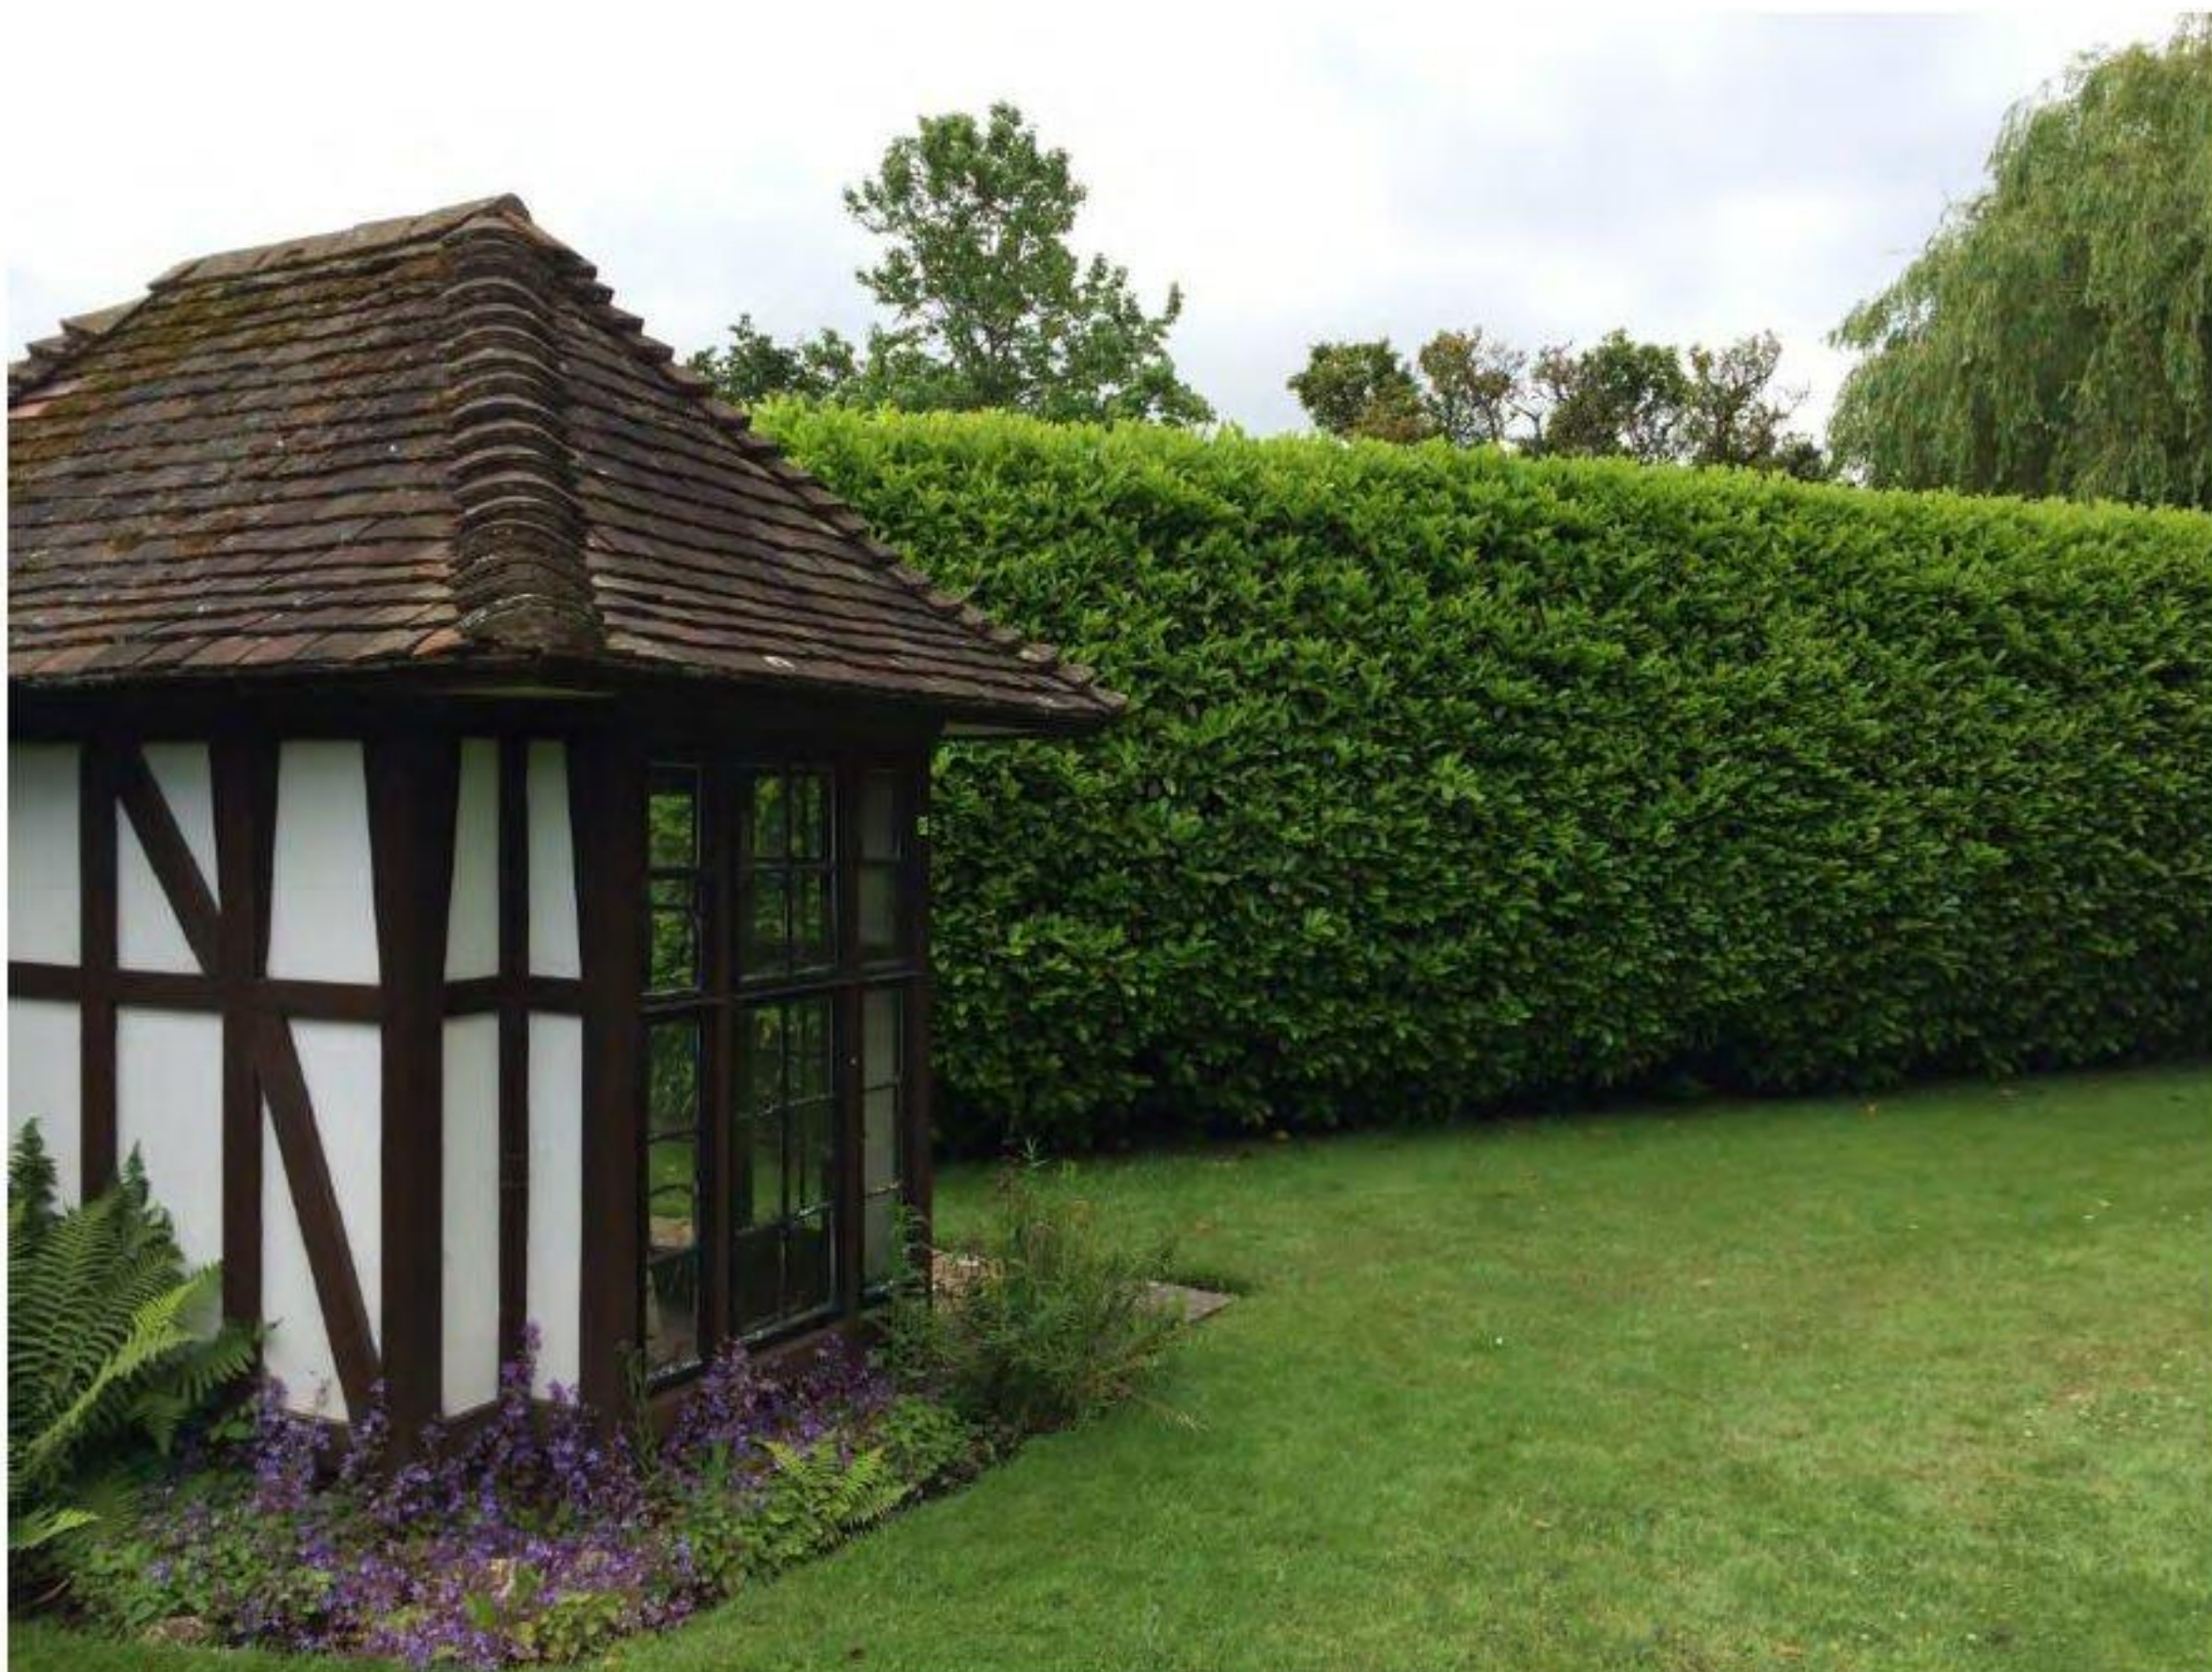
Plate 10. Summer house in central eastern part of the site.

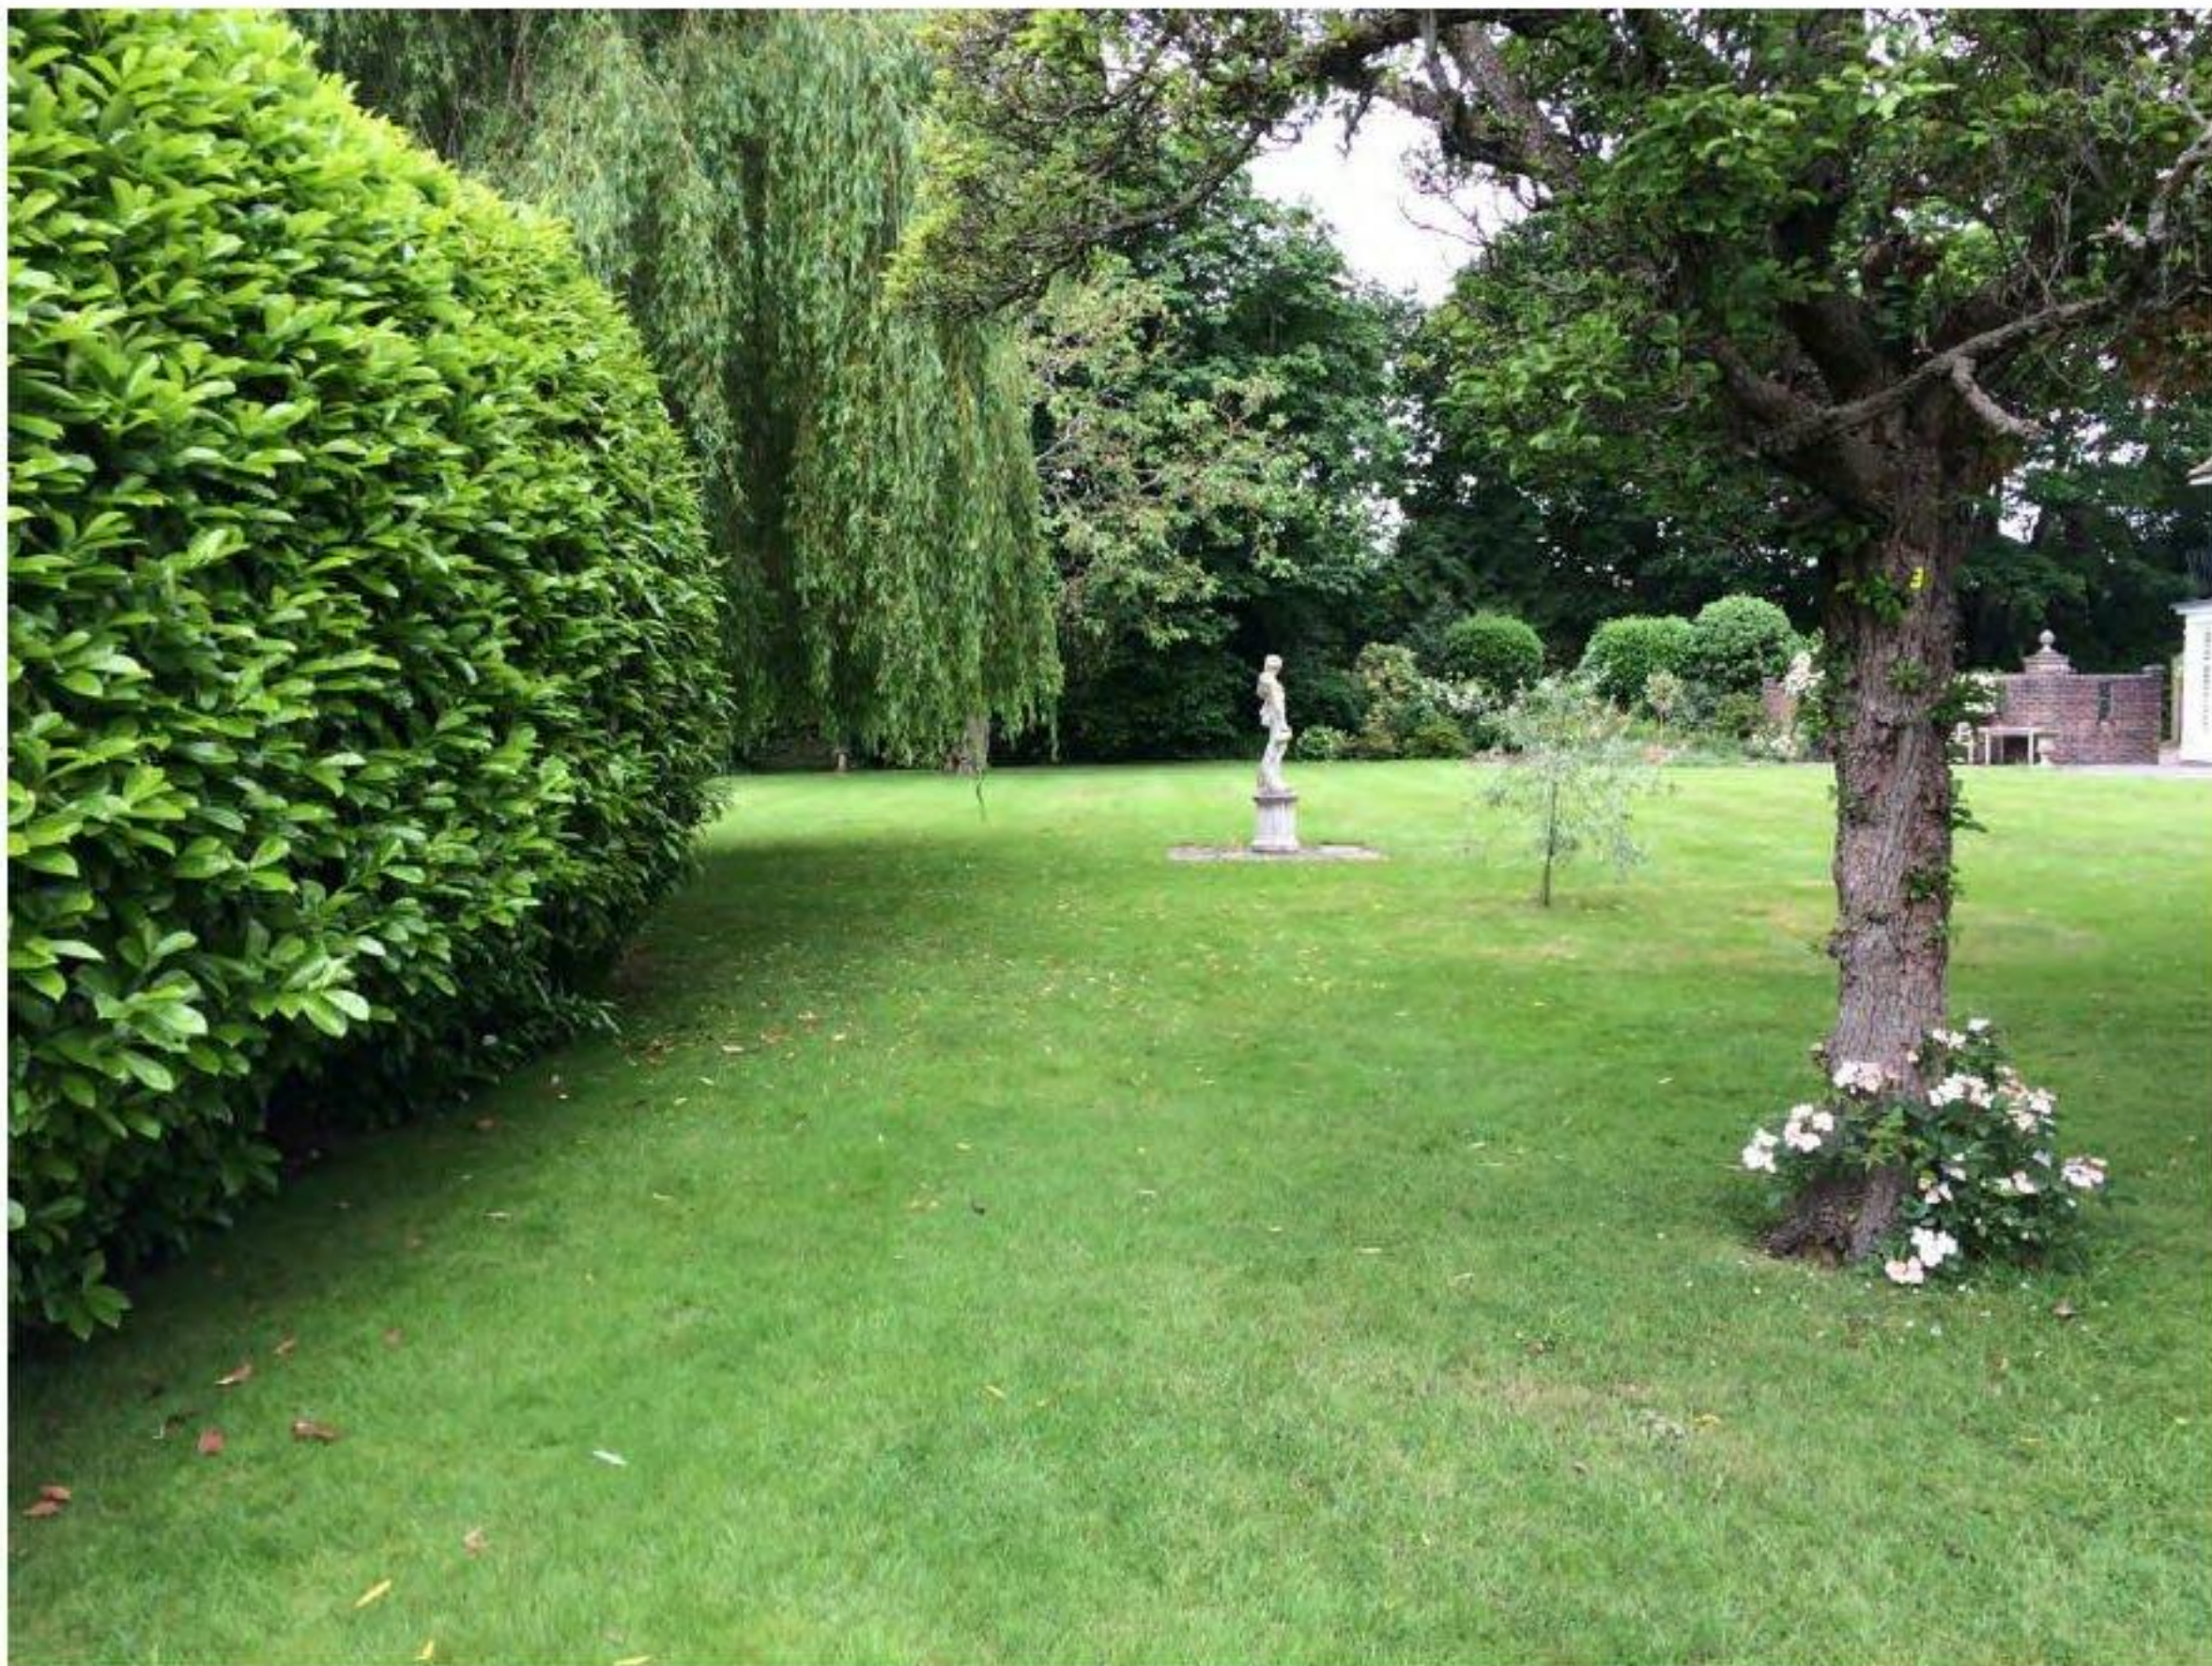
Plate 11. Current soakaway beneath statue feature in the centre of the site

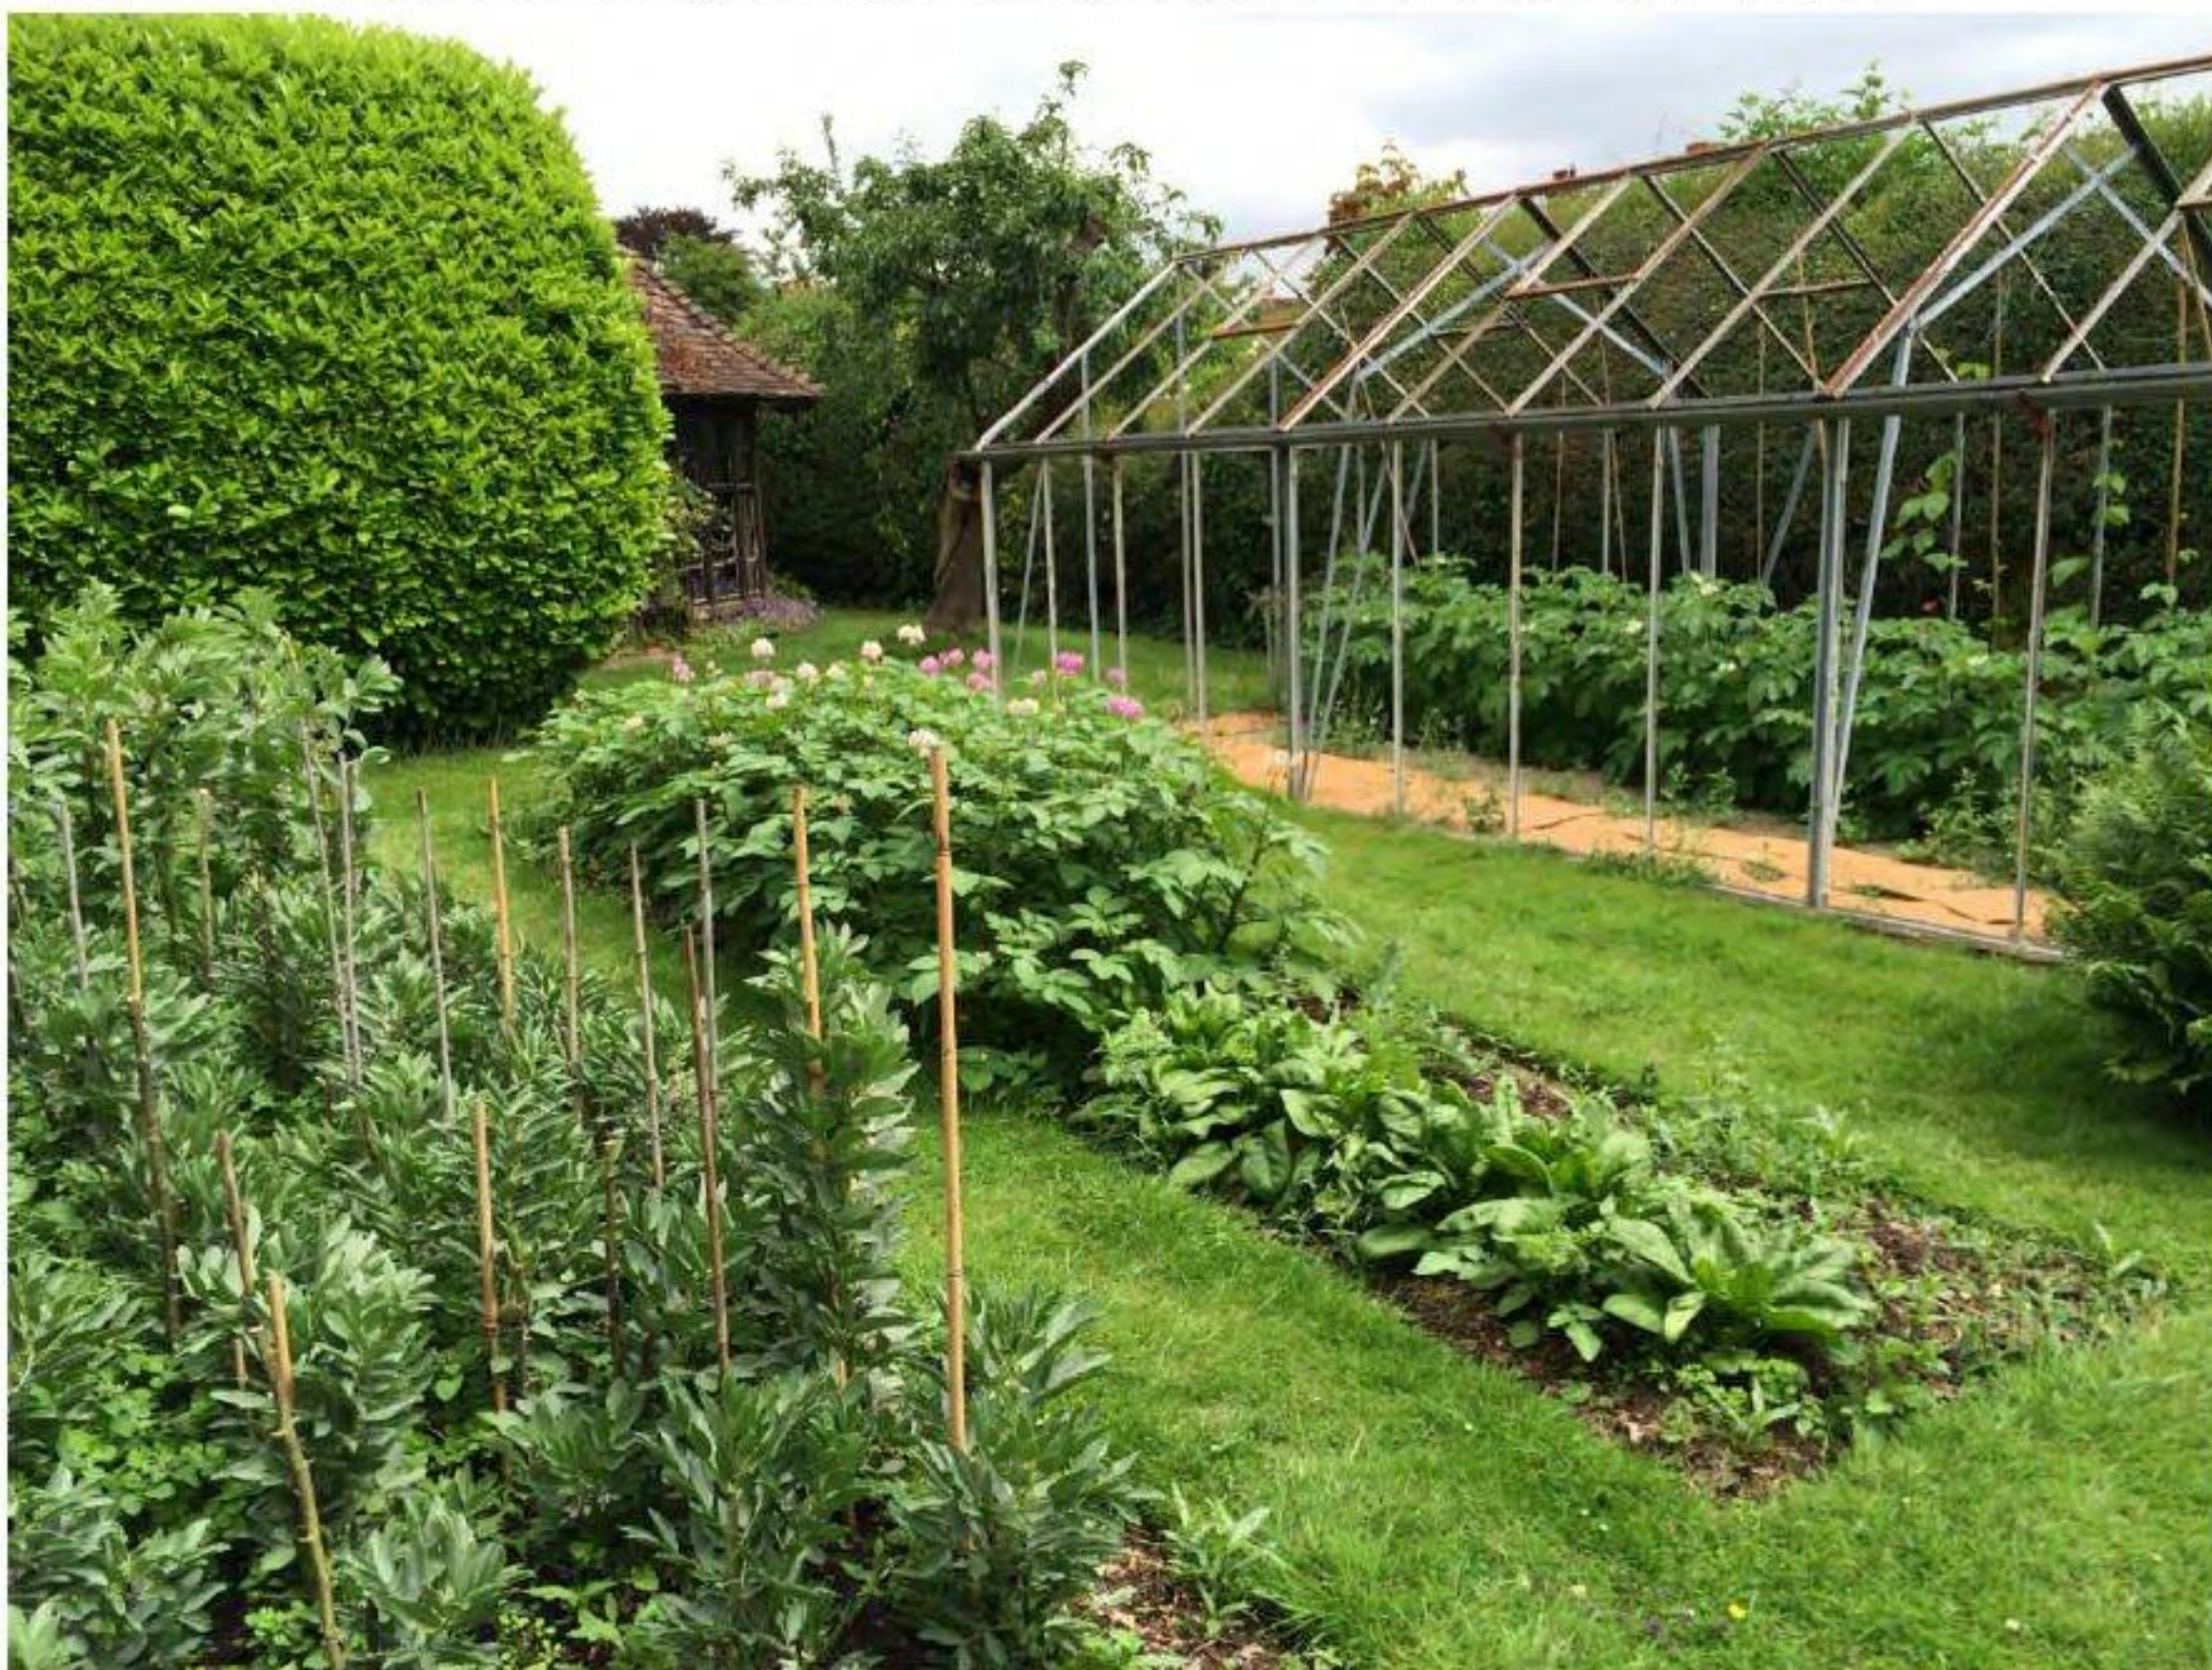
Plate 12. South-western corner of the site used for fruit and vegetable growing
