DESK STUDY REPORT  
FOR THE SITE OF:

The Orchard House  
Western Avenue  
Emsworth  
Hampshire  
PO10 7LP

## DESK STUDY REPORT

**REPORT NO:**    16-73762/GW/DSReport

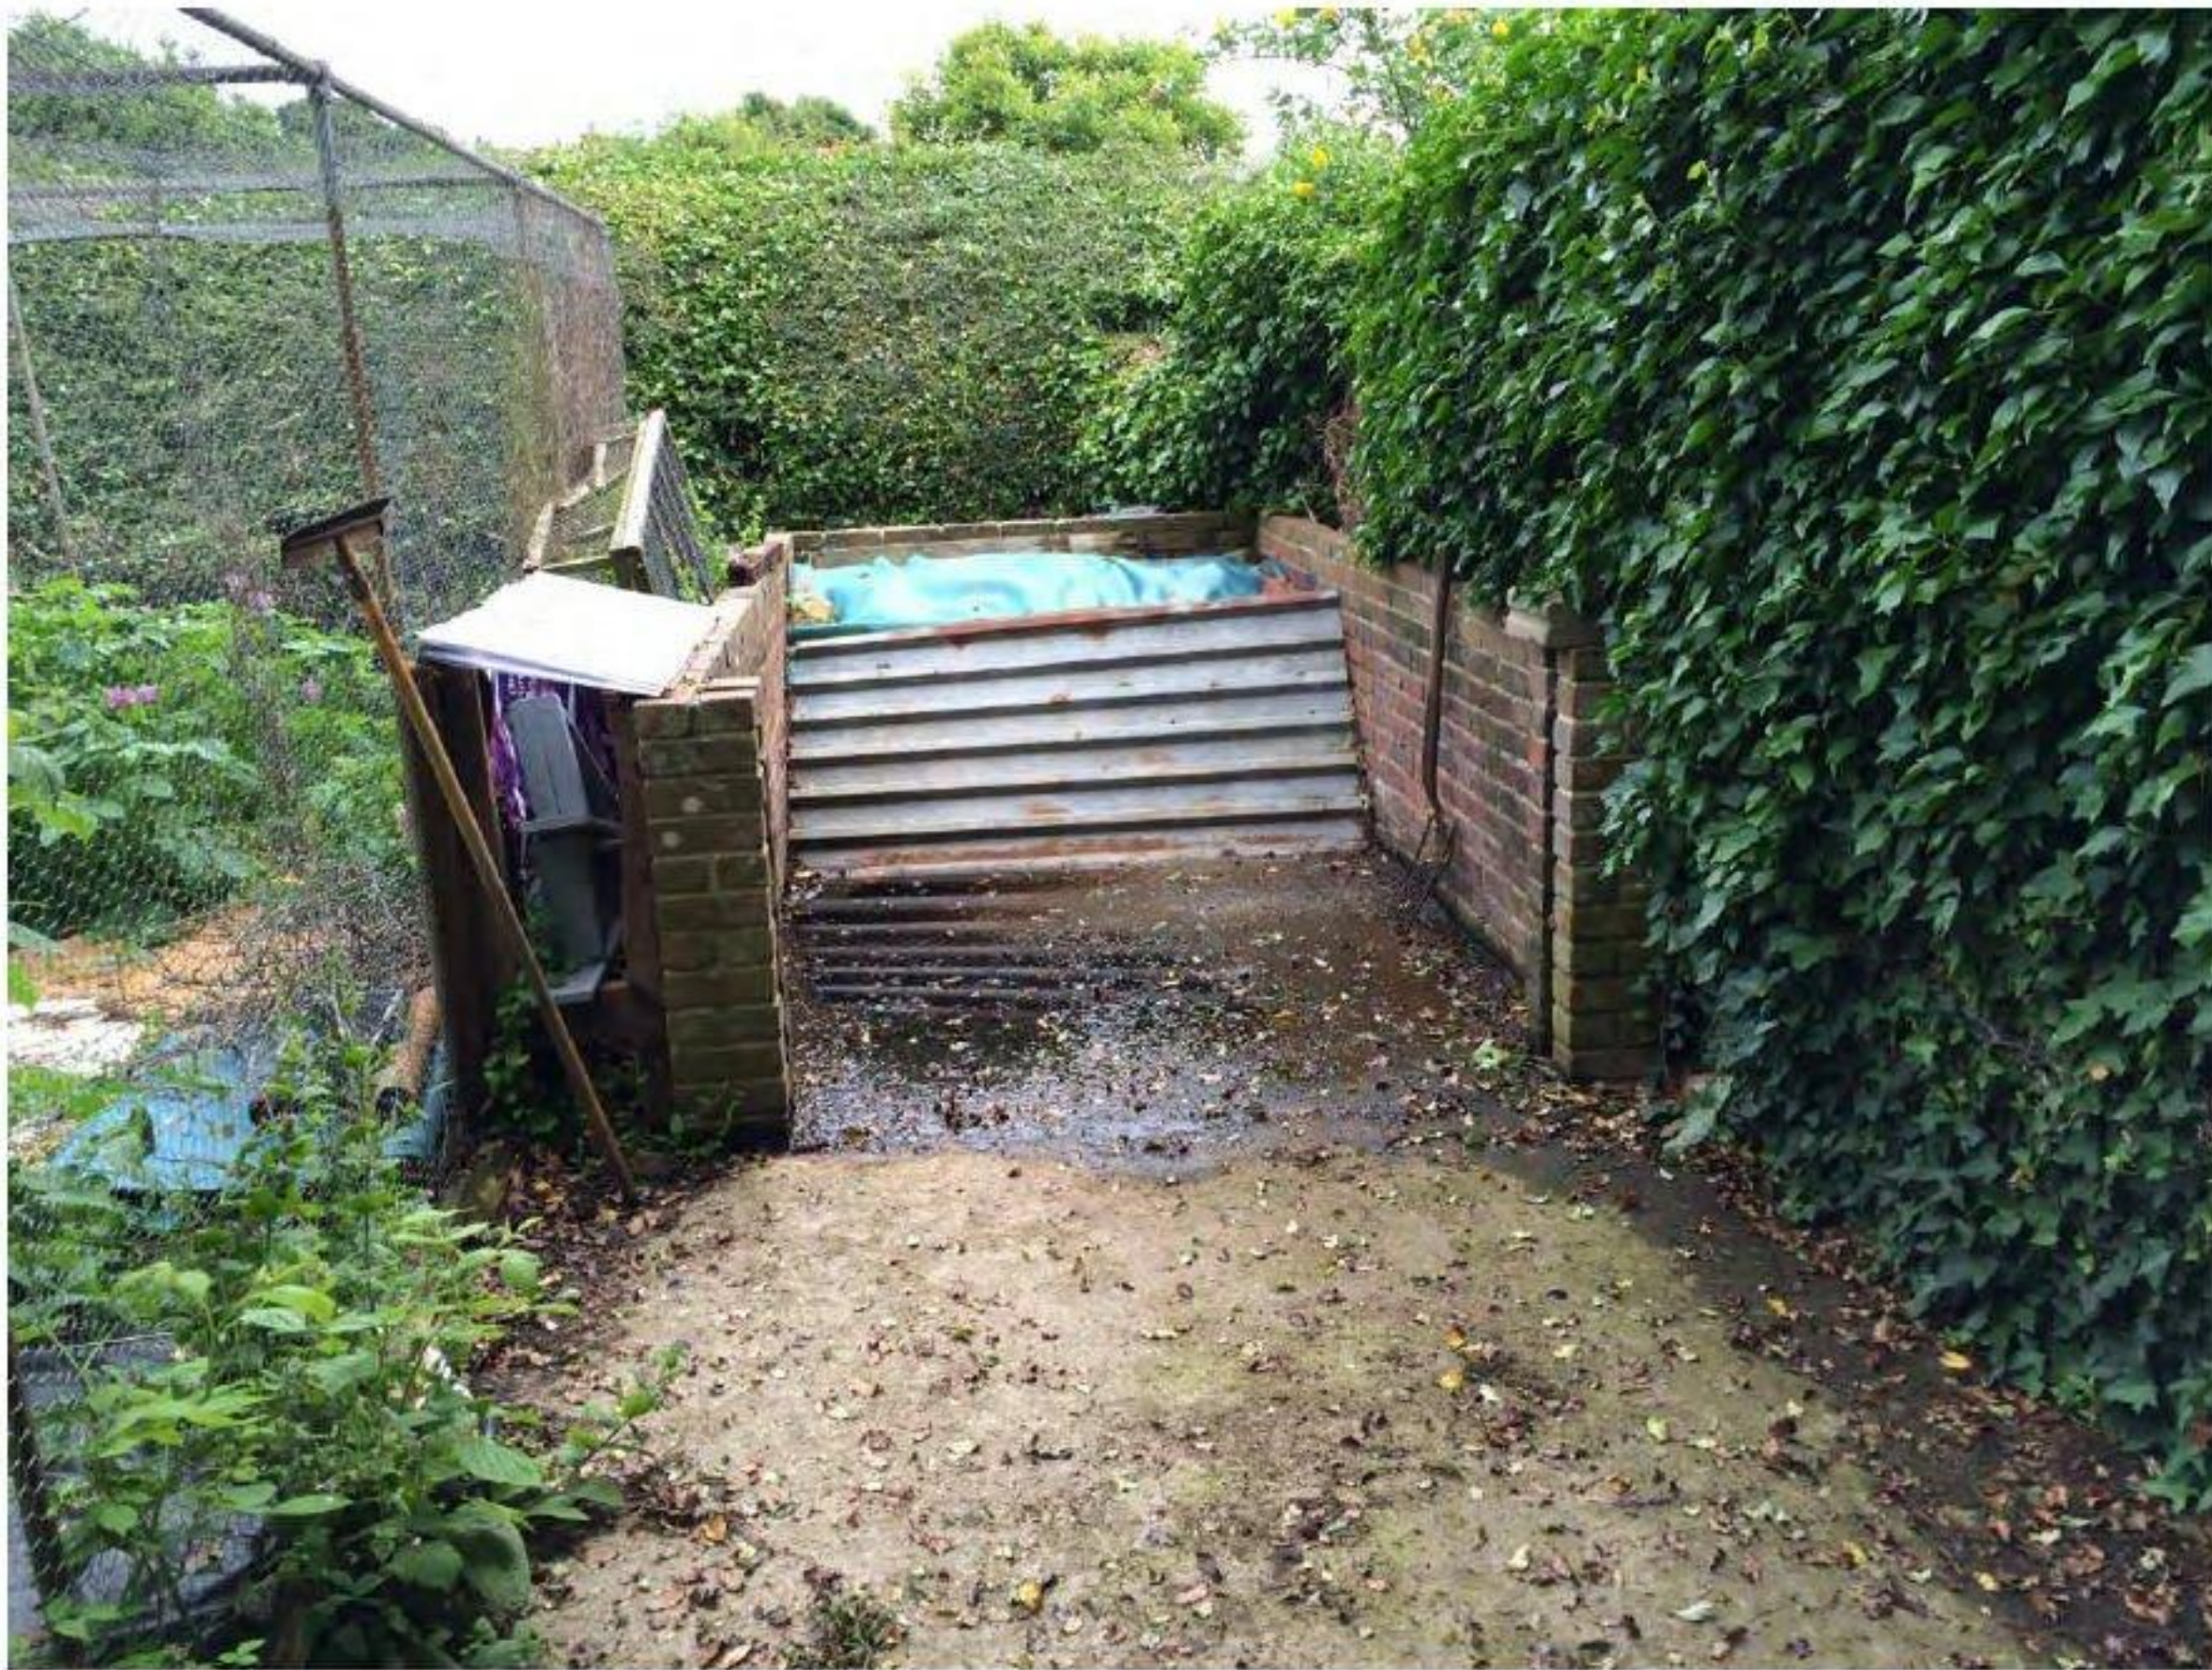
Plate 13. Concreted area for compost heap

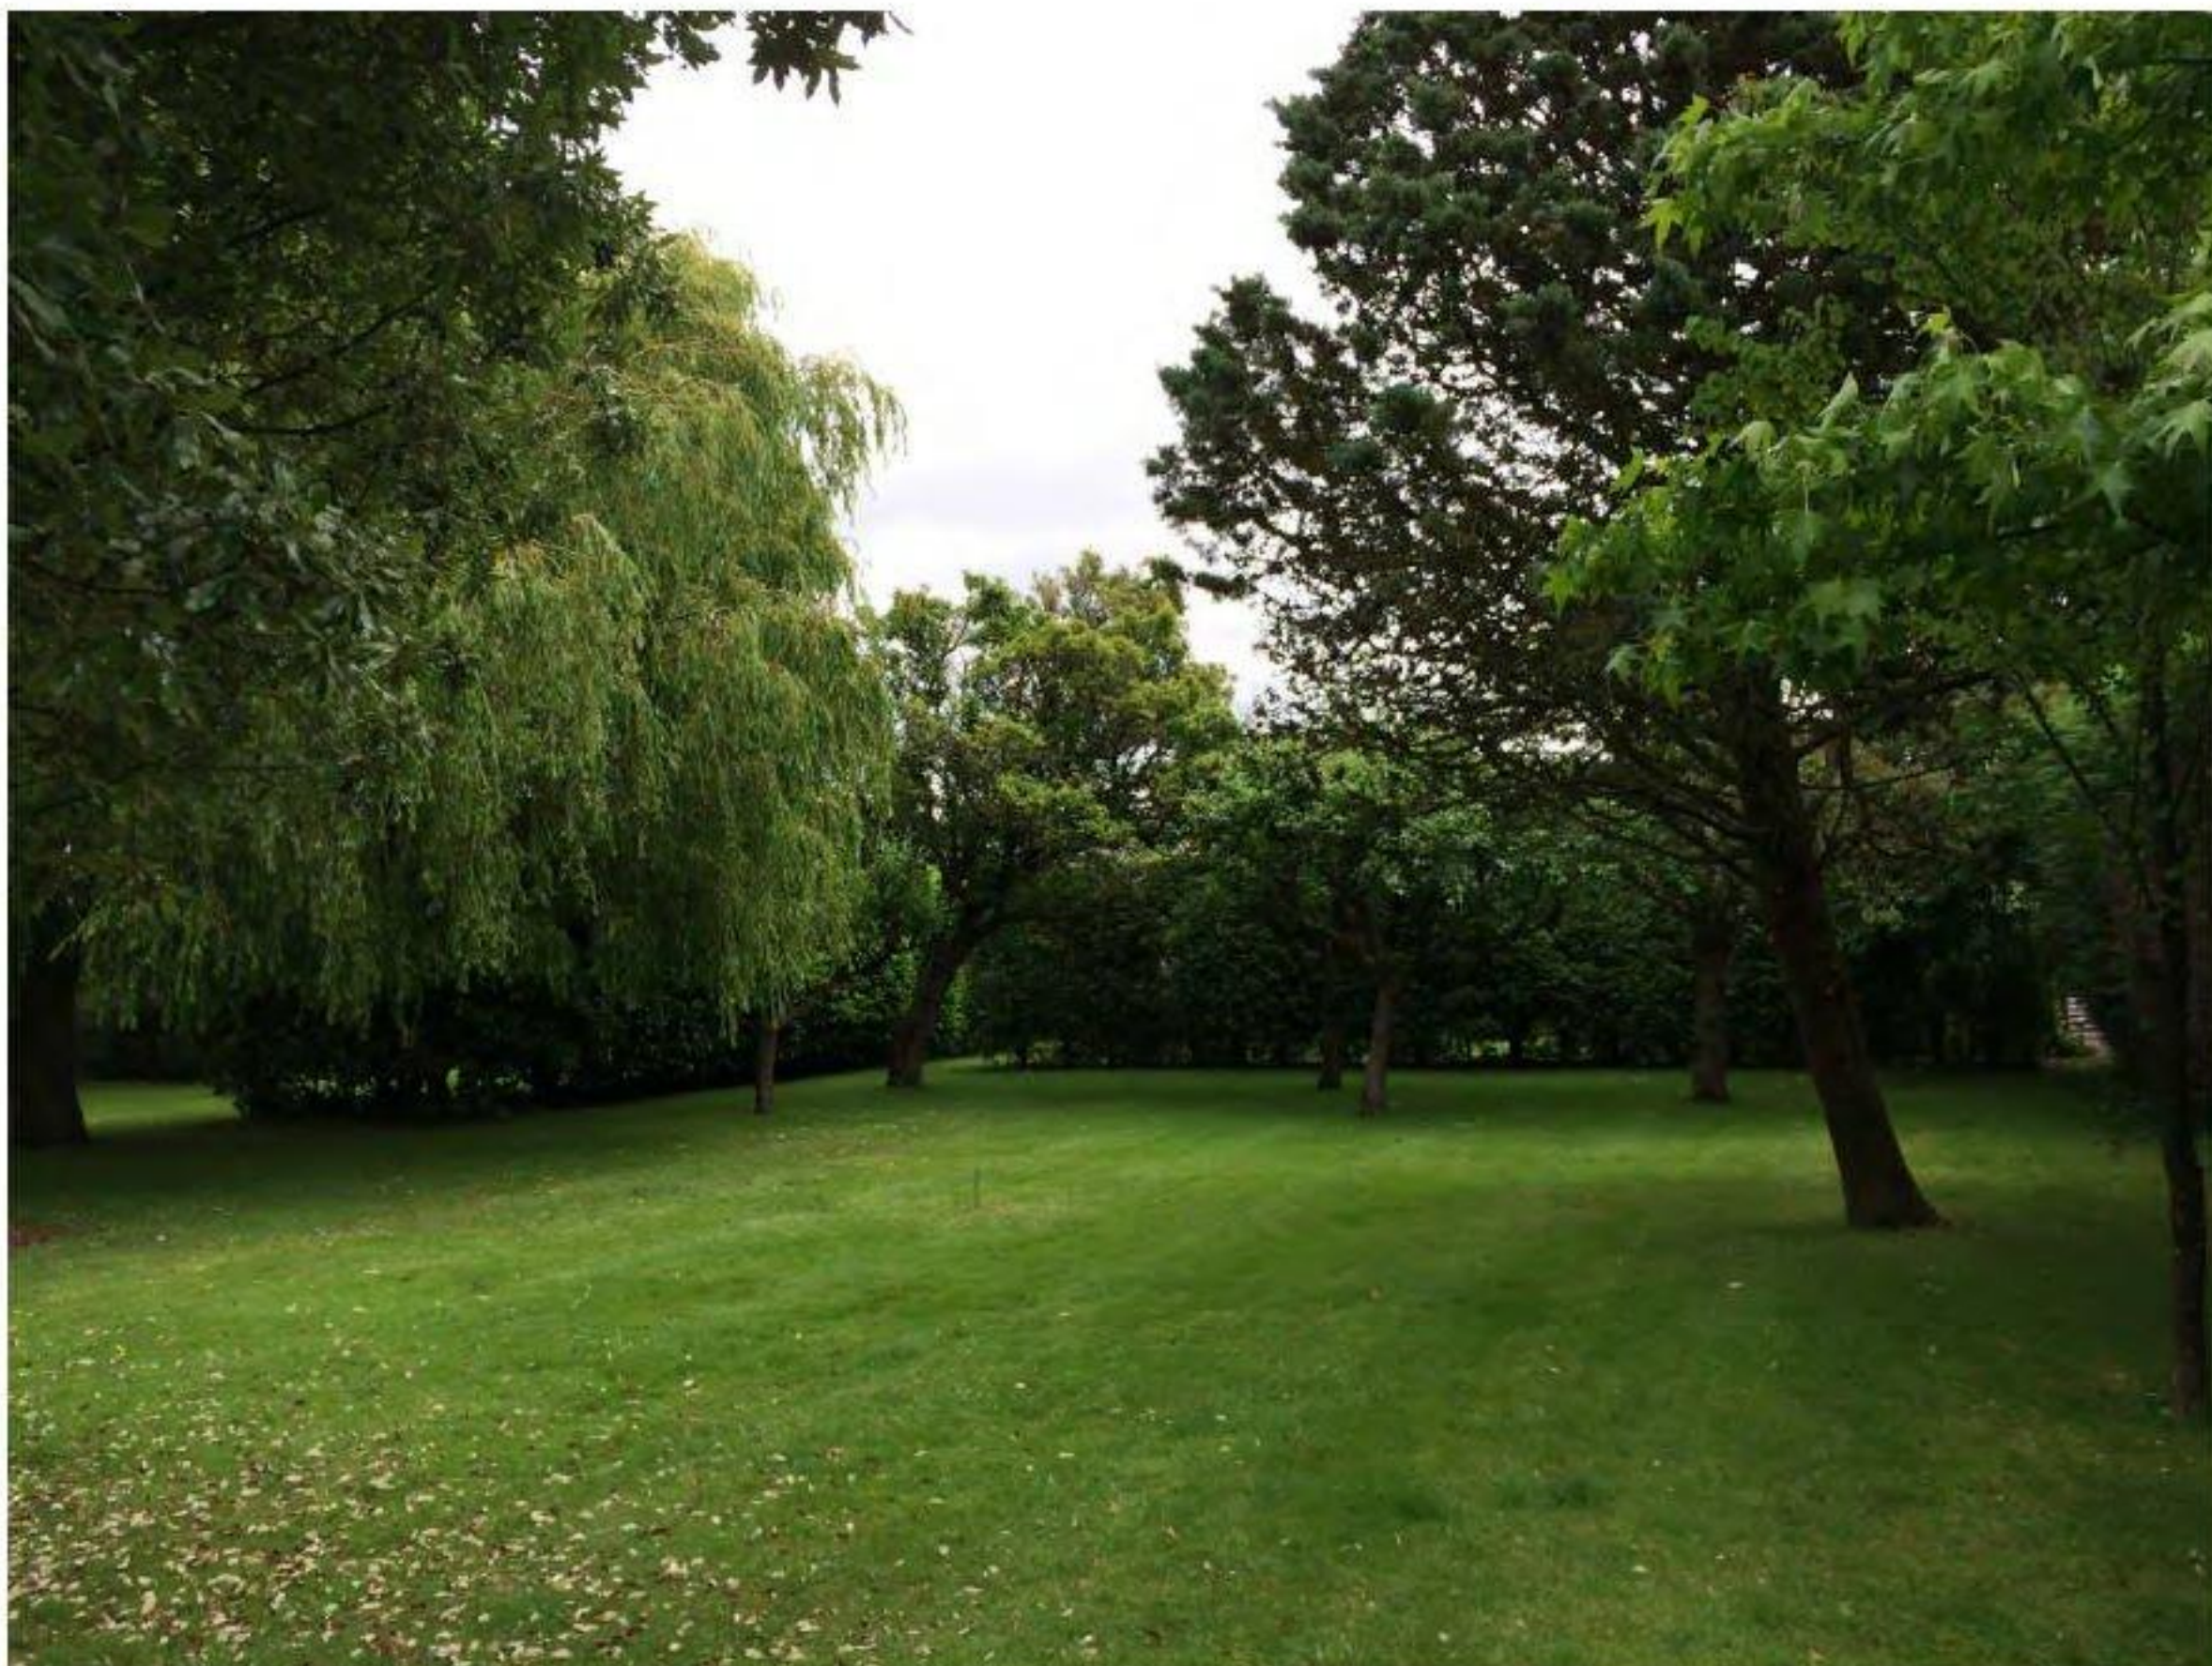
Plate 14. Garden area in the south of the site noting numerous mature trees

- 9.5.1 It is recommended that the status of the trees on site is established as soon as possible as if Tree Preservation Orders (TPOs) are confirmed on site this may represent a constraint to redevelopment. There may be restrictions to the excavation of foundations in close proximity to some of the mature trees.

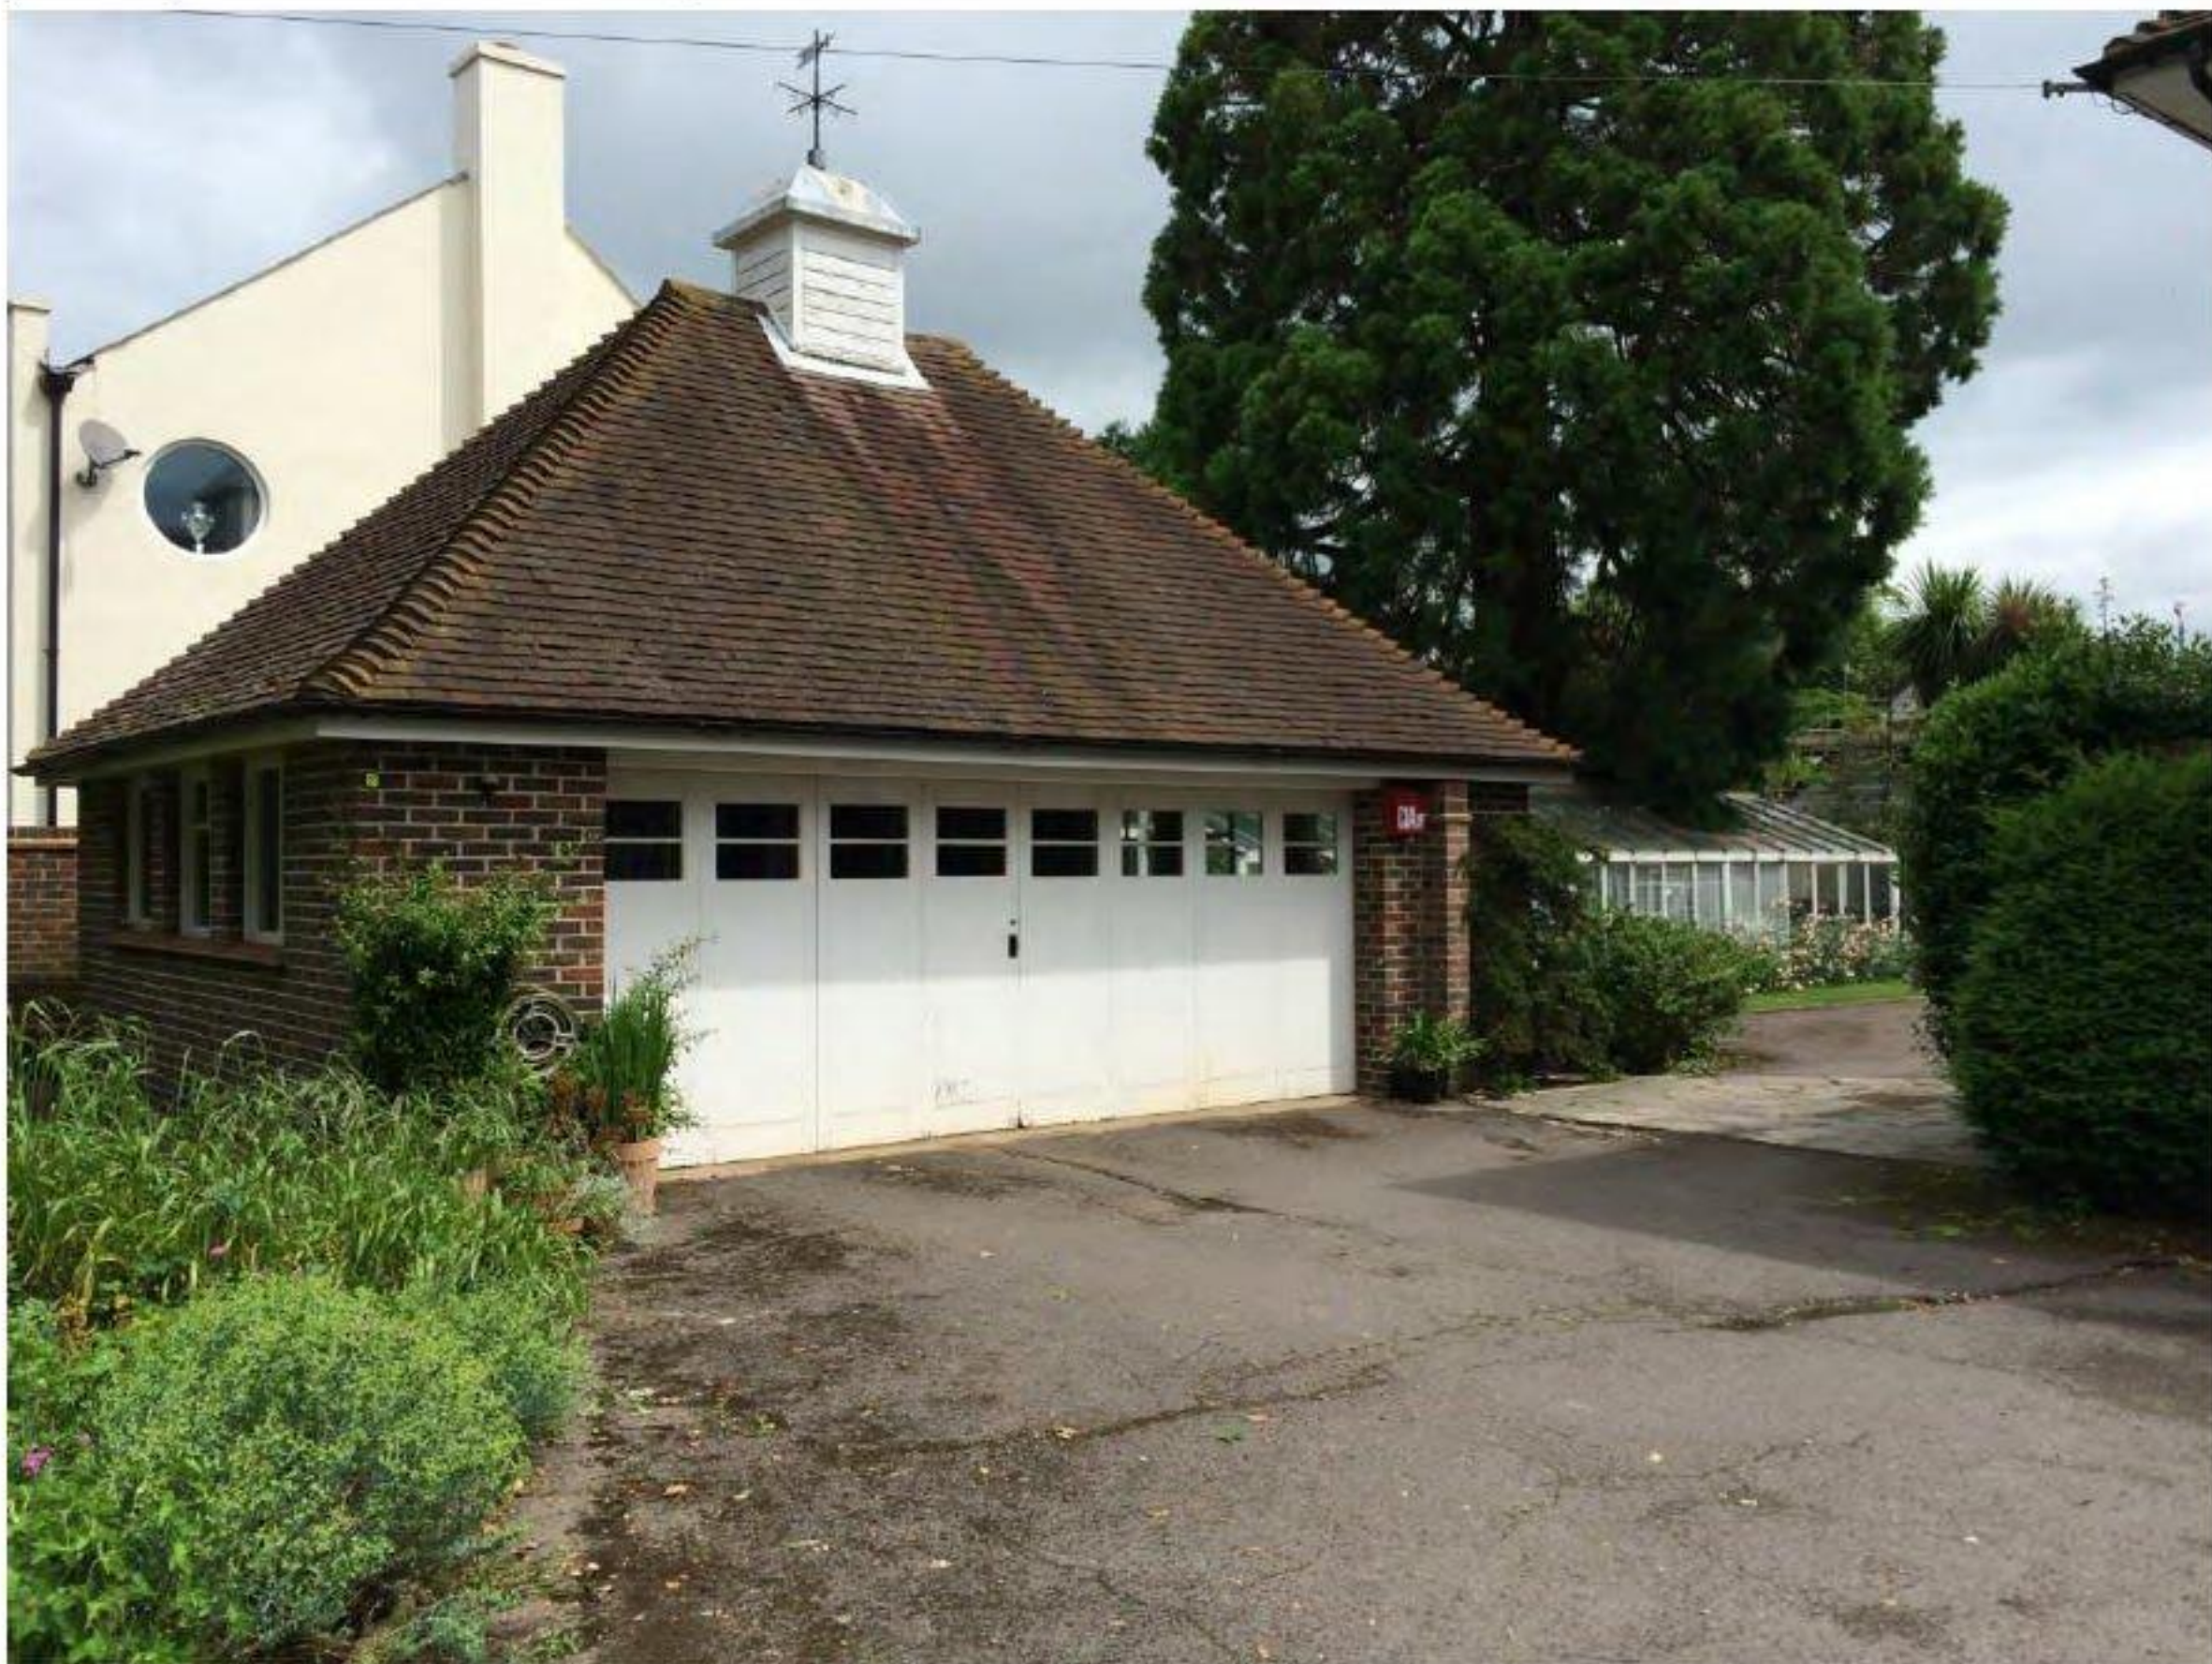
Plate 15. Garage building in the north-eastern corner of the site

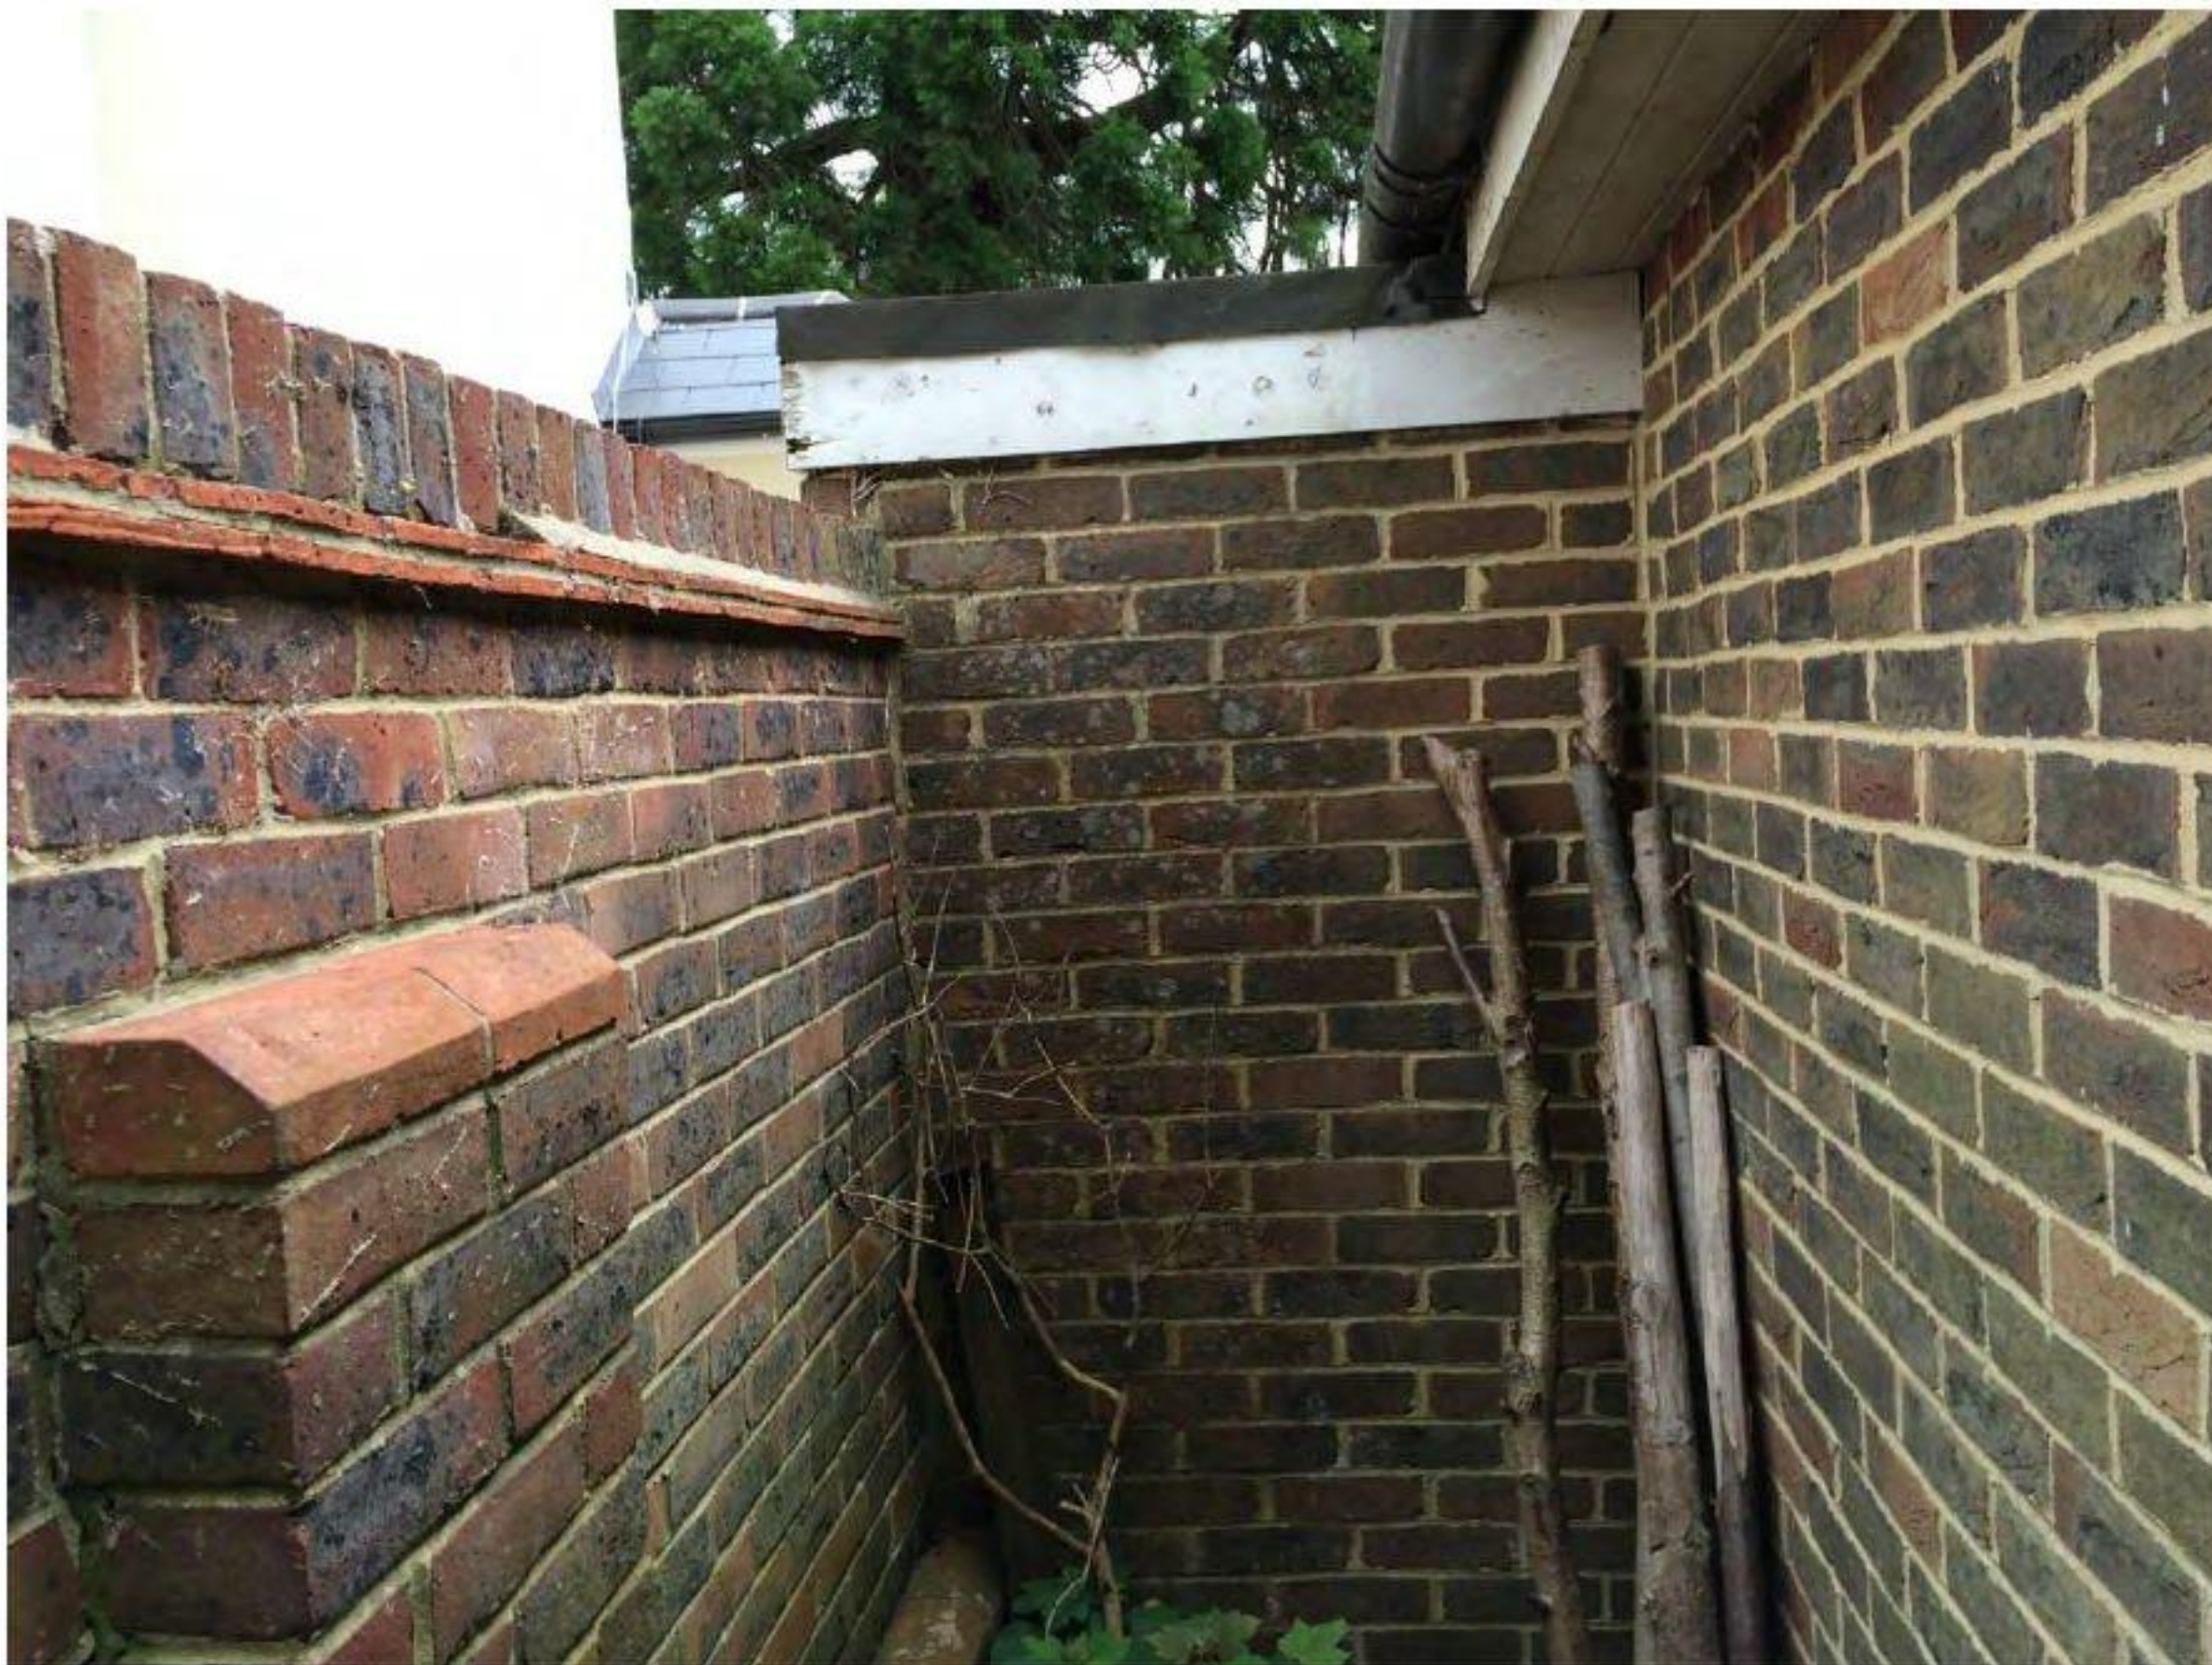
Plate 16. Garage extension adjoining northern boundary wall
