**ARBORICULTURAL REPORT**  
**at**  
**28 Damask Gardens**  
**Waterlooville**  
**Hampshire**  
**PO7 8QZ**

**Claim Number:**  
800-16-008022

**JCA Ref:**  
20946/LW

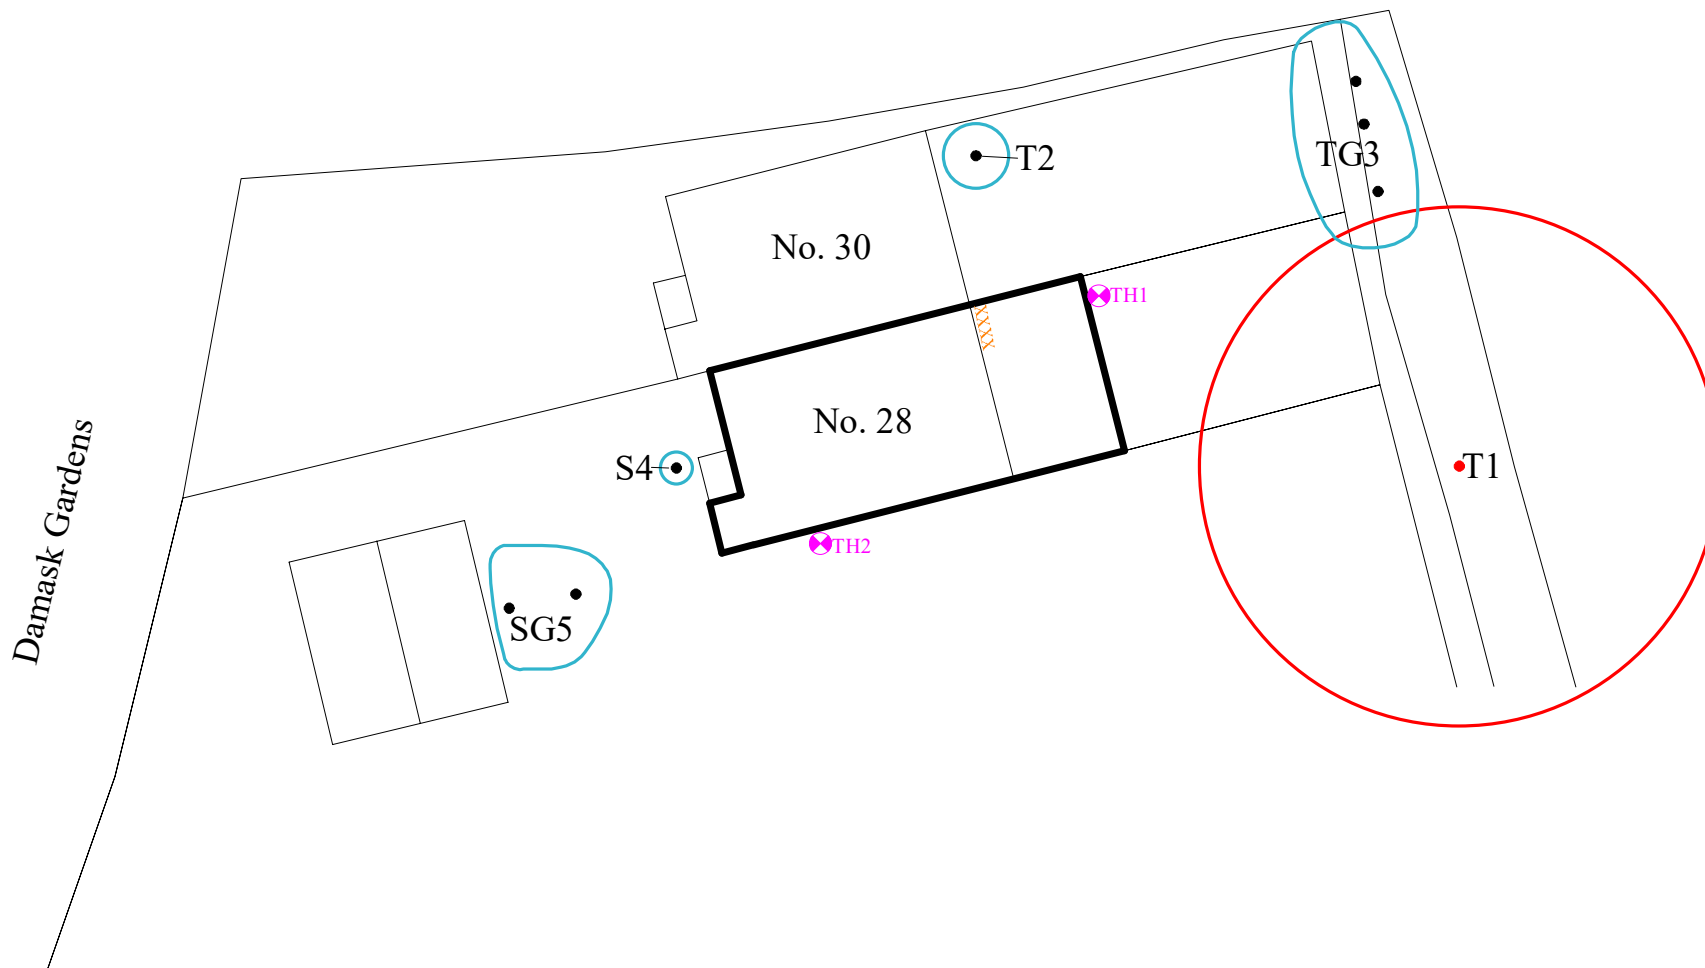
| Appendix 2: Site Plan | | |

3.4.2 The root identification is a match to the vegetation identified as **T1** in this report.

- 6.2 We consider the vegetation identified as **T1** to be contributing to the damage observed at the subject property. We have therefore recommended that this be removed to ground level, and the stump treated to prevent regrowth.

- 6.5 We consider the vegetation identified as **T2**, **TG3**, **S4** and **SG5** to be of possible future concern to the subject property, if left unmanaged. We have therefore recommended that these be maintained at their current dimensions in the forthcoming years. These works are only recommended as a precaution and are not considered a priority to resolve the damage observed at the subject property.

| Item | Species | Recommended Action | Location/Ownership | Planning Restriction |
|---|---|---|---|---|
| <b>T1</b> | English Oak | Remove to ground level and treat stump to prevent regrowth | Local Authority | Likely <b>TPO 1224</b> |
| <b>T2</b> | Juniper | Maintain at current height and spread | Third Party - 30, Damask Gardens | No TPO / Conservation Area |
| <b>TG3</b> | Hawthorn | Maintain at current height and spread | Local Authority | No TPO / Conservation Area |
| <b>S4</b> | Euonymus | Maintain at current height and spread | Policy Holder | No TPO / Conservation Area |
| <b>SG5</b> | Mixed | Maintain at current height and spread | Policy Holder | No TPO / Conservation Area |
