## **Asbestos Survey Report 03/10/2024**

**Refurbishment Survey - Report Reference - FS44123**

**Specified areas of -7-9 London Road, Widley Waterlooville, Hampshire, PO7 5AT**

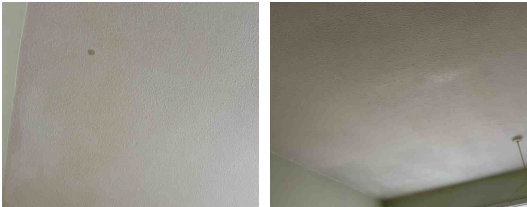
| Item ID | 003(VRS) | | |

| | | Material Risk Assessment <div></div> High |

| | | Extent of Damage (b) | 0 |

| Action/recommendations | Remove Remove ACM before Refurb. Work under FCC by FLC | | |

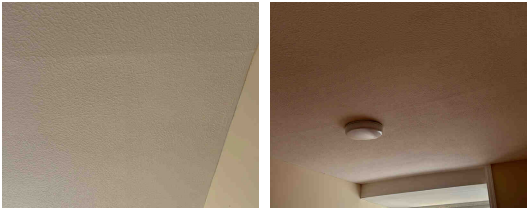
| Item ID | 006(VRS) | | |

| | | Material Risk Assessment | <div></div> Very Low |

| | | Extent of Damage (b) | 0 |

| Action/recommendations | Remove Remove ACM before Refurb. Work under FCC by FLC | | |

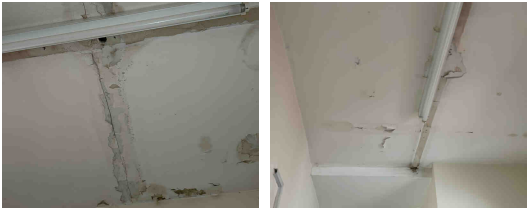
| Item ID | 009(VRS) | | |

| | | Material Risk Assessment | <div></div> Very Low |

| | | Extent of Damage (b) | 1 |

| Action/recommendations | Remove Remove ACM before Refurb. Work under FCC by FLC | | |

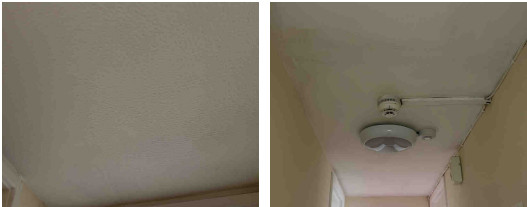
| Item ID | 016(VRS) | | |

| | | Material Risk Assessment | <div></div> Very Low |

| | | Extent of Damage (b) | 0 |

| Action/recommendations | Remove Remove ACM before Refurb. Work under FCC by FLC | | |

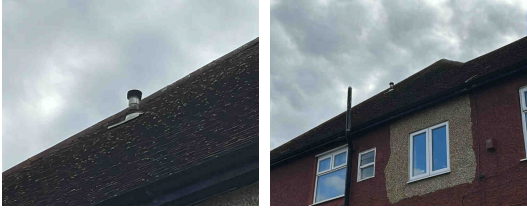
| Item ID | 019 | | |

| | | Material Risk Assessment | <div></div> Very Low |

| | | Extent of Damage (b) | N/A |

| Action/recommendations | Remove Remove ACM before Refurb. Work under FCC by FLC | | |
