# CCTV Inspection Report

Job Number  
**Post Repair Check**

Back To Fitness  
270A London Road  
Waterlooville  
PO7 7HG

A CCTV drainage survey was carried out to ascertain the condition of the existing drainage system and to produce an accurate drawing showing the layout and location of the drainage runs.

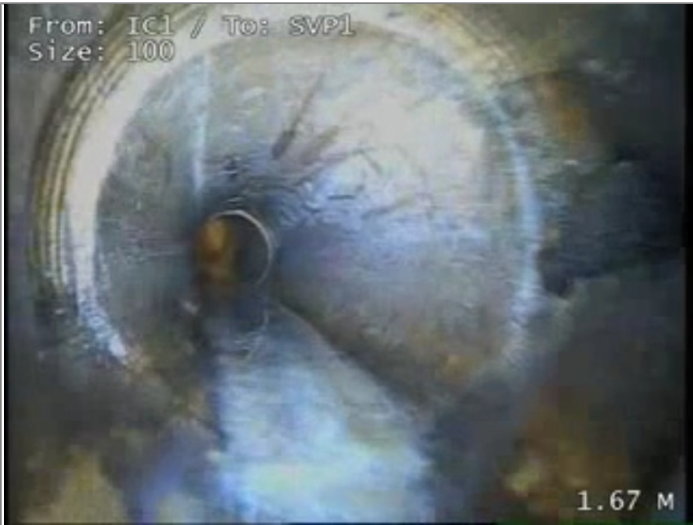
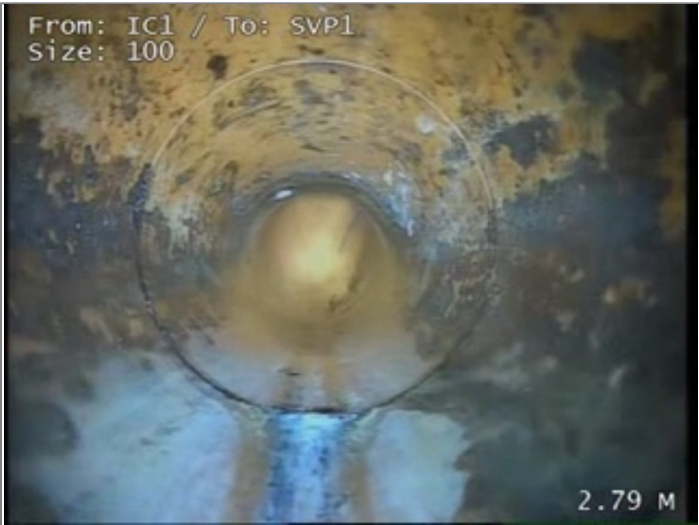
- **IC1 upstream SVP1:**  
A build-up of scale was observed within the line.
- **IC1 upstream SVP2:**  
No defects or issues identified; line is in satisfactory condition.

| Start Node Ref:IC1 I/L : metres Depth: 0.380 metres | | | | |
|---|---|---|---|---|
| 1.67 | DEC (S1) | Settled deposits hard or compacted 10% cross-sectional area loss, Start | 13302275 | Service / 3 |
| 2.79 | DEC (F1) | Settled deposits hard or compacted 10% cross-sectional area loss, Finished | 13302276 | Service / 3 |

| Job Number<br>Post Repair Check | Surveyed by (Operator)<br>BILLY LINK | Base Unit<br>2VFCPF2N7E | Date<br>10/10/2025 |
|---|---|---|---|
| <p>From: IC1 / To: SVP1<br/>Size: 100</p> <p style="text-align: right;">1.67 M</p> <p>Settled deposits hard or compacted 10% cross-sectional area loss, Start</p> | | <p>From: IC1 / To: SVP1<br/>Size: 100</p> <p style="text-align: right;">2.79 M</p> <p>Settled deposits hard or compacted 10% cross-sectional area loss, Finished</p> | |

Recommend a descale.

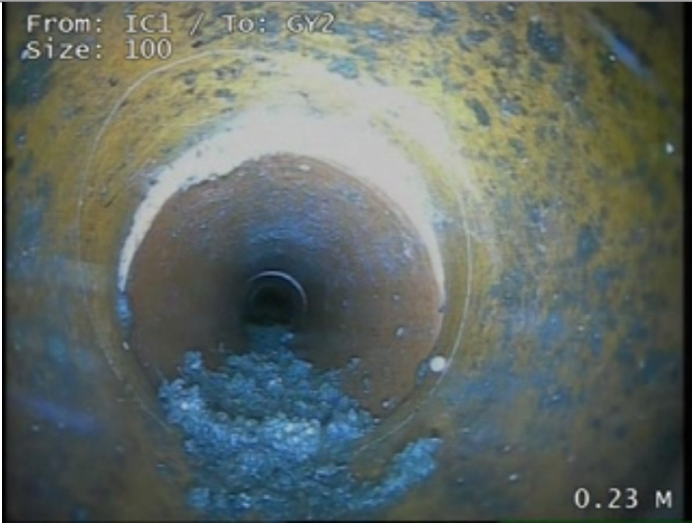
- **IC1 upstream GY2:**  
A crack was observed at **0.23m**.  
Build-up of scale noted from **0.31m**, causing the survey to be **abandoned at 2.19m** due to obstruction.

| Job Number<br>Post Repair Check | Surveyed by (Operator)<br>BILLY LINK | Base Unit<br>2VFCPF2N7E | Date<br>10/10/2025 |
|---|---|---|---|
| <div> <div> From: IC1 / To: GY2<br/>Size: 100 </div> 0.23 M </div> <div>Crack circumferential from 8 to 4 o'clock at joint</div> | | | |

Recommend a descale and further investigation.

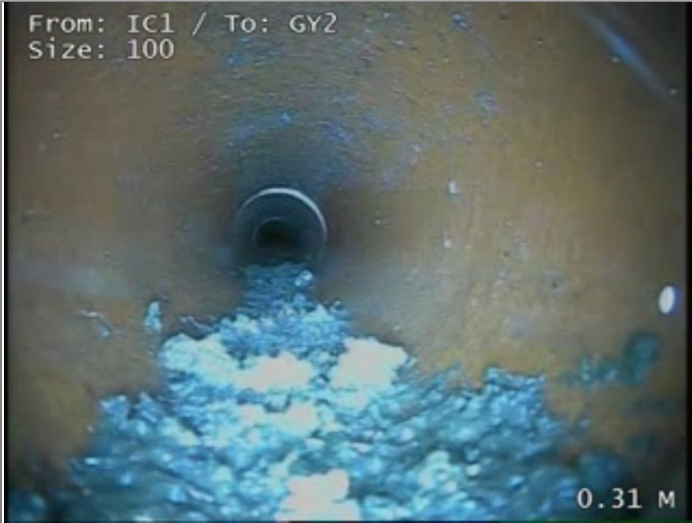
| Job Number<br>Post Repair Check | Surveyed by (Operator)<br>BILLY LINK | Base Unit<br>2VFCPF2N7E | Date<br>10/10/2025 |
|---|---|---|---|
| <div> <div> From: IC1 / To: GY2<br/>Size: 100 </div> 0.31 M </div> <div>Settled deposits hard or compacted 20% cross-sectional area loss, Start</div> | | | |

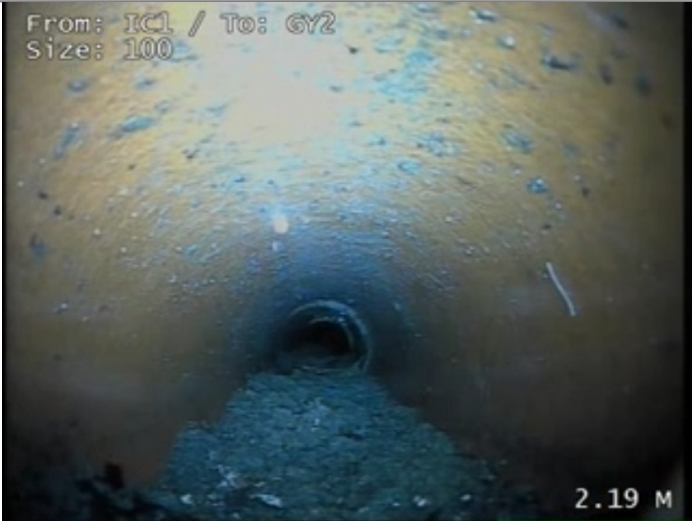
| Job Number<br>Post Repair Check | Surveyed by (Operator)<br>BILLY LINK | Base Unit<br>2VFCPF2N7E | Date<br>10/10/2025 |
|---|---|---|---|
| <div> <div> From: IC1 / To: GY2<br/>Size: 100 </div> 2.19 M </div> <div>Settled deposits hard or compacted 20% cross-sectional area loss, Finished</div> | | | |

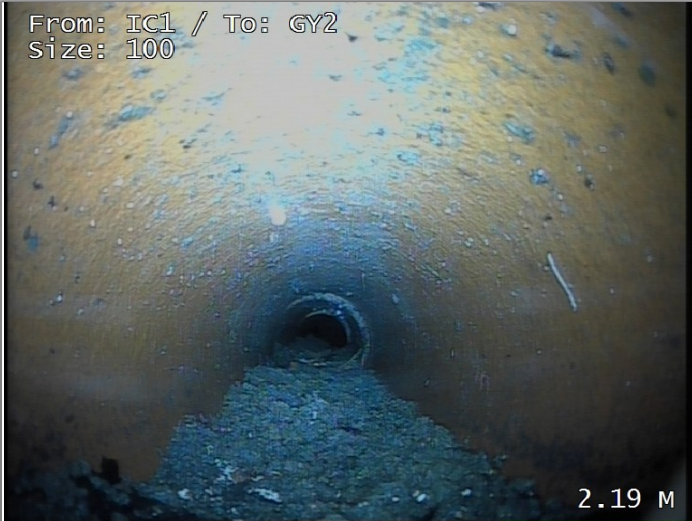
| Job Number<br>Post Repair Check | Surveyed by (Operator)<br>BILLY LINK | Base Unit<br>2VFCPF2N7E | Date<br>10/10/2025 |
|---|---|---|---|
| <div> <div> From: IC1 / To: GY2<br/>Size: 100 </div> 2.19 M </div> <div>Survey abandoned - Remark: SILT</div> | | | |

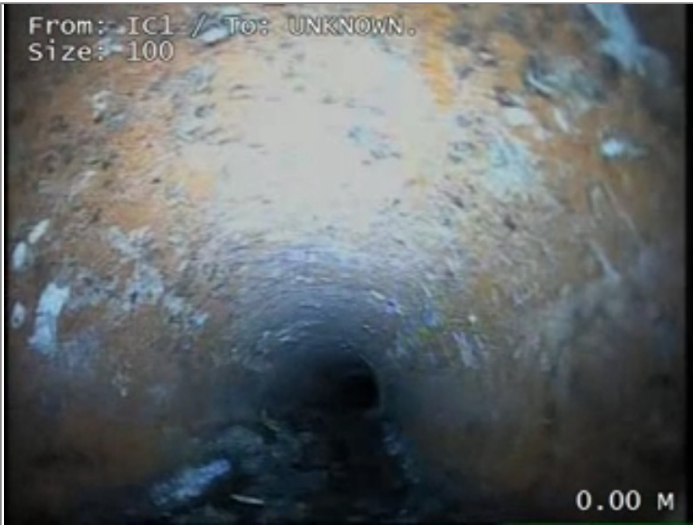
- **IC1 upstream GY3:**  
No defects or issues identified; line is in satisfactory condition.
- **IC1 upstream (Unknown):**  
Heavy build-up of scale throughout the line.  
Survey **abandoned at 1.6m** due to blockage caused by scale.

| Job Number<br>Post Repair Check | Surveyed by (Operator)<br>BILLY LINK | Base Unit<br>2VFCPF2N7E | Date<br>10/10/2025 |
|---|---|---|---|
| <div> <div> From: IC1 / To: UNKNOWN.<br/>Size: 100 </div> 0.00 M </div> <div>Settled deposits hard or compacted 20% cross-sectional area loss, Start</div> | | | |

Recommend a descale and further investigation.

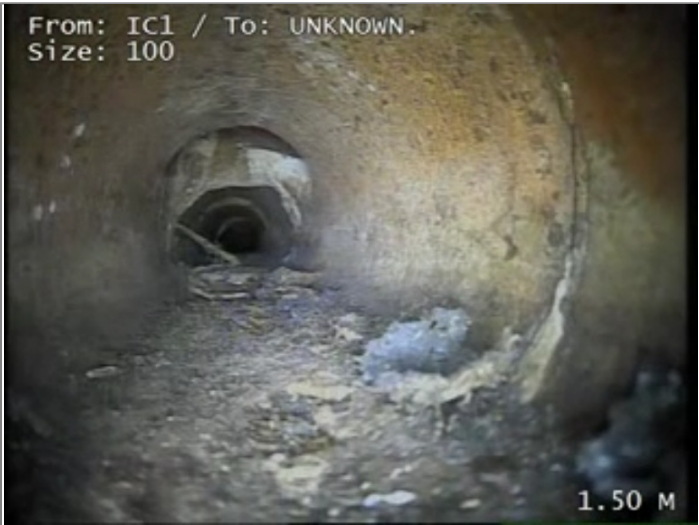
| Job Number<br>Post Repair Check | Surveyed by (Operator)<br>BILLY LINK | Base Unit<br>2VFCPF2N7E | Date<br>10/10/2025 |
|---|---|---|---|
| <div> <div> From: IC1 / To: UNKNOWN.<br/>Size: 100 </div> 1.50 M </div> <div>Settled deposits hard or compacted 20% cross-sectional area loss, Finished</div> | | | |

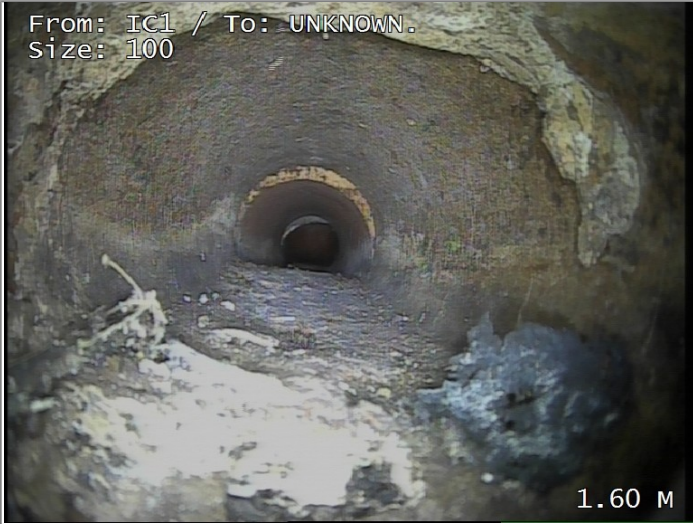
| Job Number<br>Post Repair Check | Surveyed by (Operator)<br>BILLY LINK | Base Unit<br>2VFCPF2N7E | Date<br>10/10/2025 |
|---|---|---|---|
| <div> <div> From: IC1 / To: UNKNOWN.<br/>Size: 100 </div> 1.60 M </div> <div>Settled deposits hard or compacted 30% cross-sectional area loss</div> | | | |

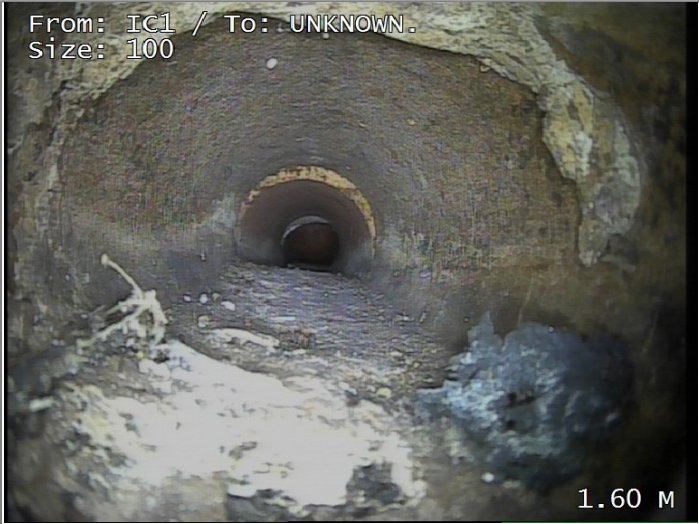
| Job Number<br>Post Repair Check | Surveyed by (Operator)<br>BILLY LINK | Base Unit<br>2VFCPF2N7E | Date<br>10/10/2025 |
|---|---|---|---|
| <div> <div> From: IC1 / To: UNKNOWN.<br/>Size: 100 </div> 1.60 M </div> <div>Survey abandoned - Remark: SCALE</div> | | | |

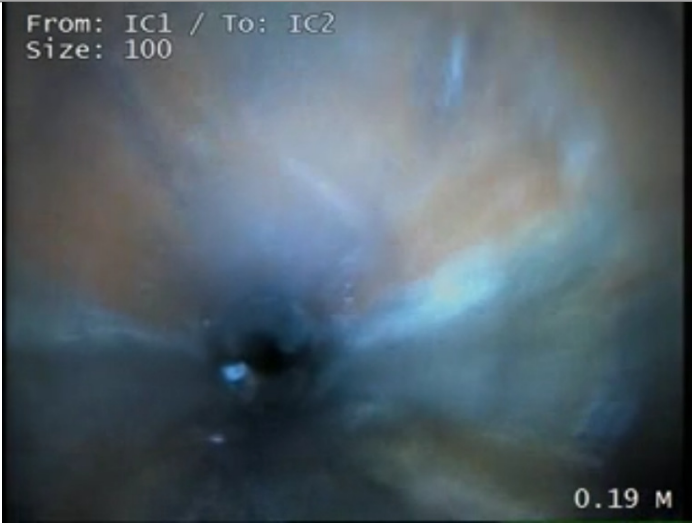
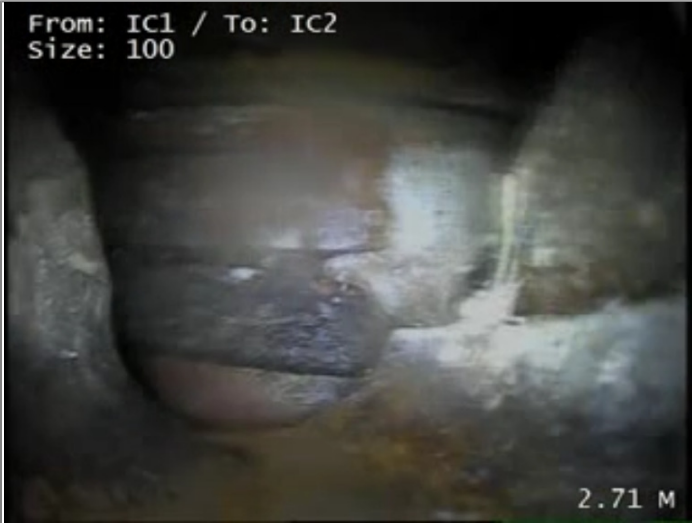
| Job Number<br>Post Repair Check | Surveyed by (Operator)<br>BILLY LINK | Base Unit<br>2VFCPF2N7E | Date<br>10/10/2025 |
|---|---|---|---|
| <div> <div>From: IC1 / To: IC2<br/>Size: 100</div> <div>0.19 M</div> </div> <div>Settled deposits hard or compacted 5% cross-sectional area loss, Start</div> | | <div> <div>From: IC1 / To: IC2<br/>Size: 100</div> <div>2.71 M</div> </div> <div>Settled deposits hard or compacted 5% cross-sectional area loss, Finished</div> | |

Recommend a descale.

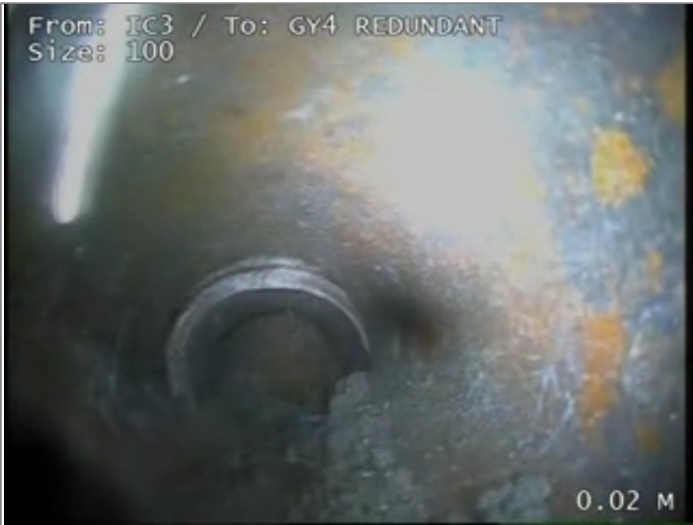
- **IC3 upstream GY4 (Redundant):**  
Build-up of **silt** observed within the line.
- **Connection downstream Manhole:**  
Heavy build-up of **scale throughout** the line.  
The main **150mm pipe** has been marked up at **14m** and **20m** (see attached drawing for reference).

| Position | Code | Description | Photo | Type/Grade |
|---|---|---|---|---|
| | 0.02 | DES (S1) | Settled deposits fine 20% cross-sectional area loss, Start | 13302289 Service / 3 |
| | 0.60 | DES (F1) | Settled deposits fine 20% cross-sectional area loss, Finished | 13302290 Service / 3 |

| Job Number<br>Post Repair Check | Surveyed by (Operator)<br>BILLY LINK | Base Unit<br>2VFCPF2N7E | Date<br>10/10/2025 |
|---|---|---|---|
| <p>From: IC3 / To: GY4 REDUNDANT<br/>Size: 100</p> <p>0.02 M</p> <p>Settled deposits fine 20% cross-sectional area loss, Start</p> | | <p>From: IC3 / To: GY4 REDUNDANT<br/>Size: 100</p> <p>0.60 M</p> <p>Settled deposits fine 20% cross-sectional area loss, Finished</p> | |

Redundant gully, recommend a line clean.

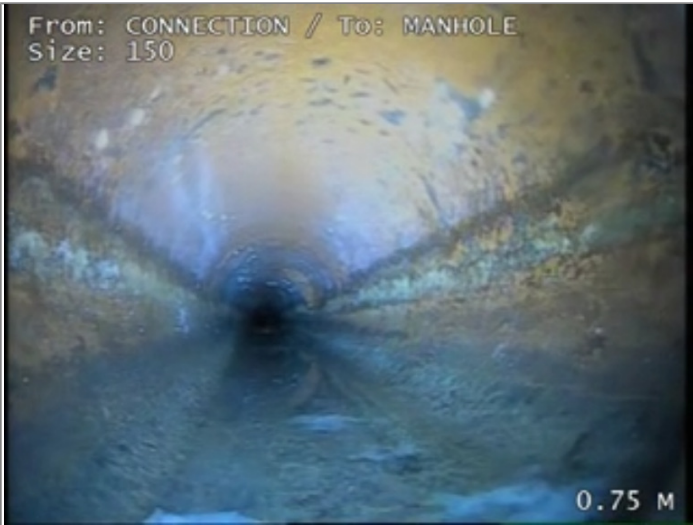
| Job Number<br>Post Repair Check | Surveyed by (Operator)<br>BILLY LINK | Base Unit<br>2VFCPF2N7E | Date<br>10/10/2025 |
|---|---|---|---|
| <p>From: CONNECTION / To: MANHOLE<br/>Size: 150</p> <p>0.75 M</p> <p>Settled deposits hard or compacted 5% cross-sectional area loss, Start</p> | | <p>From: CONNECTION / To: MANHOLE<br/>Size: 150</p> <p>30.04 M</p> <p>Settled deposits hard or compacted 5% cross-sectional area loss, Finished</p> | |
