# ARBORICULTURAL ASSESSMENT REPORT

31 Firs Avenue, Waterlooville, PO8 8RS

PRI Ref: 255369

Survey Date: 29/03/2023

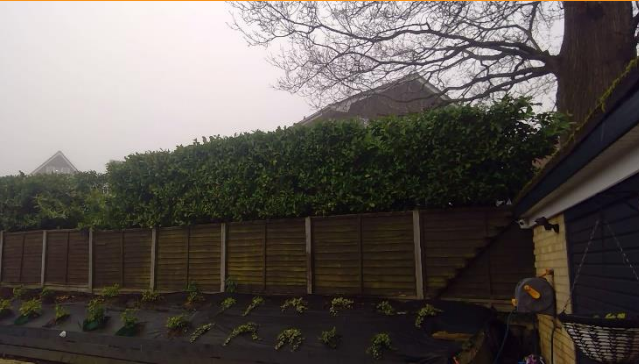
| H1 - Laurel (Cherry) | T1 - Oak |

| Tree No | Common Name | Age Class | Condition | Height (m) | Crown Spread (m) | Stem diam. (mm) | Dist to bldg. (m) | Roots Implicated | Pruning history | Recommendation | Tree work constraints | Notes | Owner address | Owner |
|---|---|---|---|---|---|---|---|---|---|---|---|---|---|---|
| H1 | Laurel (Cherry) | Mature | Fair | 2.6 | 1.2 | 45* | 0.8 | N | Managed as a hedge along boundary fence. | No work required. | | | 2 Edwards Close, Waterlooville PO8 8RJ | P3P |

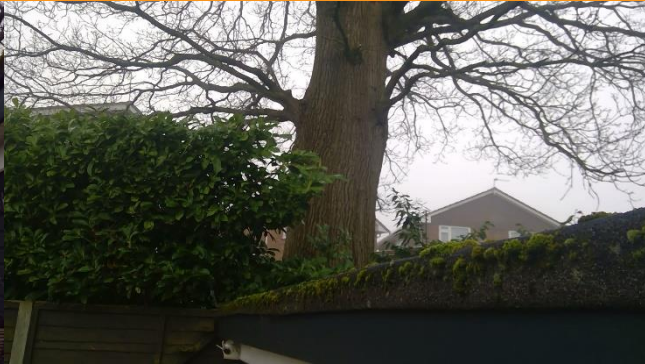
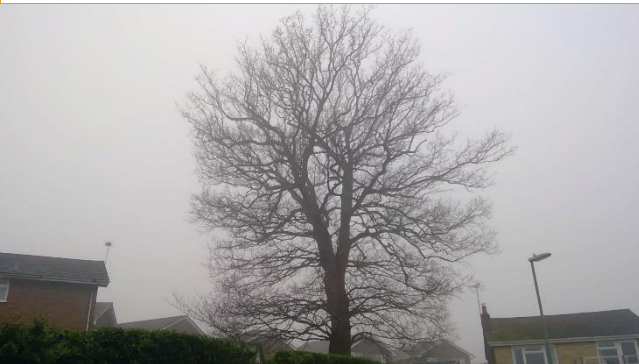
| Tree No | Common Name | Age Class | Condition | Height (m) | Crown Spread (m) | Stem diam. (mm) | Dist to bldg. (m) | Roots Implicated | Pruning history | Recommendation | Tree work constraints | Notes | Owner address | Owner |
|---|---|---|---|---|---|---|---|---|---|---|---|---|---|---|
| T1 | Oak | Mature | Fair | 19.0 | 16.4 | 900* | 3.2 | Y | Subject to past management. No significant recent management. | Fell and treat stump with eco plugs (broadleaved). | Obstructions- garages. Access through neighbours side gate. | | 2 Edwards Close, Waterlooville PO8 8RJ | P3P |

| Tree No: | Species | Works Required | CA | TPO | Ownership |
|---|---|---|---|---|---|
| T1 | Oak | Fell and treat stump with eco plugs (broadleaved). | No | Yes | P3P |

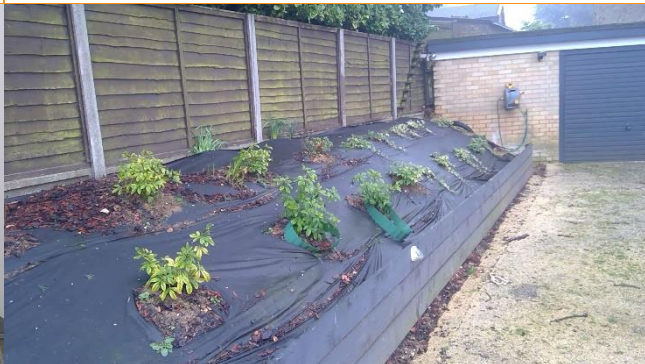
| T1 - Oak | SG1 - Mixed species shrubs |

| Tree No | Common Name | Age Class | Condition | Height (m) | Crown Spread (m) | Stem diam. (mm) | Dist to bldg. (m) | Roots Implicated | Pruning history | Recommendation | Tree work constraints | Notes | Owner address | Owner |
|---|---|---|---|---|---|---|---|---|---|---|---|---|---|---|
| SG1 | Mixed species shrubs | Young | Fair | 0.6 | 0.4 | 20 | 1.4 | N | No significant past tree works. | No work required. | | Ivy and choisya planted in a sloping bed with felt covering. | 31 Firs Avenue, Waterlooville PO8 8RS | PH |

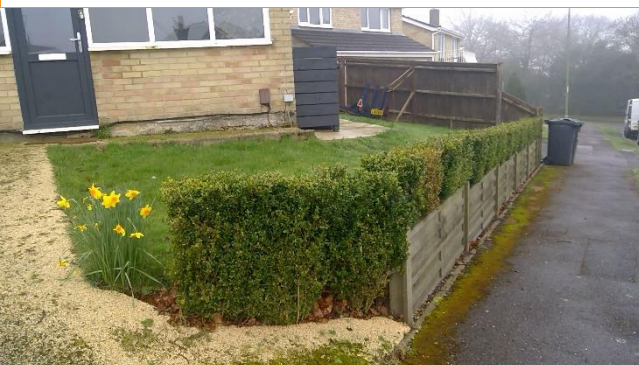
| H2 - Box | S1 - Laurel (Cherry) |

| Tree No | Common Name | Age Class | Condition | Height (m) | Crown Spread (m) | Stem diam. (mm) | Dist to bldg. (m) | Roots Implicated | Pruning history | Recommendation | Tree work constraints | Notes | Owner address | Owner |
|---|---|---|---|---|---|---|---|---|---|---|---|---|---|---|
| H2 | Box | Early Mature | Fair | 0.7 | 0.4 | 20 | 2.5 | N | Managed as a boundary hedge. | No work required. | | | 31 Firs Avenue, Waterlooville PO8 8RS | PH |

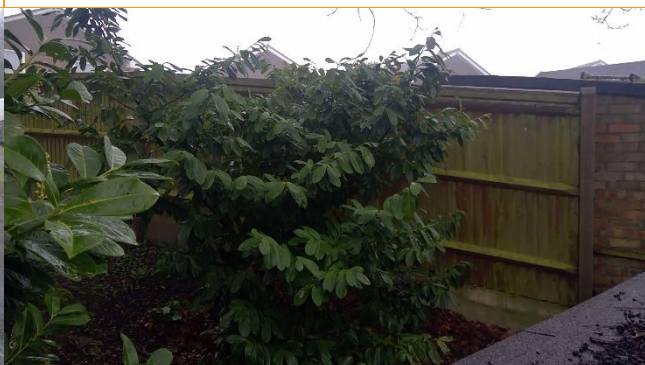
| Tree No | Common Name | Age Class | Condition | Height (m) | Crown Spread (m) | Stem diam. (mm) | Dist to bldg. (m) | Roots Implicated | Pruning history | Recommendation | Tree work constraints | Notes | Owner address | Owner |
|---|---|---|---|---|---|---|---|---|---|---|---|---|---|---|
| S1 | Laurel (Cherry) | Mature | Fair | 2.2 | 2.0* | 20* | 2.4* | N | No significant past tree works. | No work required. | | | 2 Edwards Close, Waterlooville PO8 8RJ | P3P |
