# Staunton Country Park

## ‘Lake’ Assessment Technical Note

6 November 2023

**Job Number: P13631**

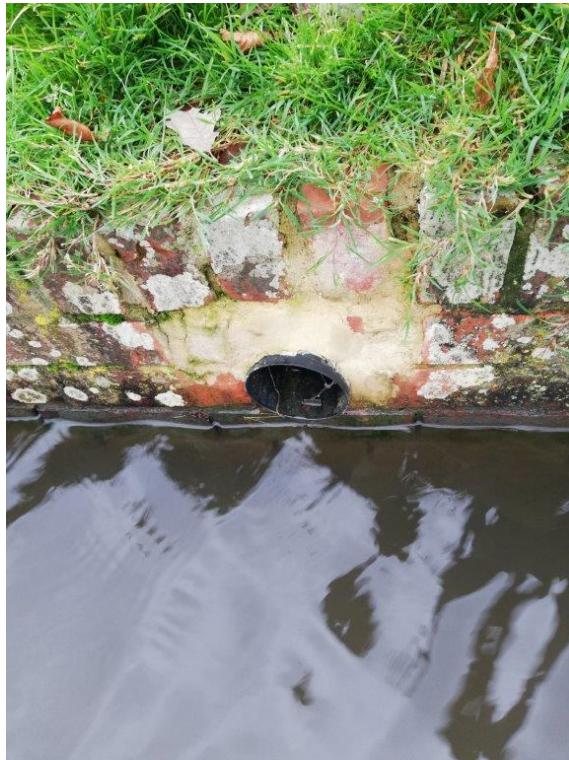
4.4.2 Based on site reconnaissance, multiple small diameter pipe outlets were observed protruding from the lake wall on western side of the lake. The site operatives confirmed these outlets corresponded with land drainage features serving the slope area between the lake and former house.

5) Land drainage outfalls on the western side of the lake [Report Section 5.2, d)]

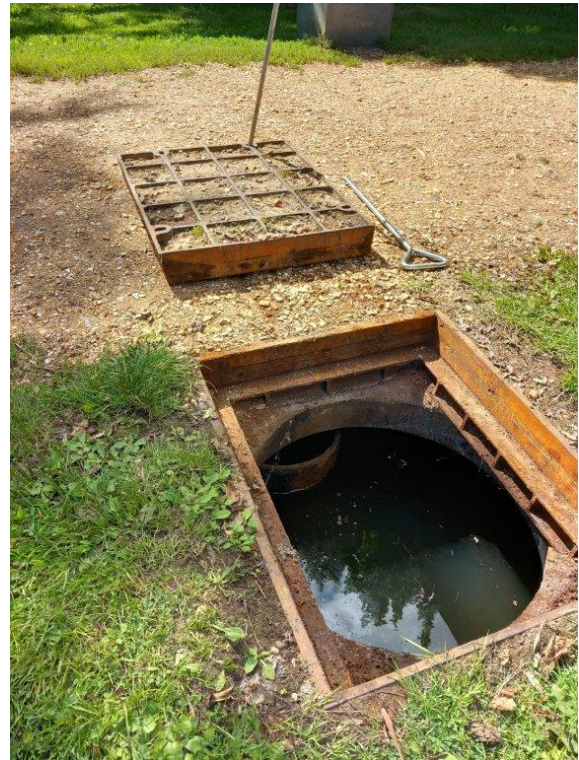
- 
- e) At the on-line outlet, the manhole chamber was lifted, and a vertically orientated 300mm diameter pipe weir crest was observed. The weir crest level was observed to be approximately 0.33m below the cover level. Also, the water level was approximately 0.05m below the weir crest level, hence the weir was not flowing.

6) Manhole chamber containing the lake's on-line outlet [Report Section 5.2, e)]

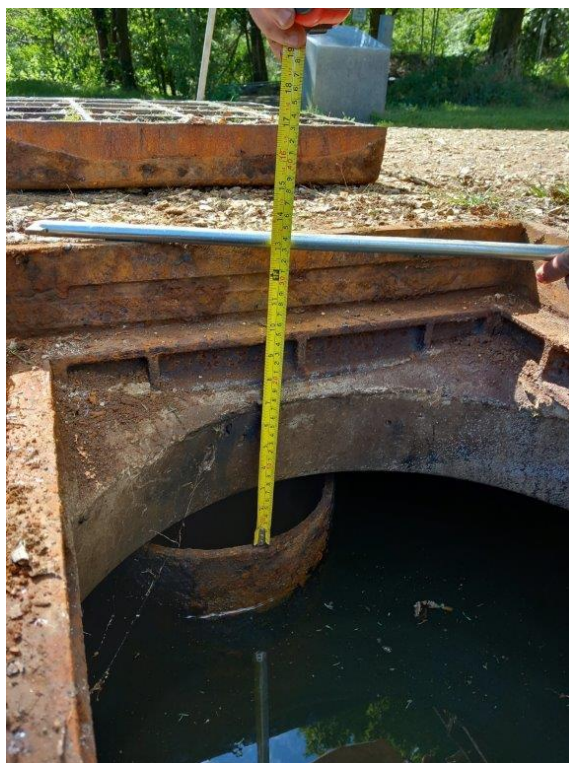
7) On-line outlet pipe weir approximately 0.33m below cover level [Report Section 5.2, e)]

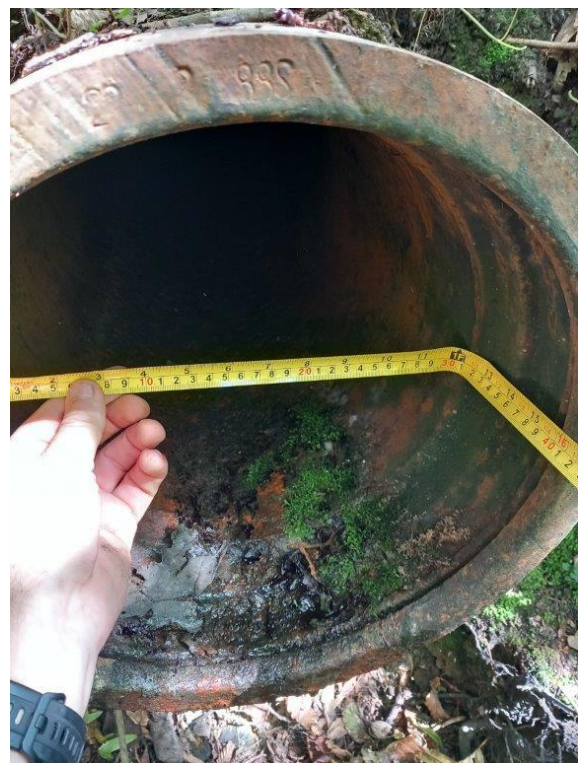
- f) A 300mm diameter pipe outlet was observed local to the downstream watercourse, south of the lake; it is assumed to have connectivity with the lake's on-line pipe weir outlet. The pipe outlet was not flowing.

8) 300mm diameter pipe outlet into downstream watercourse, south of lake [Report Section 5.2, f)]

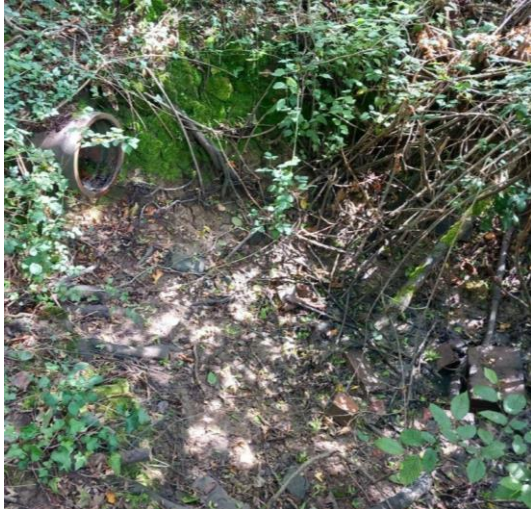
- g) The downstream watercourse, south of the lake, was observed to be dry with no flows. There was evidence of scour in the channel immediately adjacent the outlet pipe where a plunge pool has formed; this has likely been caused by high velocities from the outlet over a long period of time. Furthermore, the watercourse channel contained debris and was heavily obscured by dense vegetation.

9) 300mm diameter pipe outlet into downstream watercourse, south of lake [Report Section 5.2, f and g)]

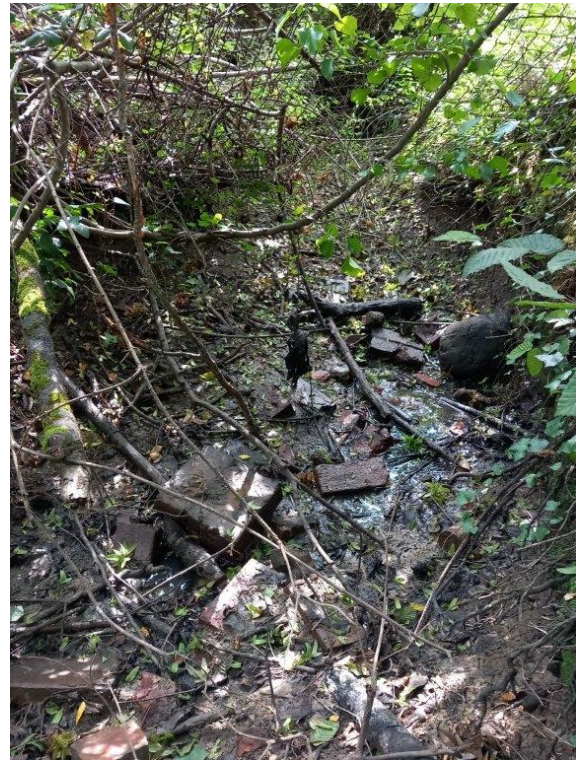
10) Lake's downstream watercourse channel with evidence of scour and debris [Report Section 5.2, g)]

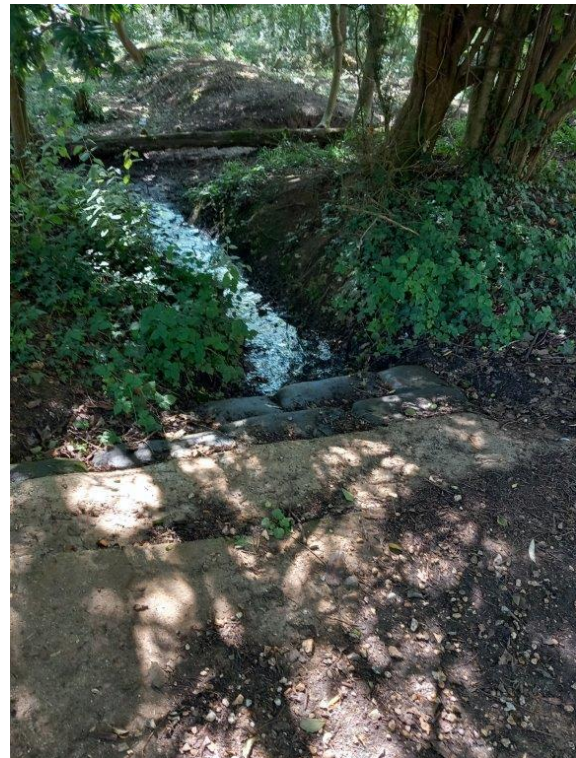
- j) The small ditch channel adjacent the off-line outlet (i.e., spillway) was observed to be wet with a small yet constant trickle of flow moving in a southern direction away from the lake; it is assumed that the water flow was from lake. Water was observed emerging from the bagwork underneath the spillway. The extent of wetness within the small ditch channel extended approximately 3m south into the adjacent woodland/scrub area at which point the ground surface was dry.

present. Firstly, water was observed flowing underneath the spillway to an adjacent ditch, from the lake direction. Secondly, several trees were observed growing through the lake wall and in these places localised sections of wall appeared to have been displaced, thus potentially creating a route through which lake water may seep.

12) Small ditch channel adjacent the off-line outlet (i.e. spillway) [Report Section 5.2, j)]

10.2.1 Based on the findings, it is recommended that remedial works are carried out to address observed defects at the lake to maintain the structure and avoid failure while also possibly reducing seepage losses, thus helping to address water loss and low water level issues at the lake.

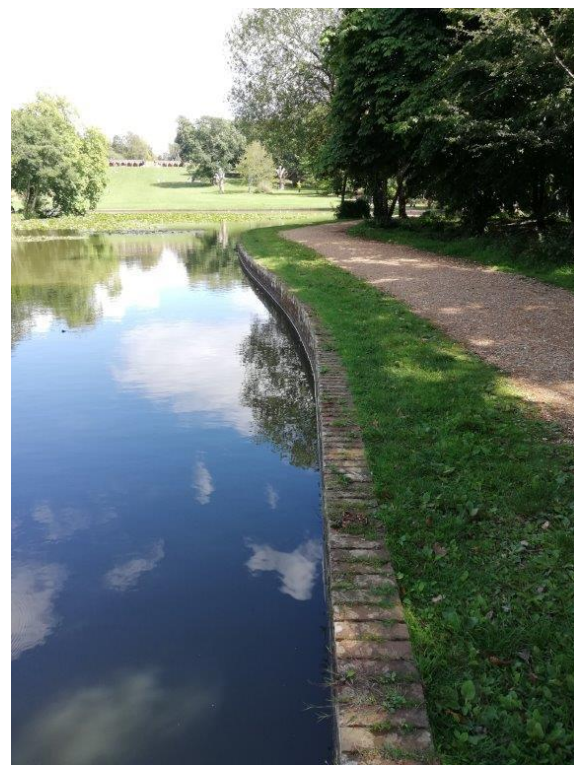
- k) The masonry wall running along part of the lake's perimeter was mostly observable on the western and southern sides; some small sections were observed on the eastern and northern sides but were mostly obscured by

earth or vegetation. Where walls were observable above the water line, they appeared to be vertical in profile and mostly intact. However, several tree stumps were observed growing through the lake wall and in these places localised sections of wall appeared to have been displaced.

13) Masonry wall running along part of the lake's perimeter [Report Section 5.2, k)]

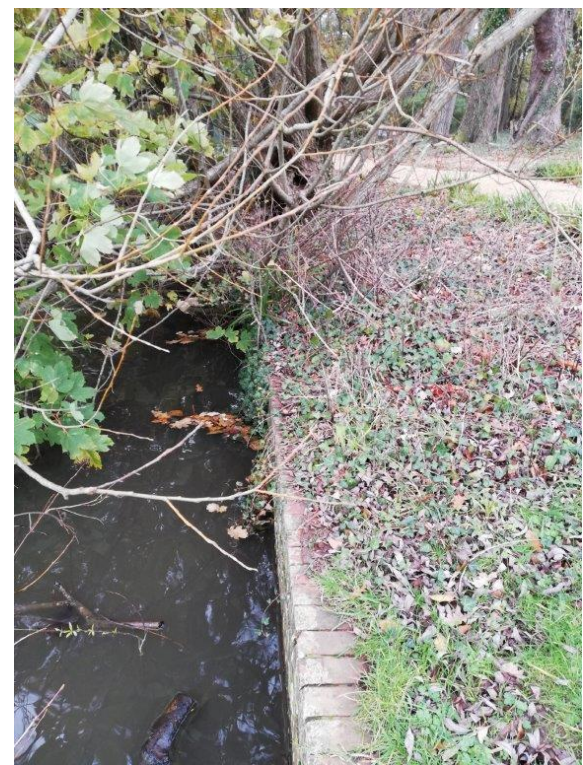
14) Example of tree stumps growing through masonry wall around the lake's perimeter [Report Section 5.2, k)]

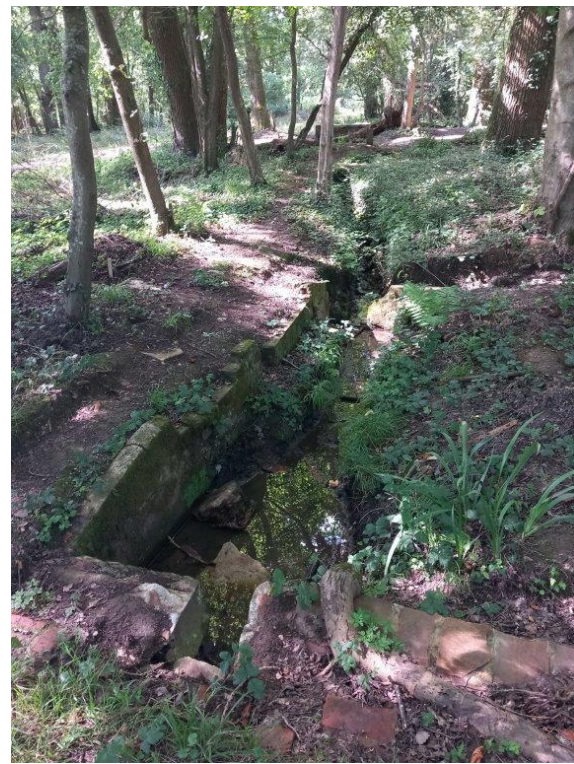
- l) A 'Well House' chamber structure is located approximately 50m north of lake. Anecdotally, this provided water supply to the house. The 'Well House' has an overflow channel which has connectivity with the north-east watercourse upstream of the lake. The chamber structure is covered with a grating; water was observed within the chamber, but no water was observed flowing from the chamber, hence the overflow channel was dry.
- m) A spring-like feature was observed in the field approximately 200m north-west of the lake; the water source is unknown. Water was observed overtopping an above ground trough feature and flowing overland and downhill towards the watercourse immediately upstream and north-east of the lake. Also, iron staining was observed at ground level local to the trough and in the overland flow route downstream.

15) Channel from 'Well House' to north-east watercourse upstream of the lake [Report Section 5.2, l)]

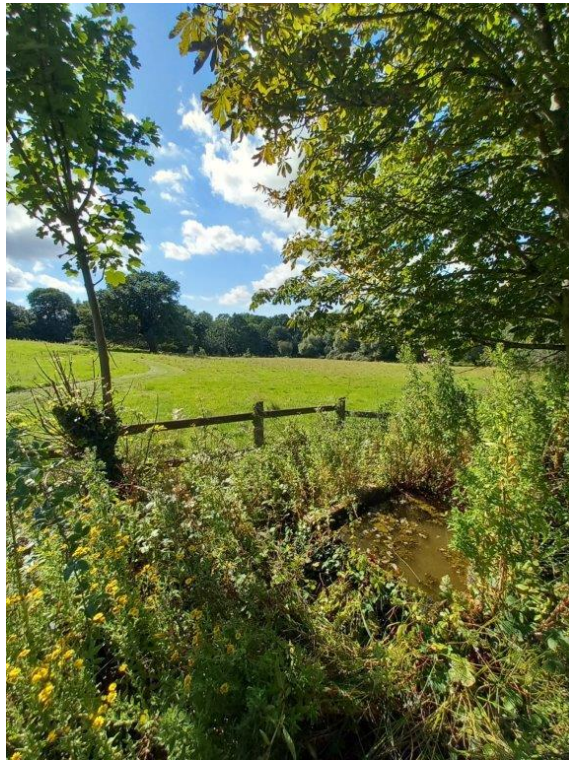
17) Spring-like feature in the field north-west of the lake [Report Section 5.2, m)]

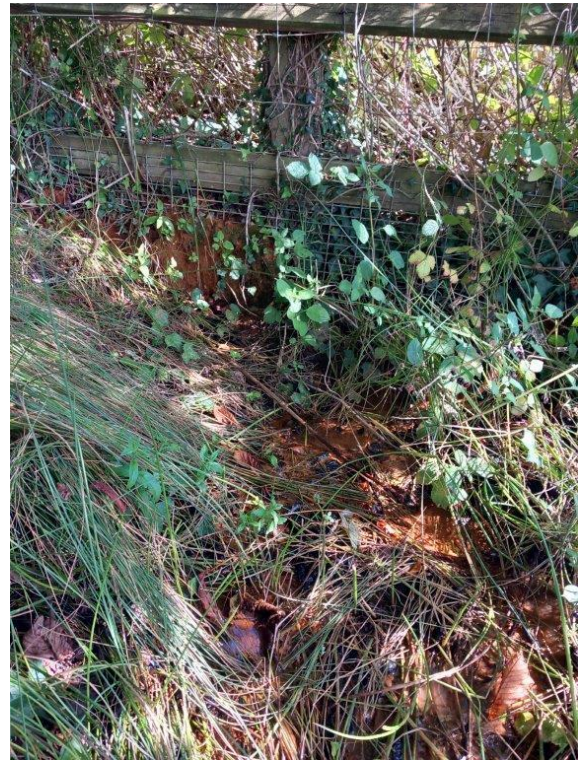
18) Water flows and iron staining local to spring-like feature [Report Section 5.2, m)]
