# Verification Report

Client: Lidl Great Britain  
Ltd

Havant, Purbrook Way

Report No: 770.06.01

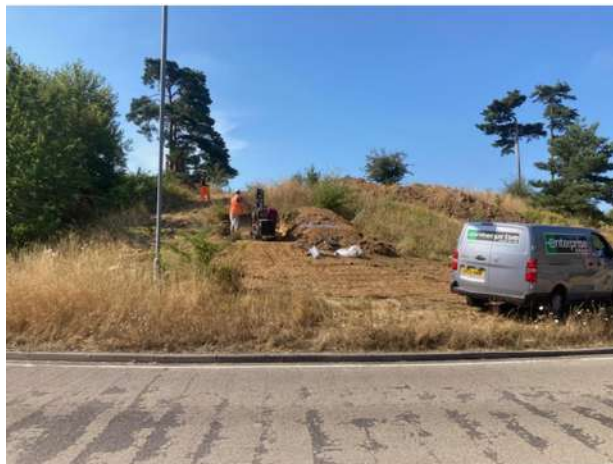
View towards the South from Purbrook at the time of Remada's Ground Investigation

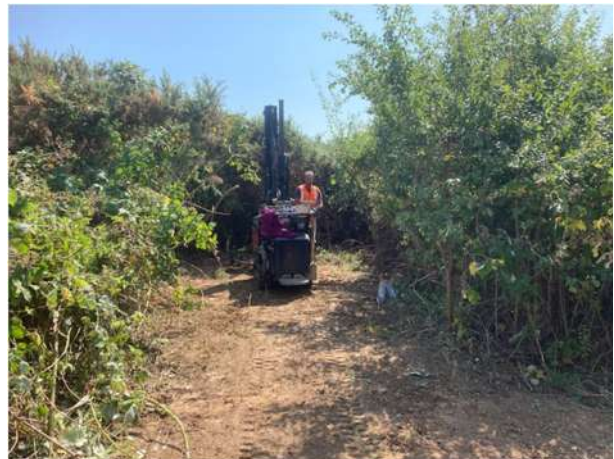
View towards South from the centre of the site at the time of Remada's Ground Investigation

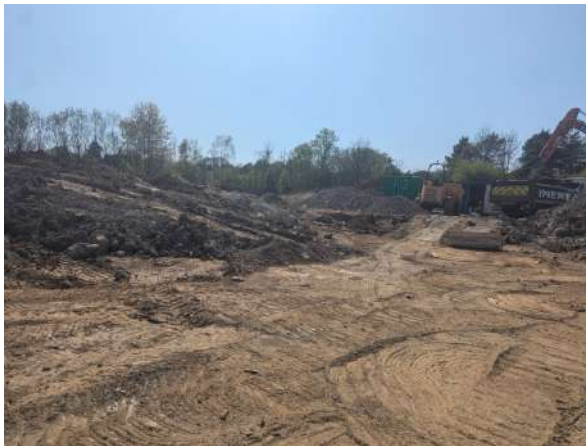
View towards west (site entrance) with reduced level dig in progress

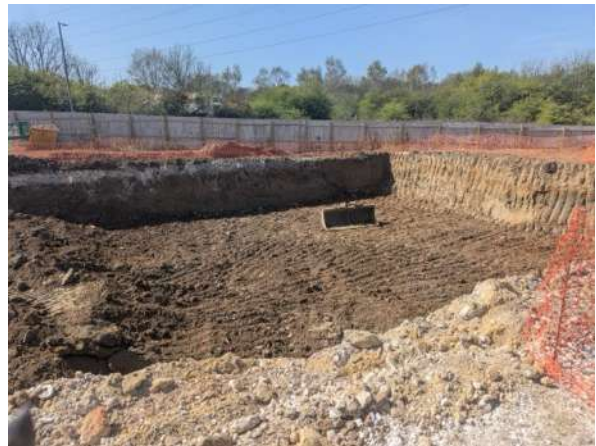
View towards west of attenuation tank excavation

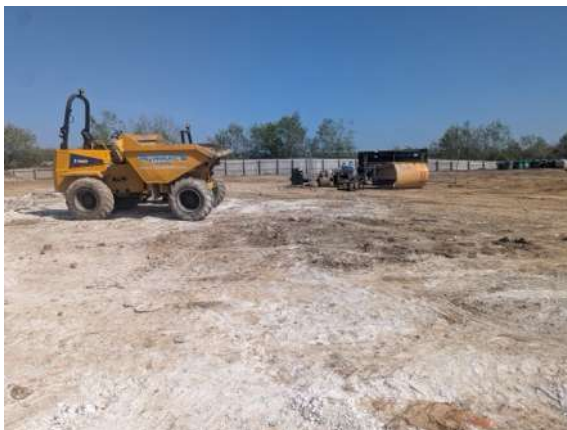
View towards Northwest

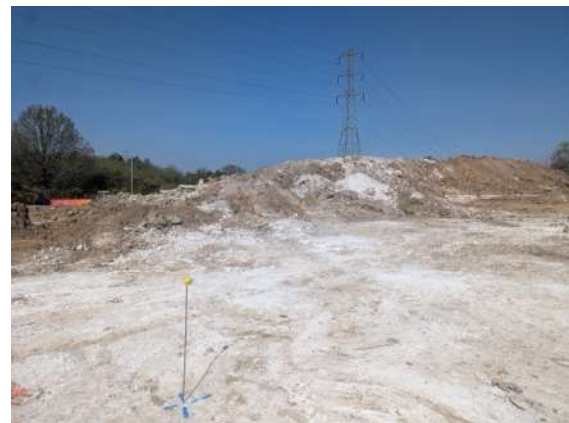
View towards North

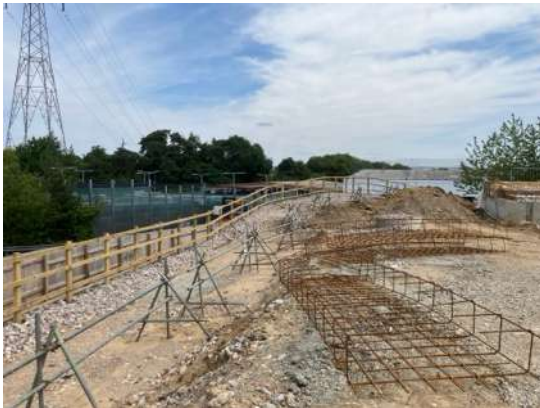
View towards Northeast over Criblock retaining wall to B&Q access road

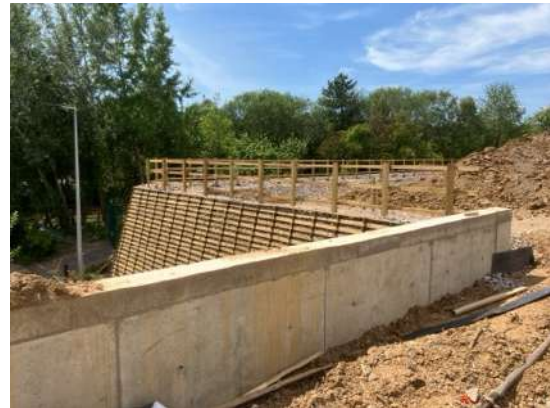
View towards East and B&Q car park of completed retaining walls.

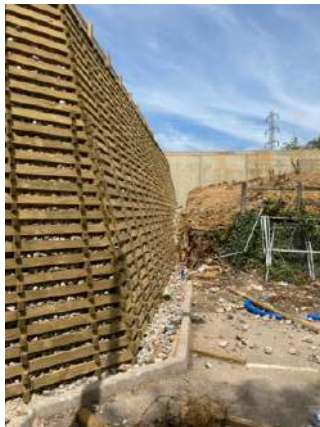
View from B&Q car park of pre-cast and Criblock retaining walls

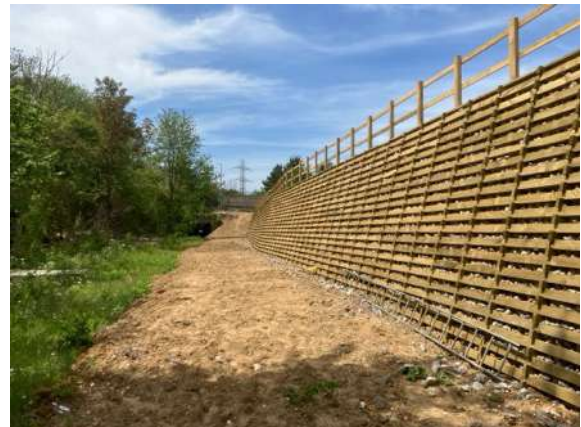
View of southern boundary and retaining wall

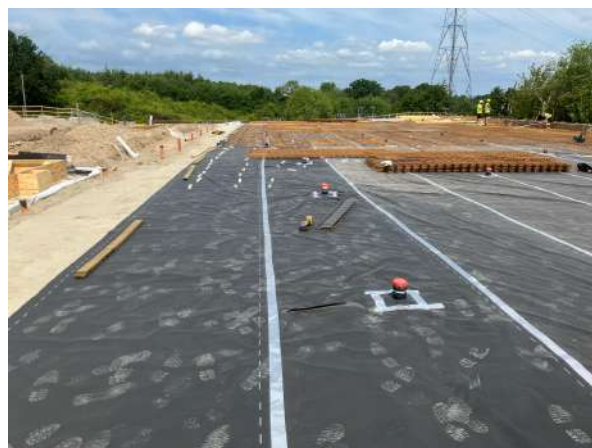
The formation was capped with 6F5 crushed concrete from Farlington Aggregates EPR /DP3091EQ prior to blinding with fines in preparation for the ground gas membrane to be installed beneath the raft foundation as per the photo below.

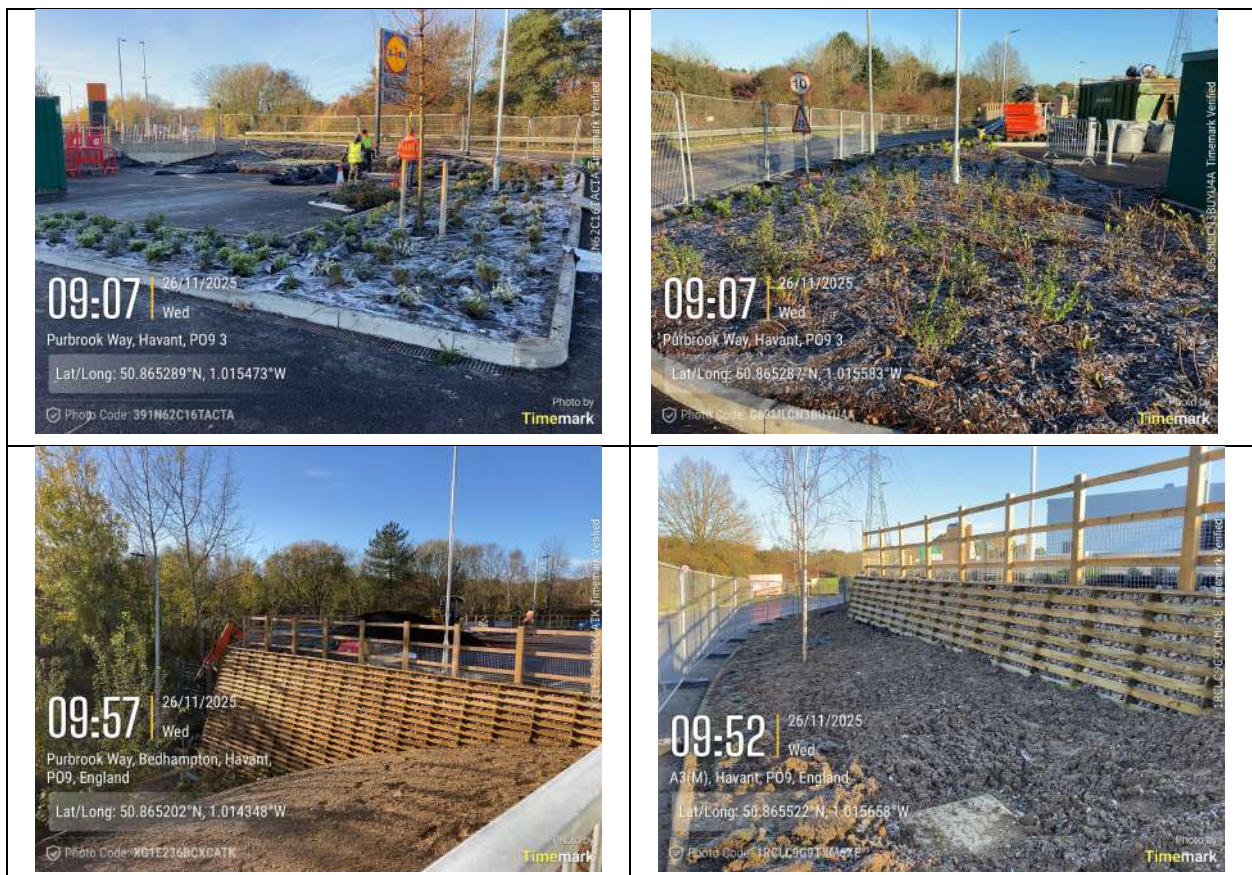
The extent of soft landscaping both outside and inside the retaining walls is indicated on SDS Drawing 25055-SDS-00-SL-DR-C-3020-CN2 at **Appendix E**. Topsoil was placed over the existing London Clay fill material or a natural sand fill.

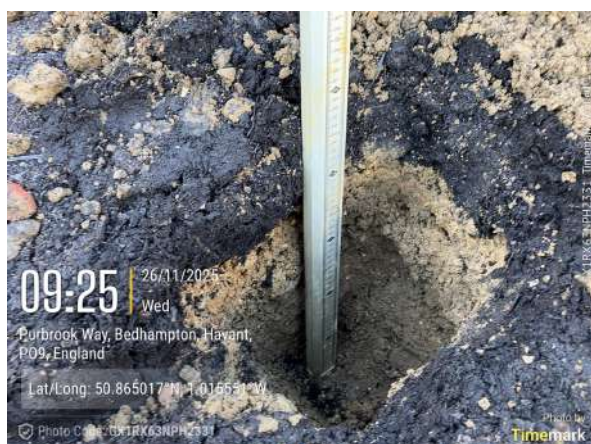
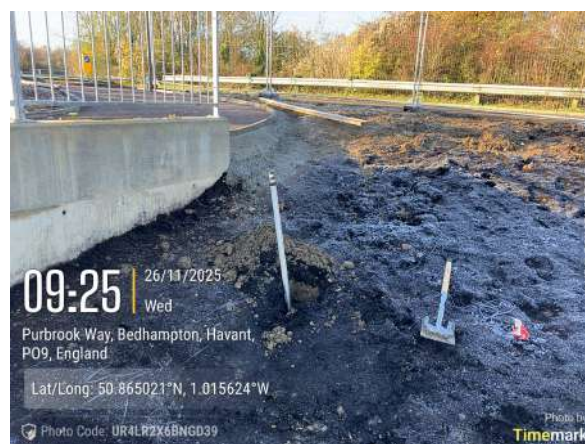
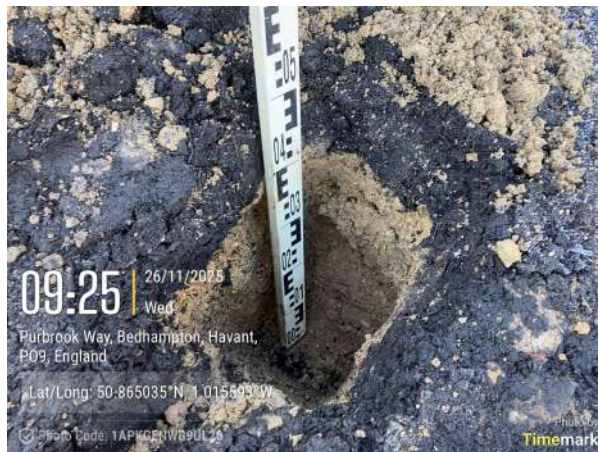
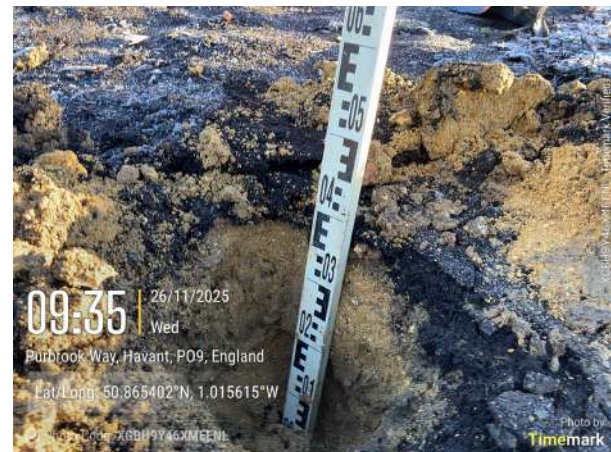
Topsoil depths were checked at the sample locations indicated in **Figure 3** and as recorded in the photos below. Approximately 100mm thickness of topsoil was found to overlie 300mm of sand fill.
