# Gas Membrane Verification Report

**Lidl, Havant**  
**Somborne Drive**  
**Havant**  
**PO9 5AN**

# GeoShield Verification Report 1

PROJECT: Lidl, Havant

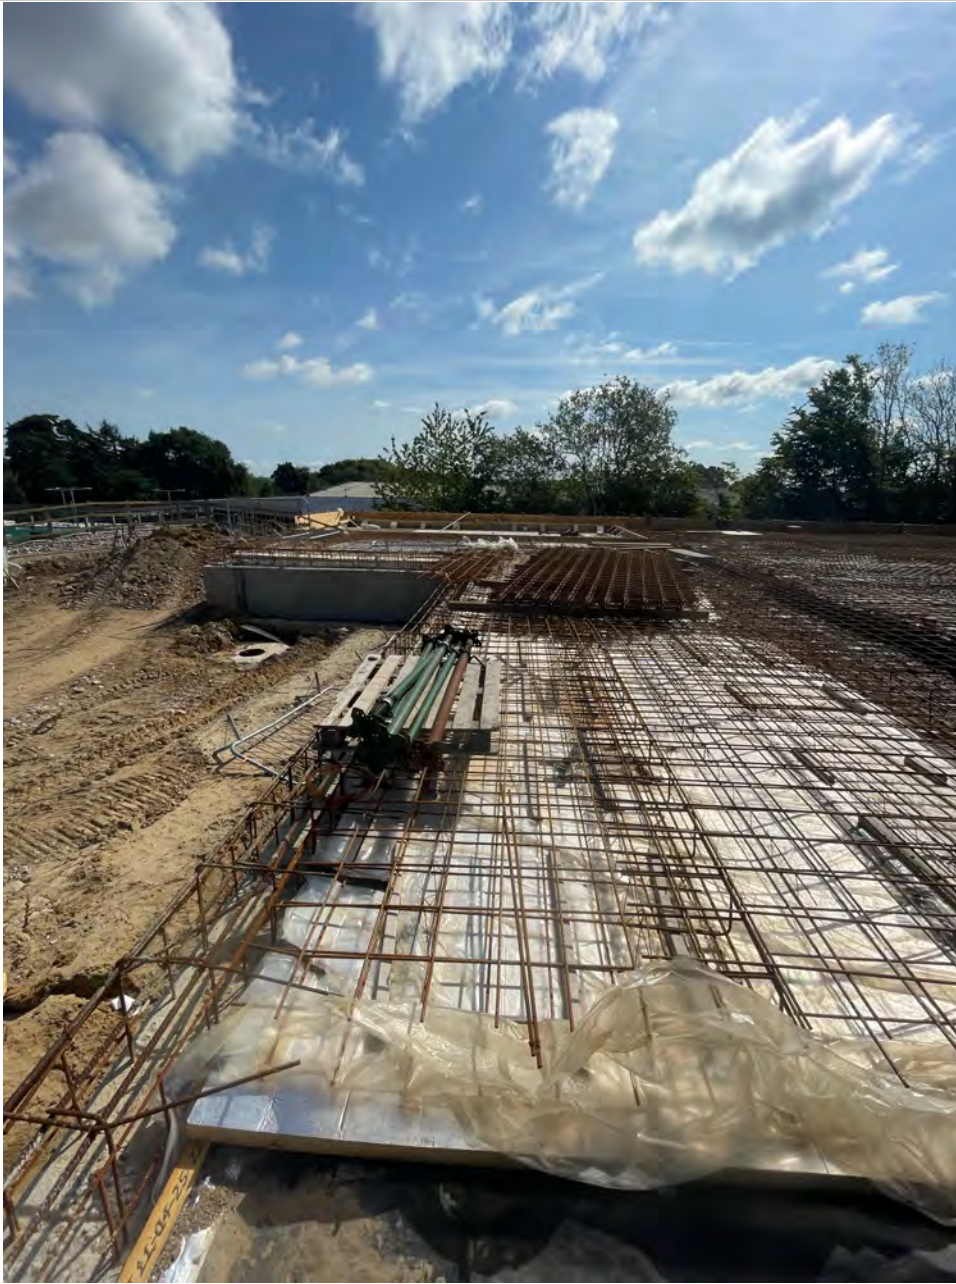
As can be seen from the above image the areas of thickenings and approximately 30% of the perimeters have had concrete already poured. These have been shown as the highlighted yellow area on the layout drawing.

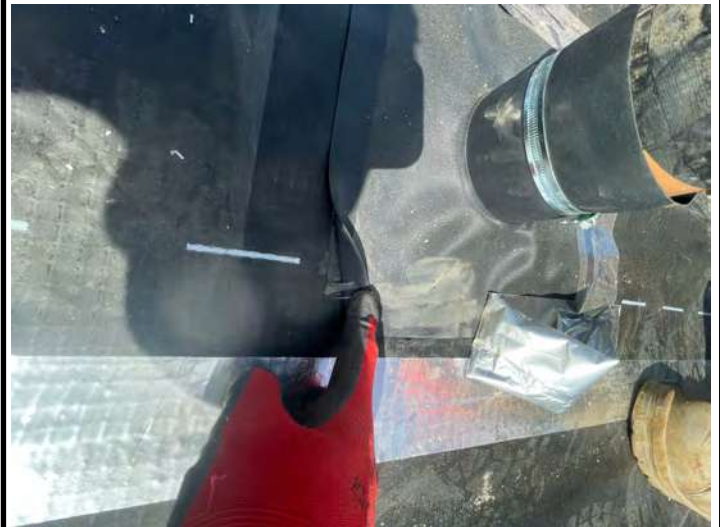
As can be seen from the above photograph all the pipe penetration were firstly sealed using a cordon top hat preformed detail. Each top hat was sealed using the cord EPS double sided tape.

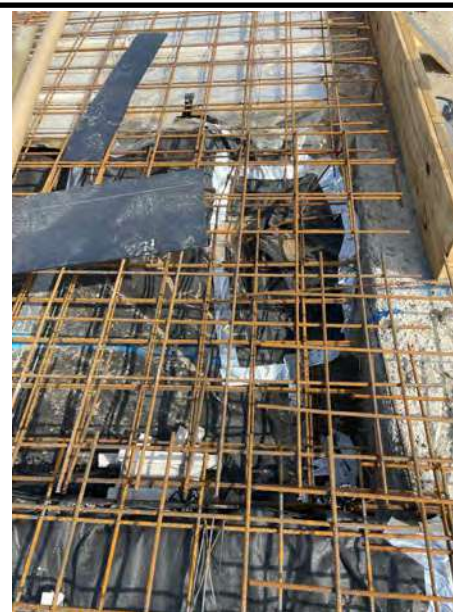
Photograph of outstanding area that requires remediation, still will need to be removed prior to repair.

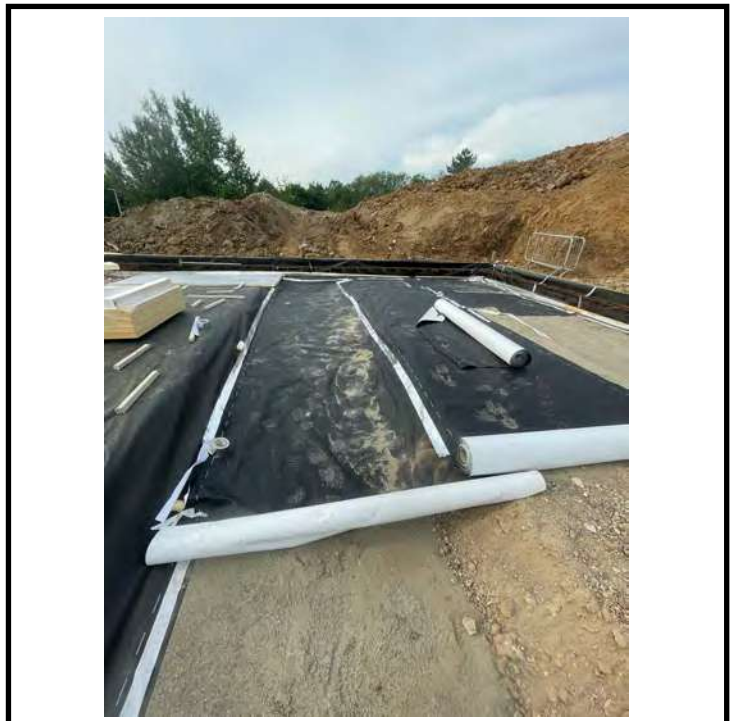
Additionally the lap has then been further sealed using the Corden EPS lap tape. However whilst on site the installers ran out of the double sided butyl tape so had to halt the installation.

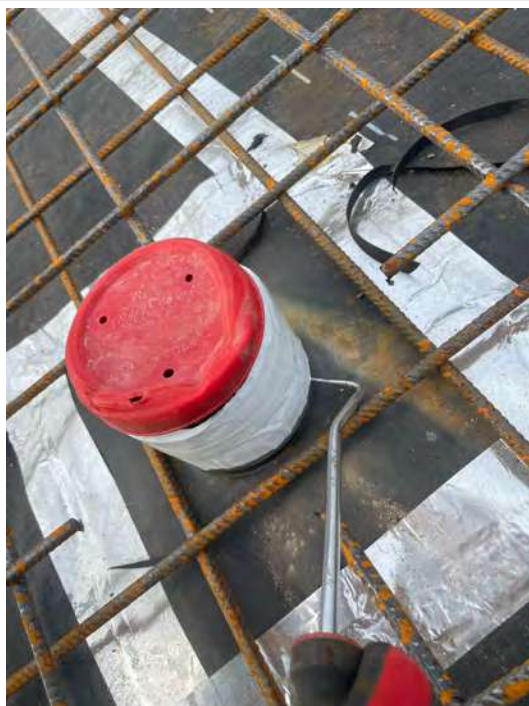
As can be seen from the above photograph the pipe penetrations which required outstanding remediations have been repaired for the exception of 8 which are still outstanding.

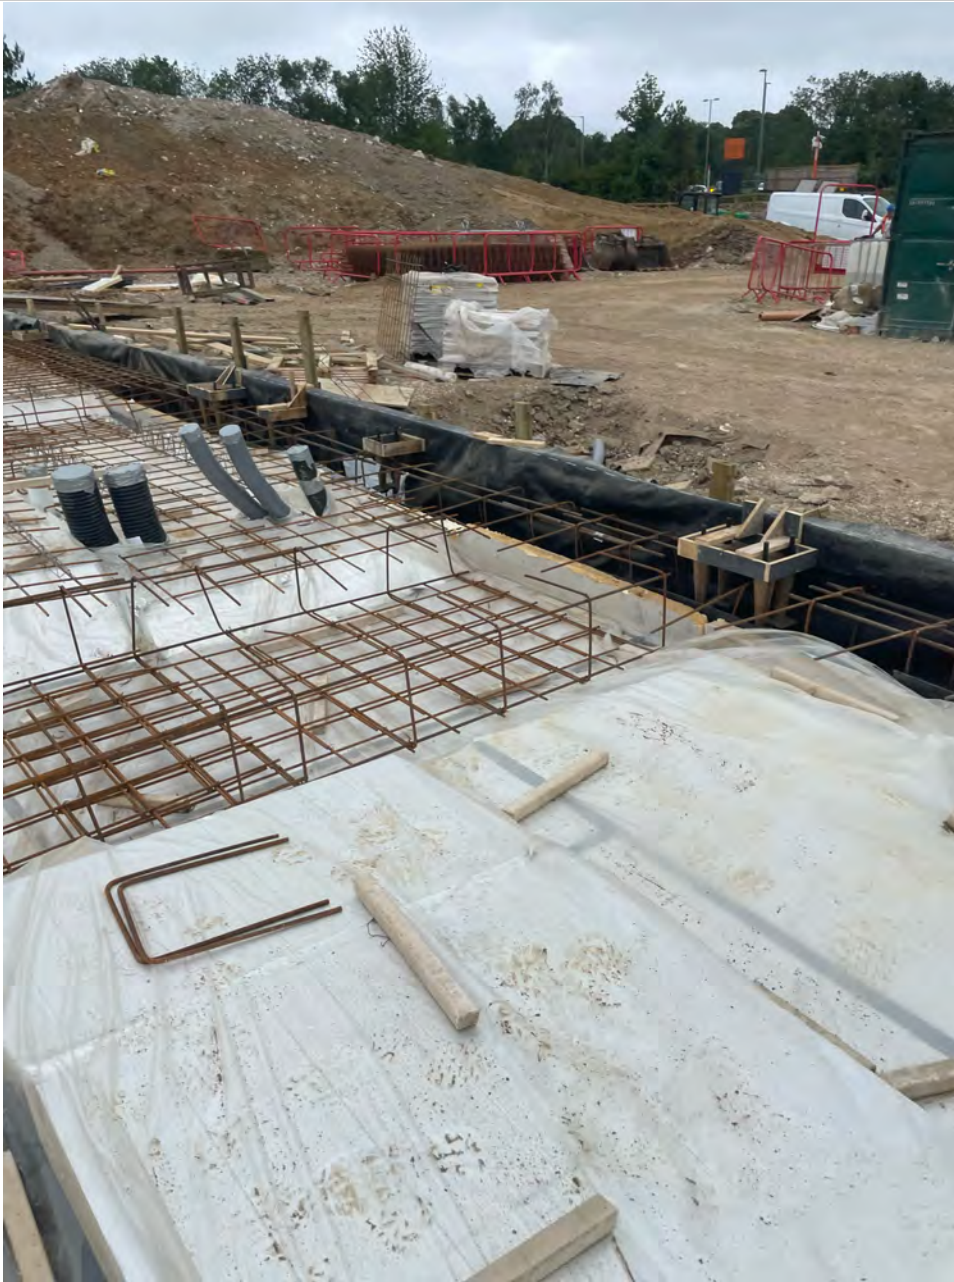
As can be seen from the above image there is an area outlined in black to the area inspected (yellow) which has been covered with insulation and steel reinforcement. Due to this being in place and unable to remove on site the client will need to provide photographic evidence of the membrane installation to this area.

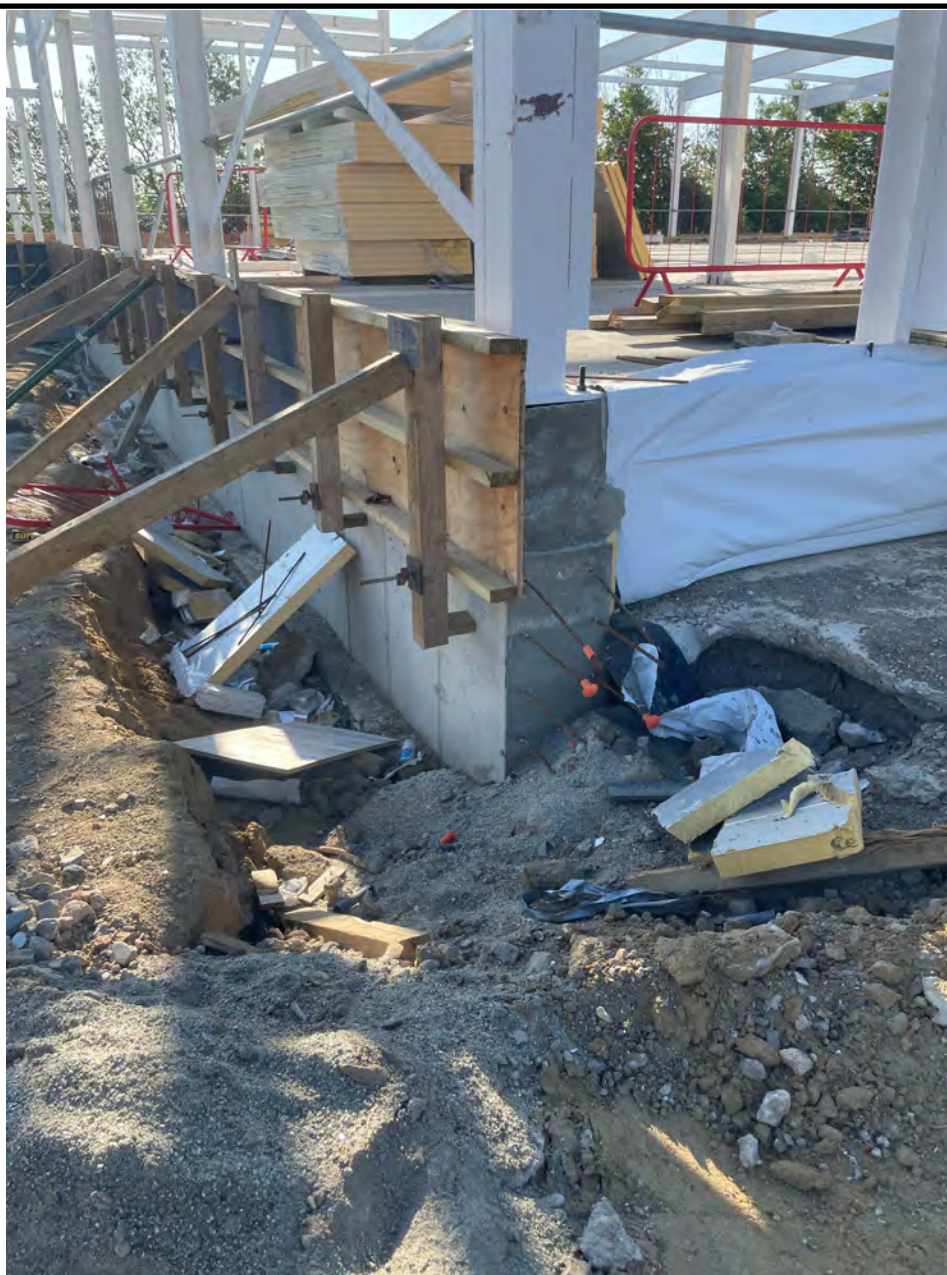
Corner of the green area that requires remediation due to steel beam no longer being extended.

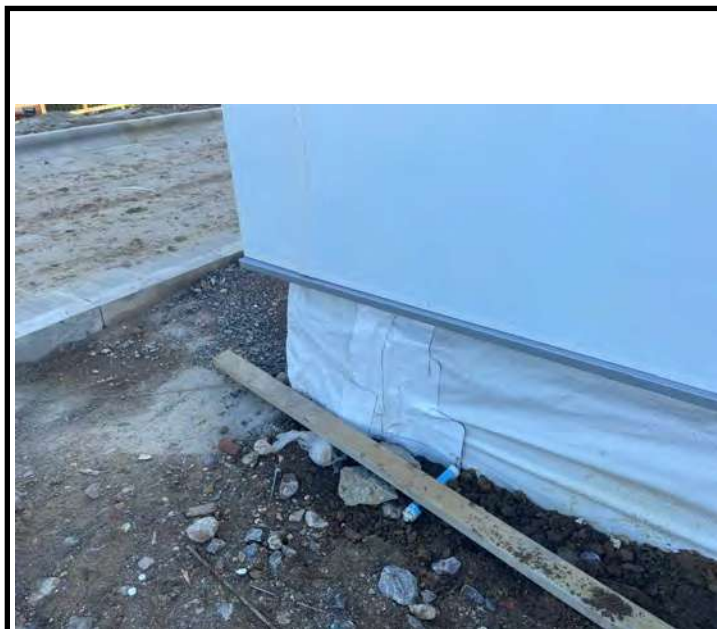
The purpose of the verification visit was to inspect the corner area which had been sealed due to the steel beam no longer being extended.

The installers have repaired the area by placing numerous strips of Corden EPS GRM Self Adhesive Membrane around the corner area, onto the existing Corden EPS

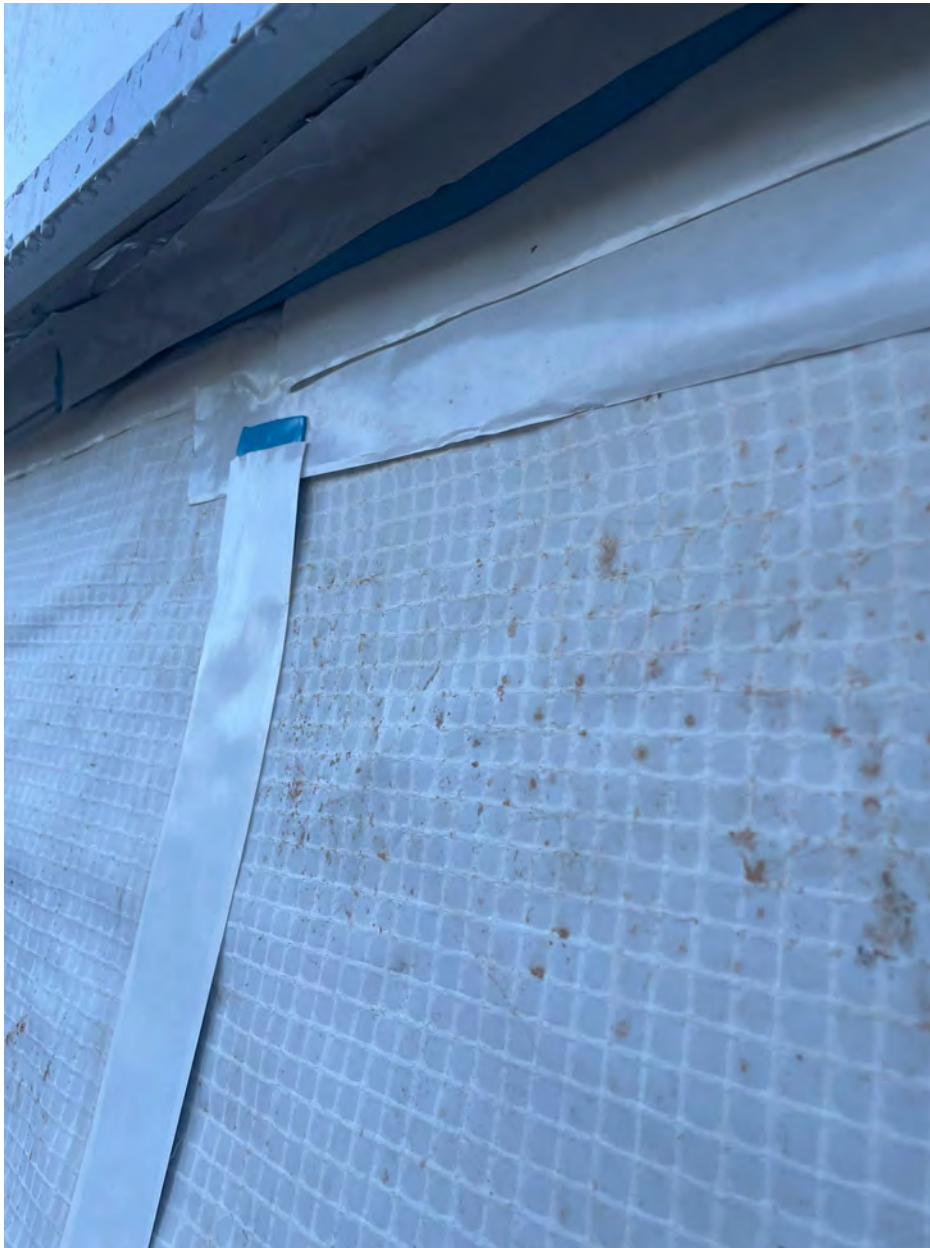
The pipe penetrations present around the accessible perimeter areas have not been sealed correctly. These have been sealed with double sided butyl tape and there were also a number of holes and defects that have been repaired using double sided butyl tape, which is not sufficient. It has been recommended to acquire and install the Corden EPS GRM Self Adhesive Membrane to any holes or defects around the perimeter. A further verification is required prior to sign off of the perimeter being achieved.

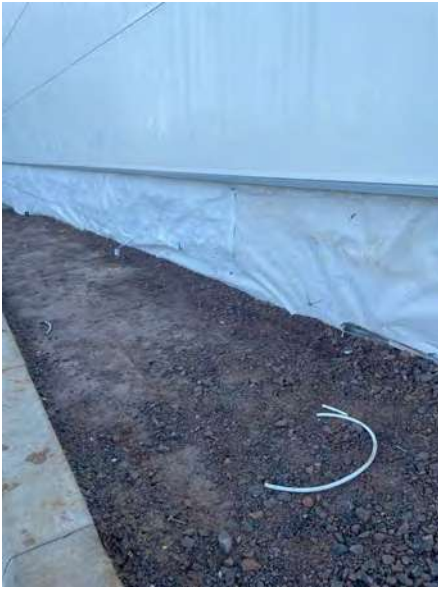
Insufficient installation to the perimeter due to the dual taped system not being correctly implemented.

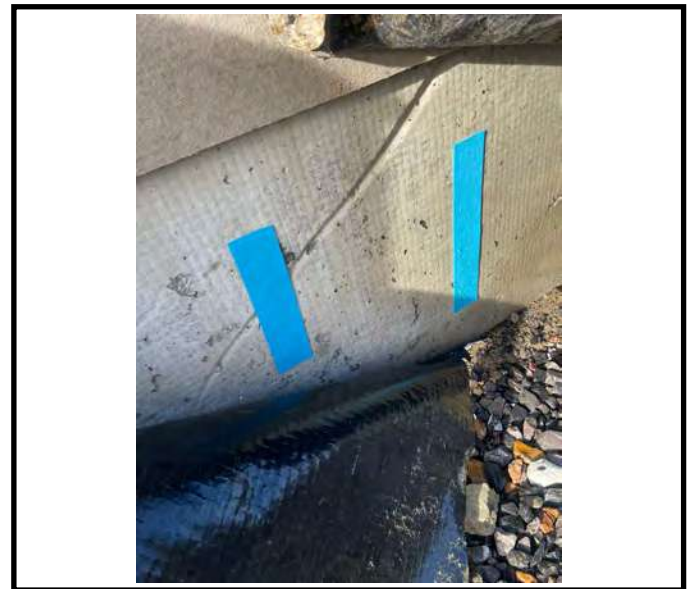
Holes and defects incorrectly sealed with double sided butyl tape.

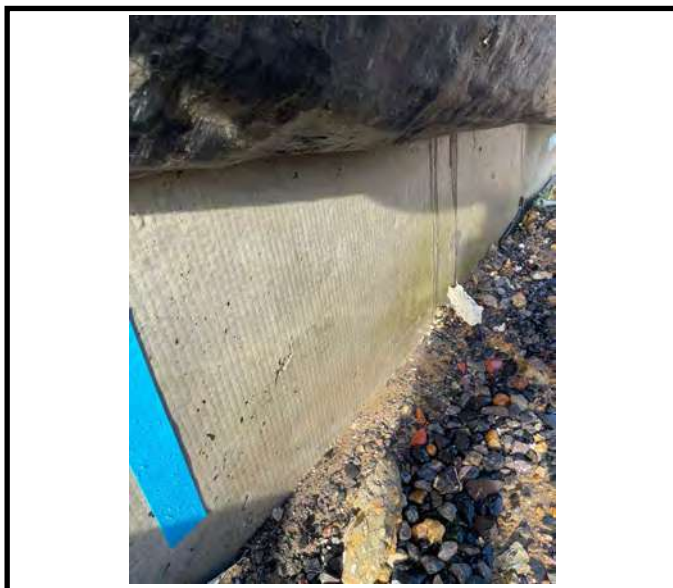
Holes and defects incorrectly sealed with double sided butyl tape.

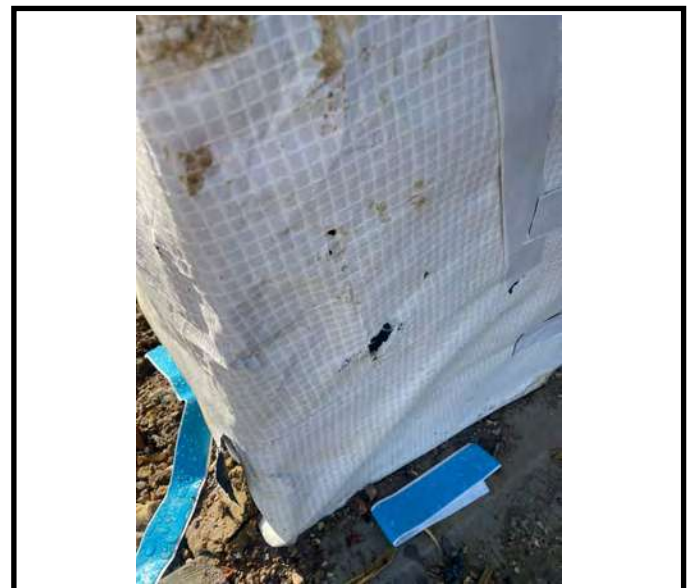
Holes and defects were incorrectly sealed with double sided butyl tape.

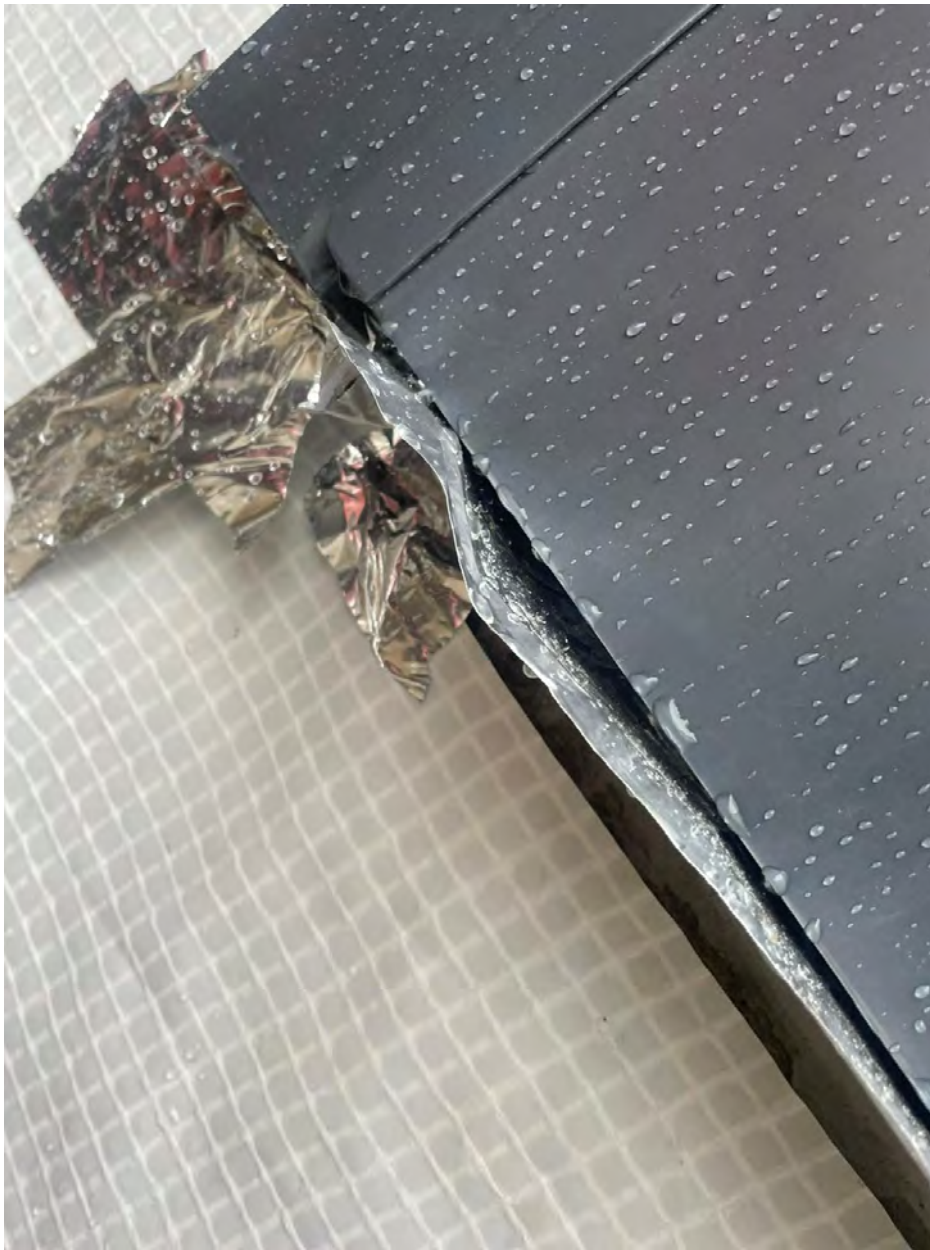
The pipe penetrations present around the accessible perimeter areas have not been sealed correctly. These have been sealed with double sided butyl tape and there were also a number of holes and defects that have been repaired using double sided butyl tape, which is not sufficient. It has been recommended to acquire and install the Corden EPS GRM Self Adhesive Membrane to any holes or defects around the perimeter. A further verification is required prior to sign off of the perimeter being achieved.

It has been recommended to use a specialist gas membrane installation team to carry out any future works.

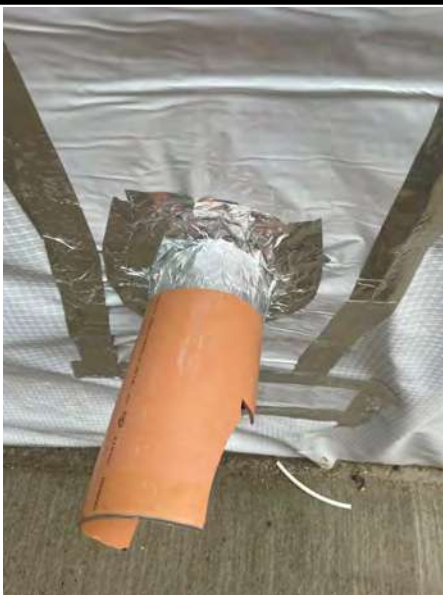
Insufficient installation to the perimeter due to pipe penetrations sealed incorrectly.

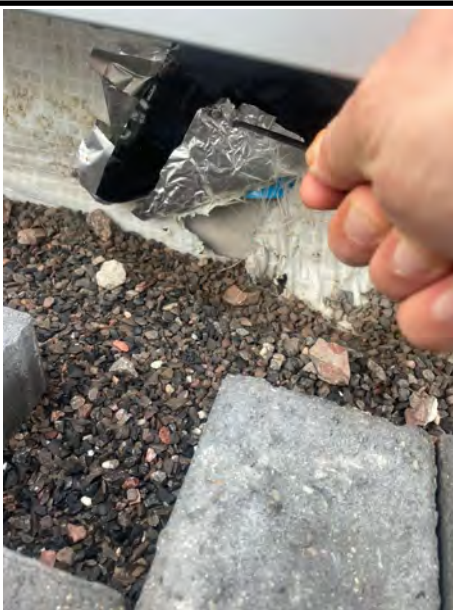
Several areas of damage identified.

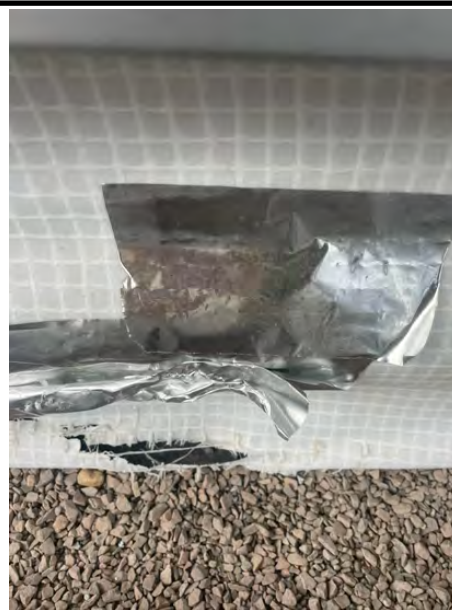
The tapes have not correctly adhered to the membrane.

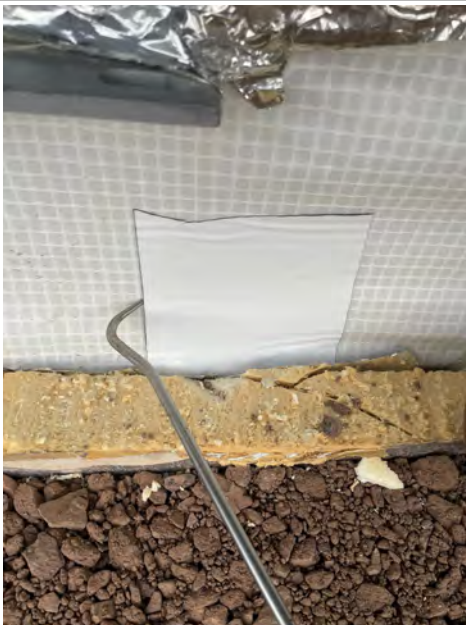
As mentioned, a number of faults were identified during the testing procedures conducted upon all completed remedial work around the perimeter. The faults consisted of holes within the membrane and the two pipe penetrations that had not been sealed upon arrival to site. All areas were brought to the attention

of the installers and remediated during the visit, in the presence of GeoShield. The faults were remediated by applying 150mm patches of Cordex EPS GRM over the affected areas, with heat and rolled pressure applied to aid in the adhesion. No further faults or defects were identified.

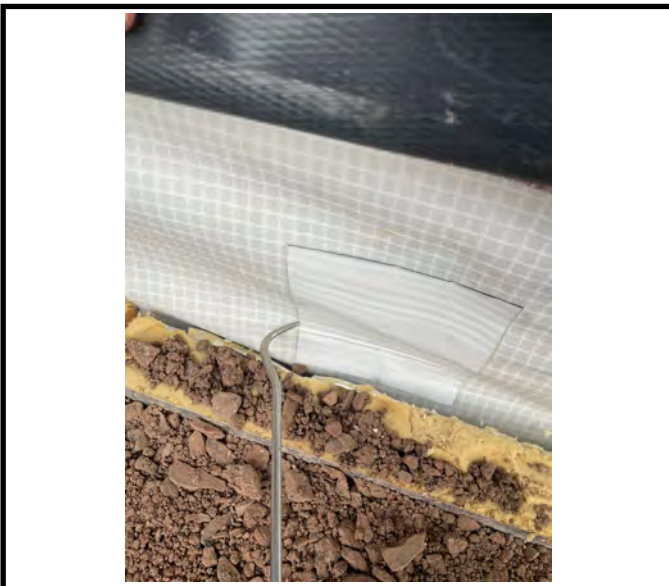
A mechanical point stress test being conducted upon the puncture, repaired using a patch of Corden EPS GRM.

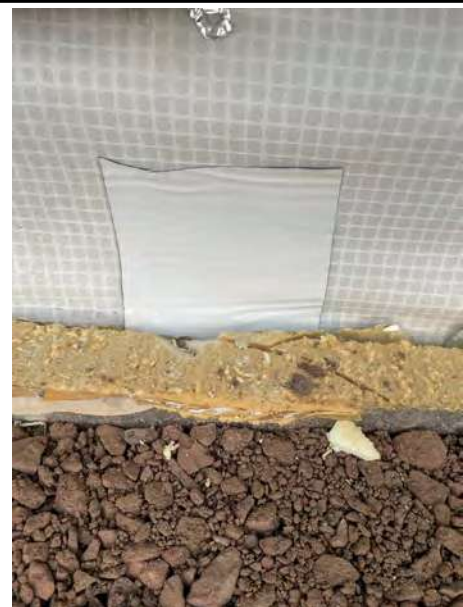
A hole in the membrane that has been repaired using a patch of Cordex EPS GRM.
