## 234 Seafront, Hayling Island

Preliminary Roost Assessment

15<sup>th</sup> October 2025

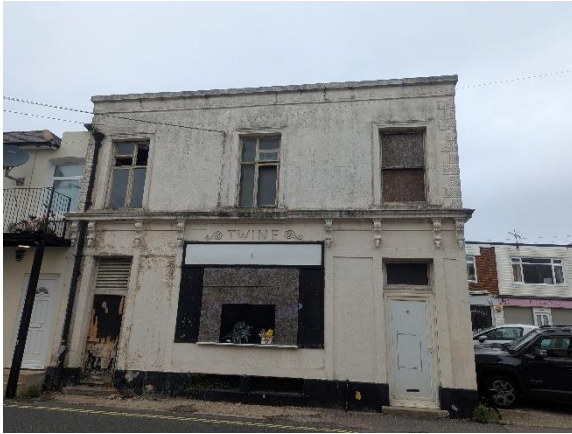
| Building | External description | Internal description |
|---|---|---|
| Building 1 – 234 seafront | <p>Derelict multi-storey brick building with many gaps in mortar and between brickwork. The south elevation was rendered brick with metal downpipe. There were also vents at the base of the building. There were boarded up windows and doors. One window on the first floor had broken glass, allowing internal access. There were slat vents above one door.</p> <p>The east elevation was a brick wall which had many gaps in between brickwork and missing mortar.</p> <p>The west elevation was connected to the adjacent building.</p> <p>The north elevation had boarded up windows and doorways.</p> <p>There were gaps in brickwork and missing mortar.</p> <p>The building was split and had two pitched roofs. From the drone images, there were many missing and broken slates visible on the roof.</p> | No internal access due to safety concerns. |

| | <p>On the south aspect, the roof was partially collapsed into the building.</p> <p>There were many PRF's recorded in missing slate, gaps in brickwork and mortar, collapsed section of roof and entry points through broken windows and vents.</p> | |

Photo 1 – external view of building 1, south elevation

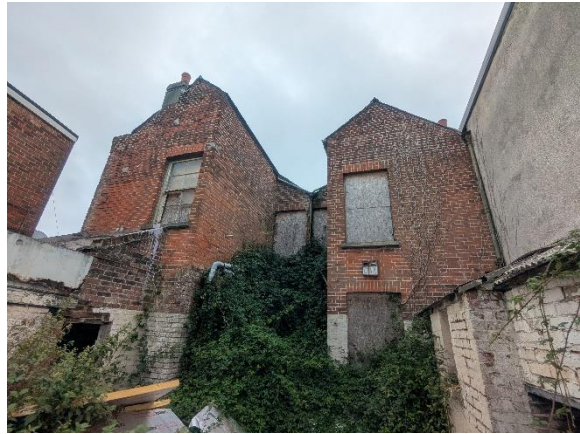
Photo 2 – external view of building 1, north elevation

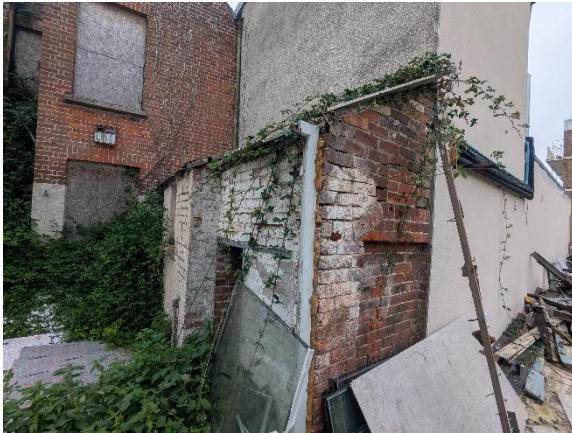
| Building 2 – lean-to (west) | <p>Small brick lean-to building connected to adjacent building. Single pitch roof, partially comprised of slate, and partially corrugated fibre cement roof sheets.</p> <p>Open doorway and windows, partially blocked by overgrown bramble and nettle.</p> <p>PRF's recorded in missing slates on roof and gaps in brickwork and mortar.</p> | No internal access due to safety concerns. |

Photo 3 – external view of building 2 – lean-to (west)

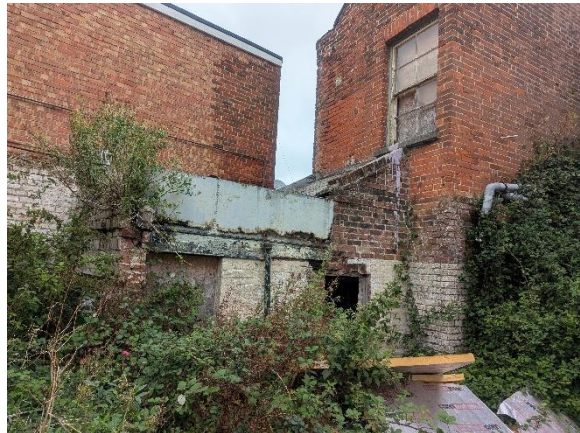
| Building 3 – lean-to (east) | <p>Small brick lean-to building connected to building 1.</p> <p>Slate on pitched aspect of roof. Roof missing on remainder of building. One doorway boarded up and the other open. Many gaps in brickwork. Too overgrown to fully inspect.</p> | No internal access due to safety concerns. |

Photo 4 – external view of building 3 – lean-to (east)

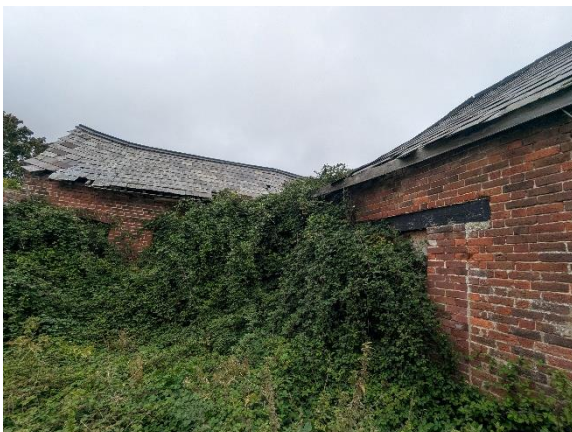
| Building 4 – L-shaped building | <p>L-shaped brick building with pitched roof.</p> <p>Roof partially collapsing in areas and many missing and broken slate on roof.</p> <p>Many entry points under eaves into building. Building was too overgrown with bramble to fully inspect.</p> | No internal access due to safety concerns. |

Photo 5 – external view of building 4

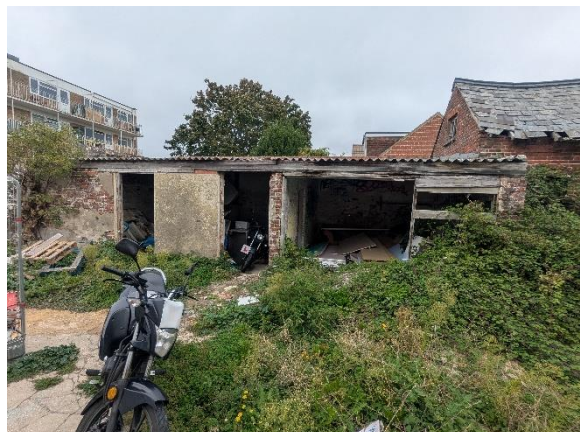
| Building 5 – flat roof building | <p>Brick building with flat roof constructed from corrugated fibre cement sheets. Large open entryways on south elevation. East elevation very overgrown with bramble and partially connects to building 4.</p> | Limited internal access from doorway due to safety concerns. Timber frame with no roof void. Roof sheets were visible internally. Building was split in two by brick wall. |

| Building | Bat Roost Potential | Reason | Requirements |
|---|---|---|---|
| Building 5 | <b>LOW</b> | <ul style="list-style-type: none"> <li>• Low number of PRF recorded</li> <li>• Building is thermally unstable due to large open doorways</li> <li>• No evidence of bats recorded externally</li> </ul> | One emergence survey should take place between 1 <sup>st</sup> May and 30 <sup>th</sup> August to confirm the presence or absence of bats. |

Photo 6 – external view of building 5

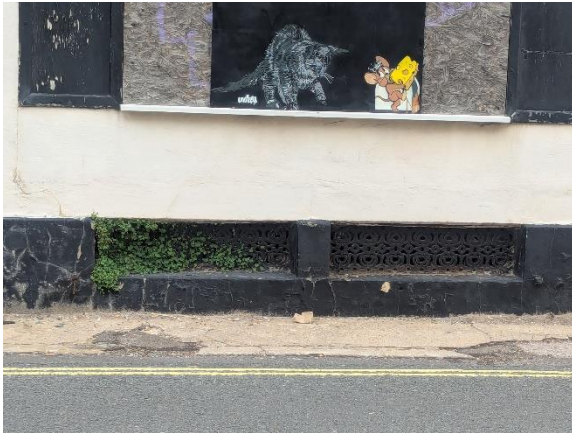
Photo 7 – external view of vents at the base of building 1, south elevation

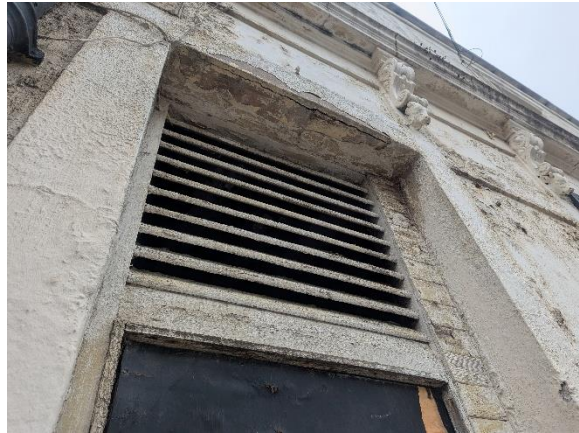
Photo 8 – external view of open vents into building 1, south elevation

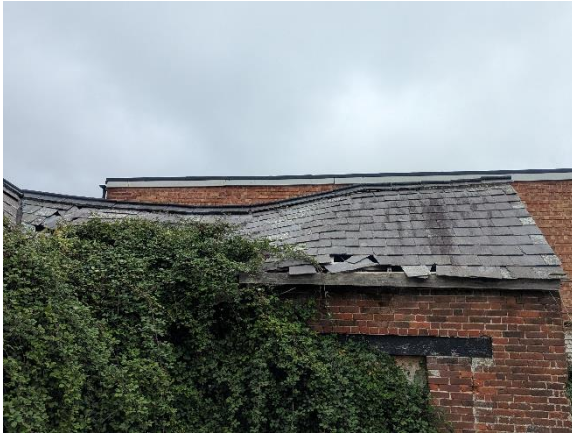
Photo 9 – broken and missing slate on building 4

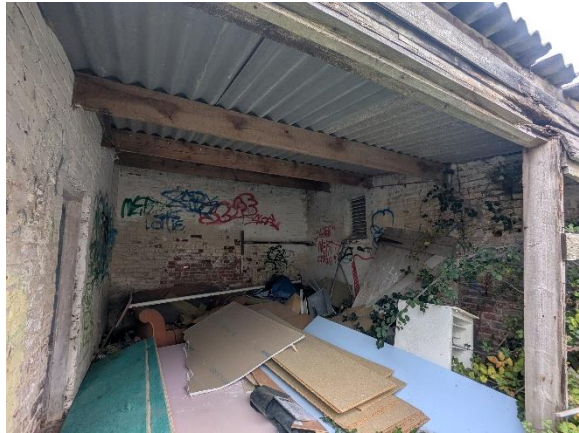
Photo 10 – internal view of building 5

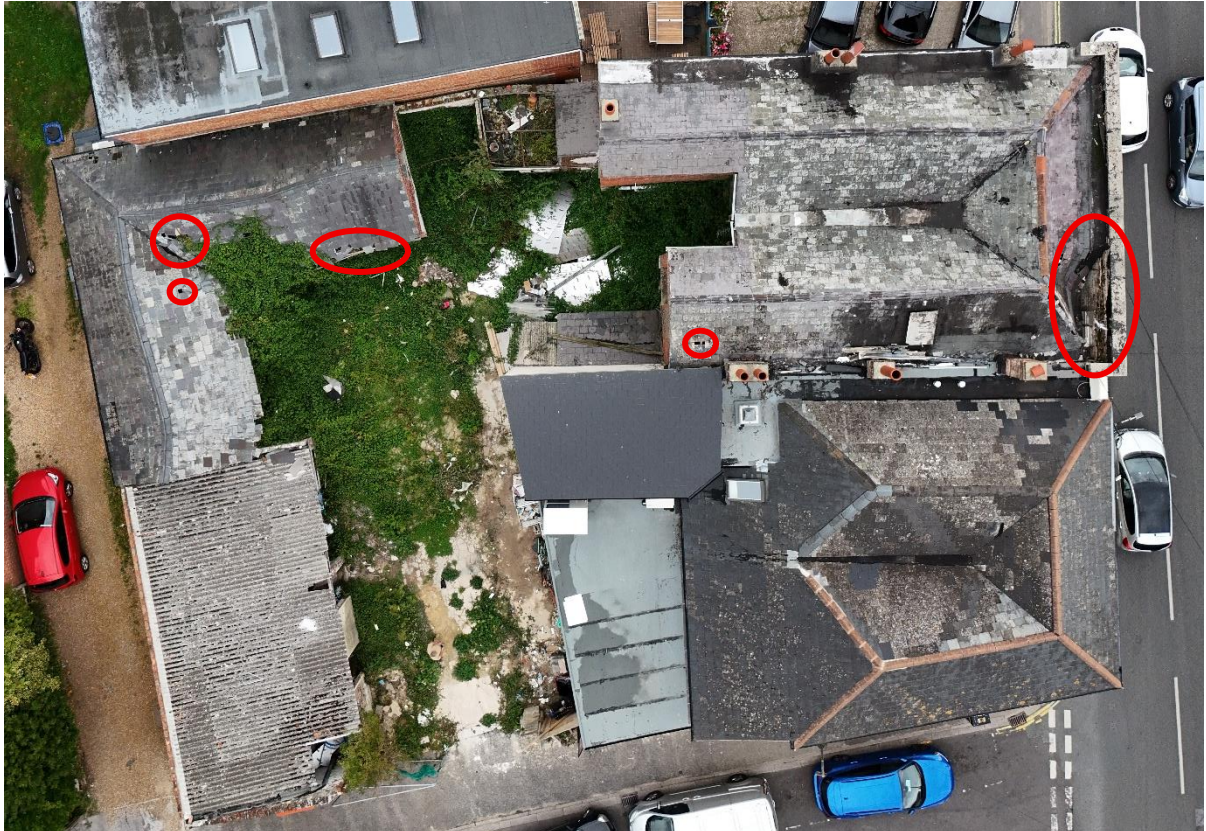
Photo 13 – drone photo of site facing down, showing many broken and missing slate

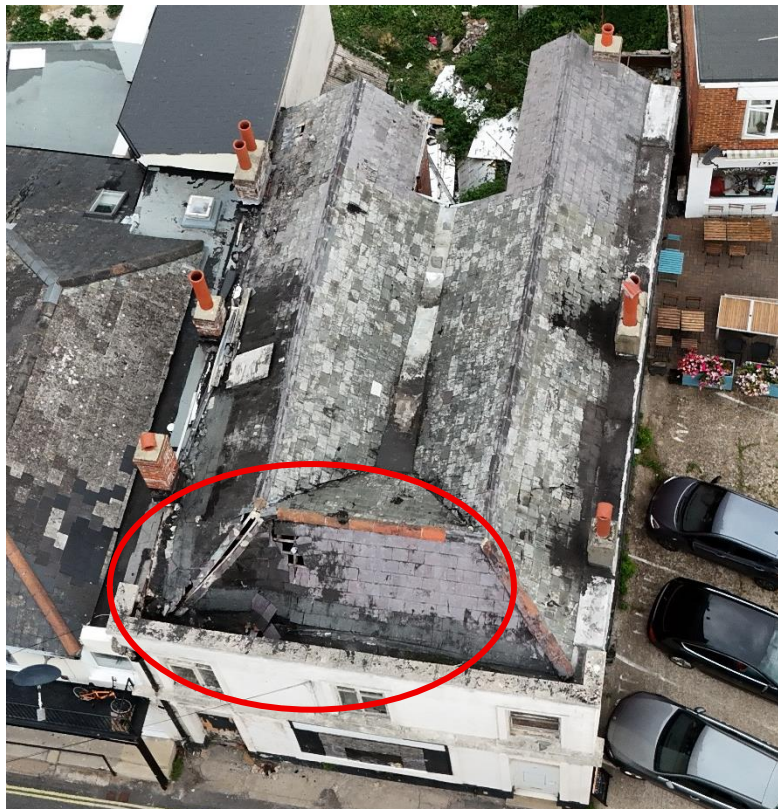
Photo 14 – drone photo of site facing north, showing collapsed roof on building 1
