# Fallen & Found Arboriculture<sup>®</sup>

## Tree Condition Survey

Ground based visual tree condition survey prior to purchase.

| Project Name: | Mr Russell, Professional Tree Inspection 2026 | Document Reference: | Q0588\Russell\PTI\2026-V1 |

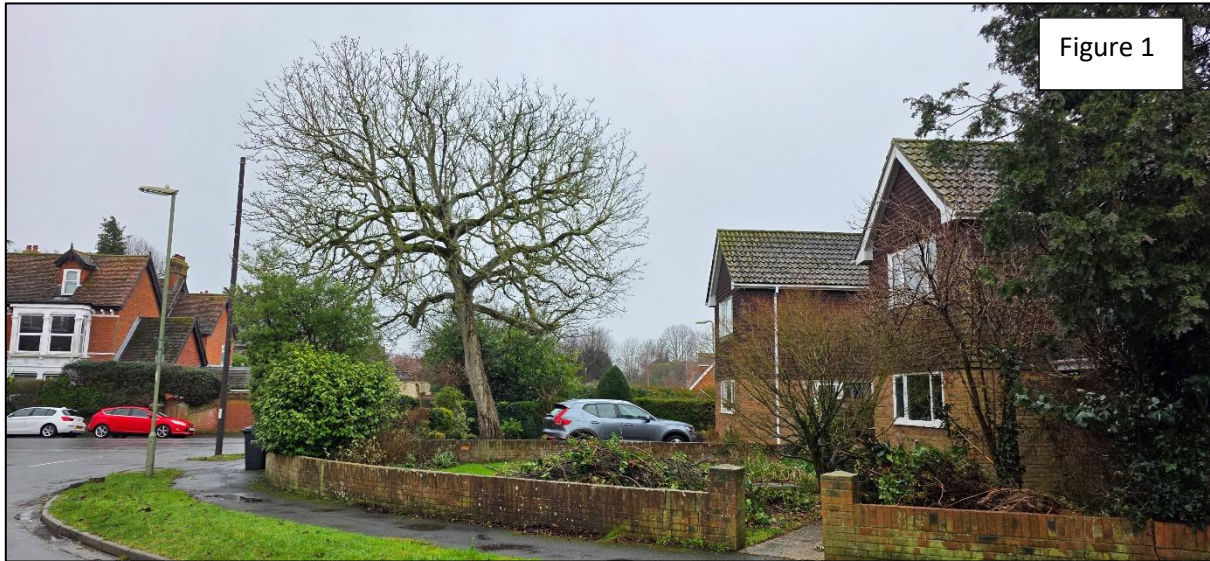
Figure 1

3.2.1. On first inspection of the tree from a reasonable distance it is apparent that the tree has a significant lean toward the north and the main entrance to Swallow Close<sup>1</sup>. Although hard to quantify accurately, I approximate this lean to equate to an angle of 25 degrees toward the north<sup>2</sup>. The tree has a profusion of low diameter deadwood within its canopy<sup>3</sup> at its canopy extremities. Considering the age, species and size of the tree, the tree has low foliar density. Black exudate can be observed on the northern side of the trees main stem to an approximate height of 1.4m above ground level<sup>4</sup>.

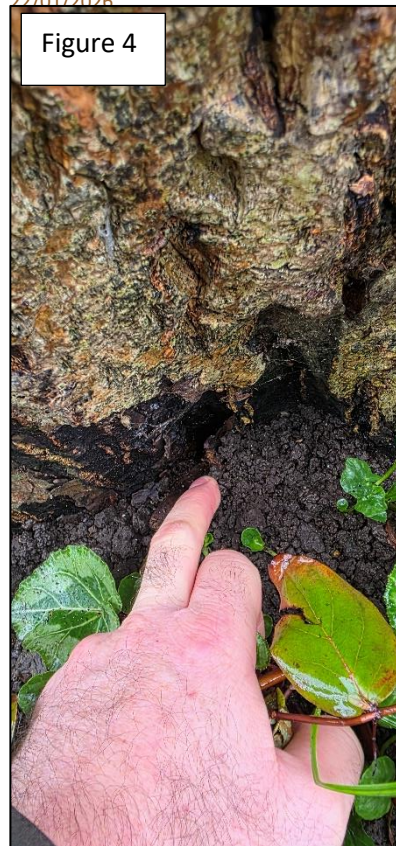
Figure 4

3.3.2. Visual inspection of the trees stem base exposed a small cavity projecting downward at a 45° angle below the trees stem base. A probe can be inserted 200mm deep into this cavity<sup>5</sup>.

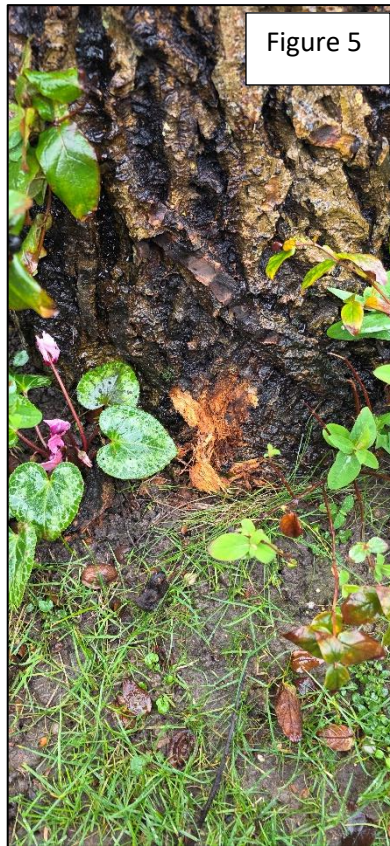
Figure 5

3.3.3. Mallet sounding of the trees stem circumference from ground level to an approximate height of 1.5m resulted in a loud resonance from the northern portion of the trees main stem to an approximate height of 1.2m above ground level. During the sounding of the trees stem a small section of bark fell from the trees lower stem base close to ground level in its northwestern quadrant<sup>6</sup>. Closer inspection of this detached area of bark revealed wood fibres which were soft to the touch, wet and smelled strongly of fungus. The cambium below the detached section of bark is obviously dysfunctional and undergoing decay.

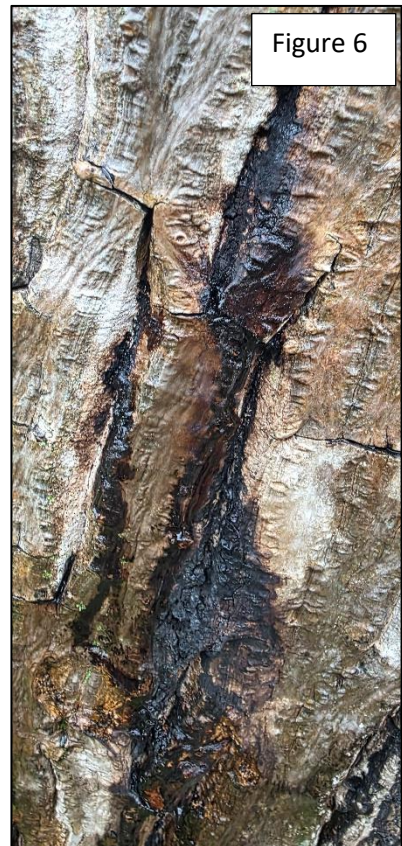
Figure 6

3.4.1. The northern side of the trees main stem, within the vicinity of the potentially decayed area highlighted by mallet sounding plays host to numerous areas of black exudate which is leaking down the bark of the trees stem<sup>7</sup>. These areas create a roughly teardrop shape when viewed from the north and extends from ground level to an approximate height of 1.4m above ground level<sup>8</sup>.

- 4.3. The black exudate covering the northern side of the trees main stem is characteristic of Honey Fungus<sup>9</sup> colonisation. This "bleeding" occurs when the fungus attacks and kills the vascular cambium (the living layer under the bark) at the base of the tree, causing the bark to crack and exude resin. I have observed this on numerous trees where the presence of Honey Fungus is confirmed. You have also mentioned that a Lime tree growing to the southeast of the subject tree was colonised by Honey Fungus and removed historically. Honey fungus (*Armillaria*) active pathogenesis involves aggressive root and lower stem infection, spreading via soil-borne rhizomorphs (bootlaces) or direct contact, destroying host tissue with enzymes, leading to wilt, dieback, and tree death, especially when plants are stressed, differentiating from its saprobic role on dead wood. The fungus actively secretes enzymes to break down host cell walls (pectinolytic enzymes), creating dysfunctional zones and progressing colonization through mycelium, often starting from infected stumps or buried wood. The ever-increasing lean of the subject tree is likely due to decay of its roots as a result of this colonisation.

- 5.1. The subject tree should be felled to ground level using sectional dismantling techniques. All arisings should be chipped and removed from site. The resulting tree stump should be mechanically ground below the existing soil height<sup>10</sup>. Grindings to be removed from site and burnt. Grindings decompose and rob the soil of nitrogen (nitrogen drawdown), which will starve a new planting of beneficial nutrients and macro-nutrients. Fill the hole with a mix of fresh topsoil and well-rotted organic matter (compost). This helps dilute any remaining fungal spores and replenishes nutrients. Ideally, wait at least **6 to 12 months** before planting a replacement tree. This allows the remaining small roots to rot down and gives you time to see if the Honey Fungus has spread.
