# Post-Clean Verification Report

## **KFC Linaker : BEDHAMPTON : LARCHWOOD AVENUE**

## Grease Extraction System Cleaning

### Post Clean Verification Report Introduction

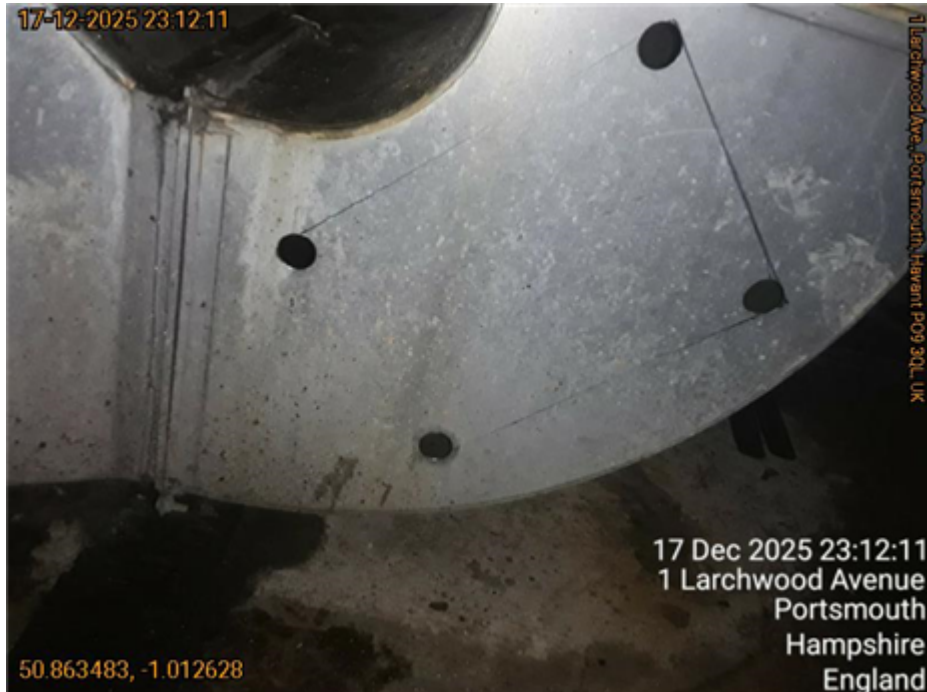
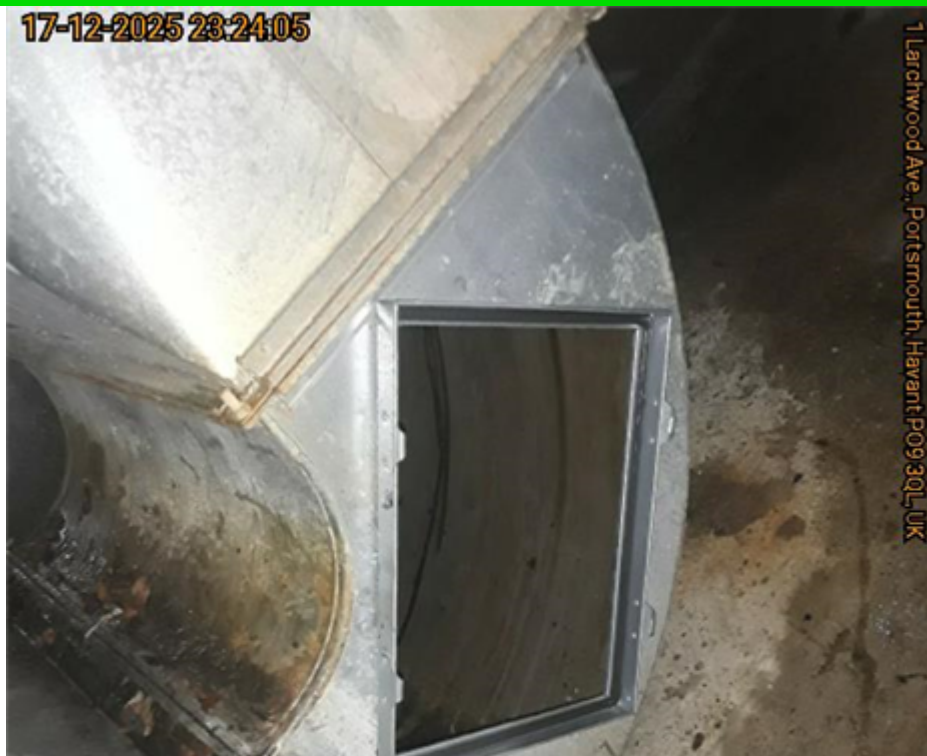
**Remedial Works – Main Cook Line – Access Door 1****Pre-Clean**
